Condition report for flood protection and land management assets for all zones

For:
Waikato Regional Council
Private Bag 3038
Waikato Mail Centre
HAMILTON 3240

December 2021

Document #: 20419287

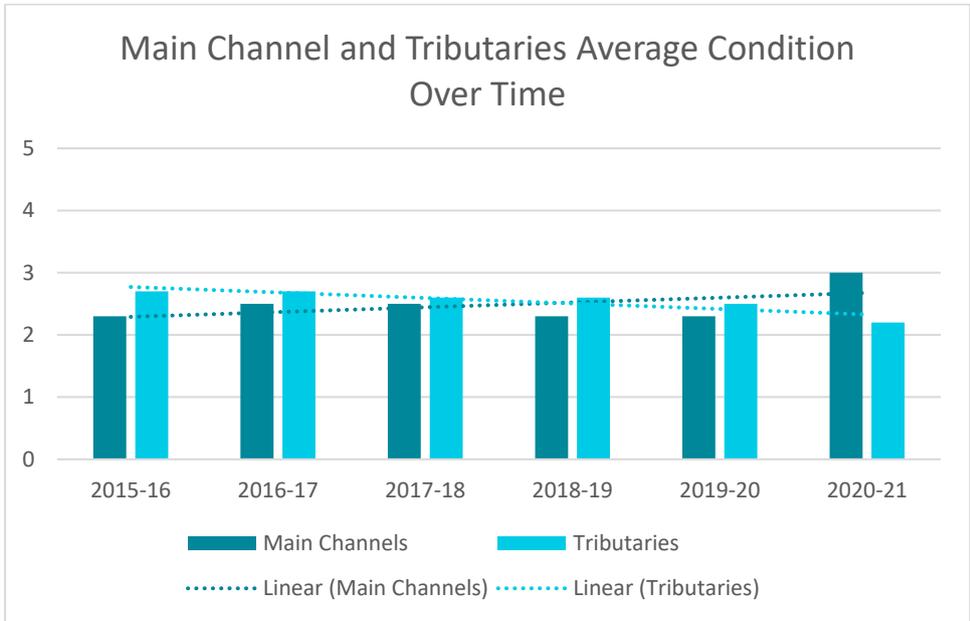
Main channels show a stable line across the previous 5 years, with a swing towards deterioration this year. Tributaries are show a slow improvement over the last 6 years. There should be some investigation as to what is being done differently between the two asset types in order to explain this difference.

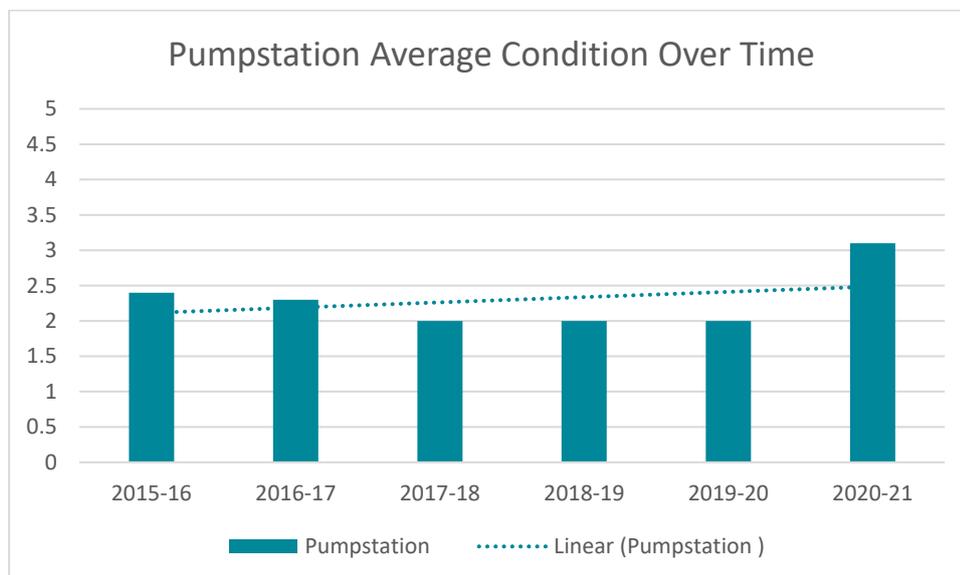
This year shows a significant swing towards deterioration in the average condition. This could be due to the new condition scoring criteria, represent a genuine deterioration in the asset base, or be a combination of the two.

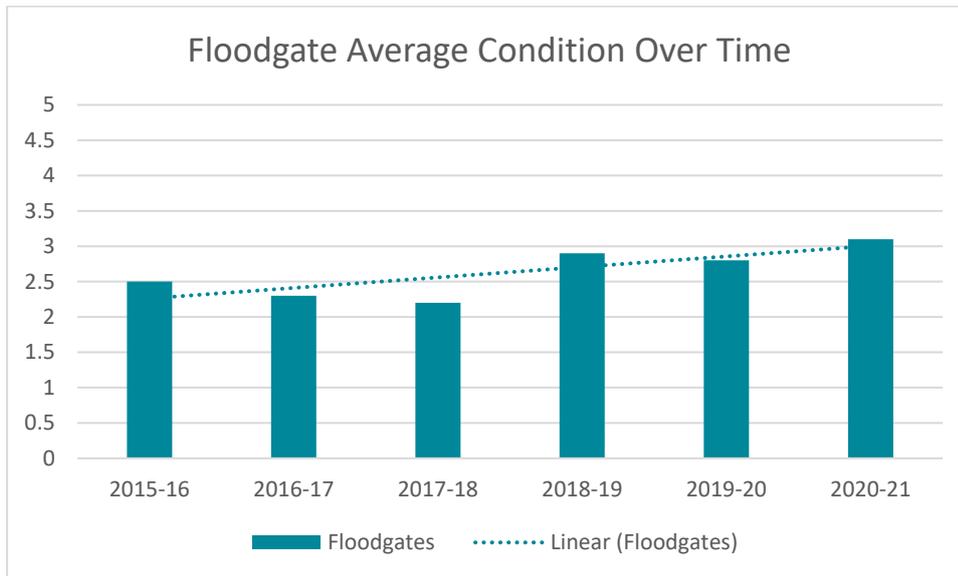
Floodgate Average condition has been deteriorating steadily over the last six years. This, combined with the 55% deterioration this year suggests that there may be a large number of assets needing major attention in Thames Valley in the next 10 years. To avert this, the current maintenance schedule should be reviewed for effectiveness.

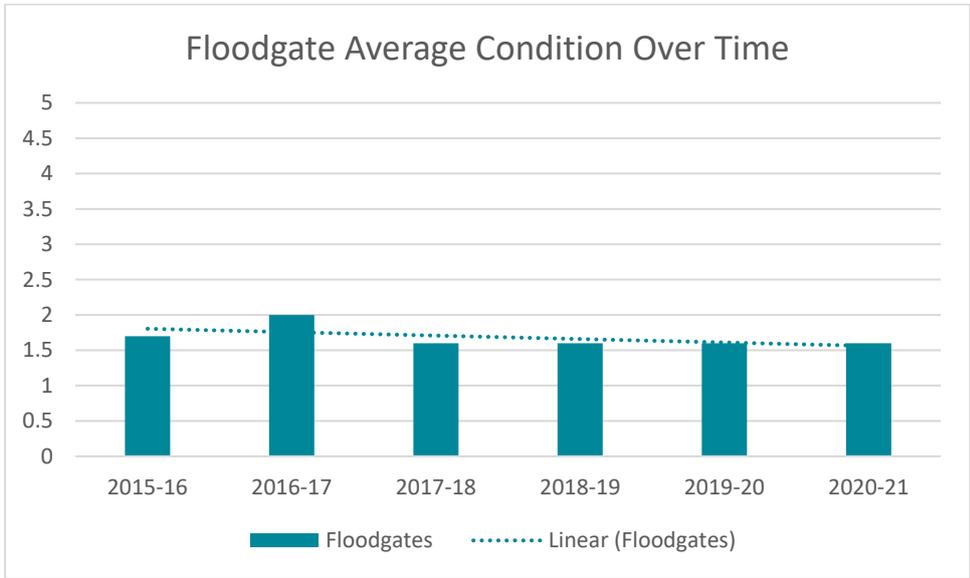
The overall trend for Coromandel Floodgates is one of stability. Year on year there is little change in the condition of these assets and inspection notes typically describe few issues other than vegetation.

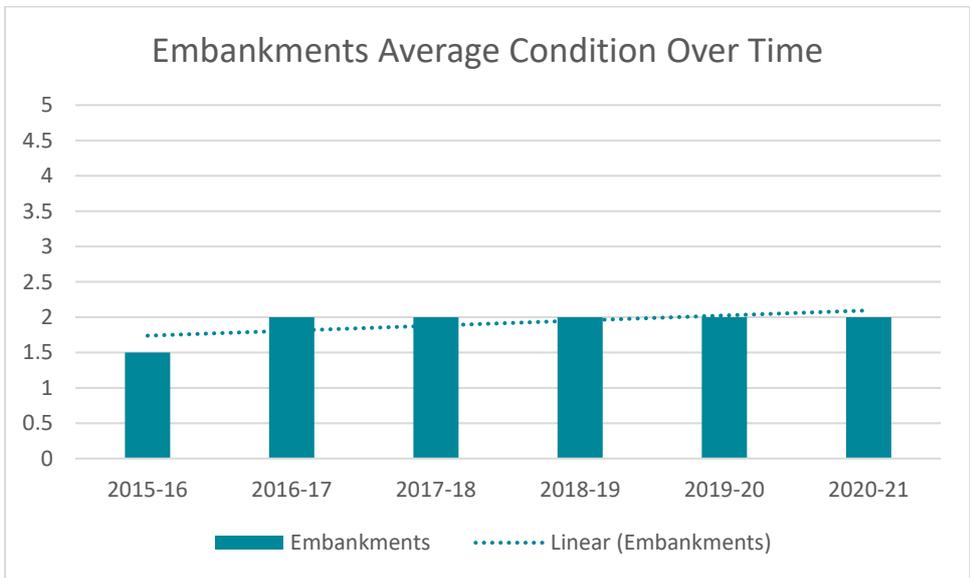
Similar to Floodgates, Embankments in Coromandel show a trend of stability with very little change. The inspection notes for these assets show a variety of minor defects to be addressed.
