Te Puru Stream flood protection scheme - service level review

Supplementary report - July 2020

For:
Waikato Regional Council
Private Bag 3038
Waikato Mail Centre
HAMILTON 3240

July 2021

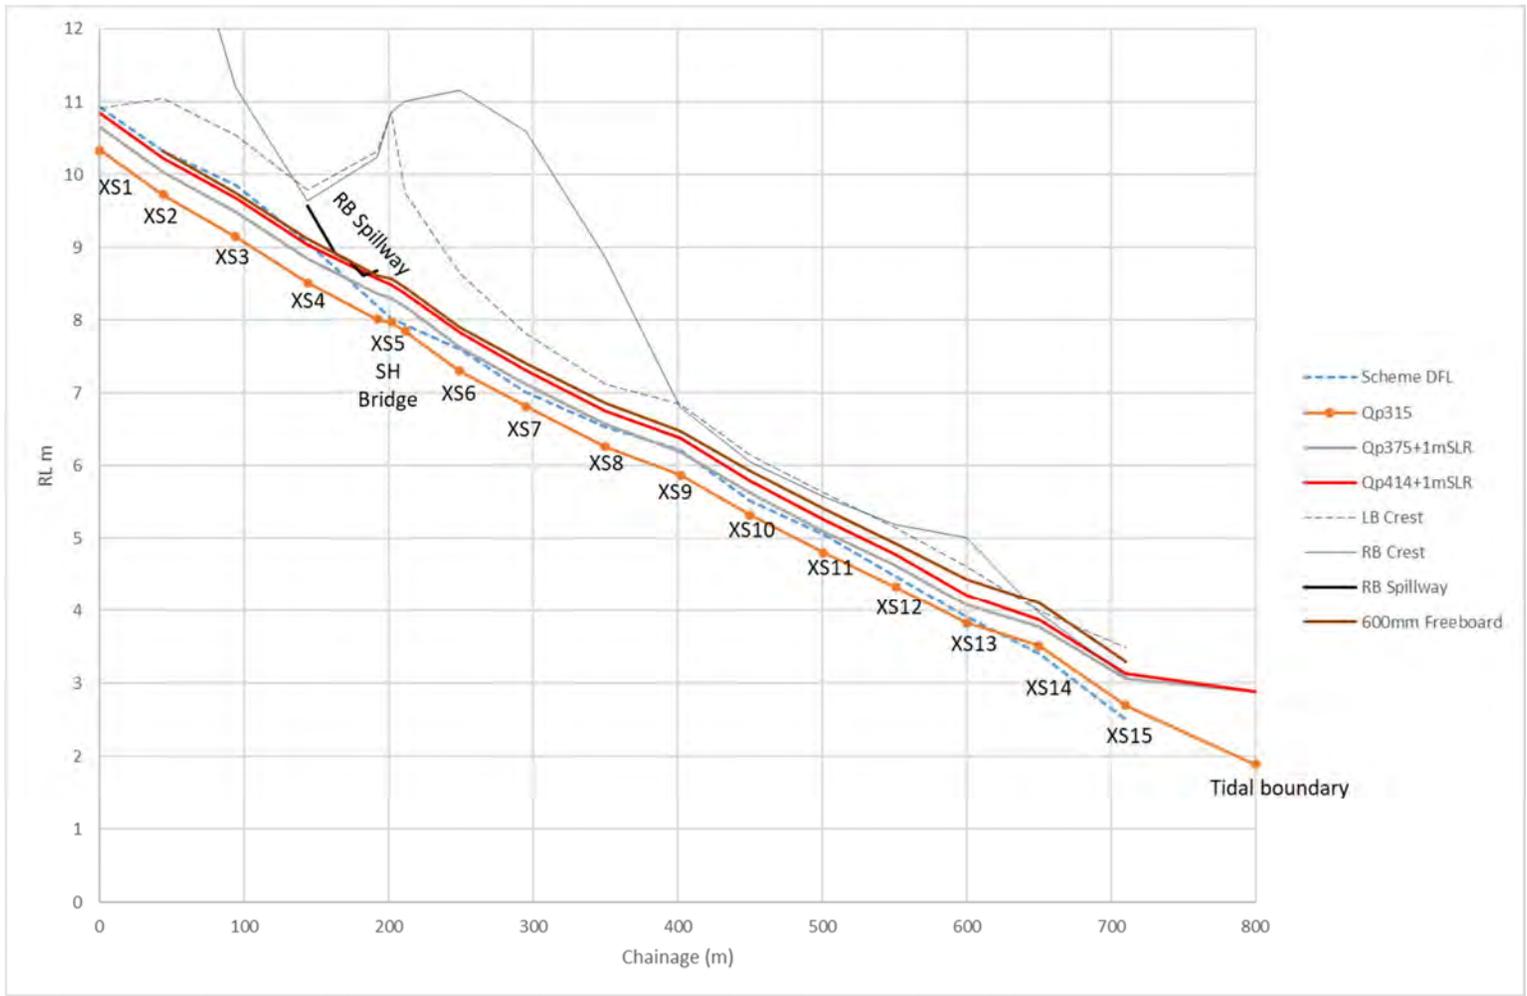
- The original design flood profile is mostly higher than the revised design flood profile. This is more prevalent upstream of the bridge and reduces downstream to less than the revised flood profile (Figure 5).

Figure 5 Modelled 2020 flood profiles compared with original design flood levels and left and right bank assets (levels are shown in Table 2).

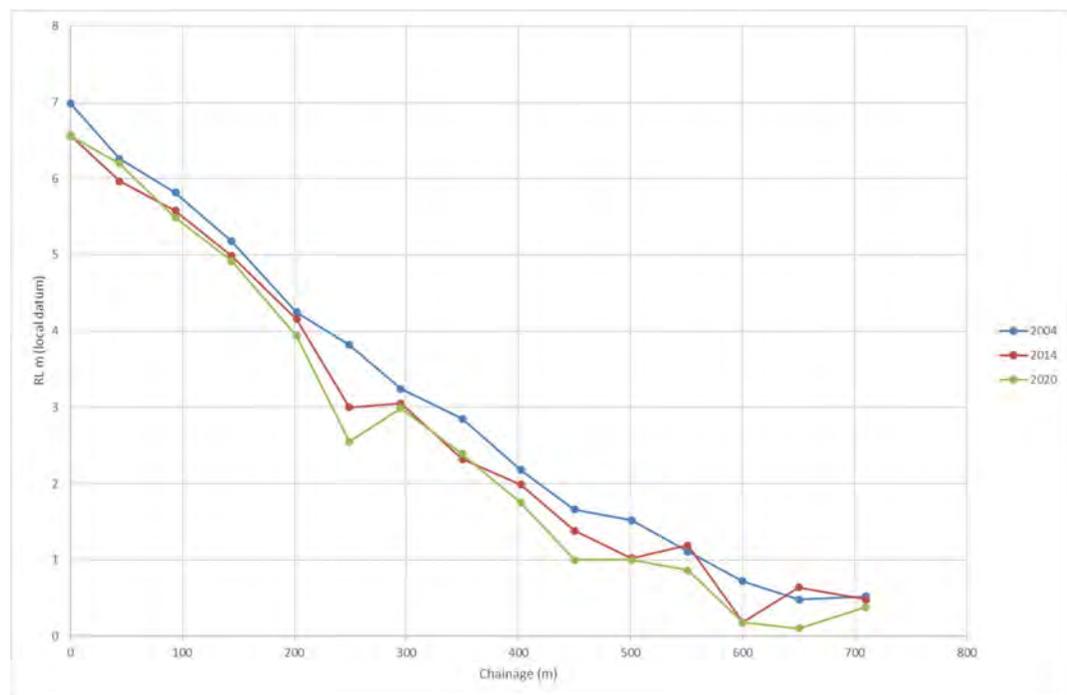
Comparison of the 2004, 2014 and 2020 channel cross-sections indicate that the minimum bed level has typically degraded and was on average -0.27m lower between 2004-2014, and -0.42m lower between 2004-2020 (Figure 6).

From 2004-2020 the minimum bed levels upstream of the bridge were -0.06m to -0.43m lower; immediately downstream of the bridge (XS 6) -1.27m lower; and further downstream towards the mouth the average was -0.40m (range -0.16m to -0.66m). Minimum bed levels are lower around the stream mouth in 2020 than in 2014, likely owing to both excavation, scouring during high flow events, and the timing of surveys.

The bed lowering recorded over the surveyed reach (2004-2020) increases the amount of available freeboard and helps explain the apparent lowering of design flood levels. The lowering of bed levels since 2014 has also helped improve the shortfall in freeboard noted in Grant (2019), although this remains an issue indicating a potential need for further excavation.

Figure 6 Minimum bed level profiles from 2004, 2014 and 2020 channel surveys between XS 1 (upstream) and XS 15 (downstream).

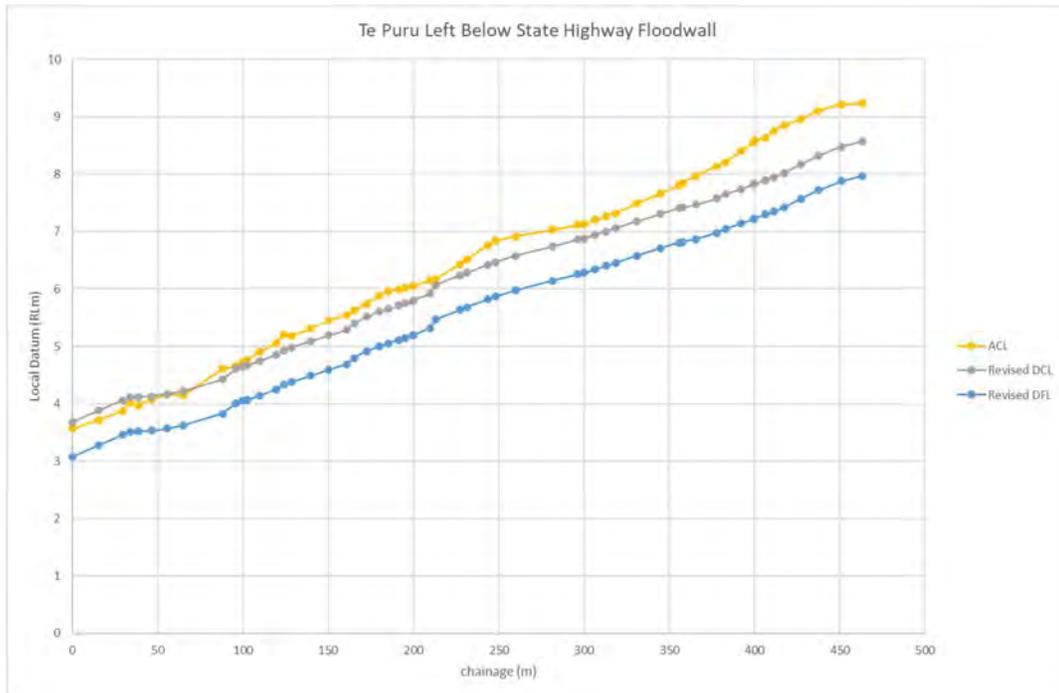
Figure 7 Te Puru Left Below State Highway Floodwall - profiles for actual crest level (ACL) compared to the revised design crest level (DCL) and design flood level (DFL).

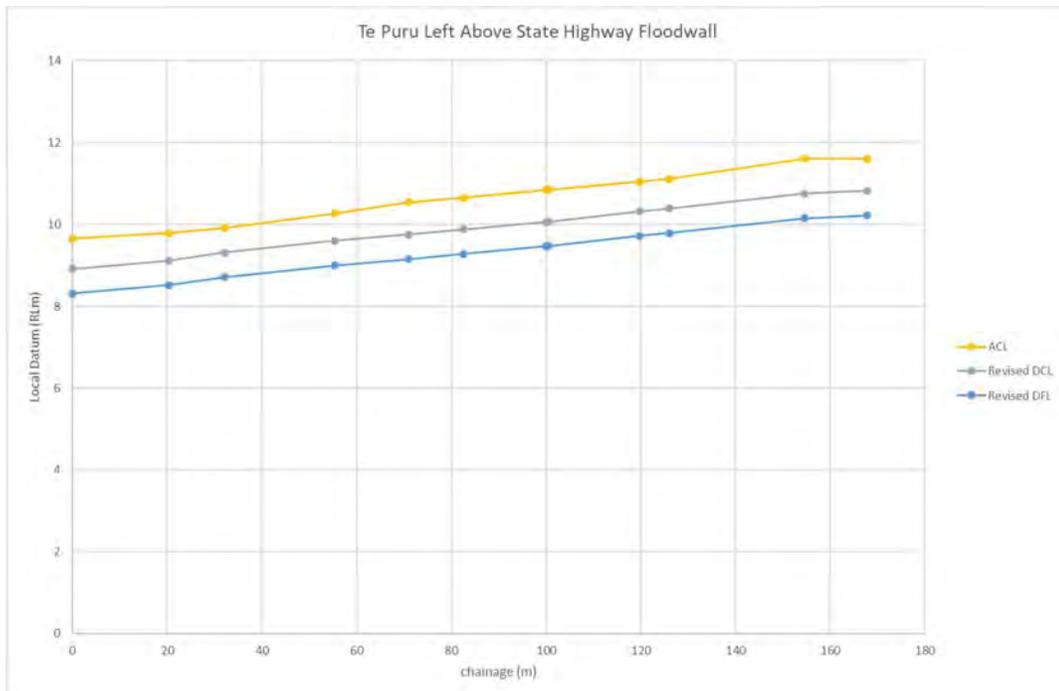
Figure 8 Te Puru Left Above State Highway Floodwall - profiles for actual crest level (ACL) compared to the revised design crest level (DCL) and design flood level (DFL).

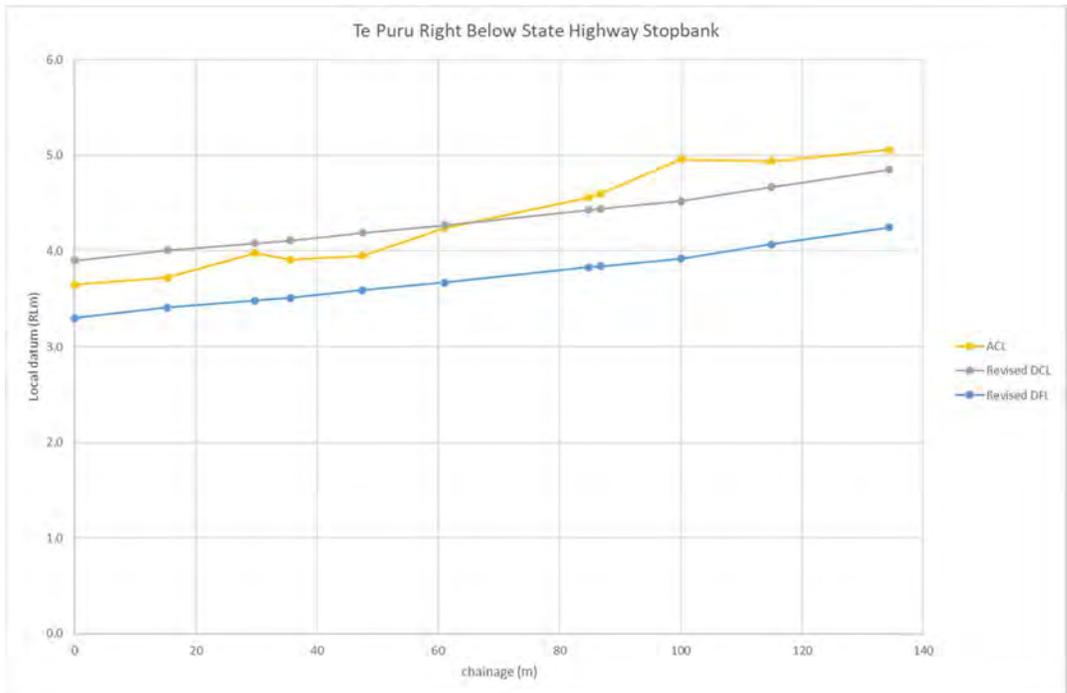
Figure 9 Te Puru Right Below State Highway Stopbank - profiles for actual crest level (ACL) compared to the revised design crest level (DCL) and design flood level (DFL).

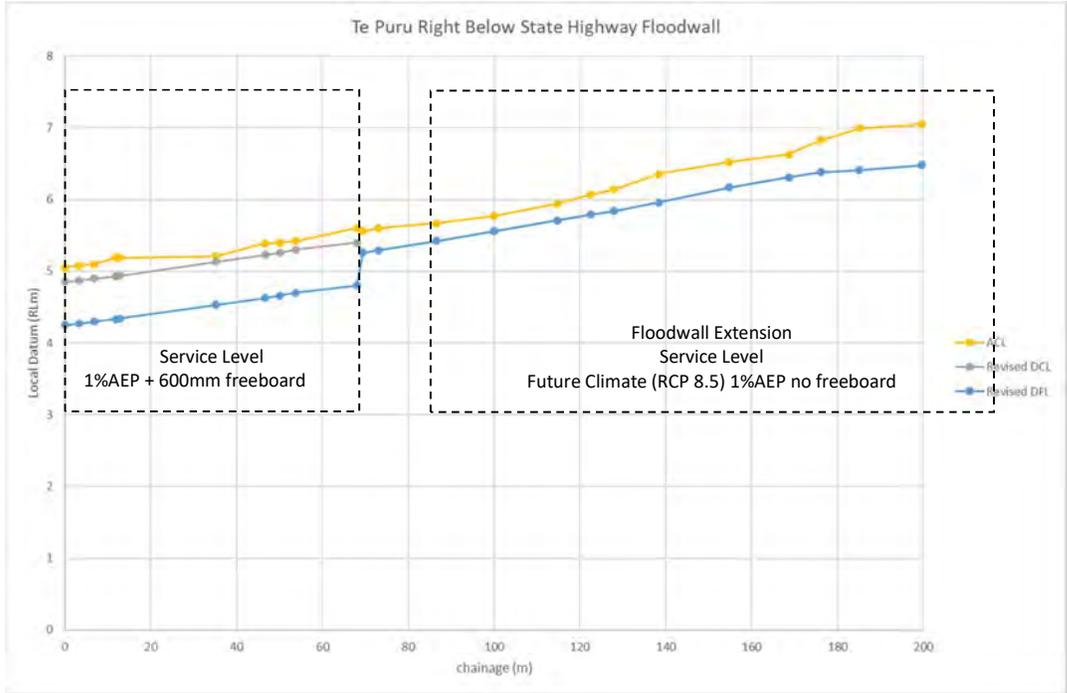
- This proposed change in service level results in design flood/crest levels 160mm higher than those currently assigned to the 'floodwall extension' asset, however the actual crest levels already cater for this condition.

Figure 10 Te Puru Right Below State Highway Floodwall - profiles for actual crest level (ACL) compared to the revised design crest level (DCL) and design flood level (DFL).

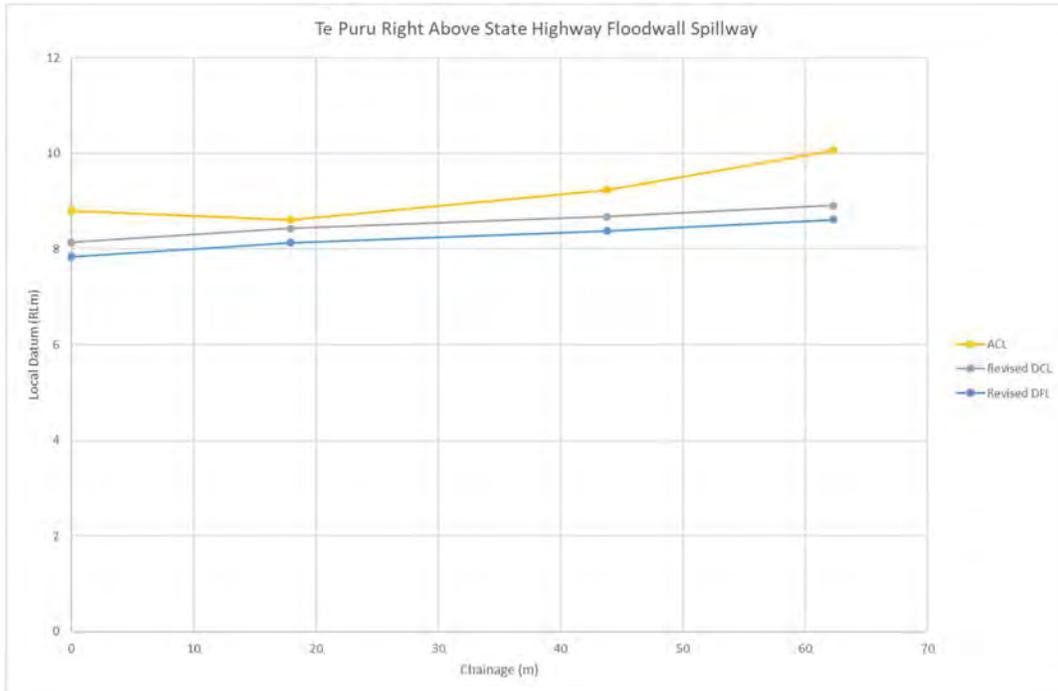
The spillway design is for the 1%AEP design flow with 300mm freeboard. The modelling suggests there is 480mm freeboard available for the revised MIKE11 model similar to the design condition. Modelling of the future climate Q_p414 event estimated that peak water levels would be just high enough to commence spillway activation.

Figure 11 Te Puru Right Above State Highway Floodwall Spillway - profiles for actual crest level (ACL) compared to the revised design crest level (DCL) and design flood level (DFL).
