Whangarahi River Survey Coromandel 2008

“Towards Streams for Fish Passage”

Manu Waiata Restoration & Protection Society
2009

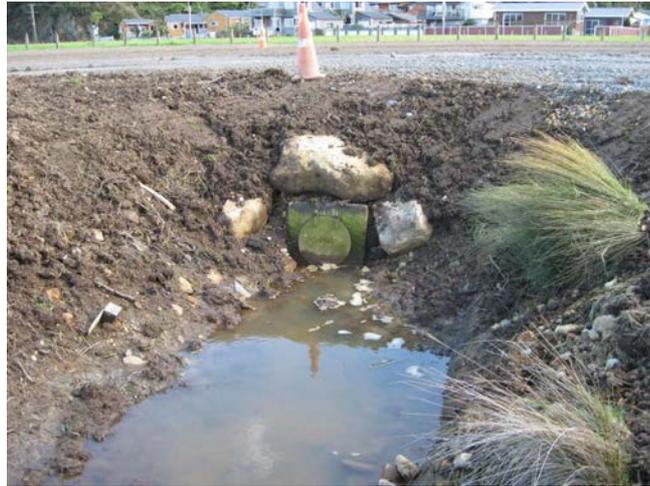
“Patukirikiri creek”. The creek is depicted in Hoyte’s painting ca 1870. In 2008 an overgrown tidal drain empties into the harbour from the area of the carpark. It has a culvert with a shut lid. Crabs and small fish were observed. Upstream, the drain passes under Wharf road towards the old sea cliffs.

Patukirikiri creek with shut lid.

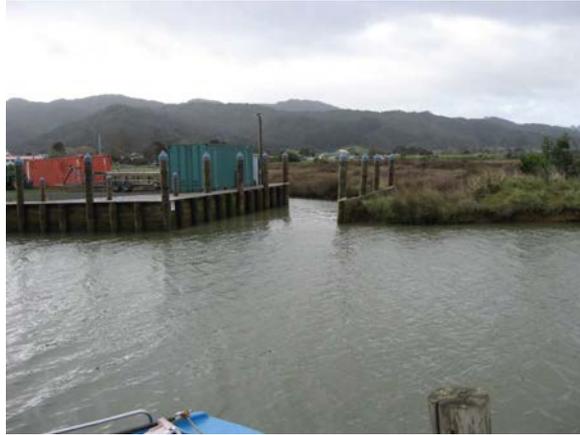
Retaining walls at Te Umuhau mouth.

Recommendation: Occupation of the “Te Umuhau” stream margin to be investigated. The retaining wall has displaced inanga spawning habitat. It is appreciated that making changes to the retaining wall is a huge undertaking, so perhaps the best remedy is to create as much new habitat as possible, such as planting some tree cover on the Te Umuhau where possible and native grasses suited to inanga spawning where possible.

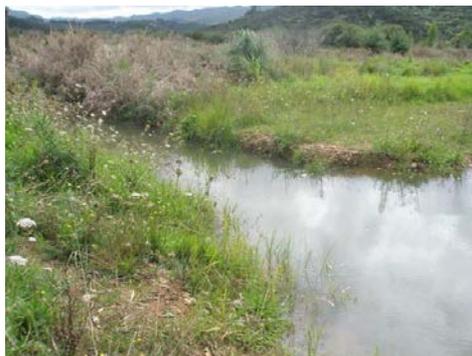
The Hauraki stream confluence without trees.

Recommendation: Plant grasses and trees around the confluence. Planting on this side of the Whangarahi in this location presents no danger for Coromandel town in the case of floods. Include the planting of native grasses for inanga spawning habitat.
Zoned for Peninsula Project restoration.

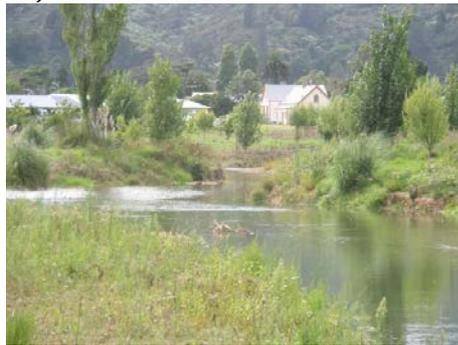
The Karaka confluence with very little tree cover.

Recommendation: Plant the confluence with trees to provide shade cover and food for fish. Planting on the true right side of the Karaka's mouth would present no flood danger as it is away from the main force of flow. On the south true left side of the mouth flaxes and other plants that can handle a flooding, though also provide shade could be planted. Tree cover could also prevent the slime and algae cover on the stream bed as it tends to grow in warm and unshaded water. Also plant grasses for inanga spawning near water's edge.

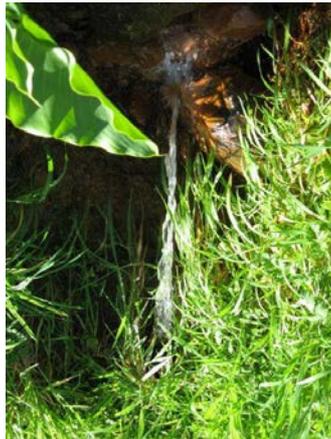
The severely disjunct culvert at “Hans Creek”

Recommendation: Restore Hans creek. Replace culvert with a bridge.

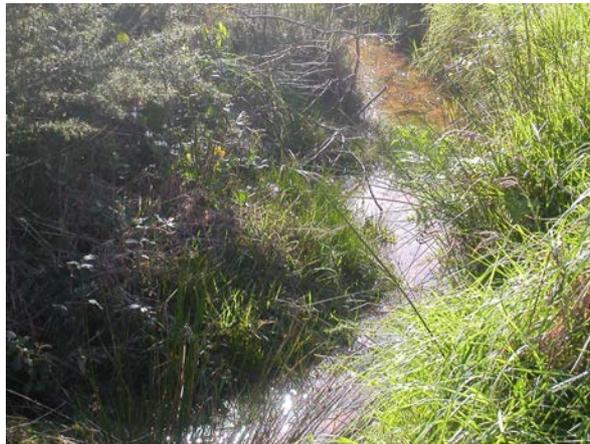
Weed choked tributary with orange slime buildup.

Recommendation. Remove all the weeds and the source of pollution causing the orange slime buildup. There are eels and native fish in the Hauraki stream and it is important not to endanger their health with contaminants that may enter from any source.

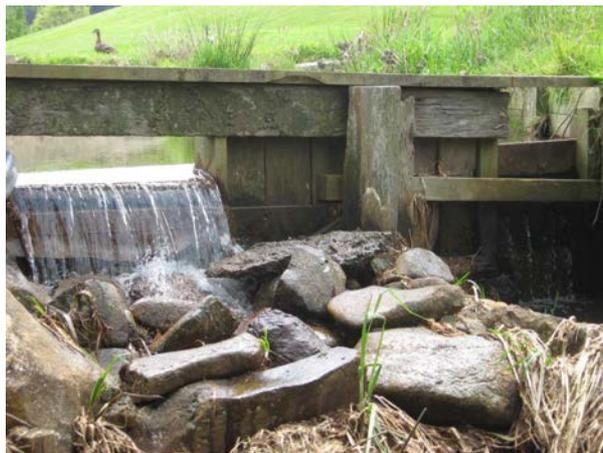
The entry of the Hauraki stream into the very long culvert is grassy and fairly overgrown. It is however passable for fish. This culvert is far too long to be ideal for fish passage. Kokopu have been found this side of the culvert.

The culvert exit at the Golf Course. The hatch is pictured closed on the right of the picture, where small dribbles can be seen.

Recommendation. It is recommended that it is made sure this hatch always be kept open, or the nature of this dam be changed. Kokopu have been recorded in the stream above the Golf Course and it is very important that their safe passage is always ensured.

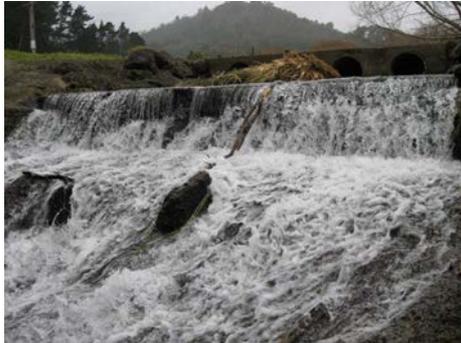
The waterfall at the Petote stream confluence does not allow fish passage.

Investigate the possibility of a fish ladder being installed at the waterfall.

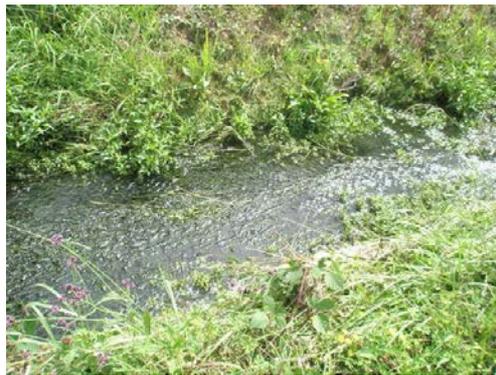
Weeds choking the Greenhills stream.

Recommendation: Plant shade cover to help prevent weed buildup. Remove weeds from stream

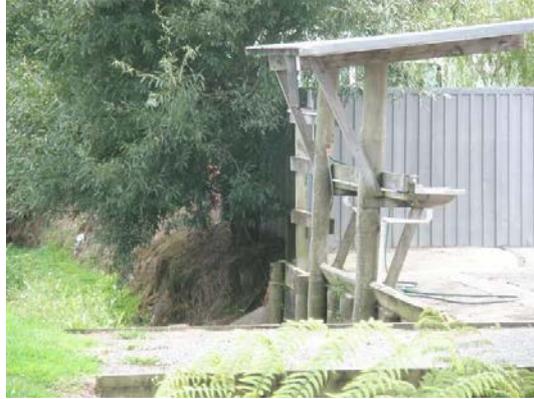
The fish cleaning site at the Coromandel Holiday Park backs onto a drain just before it enters the Greenhills stream.

Recommendation: Ask the holiday park if perhaps they could dispose of fish remains in a different way.

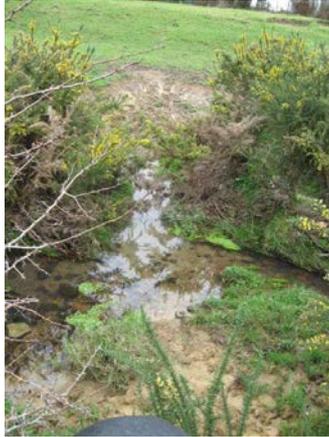
An example of degradation where cows can access Greenhills stream.

Recommendation: Talk to land owner about fencing off stream banks and introduce him/her to the clean streams project.

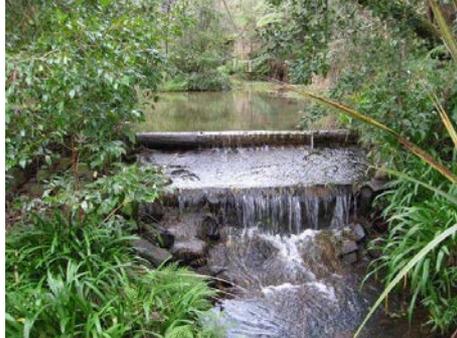
This dam exiting a pond on the greenhills stream could do with a fish ladder.

Recommendation: Install a fish ladder.

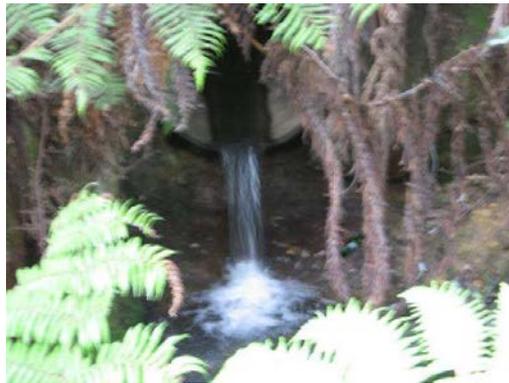
The culvert at Edward St. that needs a fish ladder.

Install a fish ladder. It could possibly be made by making a sloping mound of rocks and cement.

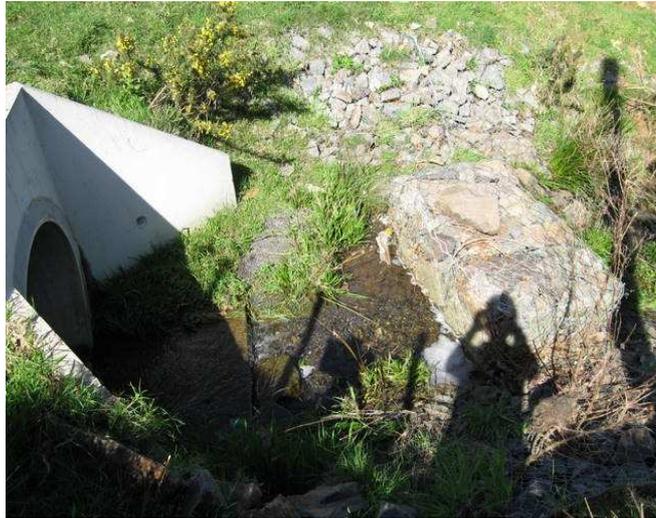
The gambian basket placed in the middle of the stream at Pagitt St. confluence where it exits from the long piping. (300 m approx.).

Pipes be retrofitted to create locks for fish passage.

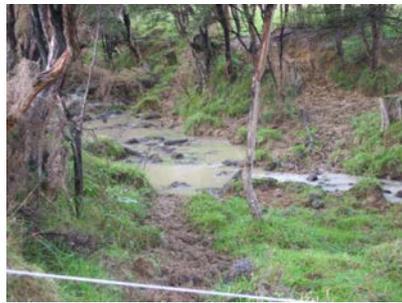
Cow degradation of the Taumatawahine.

Connect the landowner with the clean streams project. He has expressed a keen willingness to get the stream protected. He will pay for fences and put in troughs as an alternative drinking source for his stock.

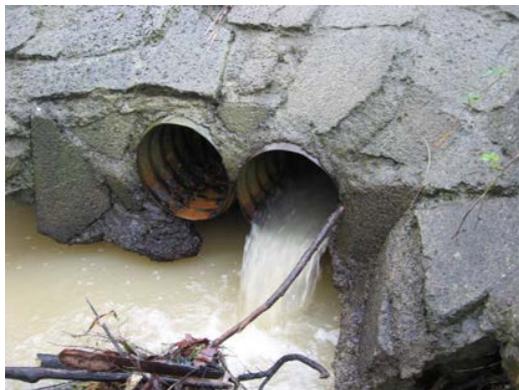
Disjunct driveway culvert across the Taumatawahine.

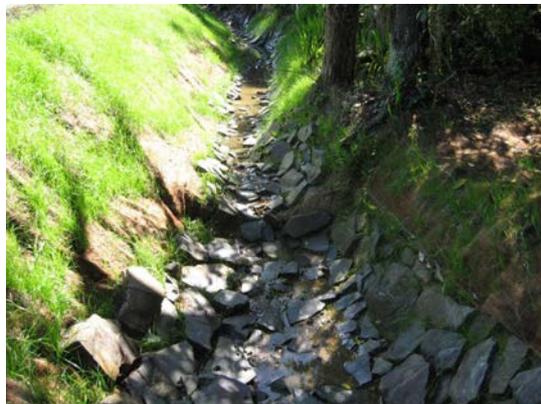
The open drain is also lined with rocks so with the limited flow it is very difficult for fish to negotiate the drain.

The open drain designed to help fish passage from the Taumatawahine is rocky bottomed with very poor flow impeding fish passage.

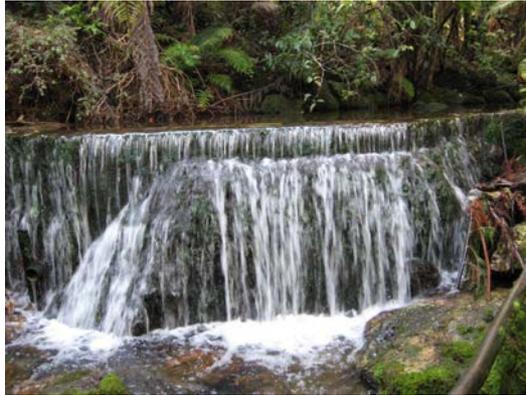
The second dam above the Buffalo stamper battery.

Three dead possums were seen lying in a pool just above the ford.
The river travels through stunning bush and mossy pools then alongside Buffalo Road and the Stamper Battery.
The Stamper battery has a small old concrete dam, about two feet high.
Then there is a second dam about 3 meters high.
Recommendation: Install fish ladders.

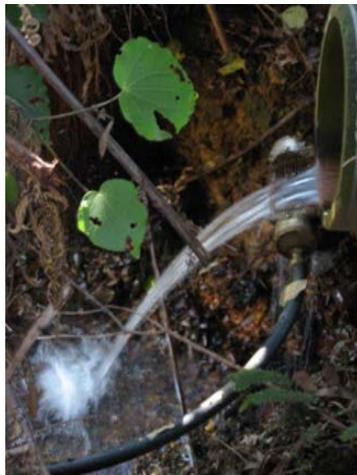
Disjunct Rings Road culvert at the top of Mary Foreman's property.

Recommendation: Replace the culvert or install a fish ladder (could be challenging for a 2 meter height).

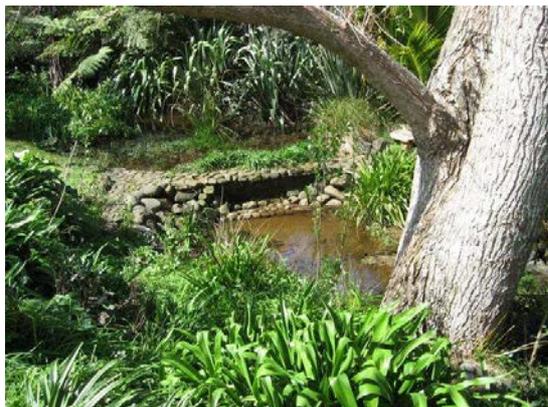
One of the dams for the ponds at Lindesfarne.

Recommendation: Talk to Erica and Mike about changing the nature of their ponds.

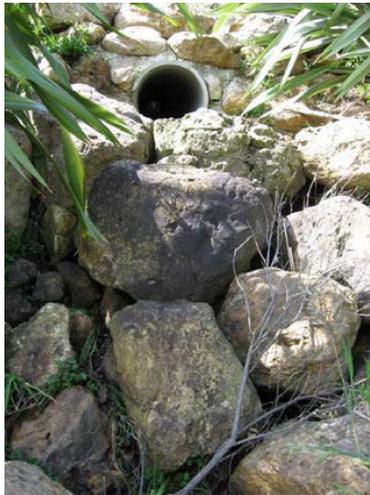
Culvert not designed for fish passage

Recommendation: Remove boulders and create a form of flow that fish can negotiate. Possibly using fish ladders.

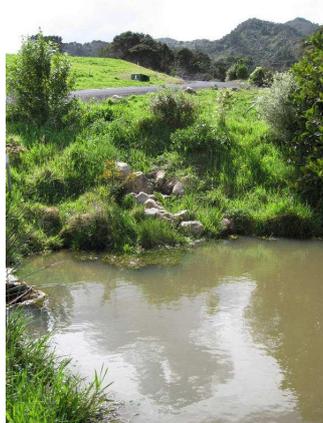
Pond 1 is fed by a very small underground pipe flowing under the rocks just barely visible in the background and is impossible for fish to negotiate.

Recommendation: As an alternative to the pipe create a slow fed sloping waterfall with fish ladder qualities.

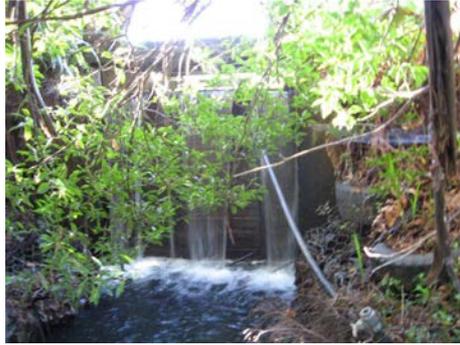
Dam for pond which obstructs fish passage

Recommendation: Install a fish ladder or remove pond. It is a challenging height for fish ladders.

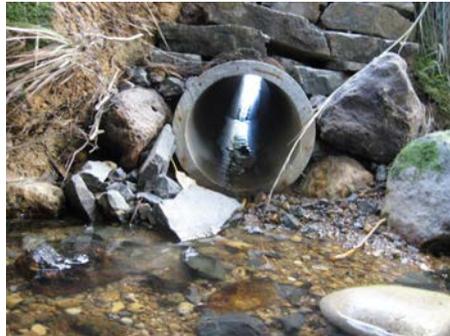
The entrance to the new open stream bed is also a culvert. Flow was inadequate for fish passage in September, 2008

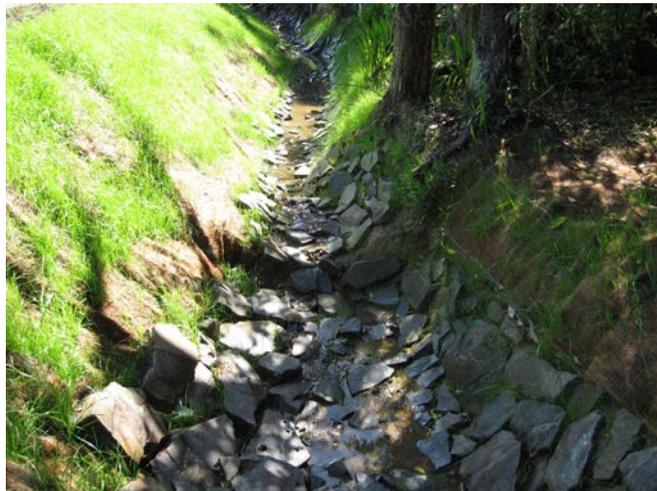
The new open stream bed has been lined with rip rap.. The original drain was a mud bottomed stream. With such a small diminished flow this type of bottom makes it difficult for fish passage.

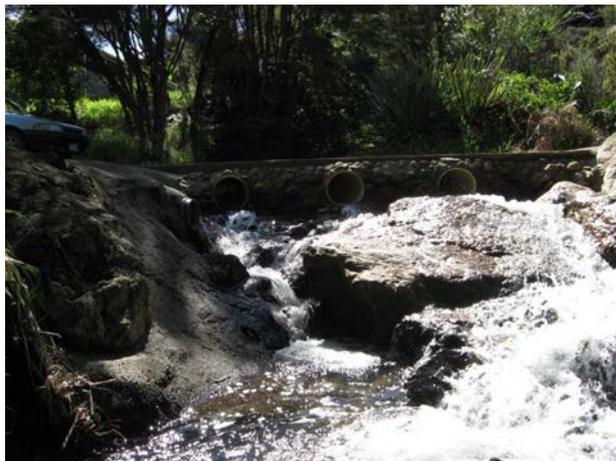
14. FORD ON DRIVEWAY AT THE END OF LILLIS LANE.

These culverts are set a little high. Though it is in the habitat zone of climbing fish this ford is a main contender for a fish ladder.

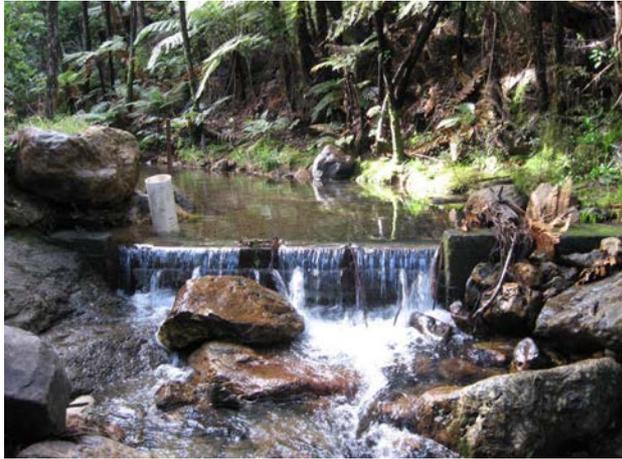
15. DAM JUST ABOVE BUFFALO STAMPER BATTERY.

This dam is also in climbing fish habitat. A fish ladder is appropriate.

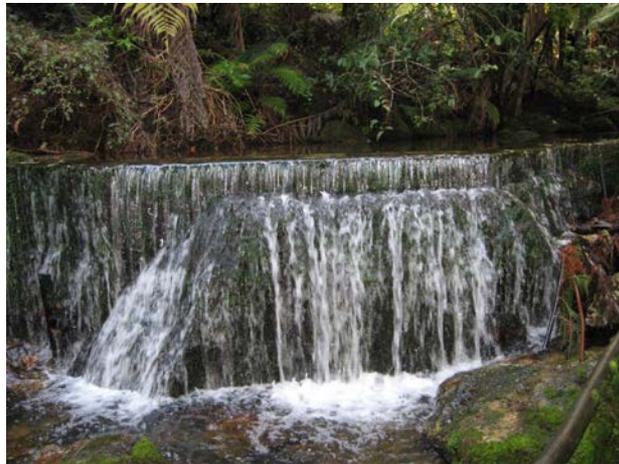
16. SECOND DAM ABOVE BUFFALO STAMPER BATTERY.

This second dam is considerably higher and certainly needs a fish ladder.

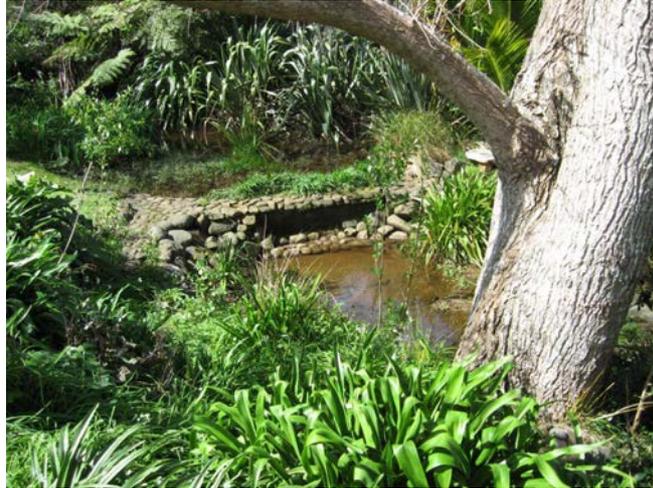
21. PONDS WITH DAMS ON LINDISFARNE PROPERTY.
The dams for these ponds make fish passage impossible.

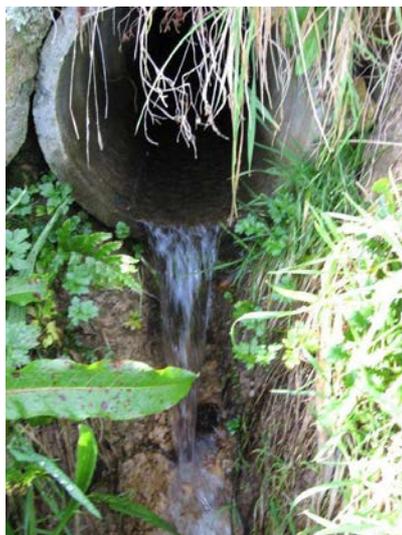
22. CULVERT SET TOO HIGH WITH BOULDERS
This culvert in the Longview subdivision is set too high. Also the steep bank preceding it is covered in boulders, blocking fish passage.

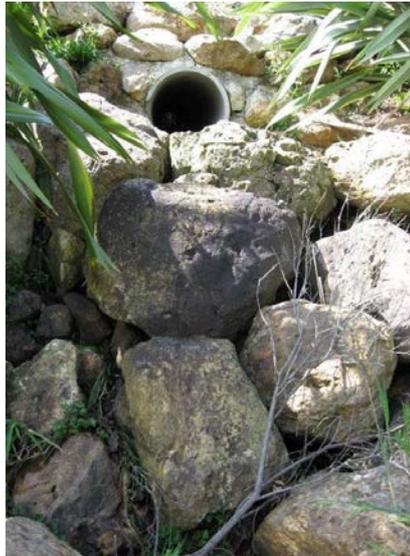
22b. Boulders at culvert outlet prevent fish passage.

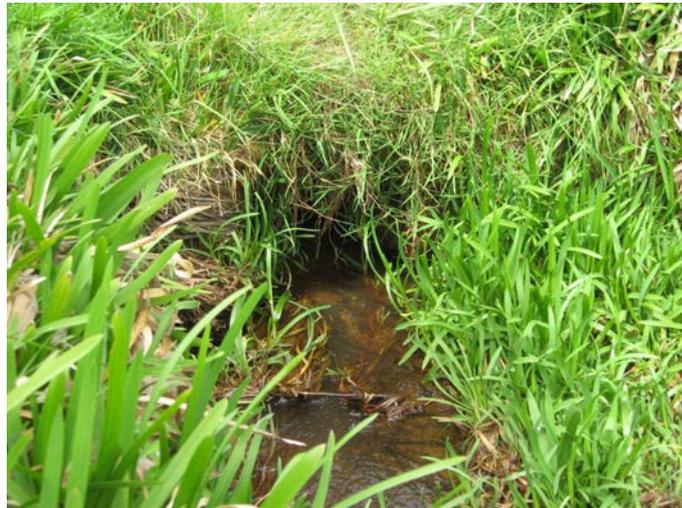
29. IN FLOW OF THE GOLF COURSE CULVERT.
This inflow is a little over grown.
