Lochiel Farm Environment Plan

Rob Macnab & Heather Gilbert

Total Ag Ltd

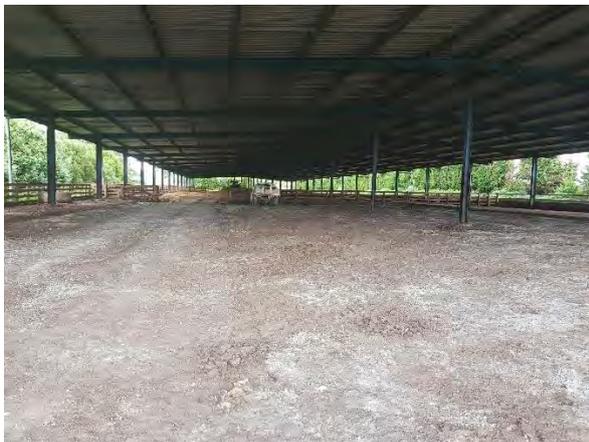
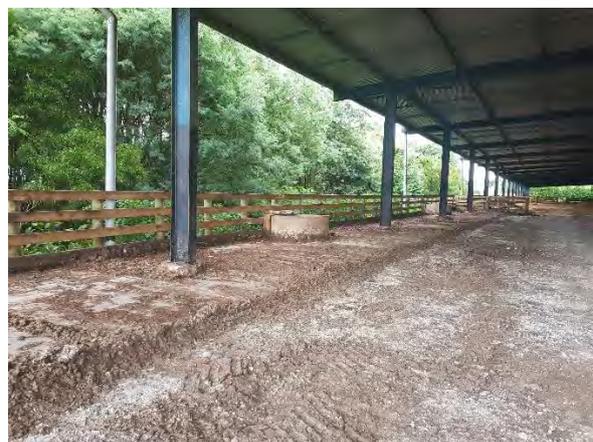
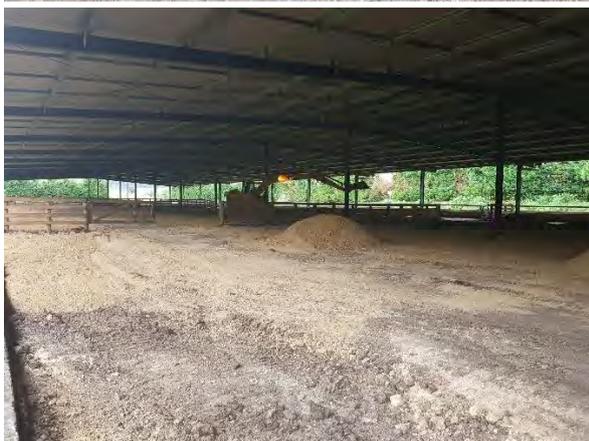
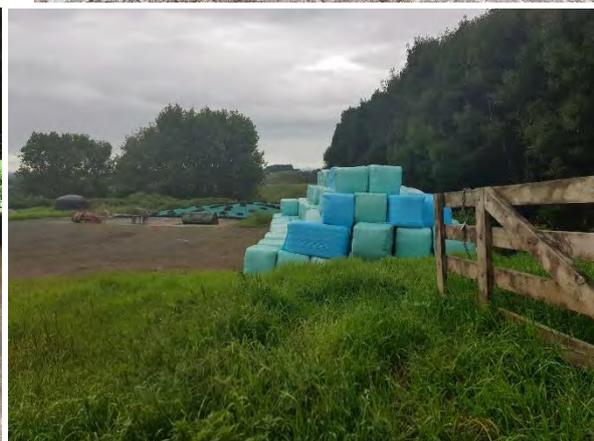
Feedlot

The feedlot is situated next to the cattle yards. The floor is stabilized clay covered with 12 inches of lime chip and sits level. There is a three-meter concrete apron either side of the lot where stock eat. This is scraped every 7-10 days into sumps at either end of the lot. The scrapings are mixed with water and stirred then spread on to the drive country.

The remainder of the lot has straw added and this is cleaned down to lime chip annually and put through the muck spreader and spread onto crop paddocks. Occasionally the chance is taken during the year to clean the pad when animals are removed, and this muck is stockpiled and stored on grass.

The feedlot is totally fenced off and there are plantings along both sides of the building. Roof water is captured in (6)3 0,000L tanks and used to water the feed pad. Any water overflowing from these tanks is filtered through the wetland below and is only ever roof water.

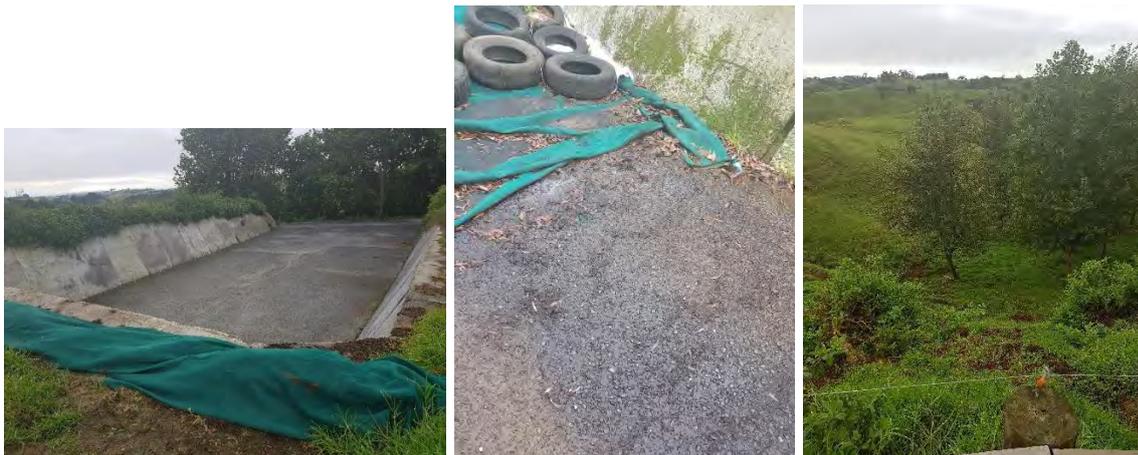
Silage bunkers

There are three large concrete banded silage bunkers however there appears to be a little slipping below the bunker closest to the cattle yard – which has caused the concrete to slump a little. This will need addressing going forward. Leachate from the bunker closest to the feedlot needs to be filtered – presently flowing over concrete onto grass – good idea to plant flaxes and sedges along this border to encourage filtering of any excess leachate. Or bund bunker so leachate is contained. There is a filtered wetland further down the gully that needs maintenance to make it fully effective.

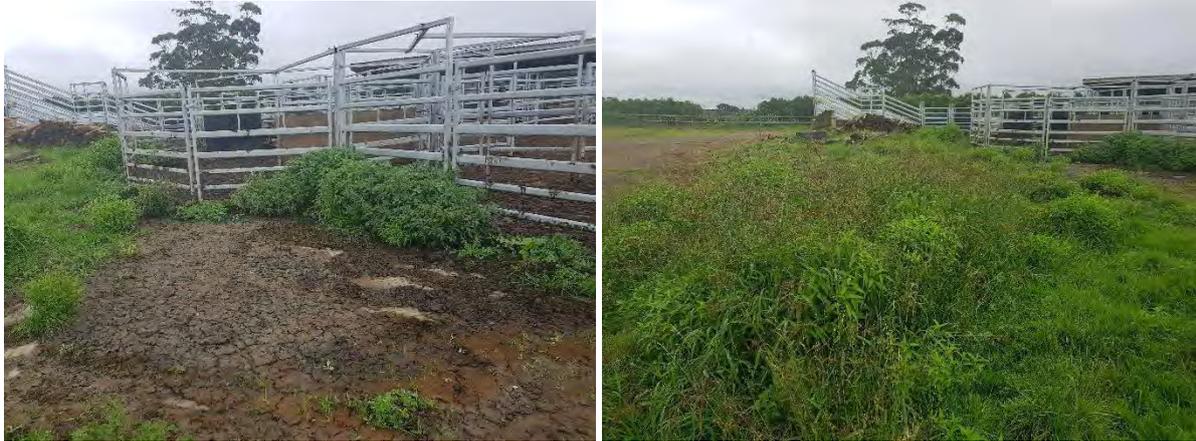
Cattle yards

The cattle yards also show evidence of leachate flowing out and into grass/swamp below. This area should be fenced off and planted with flaxes etc to help filter the leachate, so it is not flowing directly downhill into the waterway below. This also goes through the gully system that the silage bunkers do (see above).

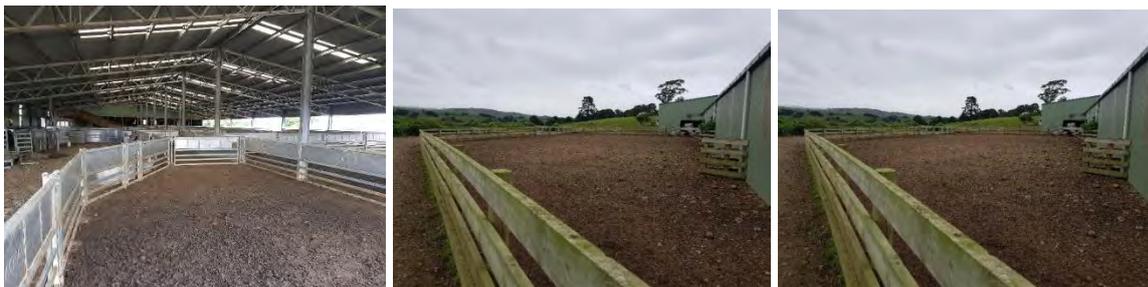
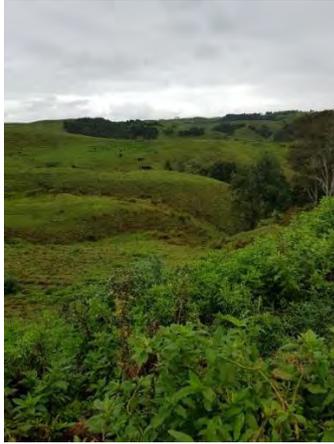
Sheep yards and woolshed

The sheep yards are covered and water from woolshed and covered yards is collected through downpipes and is channelled to a grassed area. The side of the yards slope a little and then drop off quite significantly about 10 metres from the fence. This area is currently covered with plantings but would benefit in the long term from some form of riparian planting to encourage filtering of water that runs off.

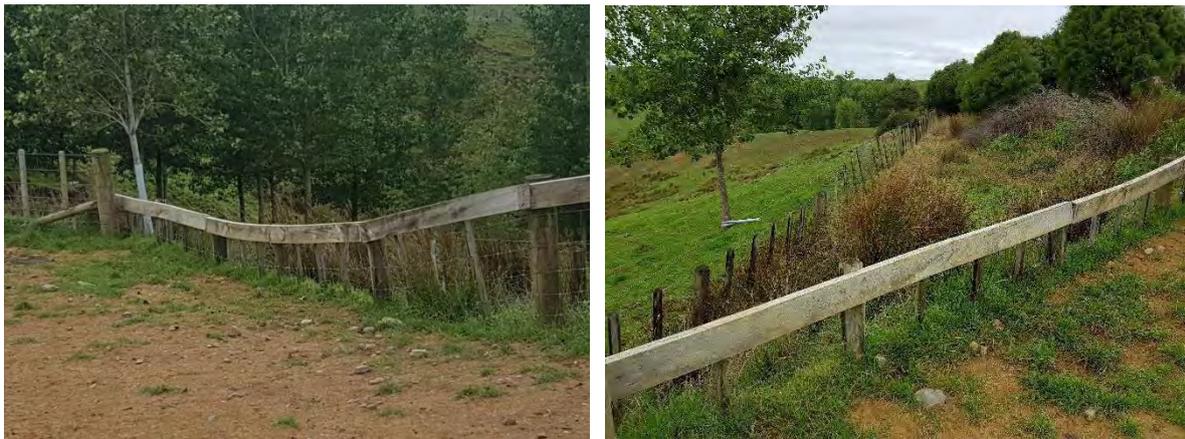
Satellite yards in 500 block

There was quite a bit of silt built up against the bottom-side fence of the holding yard, which shows the amount of run-off coming off the yard needs addressing. There is a stand of trees planted below the yard which will help with erosion and filtering, but it would also be worth planting some sedges and filtering type plants along under this boundary or building this area up so that the downhill flow of sediment is reduced.

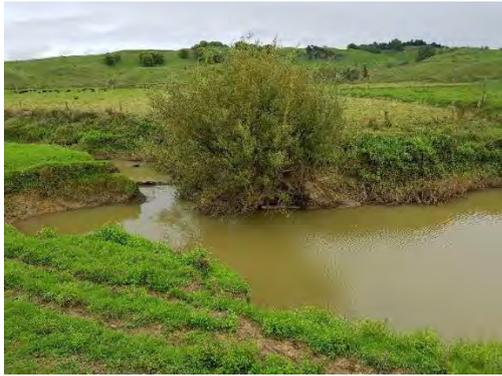
The Opuatia stream runs through the flats on the northern end of the property. It is a silt bottom stream and appears highly degraded due to the presence of koi carp. The Mangatia, which runs into the Opuatia, shows very little evidence of koi carp and is crystal clear, with small native fish present in large numbers. The Mangatia has been fenced and planted. Koi carp can generally only get into the Mangatia during flood and the difference in water quality from one stream to its tributary is extraordinary.

Corner of Opuatia stream where koi carp was seen, note lack of clarity of water

There is a small amount of stream bank erosion evident along the Opuatia stream and would be primarily due to the presence of the large population of Koi carp. This will be addressed as new technology, and funding becomes available to tackle the pest, as they are highly prolific breeders living in a near perfect ecosystem. It will take more than the effort of one farm to control them.

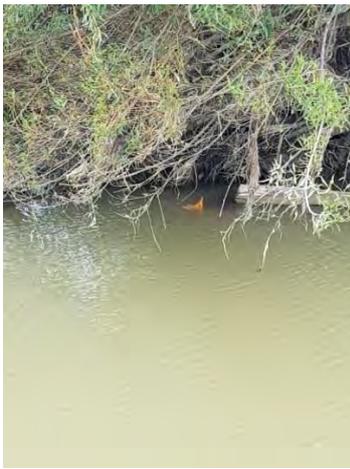
Koi carp

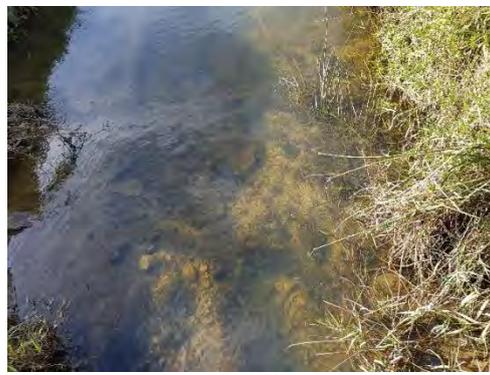
Mangatia stream

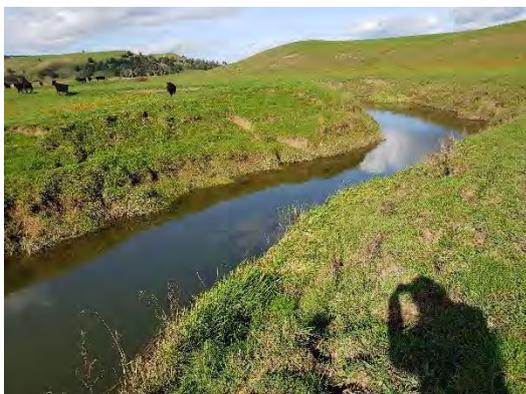
There is also less evidence of riverbank erosion as you move up the stream toward the boundary, with obvious vegetation growing right down to the water's edge. The photo below shows an unfenced stream, and the presence of vegetation shows that cattle are not grazing the riverbank. This would suggest that cattle are managed and fed well to avoid streambank damage. There is presently a programme underway to finish the fencing of the Opuatia (2018). Note flooding occurs frequently and fence design and maintenance is an ongoing issue.

Clarity of water improves as you move up the Opuatia

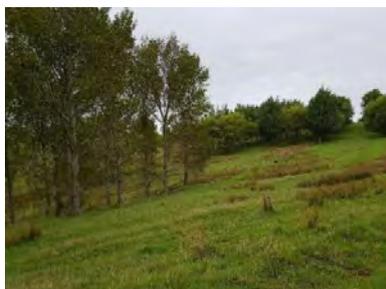
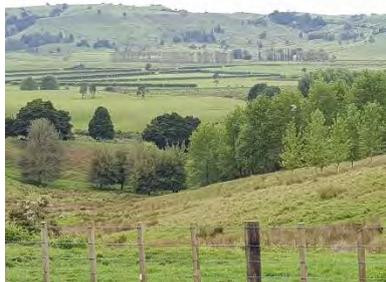
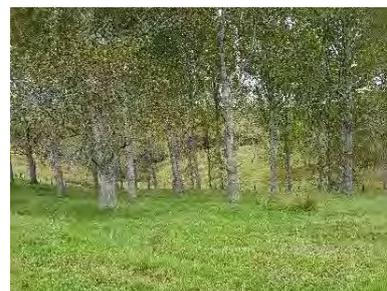
Pole planting

Extensive planting has taken place with established poplar plantations and newly planted poles evident over much of the property. There are also stands of native which have been fenced off. There are first and second-generation planting and smaller areas of third generation plantings over the entire property. Lochiel is in its fifth and final year of their planting plan. All plantings have been well thought out, with some thinning out of older stands having occurred. The pole plantings present on the farm are a credit to management and their commitment to soil conservation.

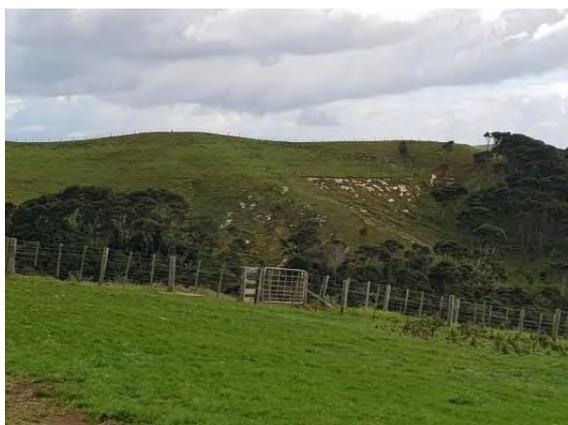
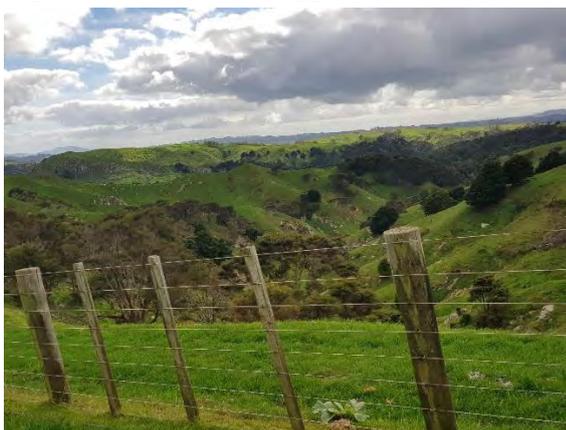
Limestone – shallow soil

There are areas of very shallow limestone in the hills, especially in the 52, 500 and Back LMU's which would require careful handling to avoid soil loss and erosion. There is very little evidence of erosion and soil loss over these blocks, and these areas are managed well. The steeper shallower slopes have lots of tag which would suggest very light grazing.

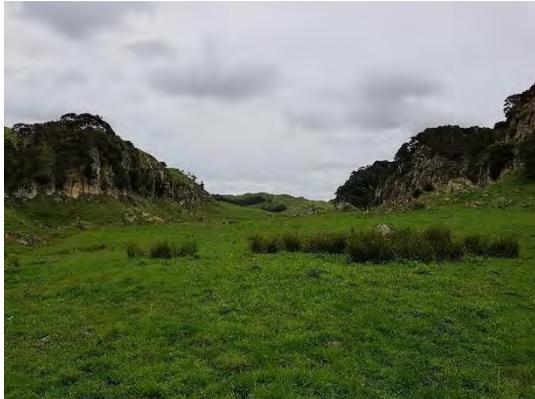
Gorge

The gorge is potentially a very wet area, which would benefit through the wetter months with extensive grazing of a smaller class of animal, such as sheep and R1 cattle. There is a small creek running down one side of the gorge, but it is unlikely fencing off this stream will

be of much benefit as stock don't appear to enter the stream or access its banks as they are quite steep and there are crossings at the top and bottom of the valley.

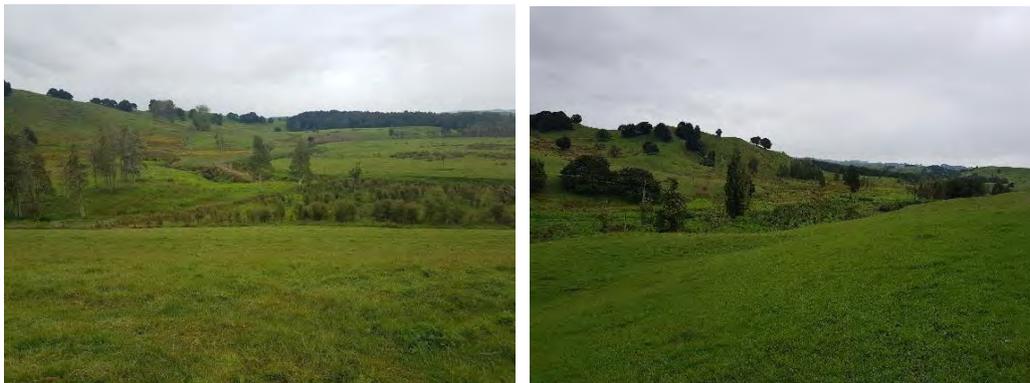
Flats

The flats across the Opuatia can flood badly during the wetter months and are sheep only. The flats can be pumped, but not when there has been large amounts of rain. There are good stands of riparian planting, both established and new, and shelter belts along the flats. One side of the Opuatia is fully fenced and the other side is currently being fenced.

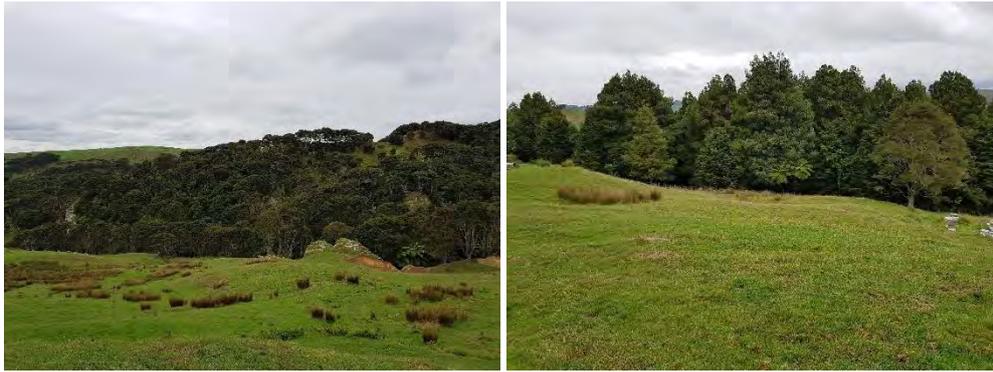
Manuka and native stands

There are stands of Manuka leading down to the gorge which could be fenced off to maintain integrity of hillsides. The regional council is currently funding the retirement of areas of land, it might be worth approaching your WRC land management officer to tap into this funding. There are quite a few native stands over this property which would benefit from this as well, to enable them to regenerate without stock pressure.

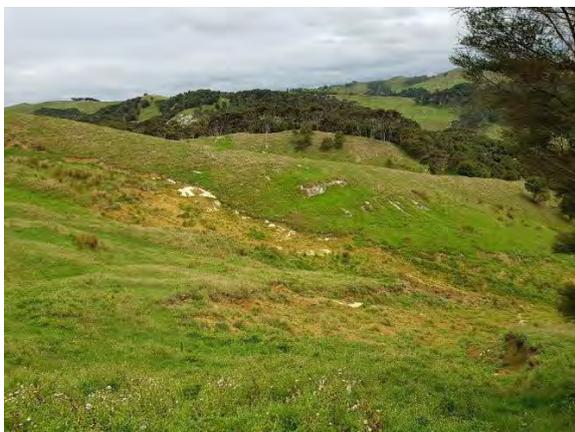
The risk is assessed as low to medium. There is a little evidence of erosion over the farm, and most of the slips have been addressed with strategic poplar and willow plantings and the fencing off the steeper blocks. Grazing intensity is carefully managed on the steeper slopes with evidence of tag left on the hills, demonstrating under-grazing of steeper slopes. There are one or two major slips evident over the property which are the product of exceptional storms in 2017 and early 2018. One of the slips has already grown over and the paddock has been lightly grazed with no evidence of further slipping or bare ground opening up. The second more recent slip also shows no evidence of stock grazing with long grass and plenty of vegetative cover still present over much of the slip.

Hillside affected by heavy rain event in 2017

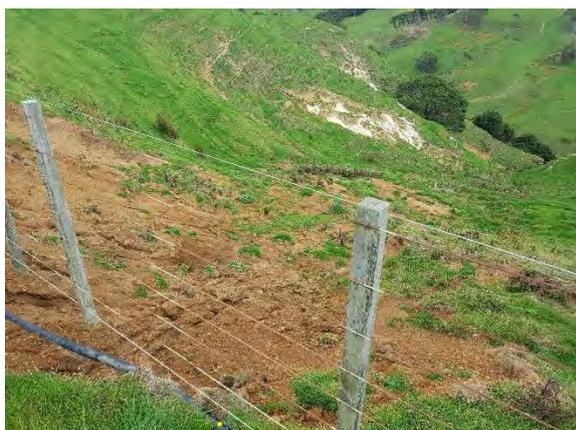
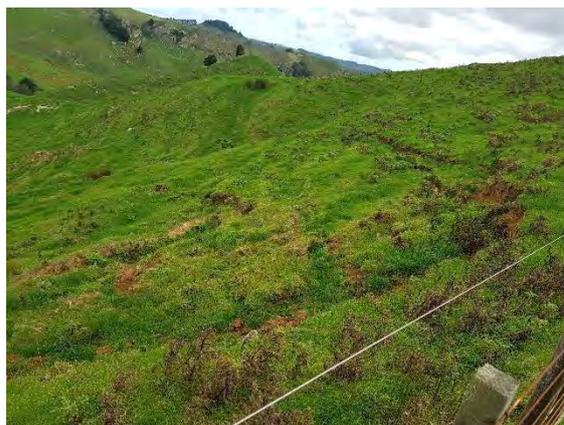
Hillside effected by heavy rain event in early 2018

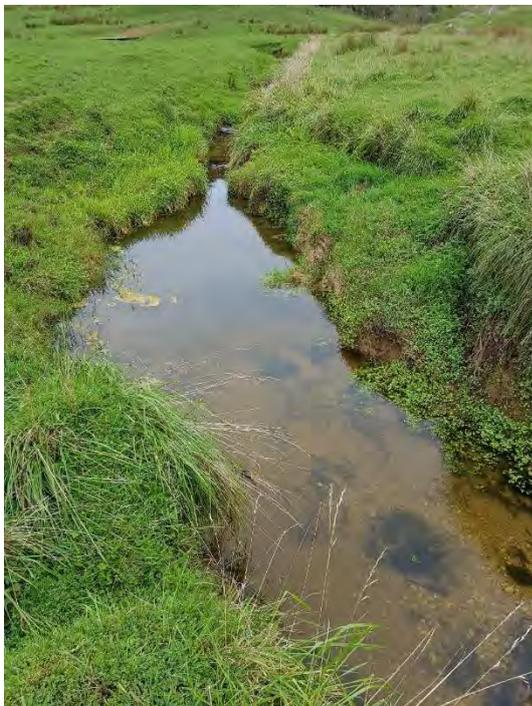
There are man-made stock crossings in all paddocks in the form of bridges and culverts and little evidence of stock crossing in through waterways. The photo below shows an unfenced stream without a crossing – the right-hand side of the creek is un-grazed and has been for some time and the stream acts as a natural barrier. You can also see a fork at the top left of the photo with crossing and grazed pasture on other side.

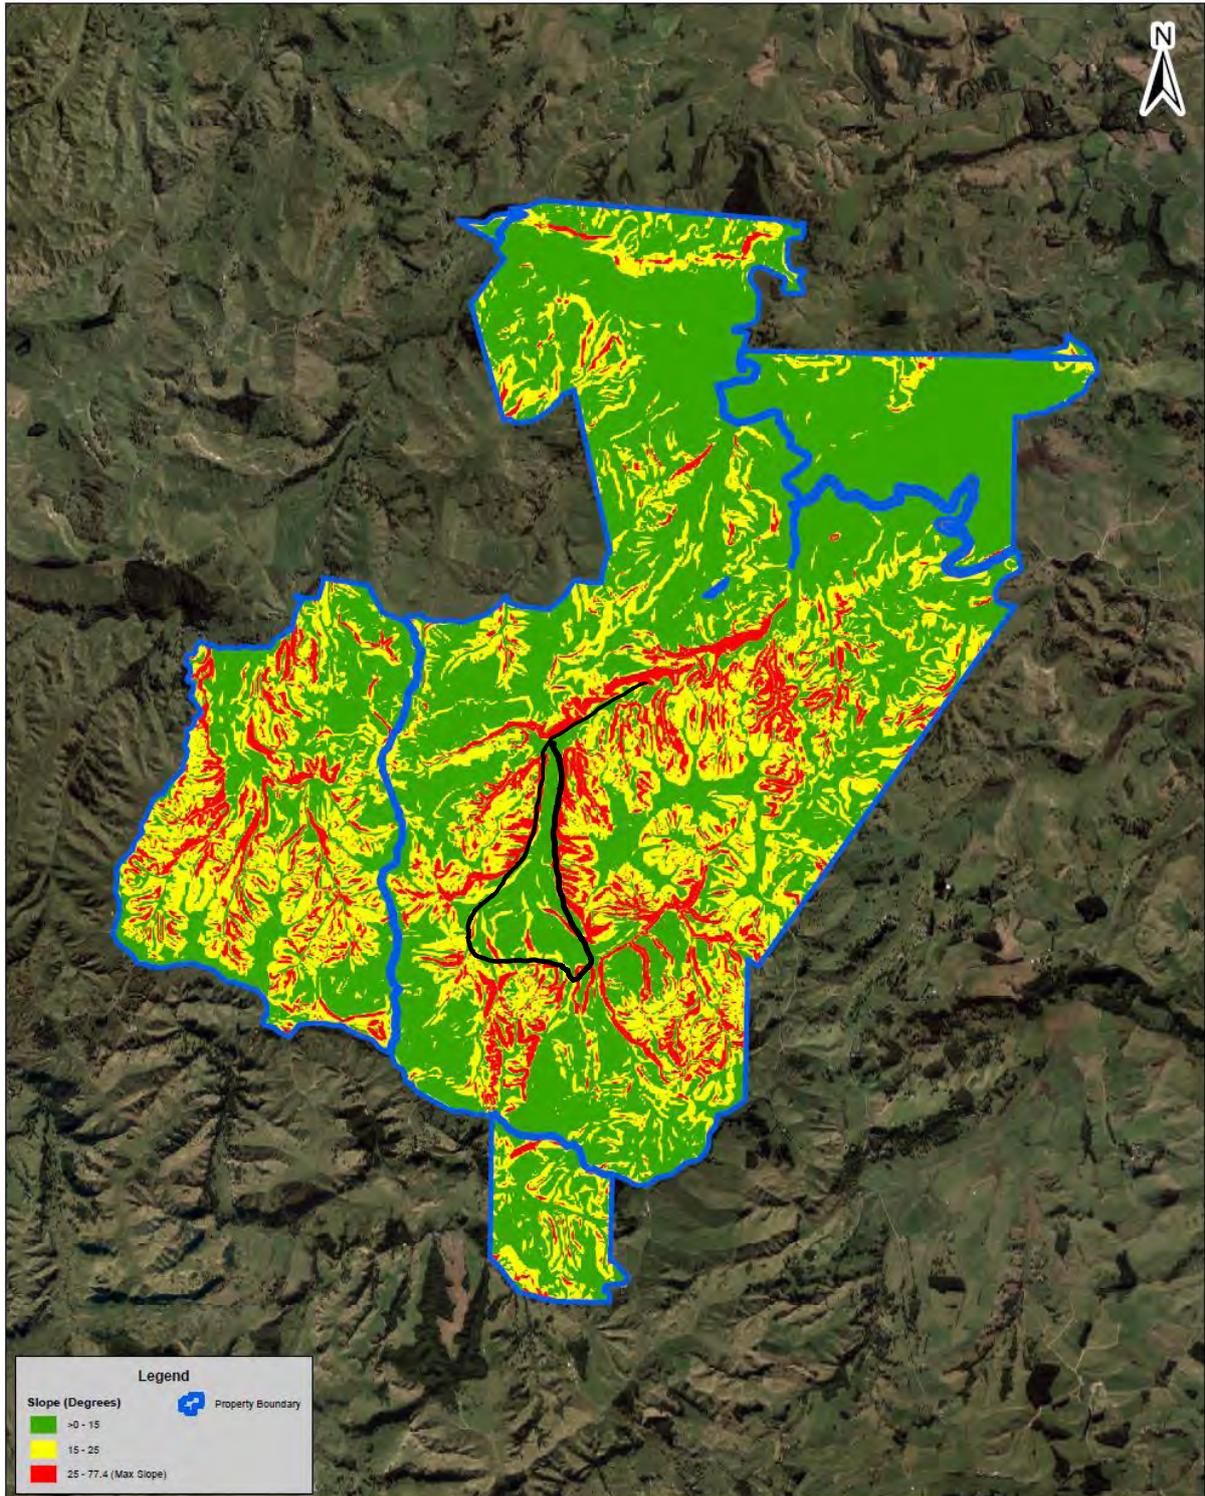
The property is of varied contour. Apart from the flat areas most paddocks contain slopes greater than 25° and would be difficult to fence. As a mitigation there is 3 separate water systems on the property with troughed water to almost every paddock.

The slope map above confirms the nature of the property.

However, a plan should be formulated to identify the at-risk areas and look to retire these. The two gorges are very prominent (drawn in black) in this map and the areas above the gorge have flatter paddocks in them. These could be fenced to exclude stock, as the water quality is outstanding coming out of the 300 block and Forsters as judged by the native snails.
