Wharekawa coast 2120 - wider river flood assessment

March 2023

Document #: 21075591

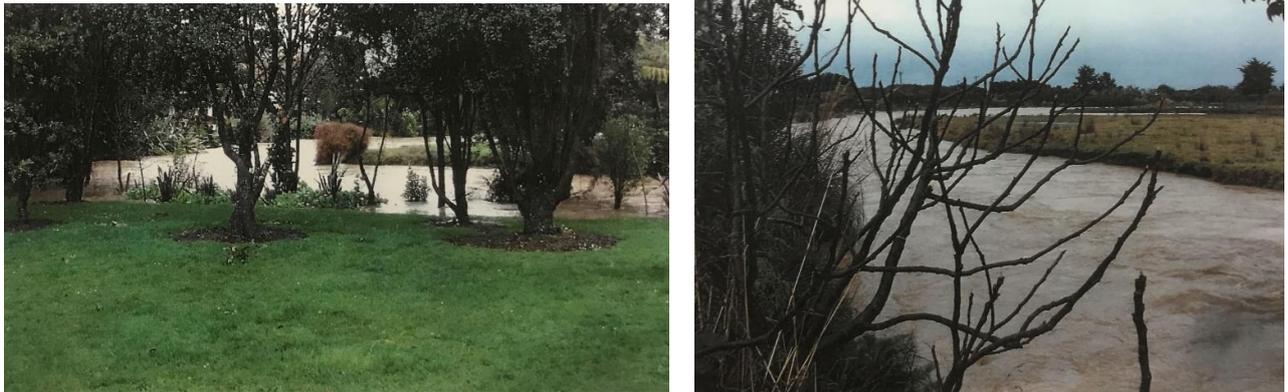
Figure 8 Flooding photographs of the Huarahi Stream on 6 August 2006. Both photos are taken in the vicinity of the fire station (Wotton R, 2006).

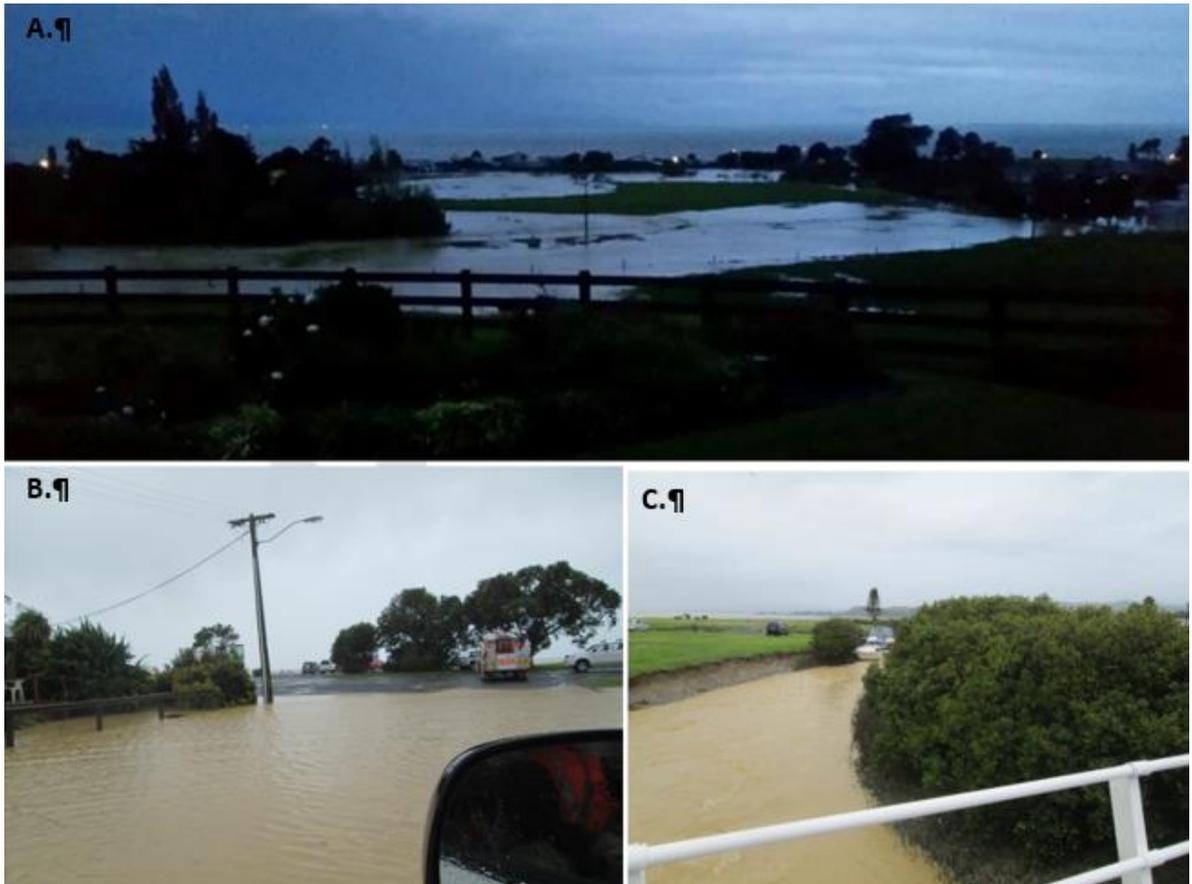
Figure 9 River flooding impacts in Kaiaua from the March 2017 flood event. A. Flooding from Huarahi Stream in Kaiaua township (Marsh et al., 2022, p.41), B. Flooding on ECR north of the County Bridge (Knight R, 2017) C. Mangroves encroaching Huarahi Stream on 8 March when WRC staffed visited Kaiaua (Craig H, 2017, p.24).

- HDC assisted residents with sandbagging to protect properties from flood water.
- During the event, WRC staff were sent to investigate the situation in the project area (Figure 9 and 10) (Craig H, 2017; Knight R, 2017).

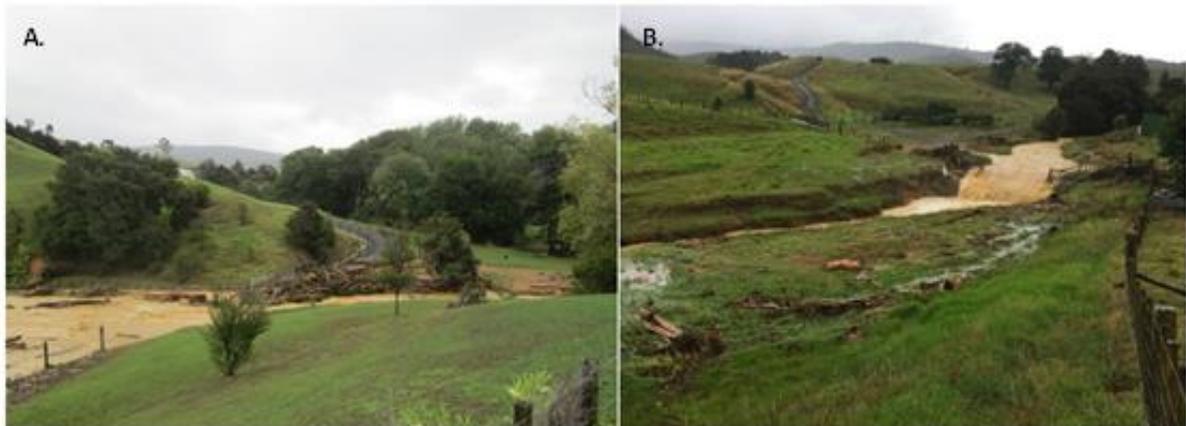
Figure 10 Rural land impacts flooding from the March 2017 rainfall event. A. Flooding of farmland from the Waharau Stream. B. Huarahi Stream flooding, several hours after the stream was in peak flood, in which the peak flood extent can be seen in the right of the photo by debris deposits. Photos were taken by WRC staff when visited on the 8th of March (Knight R, 2017).

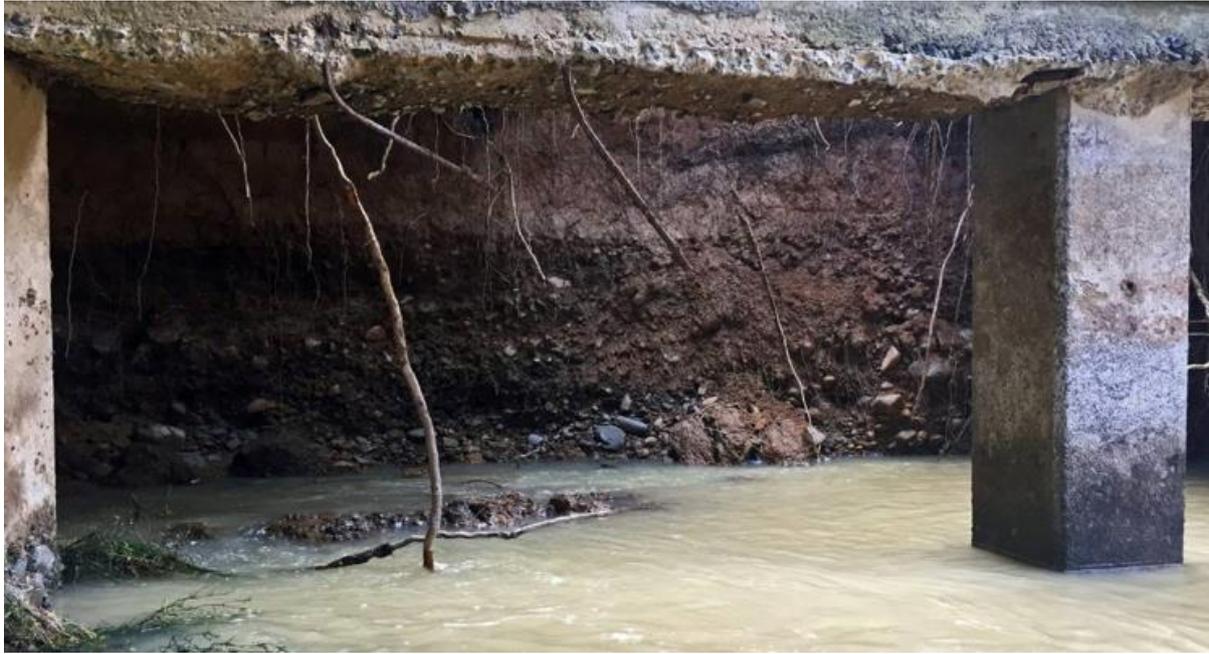
Figure 11 Eroded bridge abutments at Waharau Bridge following Ex-Tropical Cyclone Debbie on the 4th - 6th April 2017 (Marsh et al., 2022, p.42)

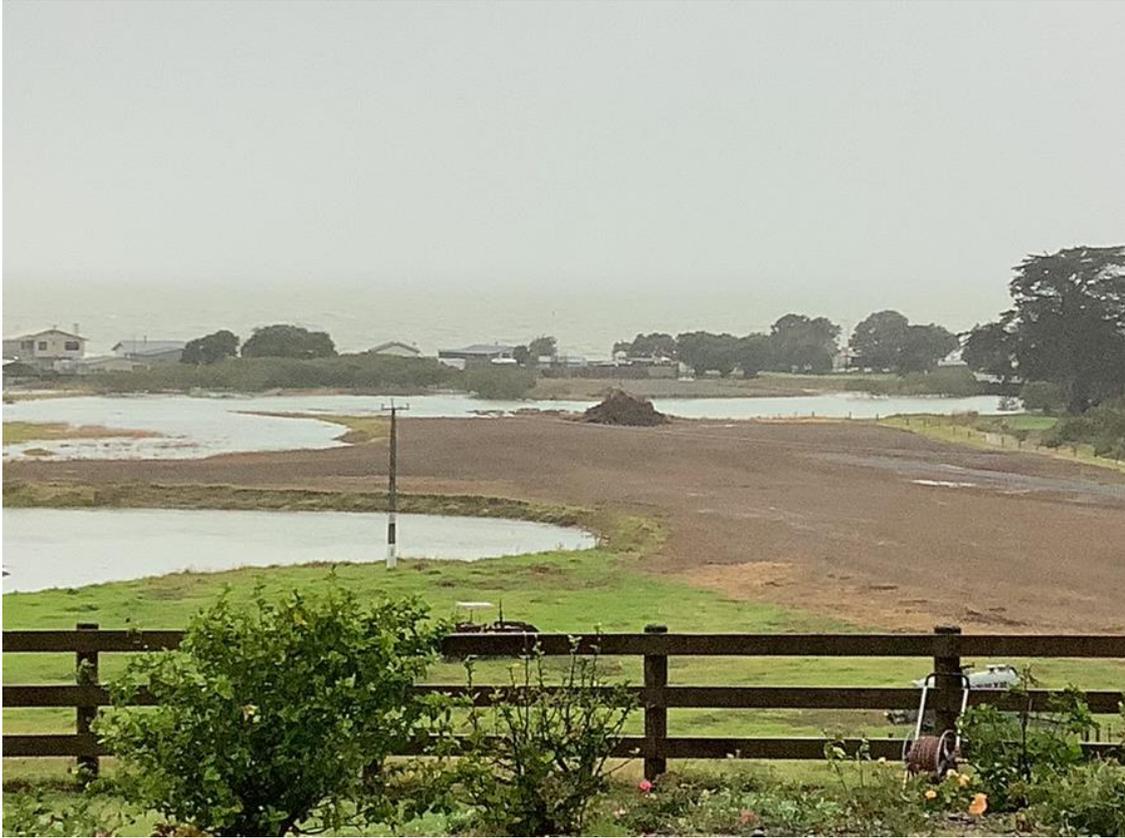
Figure 12 Huarahi stream on the morning of 21 March 2022 in high flow. (Johnstone J, 2022).

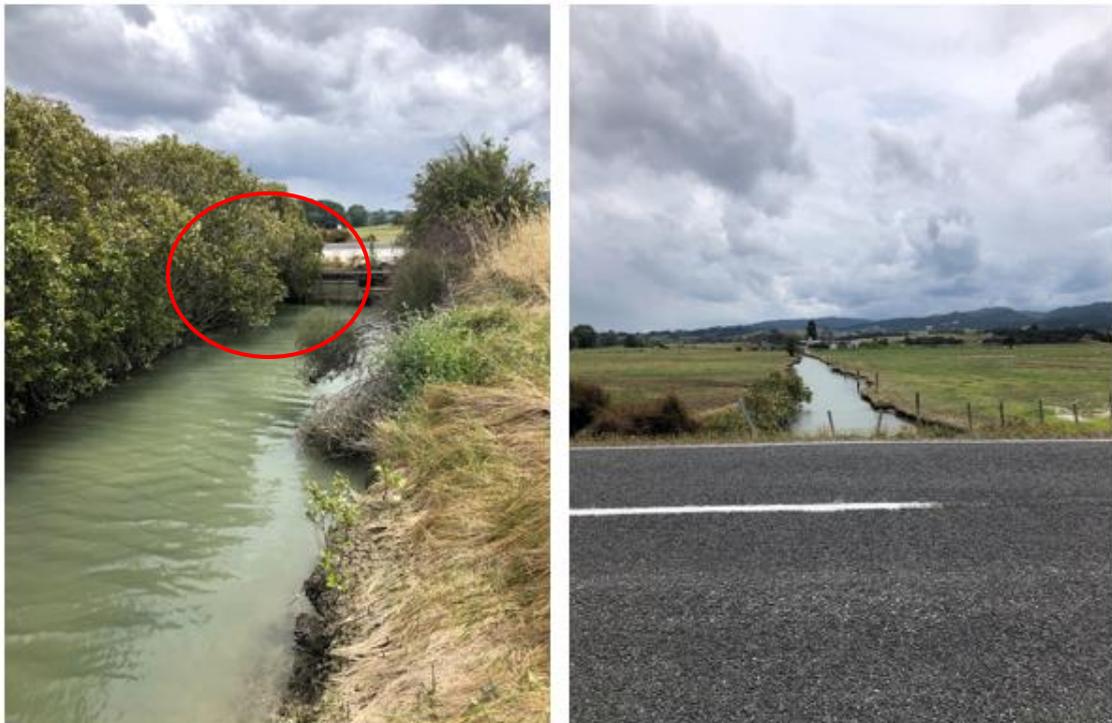
Figure 13 Photos of a floodgate and culvert underneath ERC and a channel through rural land on an outgoing tide. Note you can see the misalignment of the metal floodgate with the culvert size allowing saltwater to pass through (Mills W, 2021b).

Continual inundation from both freshwater and saltwater has presented an uneconomical risk for farmers near the Miranda/ Pūkorokoro streams, where the overall productivity of pasture land has reduced. Nearby farmers indicate that the cost of buying and spreading fertilizer or regressing these continually inundated areas is not feasible anymore (Golder Associates, 2014).

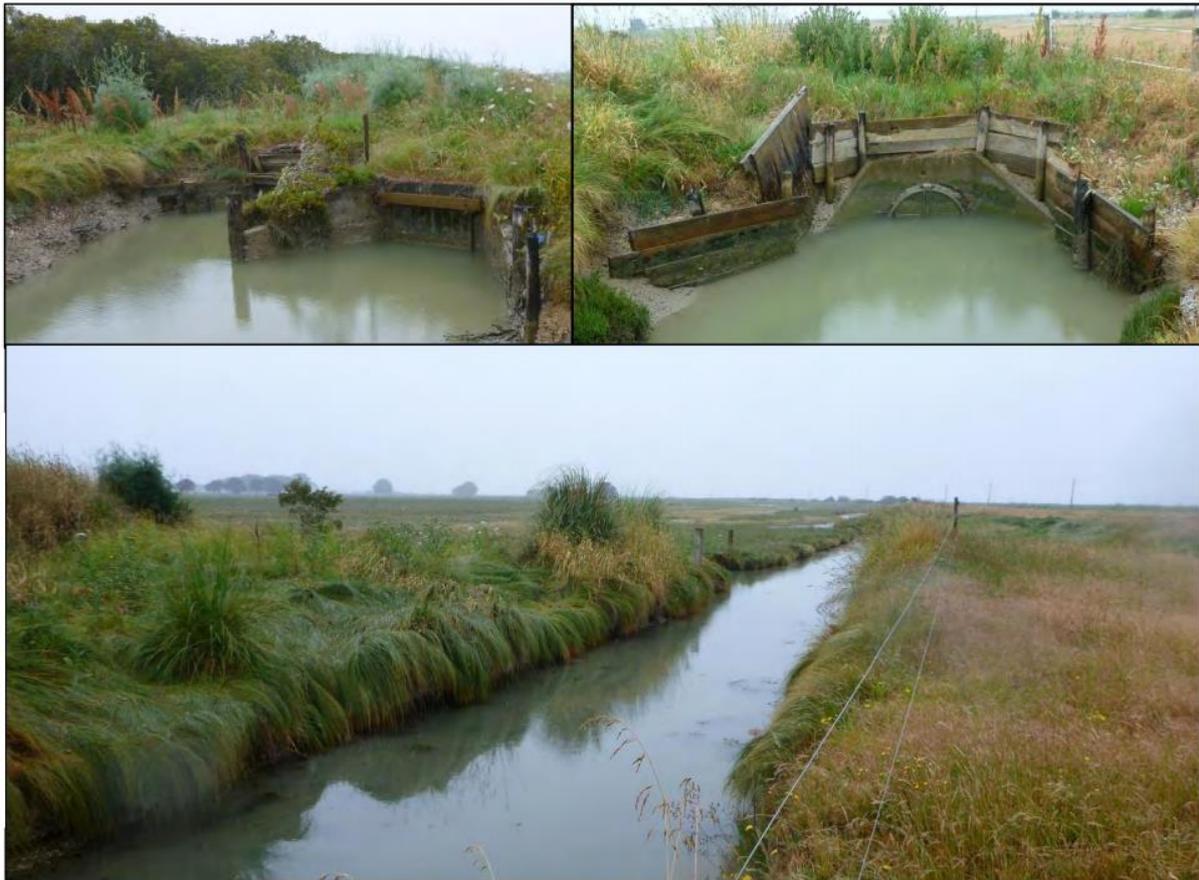
Figure 14 Existing flood control gates and Pūkoro Stream upstream of the gates. Photos were taken on an incoming tide. Note mangroves in the Miranda Stream (top left photo) (Franklin District Council, 2007, p.6).

Consequently, a historical storm surge event corresponding with high flows in the Miranda Stream overtopped the Miranda Stream stopbanks and ECR, inundating farmland for several days following the event. The deposition of silt and debris from the Miranda Stream and saltwater inundation generated pasture dieback and loss of productivity. Unfortunately, it is unknown what flood event in the flood registry these impacts are associated with (Golder Associates, 2014). Recently, there have been many smaller stream mouths in the sub-compartment that have been dredged by private landowners with guidance from WRC. Where HDC have culverts that run underneath ECR, the council keeps the downstream end of the drains open (Growden et al., 2021).

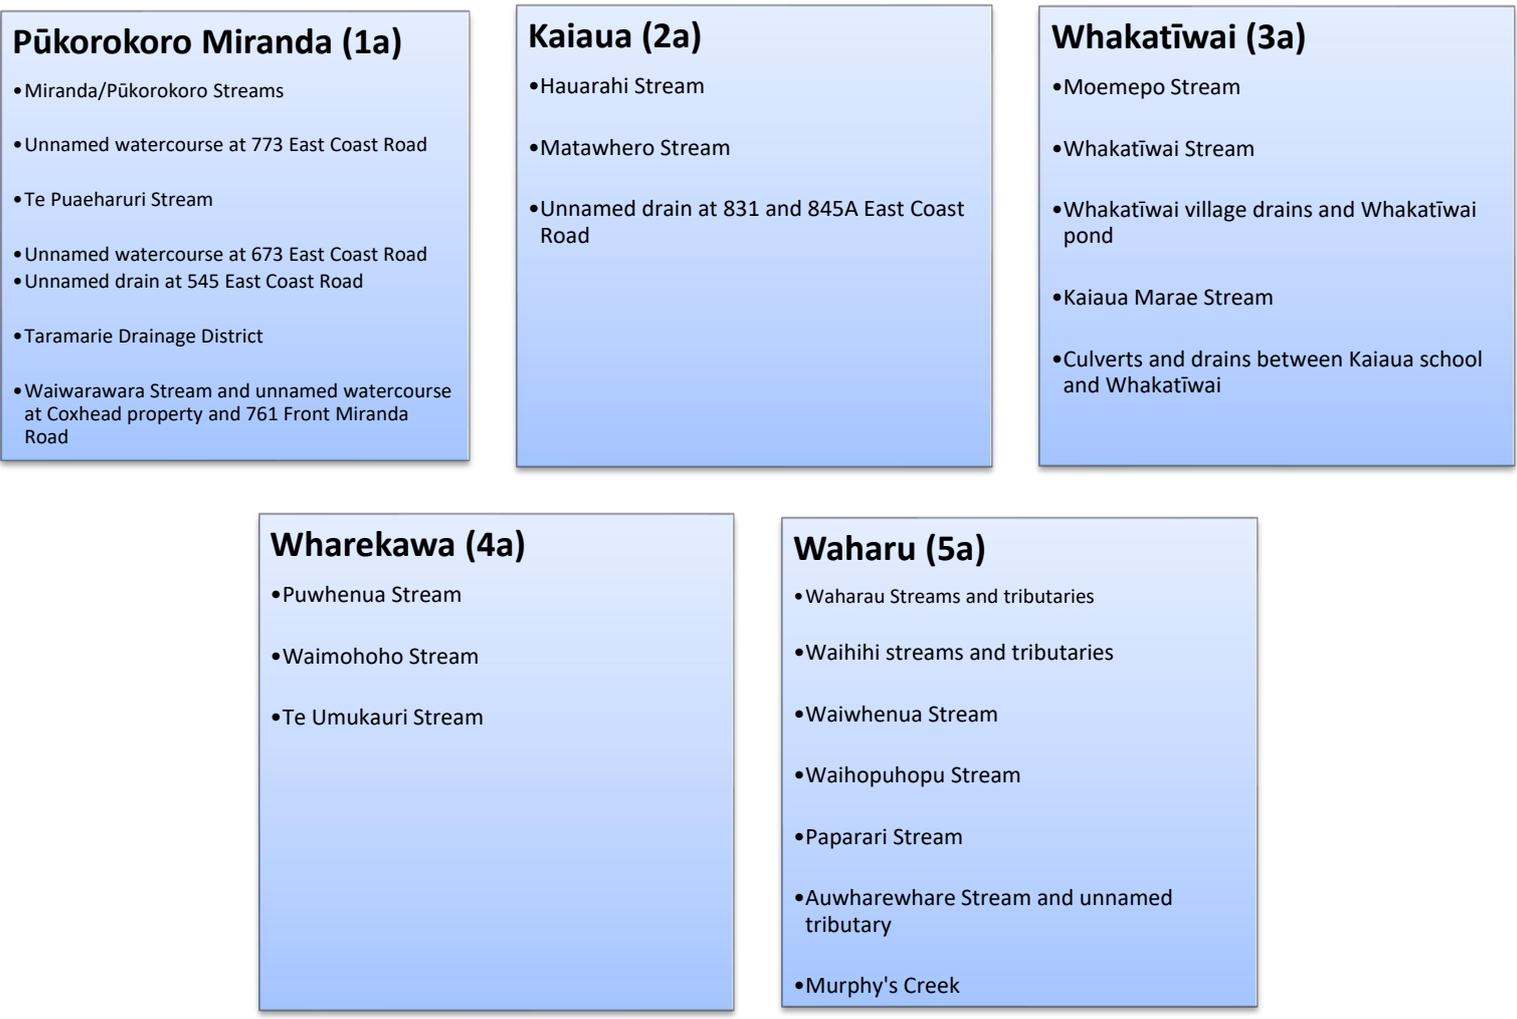
Figure 19 Streams and drains included in the River Management Work Programme by compartments.

Streams and culverts identified in the River Management Work Programme are outlined below in Figure 19, where Appendix 7 outlines the complete River Management Work Programme.

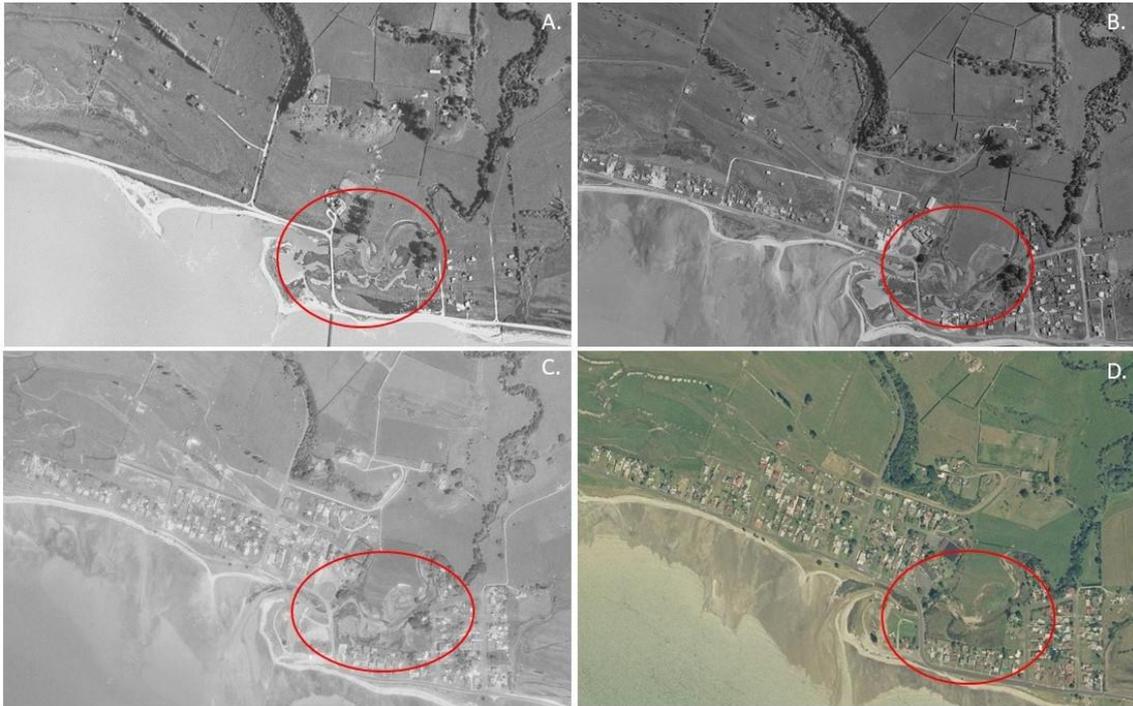
Figure 22 Migration of the Haurahi Stream channel through Kaiaua township from the 1940s to 2004. A. 1944, B. 1960. C. 1988. D. 2004 (RetroLens, 2018).

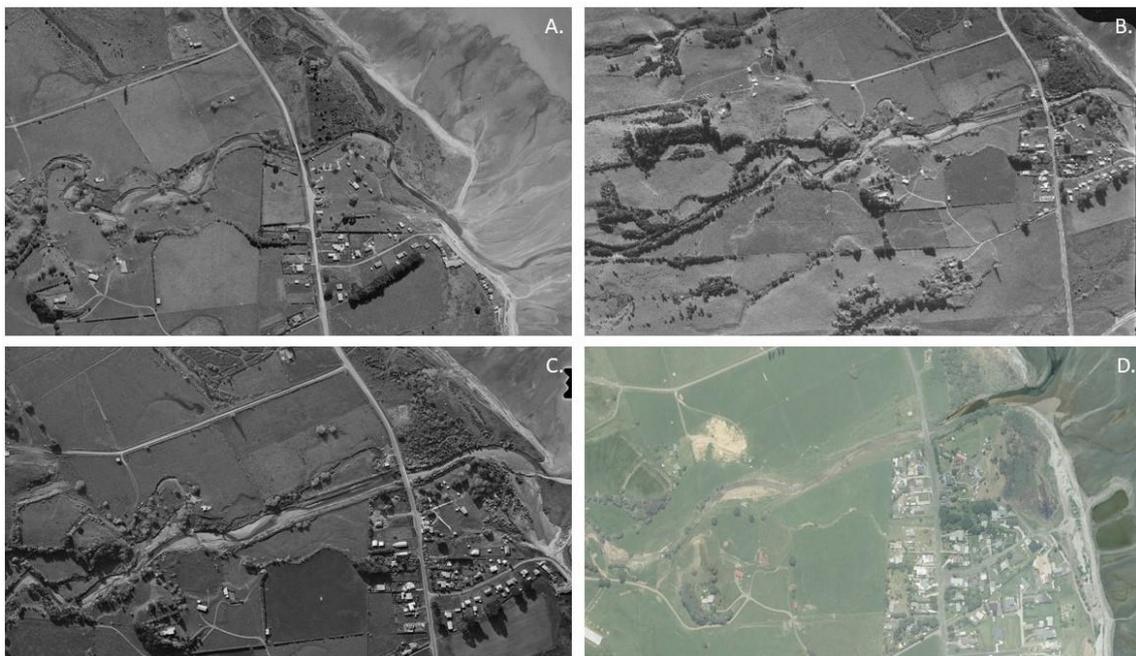
Figure 23 Whakatīwai Stream evolution from the 1960s to present day. A. 1960. B. 1969. C. 1974. D. 2017 (RetroLens, 2018).

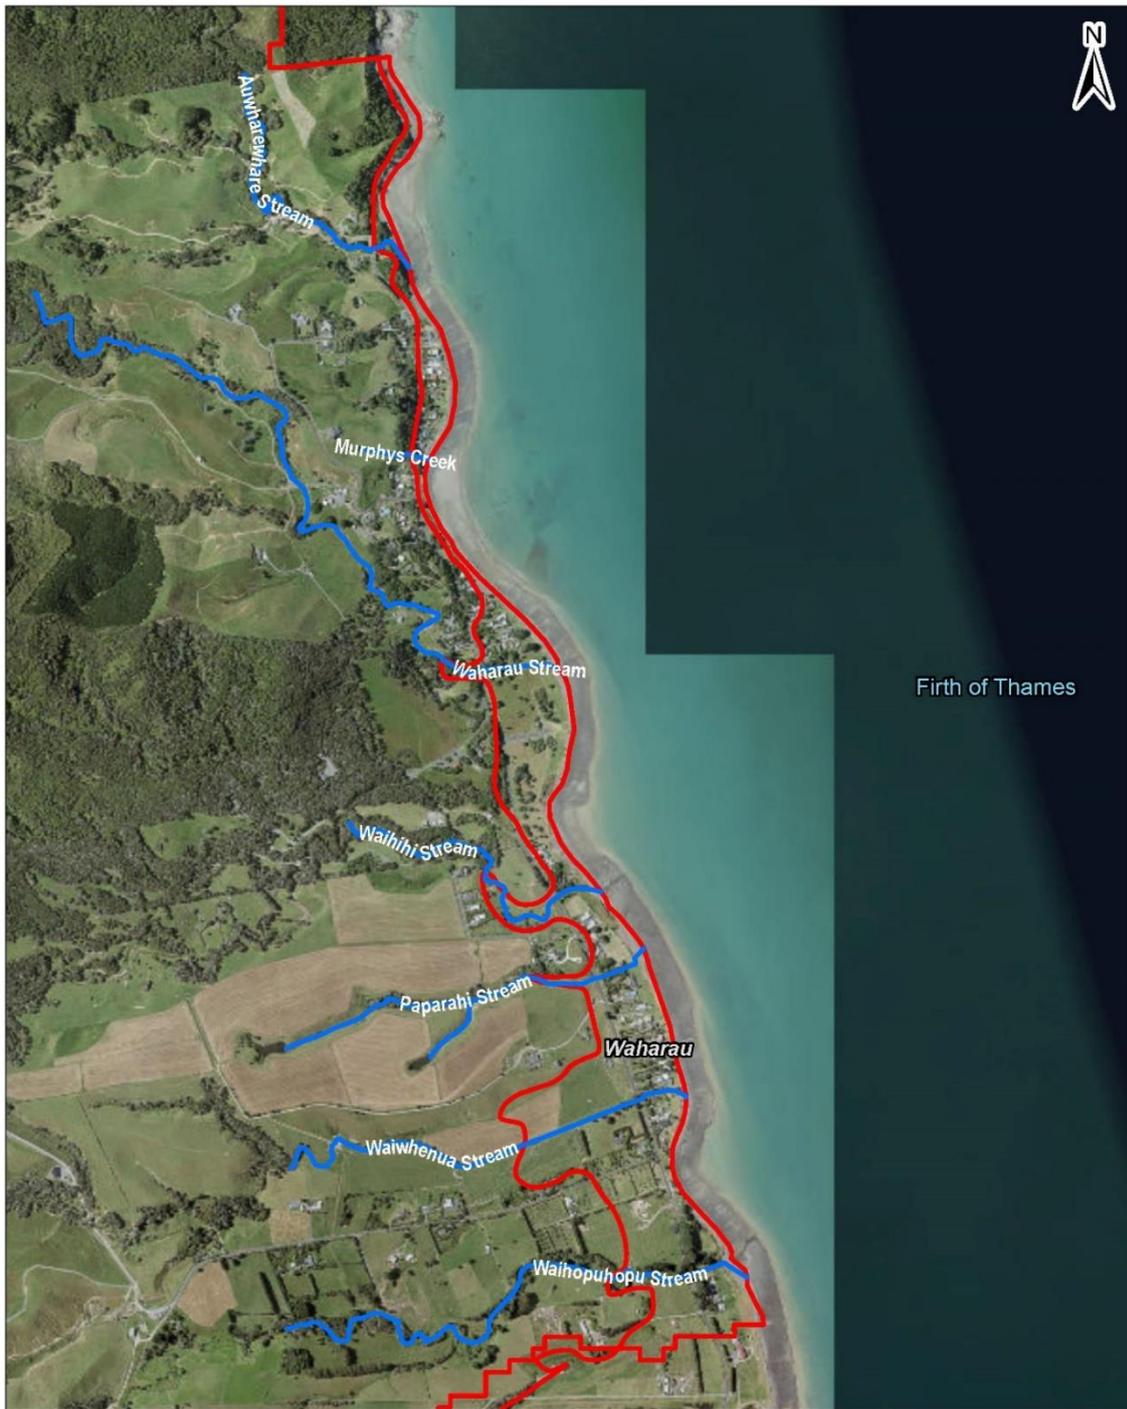
Auwharewhare stream and unnamed tributary	Low	<p>Existing Assets: 1x culvert underneath East Coast Road.</p> <p>a. Upper catchment stability control</p> <p>b. Stream management work - removal of blockages, maintaining channel capacity, ensuring stability of channel (erosion control as required)</p> <p>c. To ensure performance under flood conditions, structural integrity and stability of the assets on this stream. Ensuring the culvert</p>	<p>This stream is of cultural and historical significance that will need to be considered. Local iwi will need to be consulted when any works are planned and/or undertaken (Historical Kauri Mill location, urupa for Spanish Flu victims)</p> <p>No real concern around opening on the beachfront as this gets blown out during a big event, but clearance may be required prior to big events to ensure no water backs up.</p>

Stream/watercourse	Priority	River Management Work Programme	Comments
		<p>is not undermined with erosion around structure, and the culvert is managed, and blockages are removed to ensure it perform as designed.</p> <p>d. Culvert and discharge location opening is required to ensure continual clearance</p> <p>e. Improvement plan - investigation of issues and upgrade requirements of the existing systems and assets to improve performance and reduce maintenance costs.</p>	
Murphy's Culvert	Low	<p>Existing Assets: 3 x Culverts</p> <p>a. To ensure asset performance under flood conditions an assessment of suitable culvert size is required.</p> <p>b. Management of blockages to ensure they are removed, and culverts perform as designed.</p> <p>c. Discharge outlets clear</p> <p>d. Improvement plan - investigation of issues and upgrade requirements of the existing systems and assets to improve performance and reduce maintenance costs –</p> <p>e.g investigate size of culverts, pathways of culverts.</p>	<p>Coastal inundation pushes the rocks up and makes a mound on the coastal side, and the road is higher than the properties – therefore the properties are located in a bowl and susceptible to flooding.</p> <p>Murphy's Culvert splits into 3 drains and culverts, (one under the road, one to the south and to the north and then under the road) currently only 1 is open and working. Ensure accompanying culverts are appropriate for the amount of water discharge and working with the flow of water not against.</p>

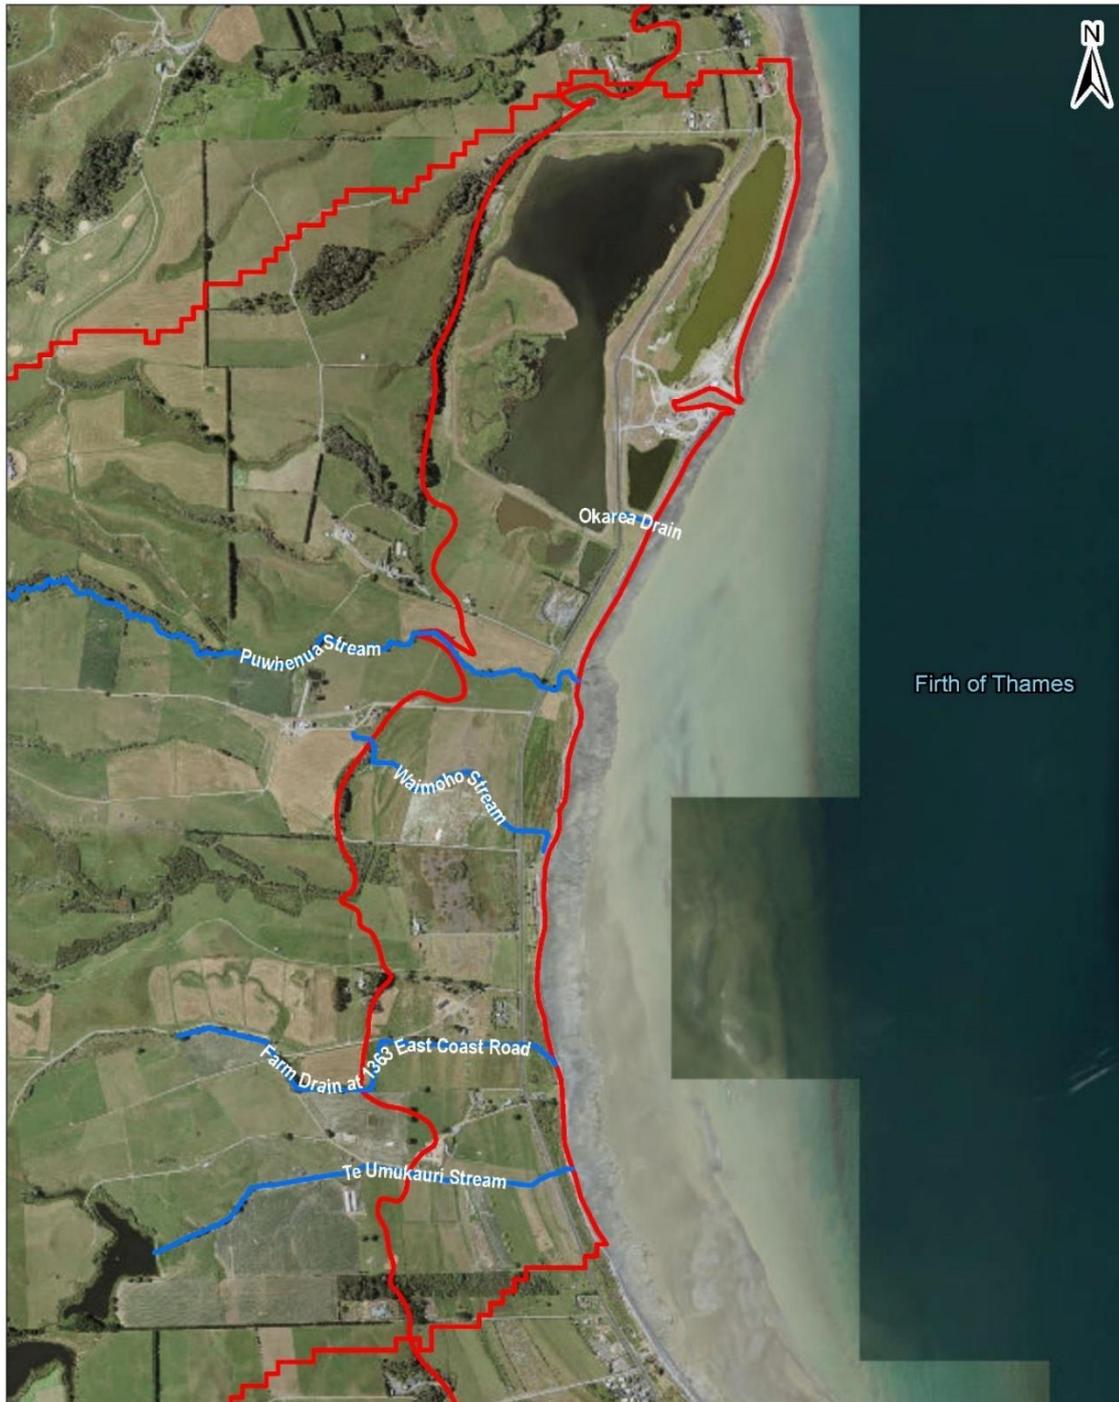
Stream/watercourse	Priority	River Management Work Programme	Comments
		improve performance and reduce maintenance costs.	
Te Umukauri Stream	Low	<p>Existing Assets: 1x Culvert and 2x private dams</p> <p>Council to communicate and provide technical advice to landowner. It is the landowner's responsibility to maintain and manage works and any privately owned assets on their property, due to the stream only running through their property.</p> <p>a. Upper catchment stability control (e.g. planting, stability control, pest control) - to communicate with the land owner</p> <p>b. River management work - removal of blockages, maintaining channel capacity, ensuring stability of channel (erosion control as required) - to communicate with the landowner</p> <p>c. To ensure performance under flood conditions, structural integrity and stability of the dams that discharge into this stream. Ensuring the dams are not undermined with erosion around the structures and is managed and blockages are removed to ensure it performs as designed.</p> <p>d. To ensure performance under flood conditions, structural integrity and stability of the asset on this stream. Ensuring the culvert is not undermined with erosion around the structure, and is the correct size and blockages are removed to ensure it preforms as designed.</p> <p>e. Stream mouth opening</p>	<p>Assets are a combination of both private landowner responsibility and council responsibility.</p> <p>Two private dams on private property require technical advice from council to ensure the performance and integrity of these dams under flood conditions to reduce the risk of dam failure.</p> <p>Historical sand dune used to be along the beachfront and provide protection from coastal inundation events. However, a resident 20+ years ago removed this sand dune to sell properties and now this area is constantly flooded.</p> <p>The Community Panel would like clarification around the council's current maintenance guidelines for this stream.</p>

Stream/watercourse	Priority	River Management Work Programme	Comments
		f. Improvement plan - investigation of issues and upgrade requirements of the existing systems and assets to improve performance and reduce maintenance costs.

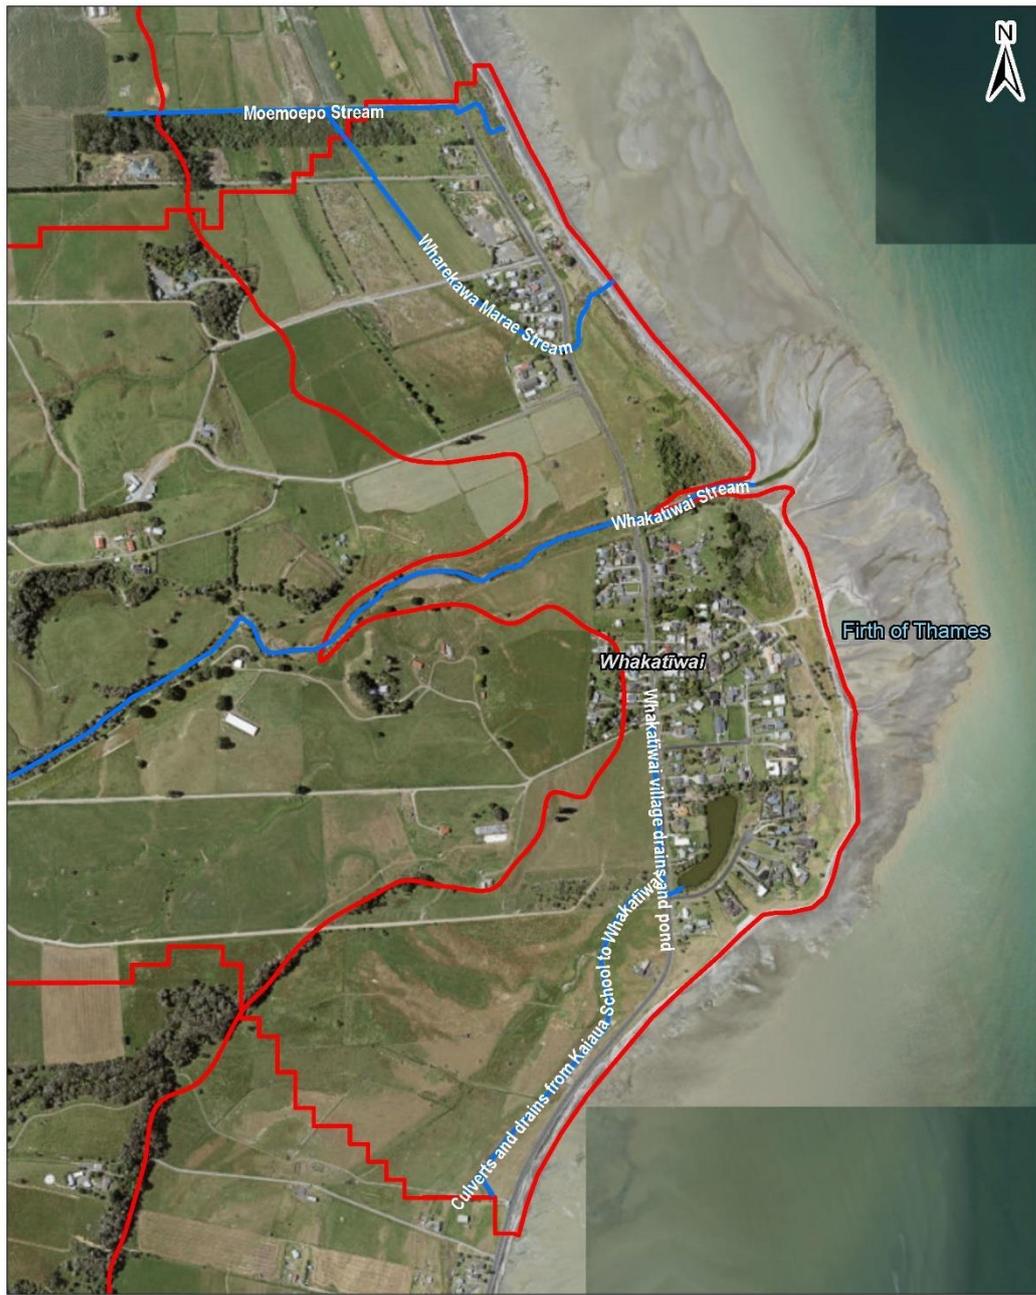
Stream/watercourse	Priority	River Management Work Programme	Comments
		assets to improve performance and reduce maintenance costs.	
Culverts and drains between Kaiaua school and Whakatīwai	Low	<p>Existing Assets: 4x culverts</p> <p>a. To ensure performance under flood conditions, structural integrity and stability of these culverts and drains including: ensuring the culvert is not undermined with erosion around the structure, blockages are removed to ensure culverts perform as designed, drains are sprayed and cleaned regularly, and investigate the shortening of culverts into the sea to increase discharge volumes.</p> <p>b. Improvement plan - investigation of issues and upgrade requirements of the existing systems and assets to improve performance and reduce maintenance costs (e.g. blockages by shellfish in culvert, such as installing grates or one way valves, reduce culvert length on beachside of the road to allow discharge across the tidal sequence, investigate increase in drainage capacity).</p>	<p>All culverts are blocked from shells, gravel and sand and are only allowing a very small percentage of water from the drains to discharge in the ocean.</p> <p>Investigate the shortening of the culvert pipes into the sea which will increase water discharge volumes.</p> <p>The Community Panel would like clarification around the council's current maintenance guidelines for these streams and drains.</p>

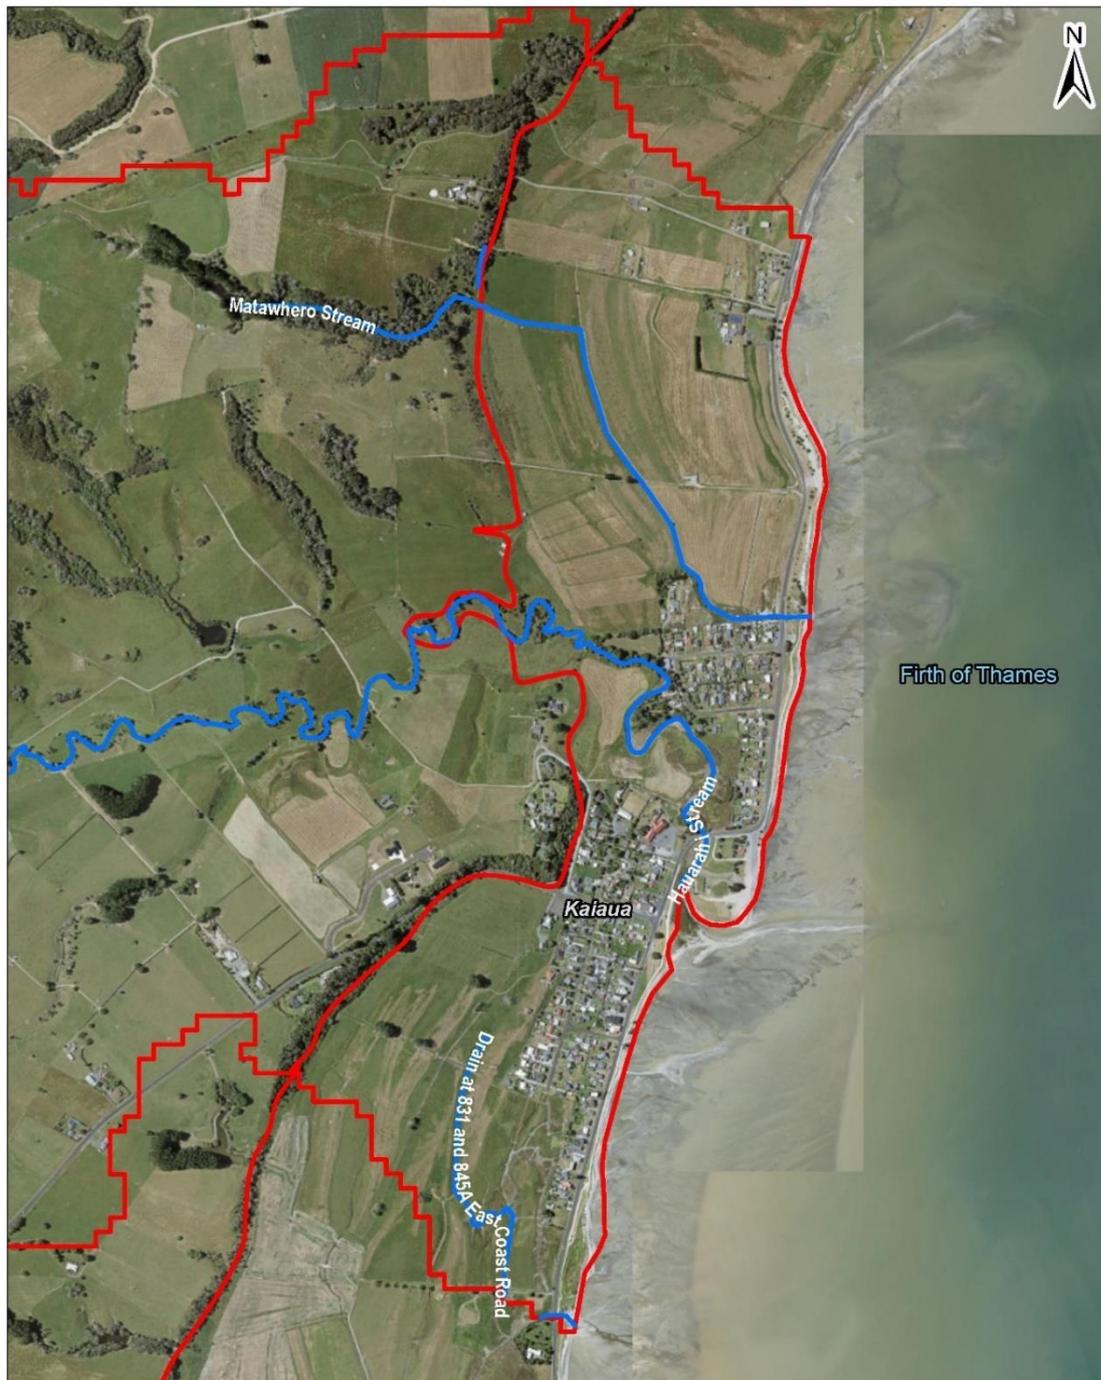
Small unnamed drain at 831 and 845A East Coast Road	Low	<p>Existing Assets: 1x stormwater pipe, 2 outlets and 2x floodgates</p> <p>Council to communicate and provide technical advice to the landowner. It is the landowner's responsibility to maintain and manage works on any privately owned assets on their property, due to the stream only running through their property.</p>	<p>This drain and associated drainage assets are part of the Kaiaua township stormwater system network.</p> <p>Assets are a combination of both private landowner responsibility and council responsibility.</p> <p>Upstream of the culvert, there is only one landowner who would receive benefit from this work. Council to provide technical advice to the landowner and it is</p>

Stream/watercourse	Priority	River Management Work Programme	Comments
		<p>a. To ensure performance under flood conditions, structural integrity and stability of the assets on this drain. Ensuring the assets are not undermined with erosion around the structures, and blockages are removed to ensure it performs as designed.</p> <p>b. Stream mouth opening</p> <p>c. Improvement plan - investigation of issues and upgrade requirements of the existing systems and assets to improve performance and reduce maintenance costs (e.g. investigate alignment and capacity of floodgates to ensure they are operating correctly).</p>	<p>the landowner's responsibility to complete works, as they would only benefit from the works on their property.</p> <p>Investigate one-way valve system and shortening of the existing culvert pipes into the sea which will increase water discharge volumes.</p>

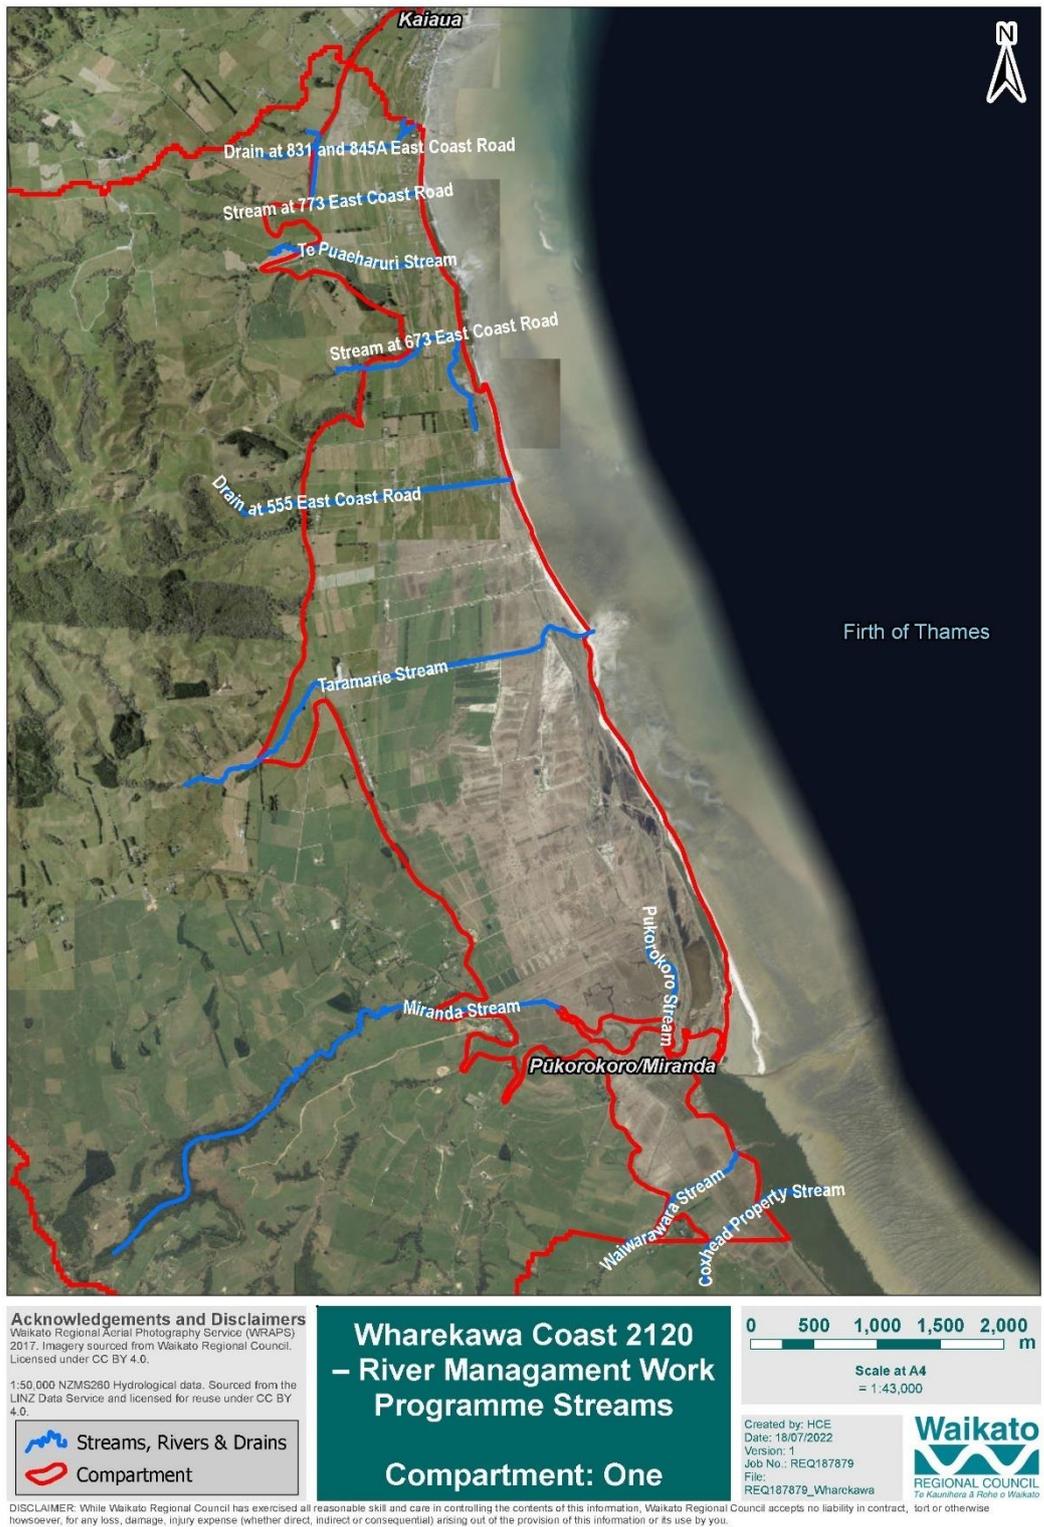
Figure 31 River Management Work Programme for Compartment One (Pūkorokoro Miranda) stream locations
