A GUIDE TO WAIKATO DUNES

Waikato

REGIONAL COUNCIL

INSIDE FRAGILE

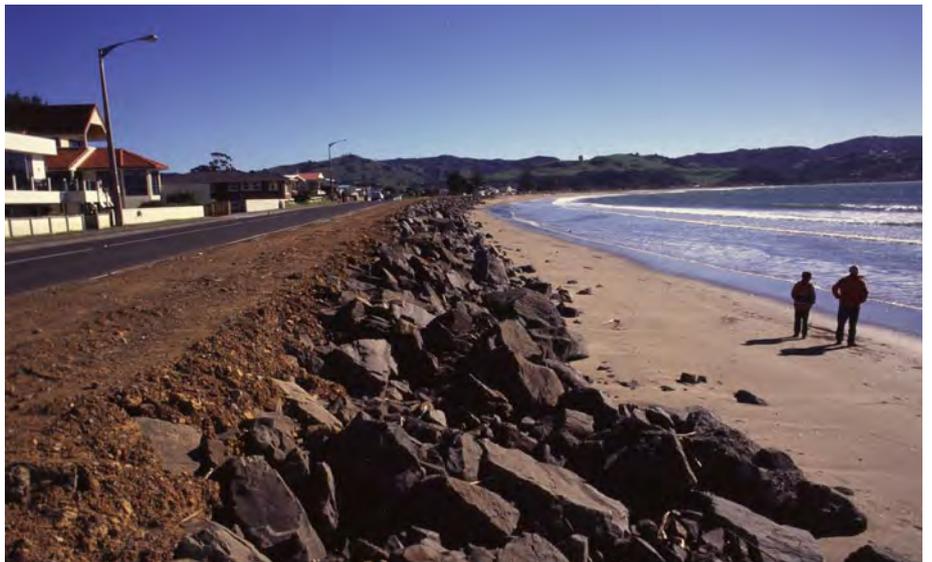
Dune damage and modification – Buffalo Beach south.

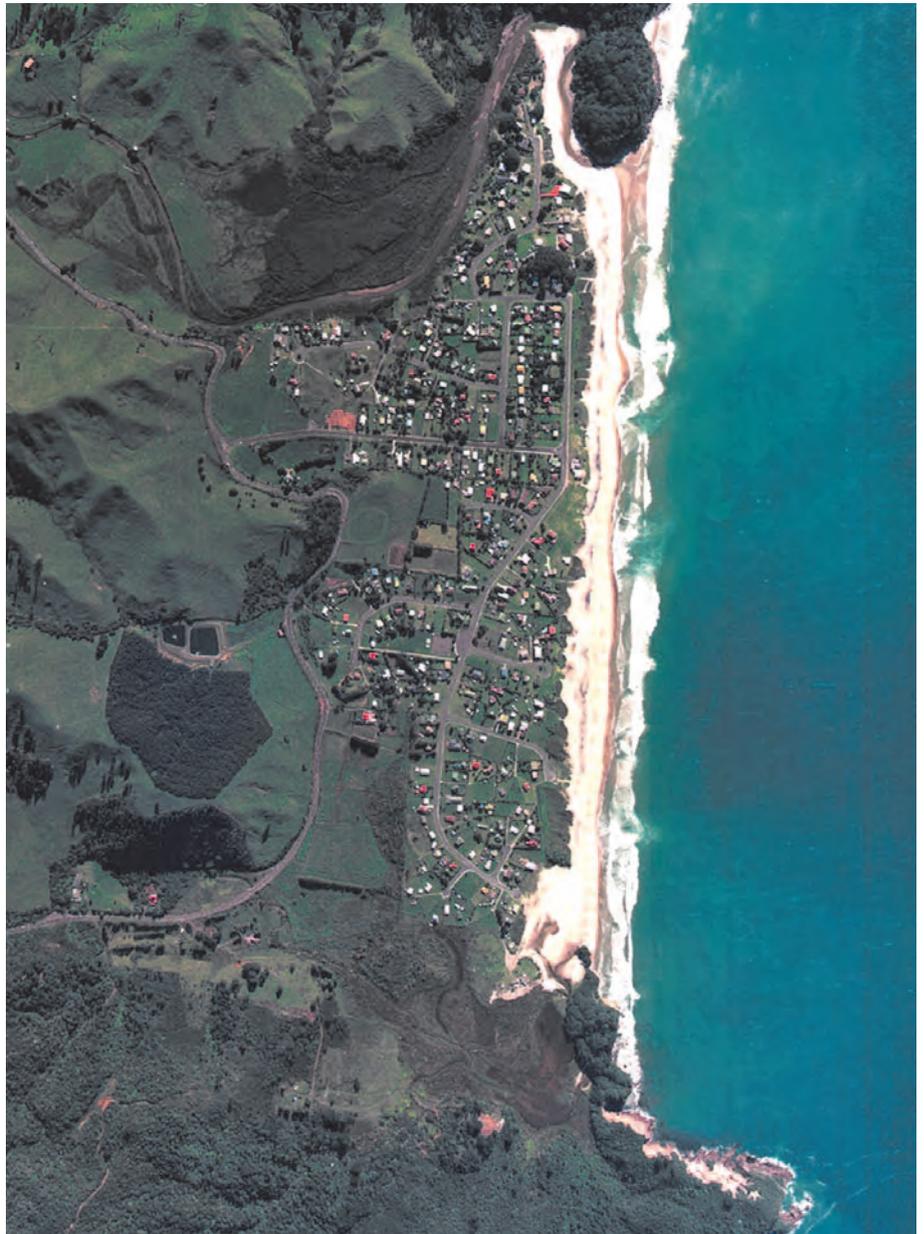
Whiritoa Beach, an isolated pocket beach with limited sand reserves.

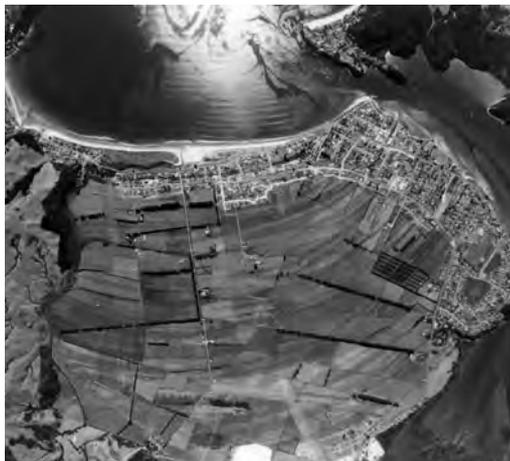
Whitianga showing wide, multiple dune system behind the beach.

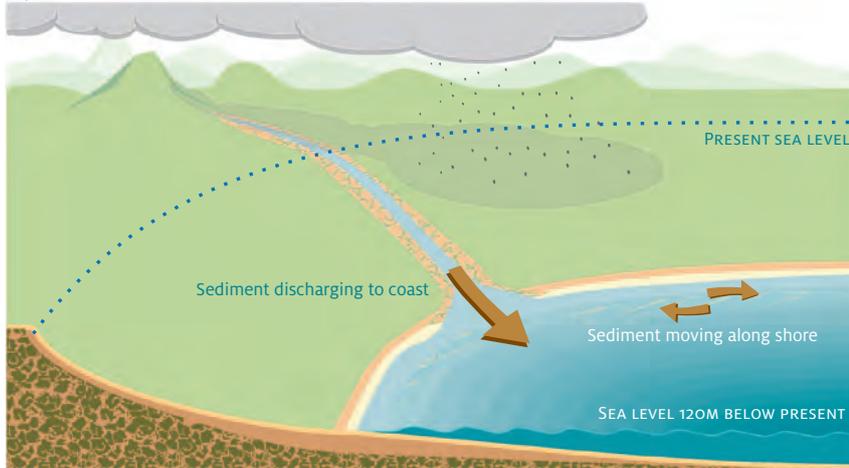
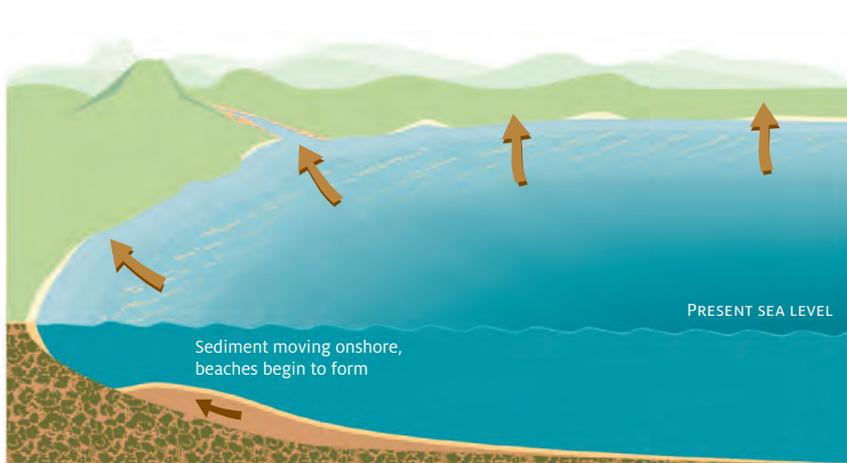
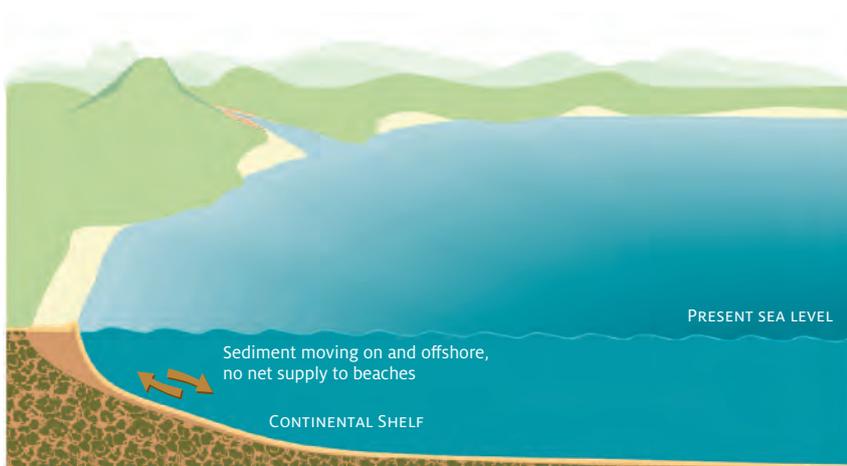
Formation of Coromandel beaches

← **18,000 years ago, the world was in an ice age.** The sea level was about 120 metres lower than at present. Sediments from rivers, volcanic eruptions and other sources accumulated on what is now the continental shelf. As the world warmed, ice melted and the sea level rose, submerging these sediments.

← Present sea level was reached about 7000 years ago. **The sediments buried by the rising sea level were then rapidly moved onshore by waves and currents to form beaches.** Some sediments also came from the remains of beaches that had formed the last time the sea level was at about the present elevation (about 120,000 years ago). Rivers, cliff erosion and shells from marine organisms also provided some beach sands.

← **Over the last few centuries, forward building of the beaches has virtually stopped.** In other words, most Coromandel beaches now have all the sand they are going to get.

Most of the sand reserves of Coromandel beaches are stored in dunes behind the beach. These sand reserves can be regarded as savings for the future of the beaches.

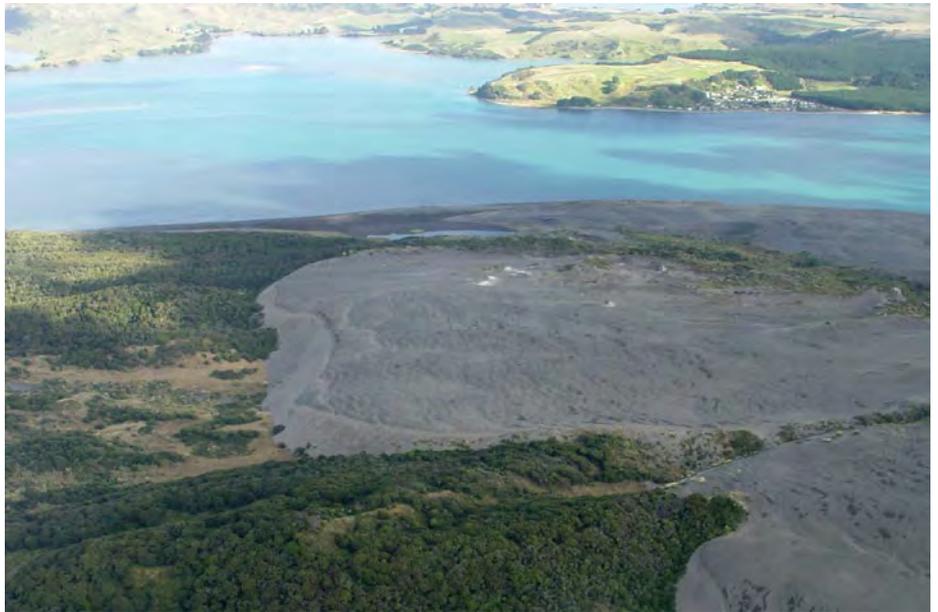
Aotea dunefield.

Over centuries, this process has resulted in mobile sand migrating inland from the coast to form large dunelands. Notable examples include the scientific reserve on the northern side of Aotea Harbour, the area between Kawhia and Aotea Harbour and the northern side of Whaingaroa (Raglan) Harbour.

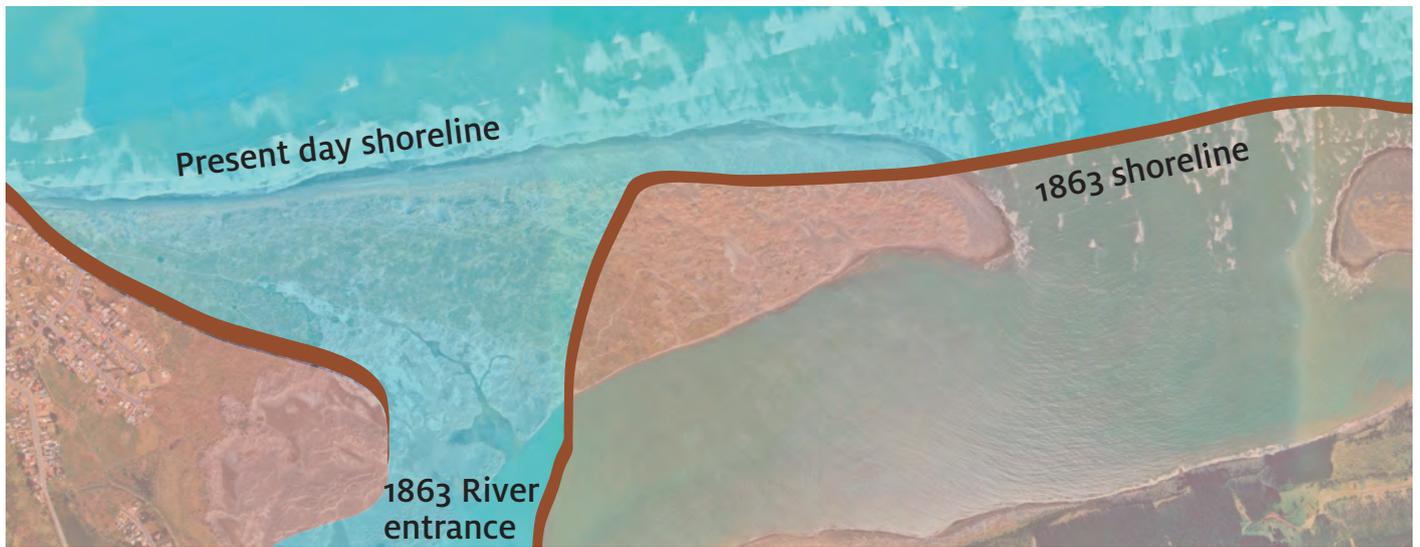
Changes at Waikato River entrance.

Sand spits built across river entrances also contain large areas of dunes, particularly the southern side of the Waikato River entrance at Port Waikato. These sand spits can be very dynamic, experiencing major shoreline changes over decades and centuries. The Port Waikato spit has grown northwards over the last 150 years, eroding large volumes of dunes from the north side of the river. These changes cause major problems where they threaten coastal development.

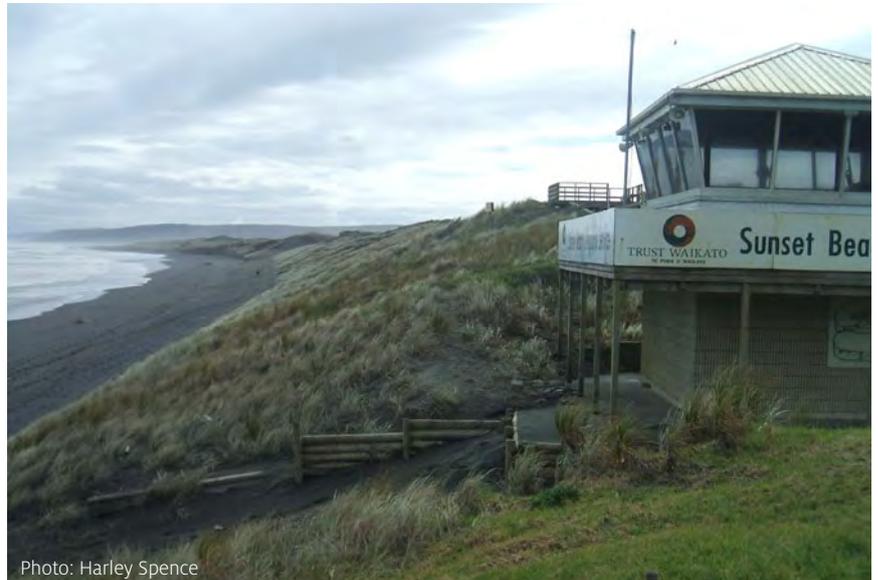
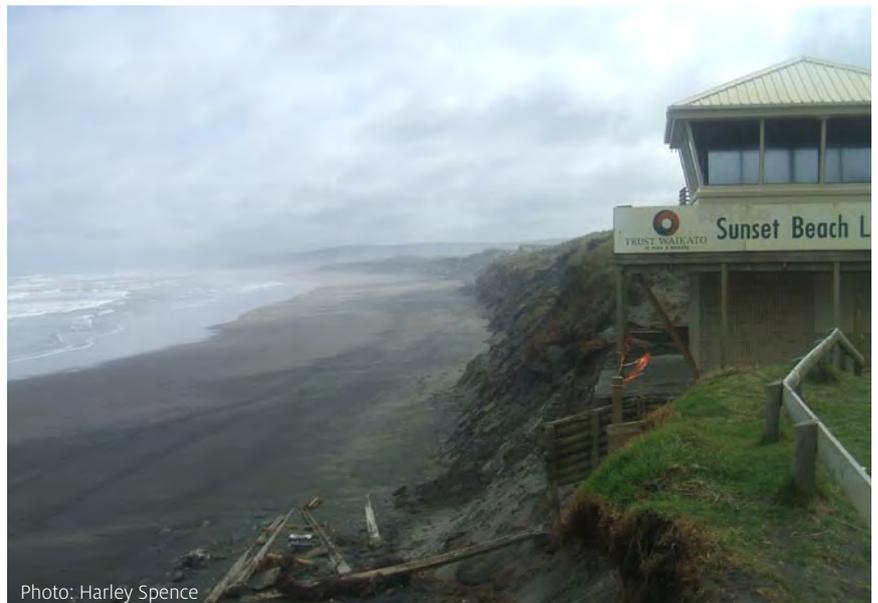
Port Waikato 2007, before the severe erosion.

Port Waikato after a series of storms hit the coast in the winter of 2008.

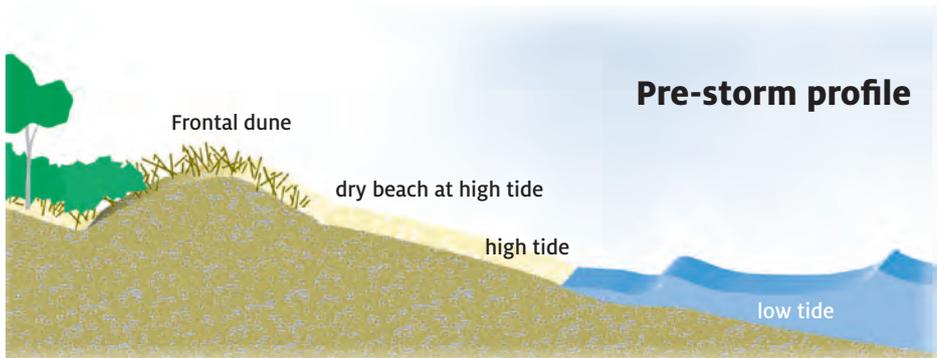
← **During periods of prolonged settled weather, sand builds up** on the visible part of the beach, including the dune.

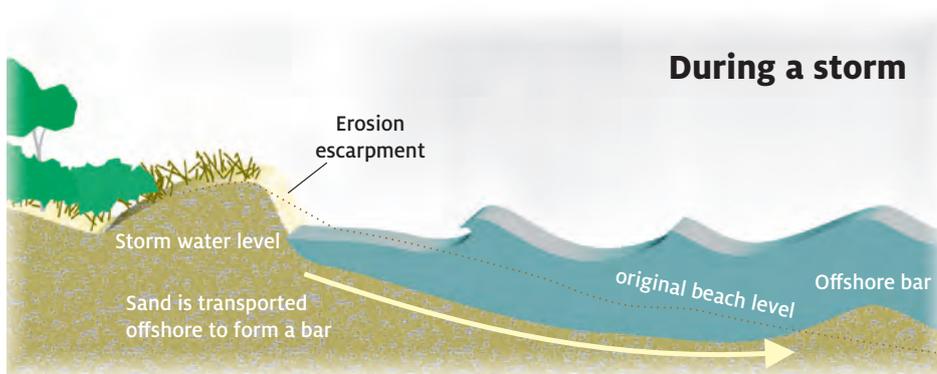
← **During major storms, waves erode the beach** and the most seaward dune, often leaving a near vertical erosion scarp cut in the face of the dune. **The eroded sand is deposited offshore** in the surf zone, where it forms shallow bars that help dissipate the high storm wave energy.

Significant dune erosion can occur in a few hours, but it can take years for the dune to fully recover.

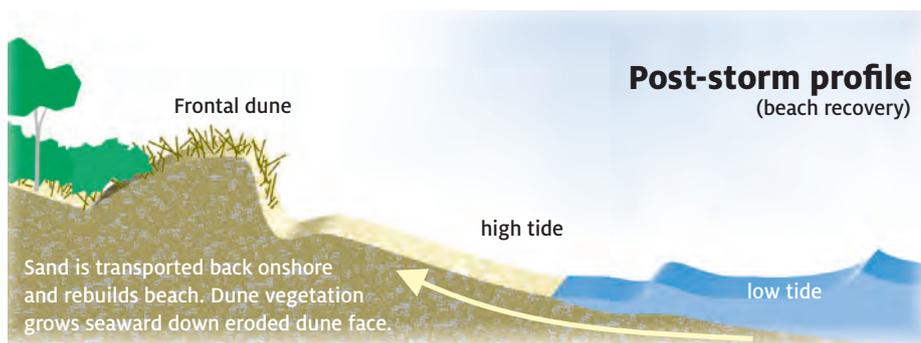
← After the storm, gentler wave action moves sand back to the shore, slowly rebuilding the beach.

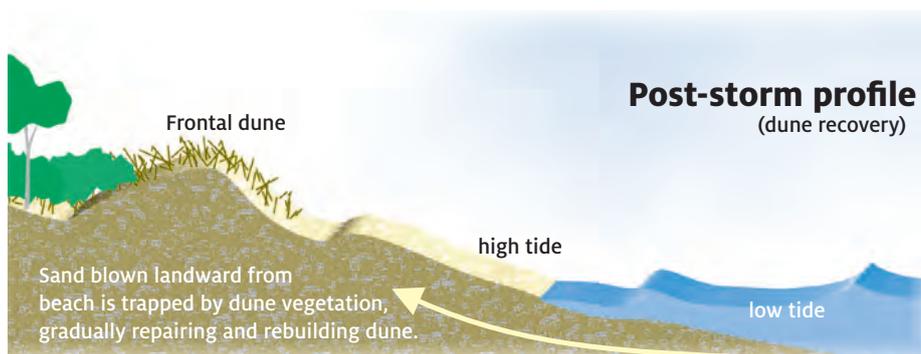
← **As the beach recovers, dry sand is blown landward** and trapped by sand binding vegetation to repair the eroded dune. Natural dune repair depends on a good cover of native sand binding grasses, such as spinifex and pingao. If there are no suitable sand binding grasses on the seaward face of the dune, sand will not be trapped and little natural dune repair will occur.

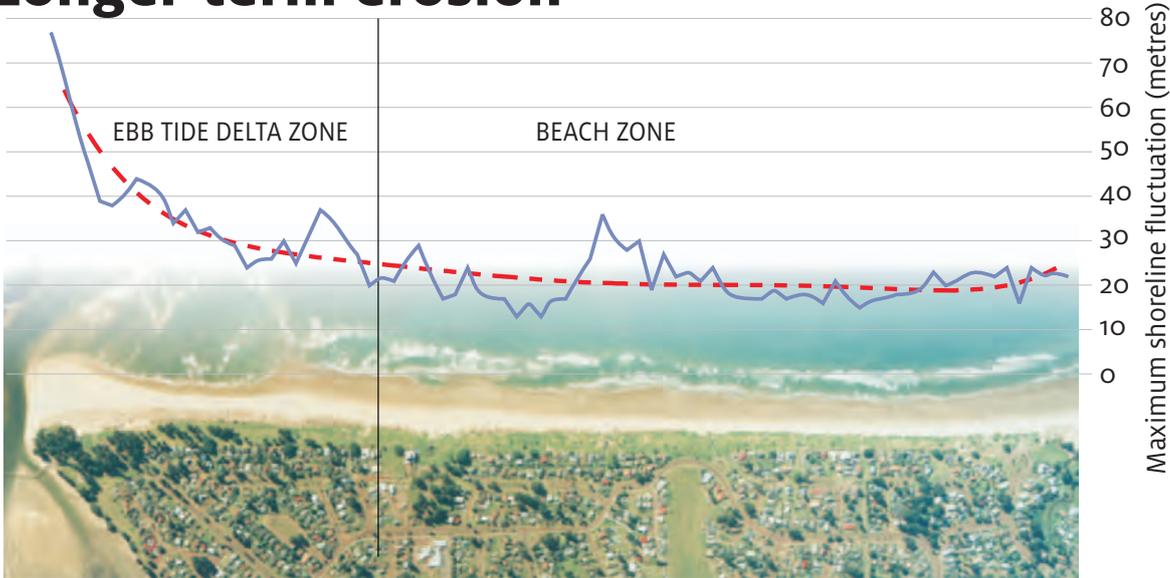
As well as storm erosion and recovery, beaches can also experience longer term and larger scale erosion. Maintaining adequate dune reserves to cope with such erosion is critically important.

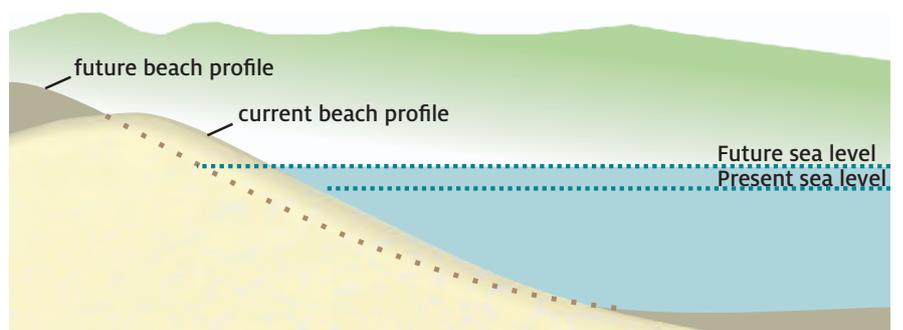
The effect of long term sea level rise.

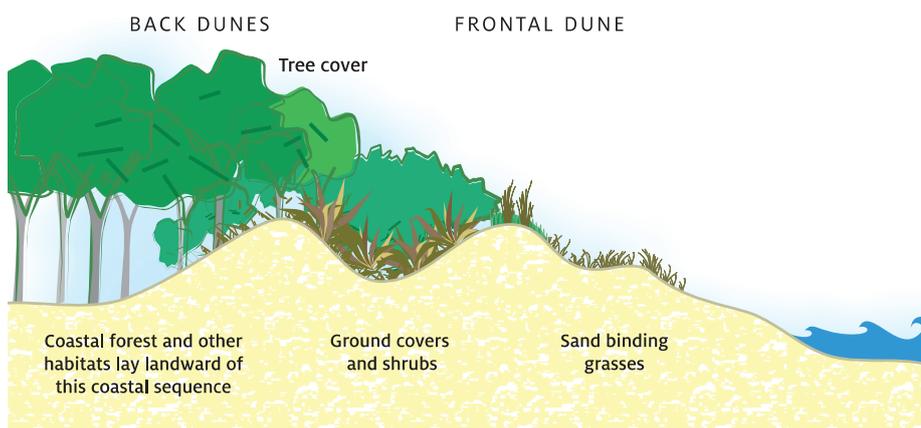
Natural sequence of Waikato dune vegetation.

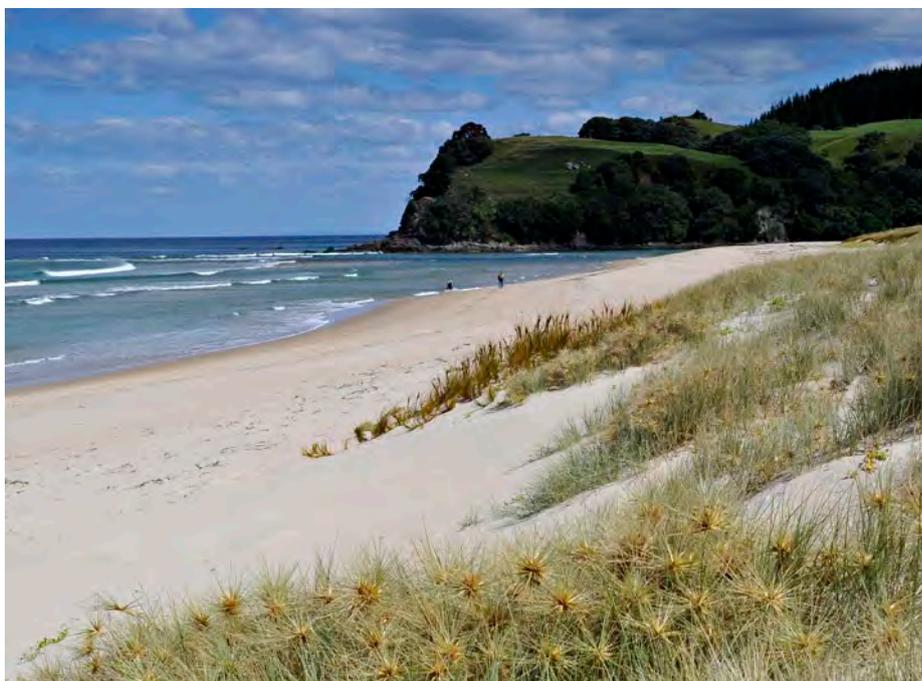
Sand binding plants spinifex and pingao on the frontal dune.

Sand binding vegetation plays a critical role in natural dune building and repair. The plants slow wind speed near the ground, causing sand to be deposited, thereby building up the dune. Deposited sand is bound by extensive horizontal and vertical rhizome systems. A cover of sand binding vegetation therefore protects dunes against wind erosion.

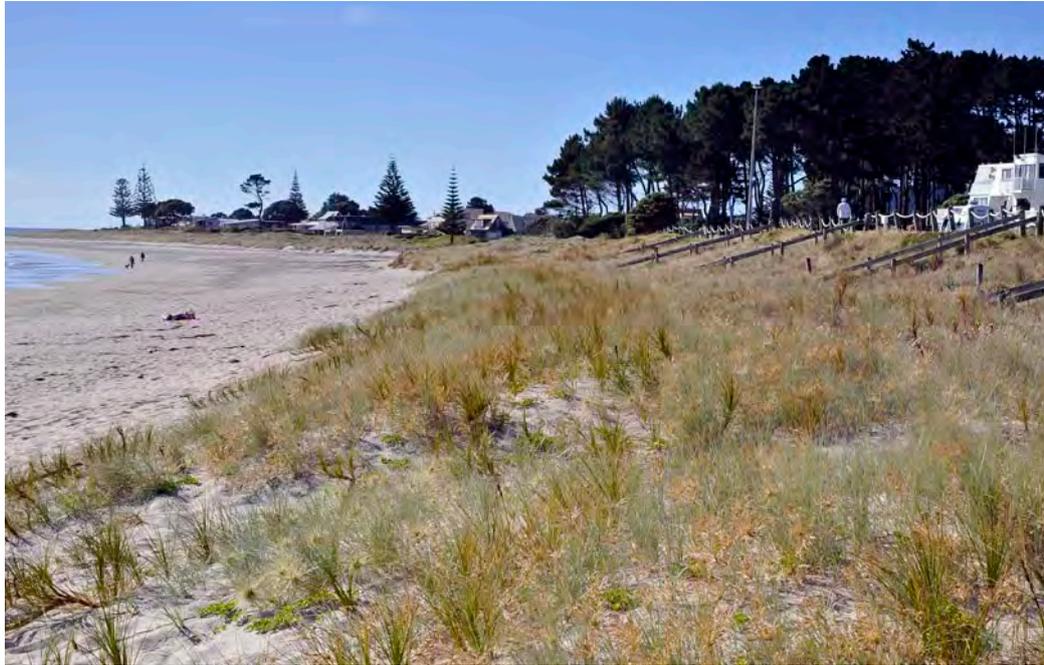
Property at Whangamata that is well protected by a natural well vegetated dune.

Maintaining an adequate width of well vegetated dunes provides a natural buffer that absorbs the impact of coastal erosion during storms and can repair itself naturally.

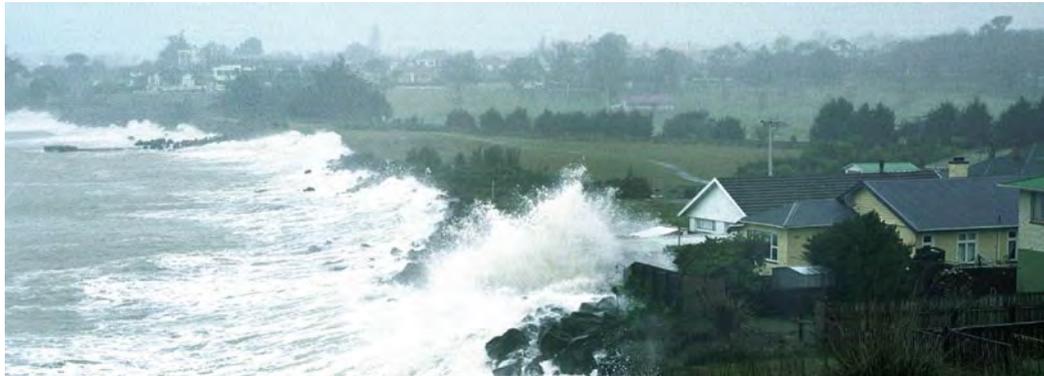
Timaru properties threatened by coastal flooding in July 2003
(Photo: Timaru Herald).

The height of natural dunes also provides protection from coastal flooding due to storm surge and wave action. If the natural protection provided by dunes is lost or destroyed, then serious coastal flooding problems can arise.

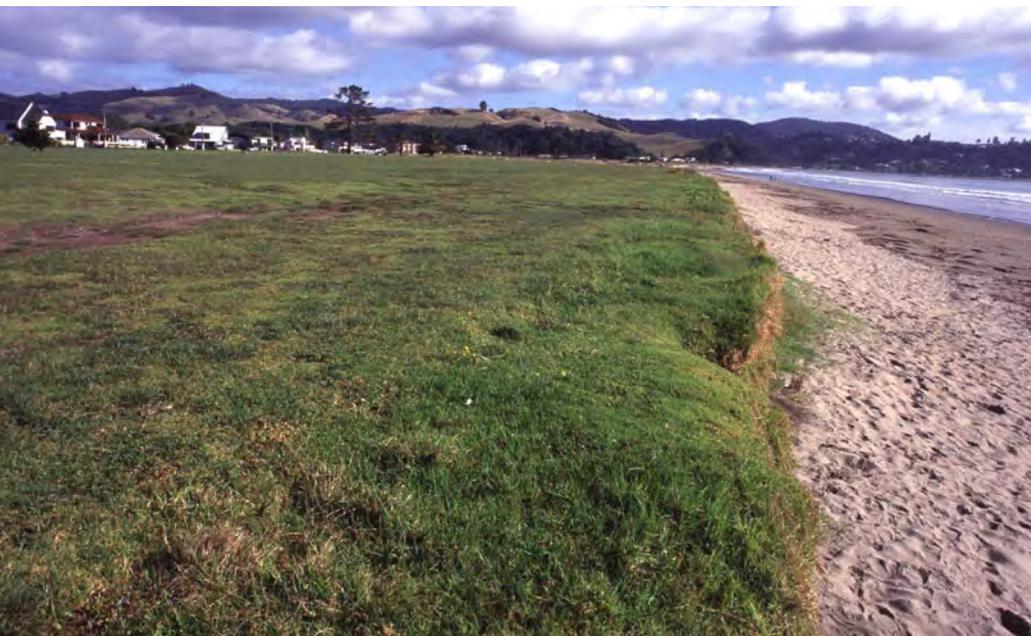
Barren modified dunes at Whitianga.

No intact examples now remain of the original plant sequences that once characterised the most seaward dunes, nor are there any significant areas of coastal dune forest anywhere on the Waikato coastline. Most coastal dunes in the Waikato are now relatively barren and degraded environments compared to their original state, though regenerating secondary and tertiary vegetation is evident at some rare sites.

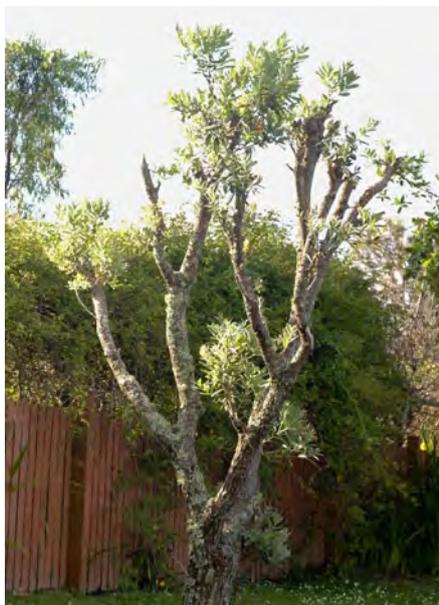
Trees damaged to protect views.

The barren nature of Waikato beaches is often accentuated along developed coastlines as property owners frequently damage or destroy regenerating shrubs and trees to protect sea views.

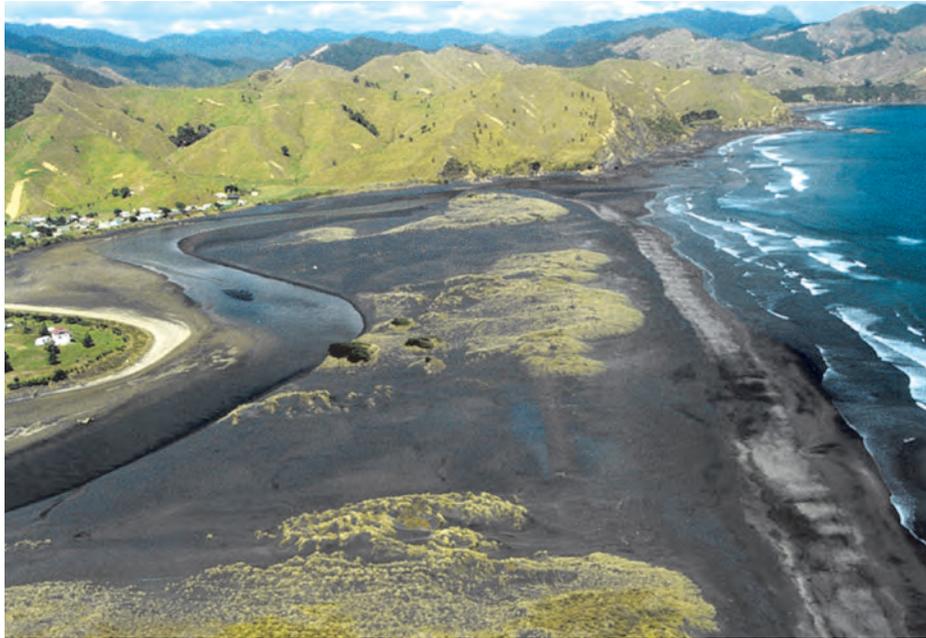
Marakopa dune damage arising from human use and stock tramping.

Early European settlement saw the introduction of stock to coastal dune systems. This resulted in disruption of sand binding grasses from trampling and grazing. This damage was also aggravated by fires. This led to widespread and serious wind erosion in the late 1800's and early 1900's, generating large inland migrating dunes and sand sheets. This wind erosion significantly disrupted many dunes along both the east and west coasts of the region, particularly those nearest the sea.

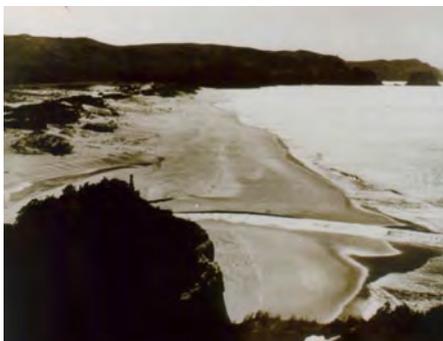
Serious wind erosion at Whiritoa Beach, 1911.

Sand extraction has also occurred at various eastern Coromandel beaches, removing large volumes of the finite and non-renewable beach sand reserves. Scientific investigations indicate that dune erosion has been aggravated by sand extraction at some of these sites, particularly Whiritoa and Kuaotunu west beaches.

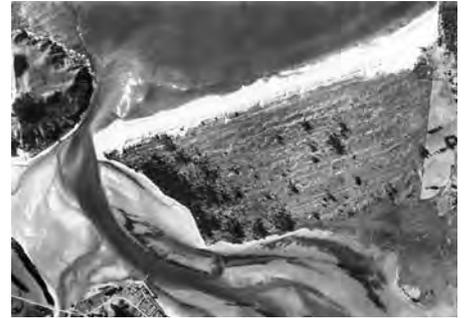
Pauanui before development, 1944.

Coastal development has tended to target beach and dune areas along the east coast, leaving very few undeveloped beaches. Over 75 per cent of all eastern Coromandel beaches are developed or partially developed. This issue is particularly significant at those sites with road access. Over 95 per cent of such sites are now developed to some extent.

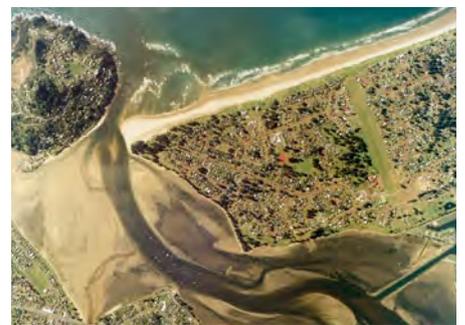
Pauanui after development, 1995.

Coastal development is generally located very close to the shoreline, with only a very narrow strip of dunes retained between properties and the sea. The width of dunes fronting this development is often inadequate, or only barely adequate to protect from serious coastal erosion and flooding. At many beaches, most of the dune sand reserves important to the future of the beach now lie buried under houses and properties.

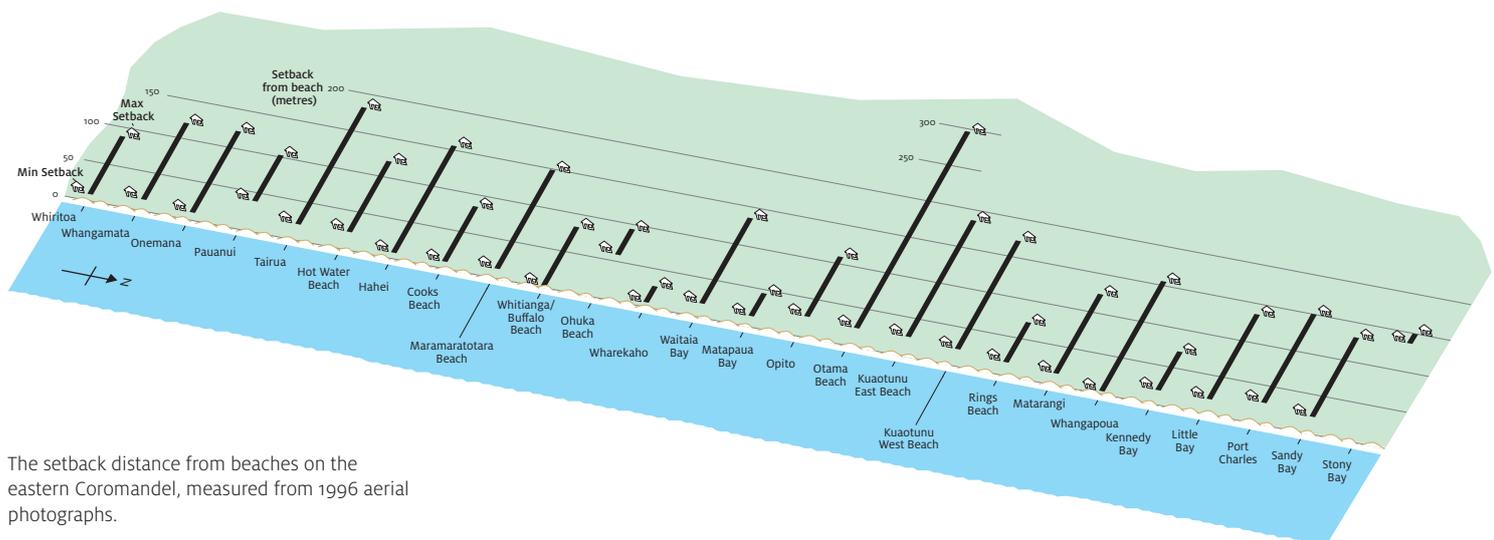
The setback distance from beaches on the eastern Coromandel, measured from 1996 aerial photographs.

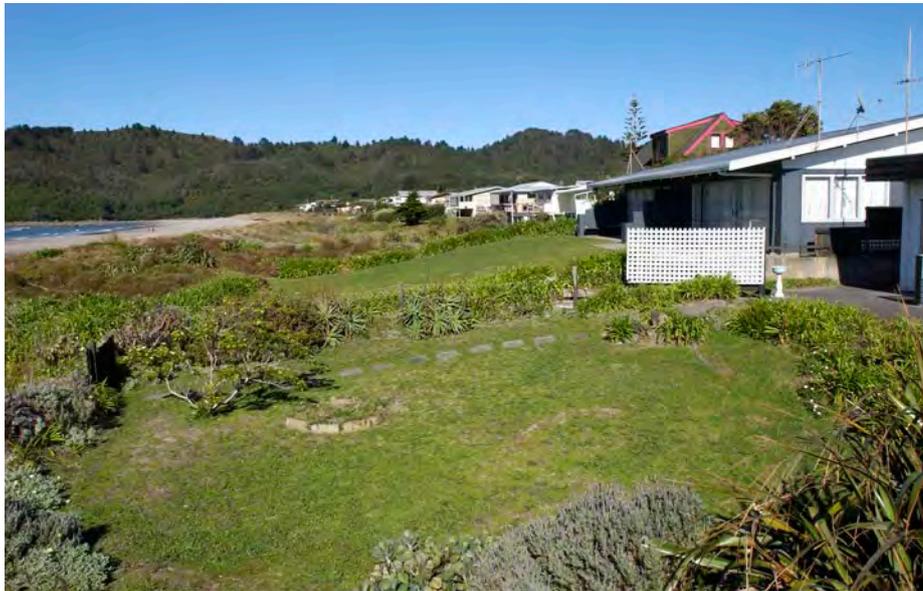
Lawned dune at Whangamata.

At some sites, frontal coastal dunes have been bulldozed to provide improved sea views, and have been capped with fill to enable lawns to be developed. At many sites, sand-binding grasses have been displaced by lawns or exotic vegetation. These practices have significantly altered the natural character of coastal dunes and affected natural dune building and repair.

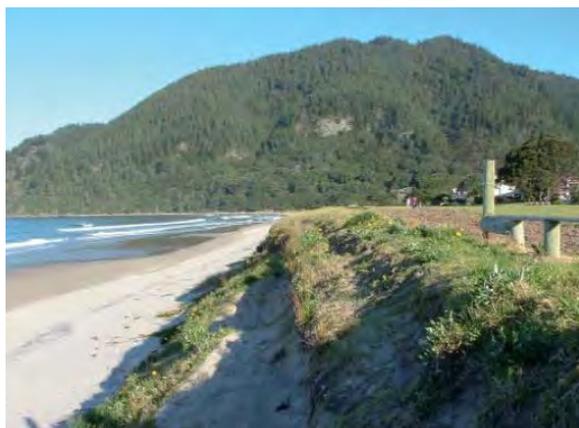
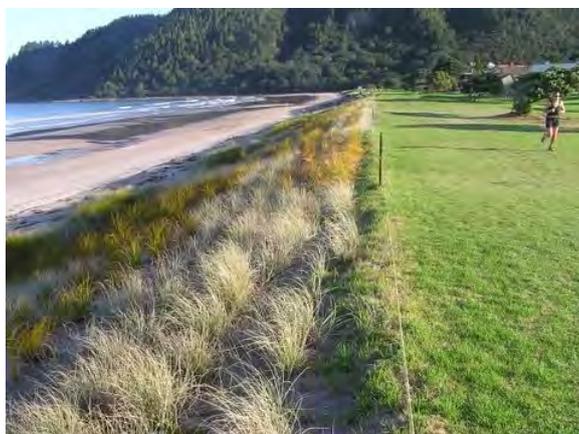
Pauanui showing bulldozed dunes and clay cap.

Pauanui after dune restoration.

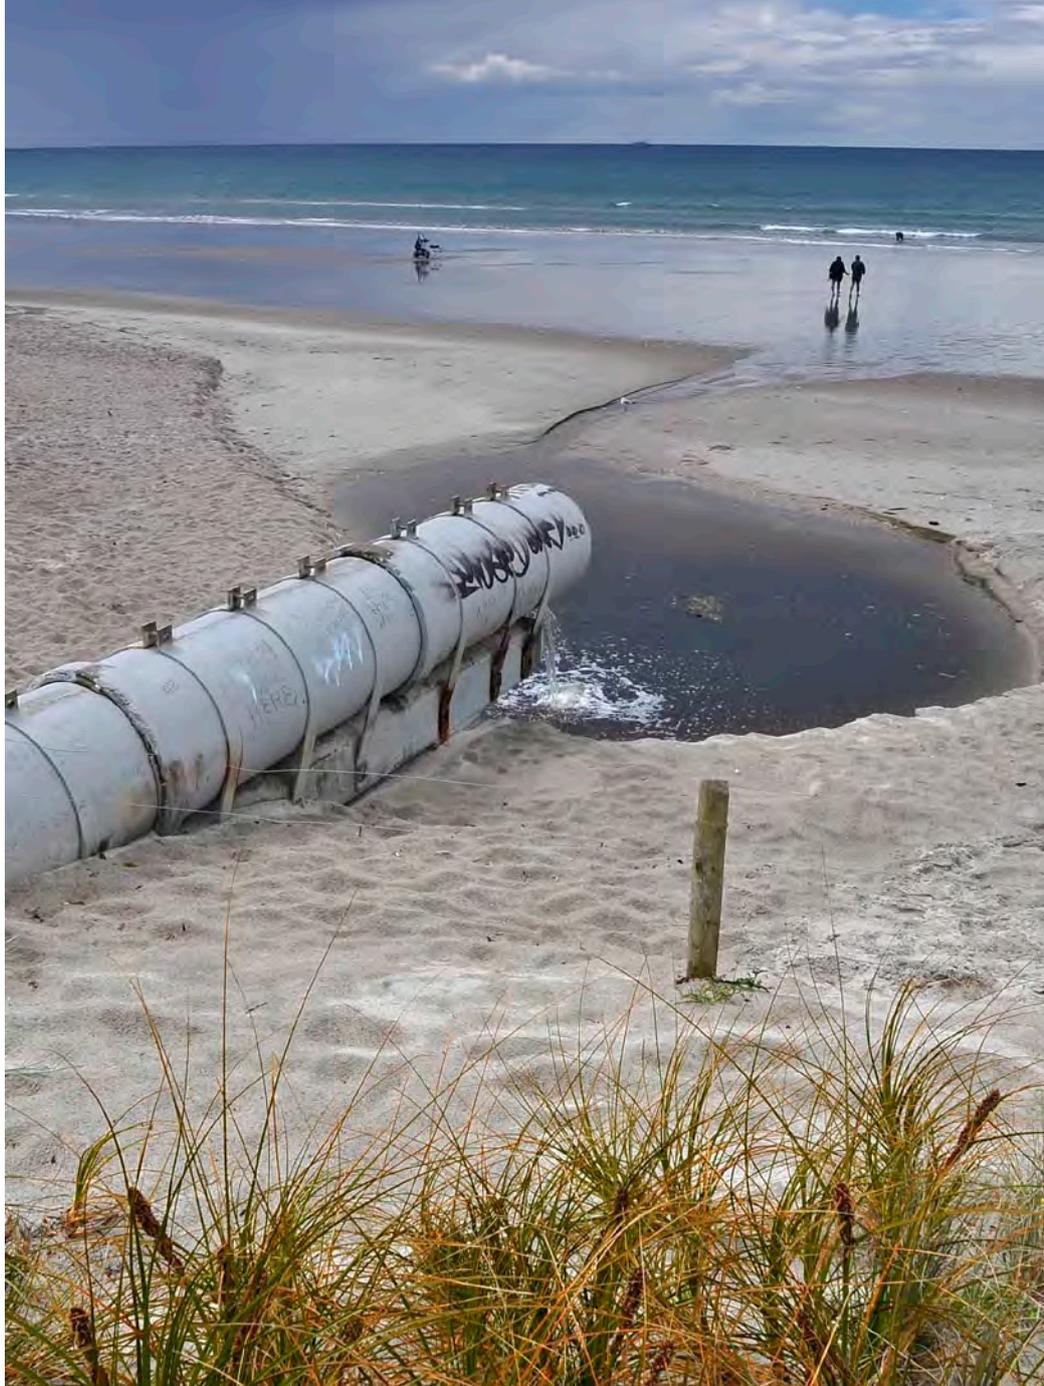
Stormwater outlet.

Stormwater from coastal subdivisions has commonly been discharged from outlets onto beaches, worsening beach and dune erosion in these areas and degrading amenity and natural character.

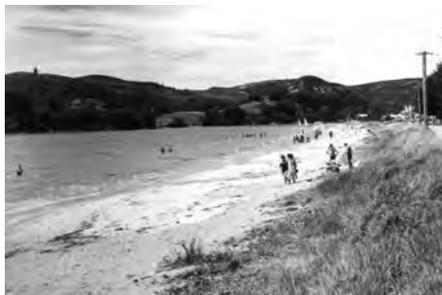
Buffalo Beach 1950: the dune has already been modified by the road.

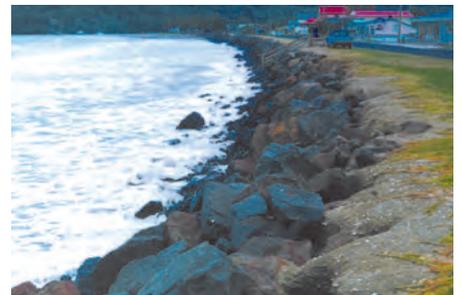
Buffalo Beach 1995: major structures are now necessary to protect the road.

Existing erosion problems have often led to the placement of property protection works such as seawalls. These structures typically degrade the natural and recreational values of beaches and also affect public access along the beach at high tide.

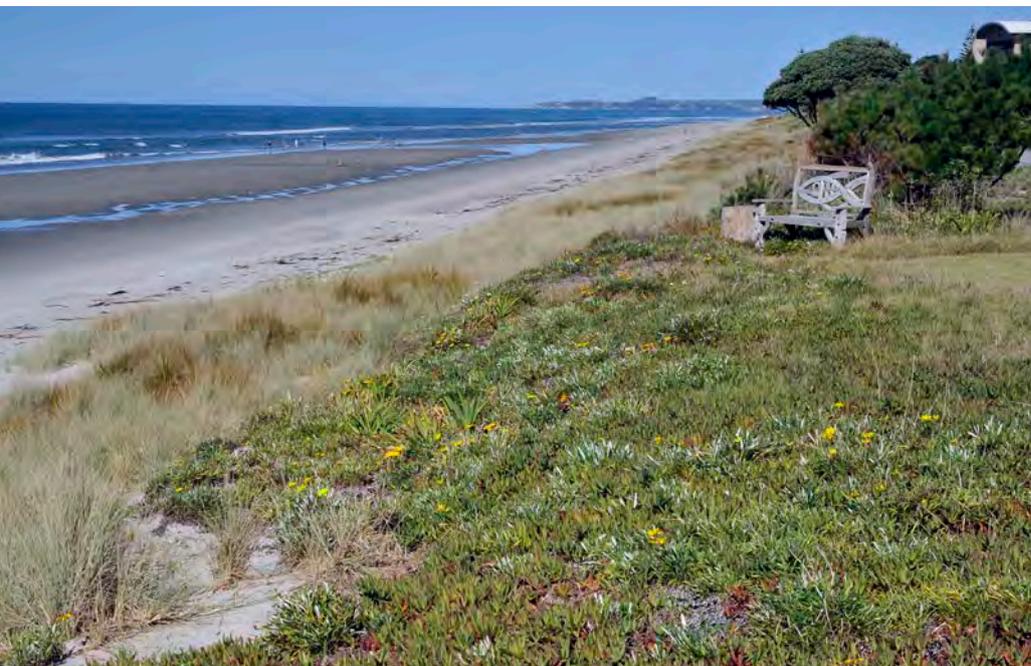
Exotic garden plants encroaching on the native dune plants on the east coast.

Many exotic species have been introduced to the coastal dunes of the Waikato. These species have often resulted in weed pest problems and loss of natural character, and adversely affected natural dune building and repair.

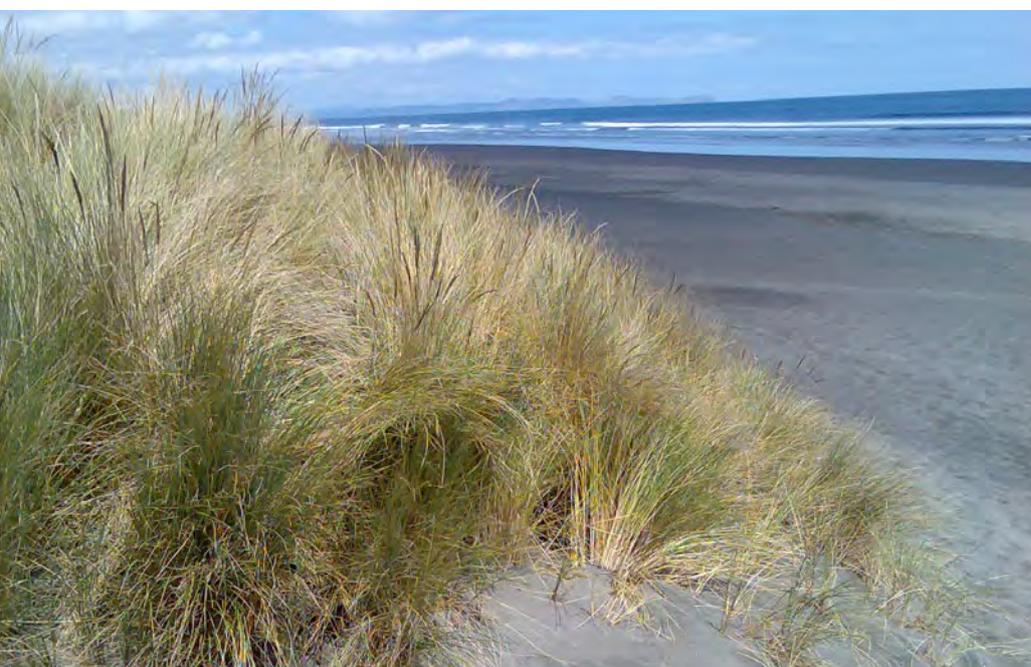
Marram dominated dune.

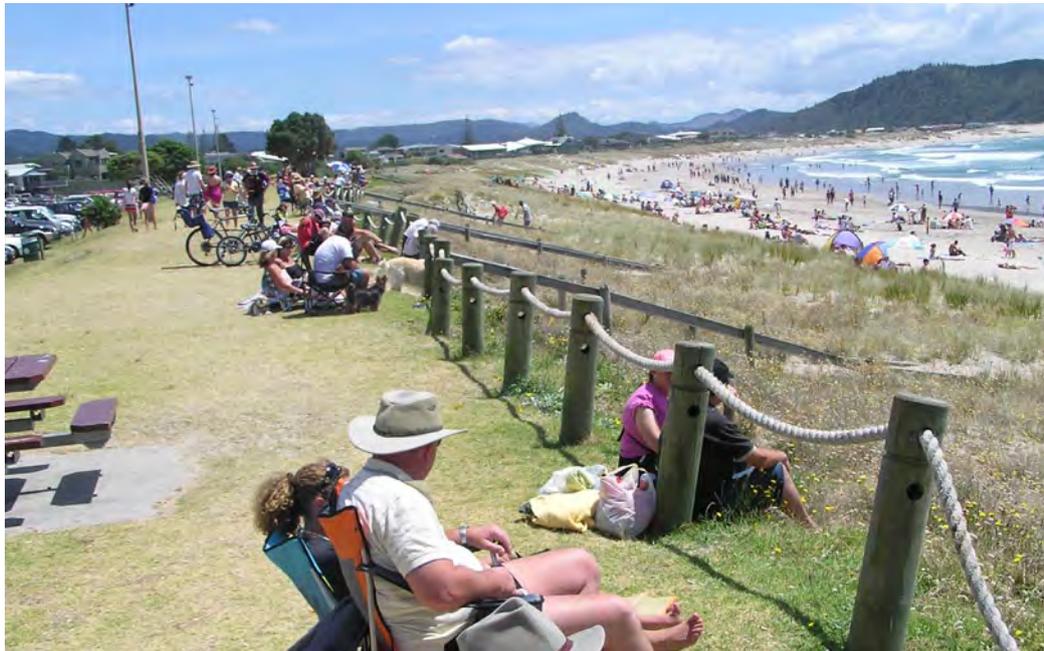
Whangamata Esplanade after restoration.

In some high use areas along the Coromandel east coast, human trampling and subsequent wind erosion has almost completely eliminated the frontal dune. The esplanade area at Whangamata was a notable example, though the local community have since begun restoration activities.

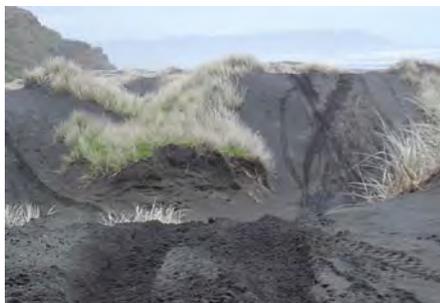
Dunes damaged at Karioitahi by motorbikes and 4WD vehicles.

In many areas, the sand binding grasses on coastal dunes have been damaged or destroyed by off-road vehicles and pedestrian trampling. This disrupts natural dune building and can also lead to serious wind erosion. Off-road vehicles have seriously impacted on coastal dunes of the west coast.

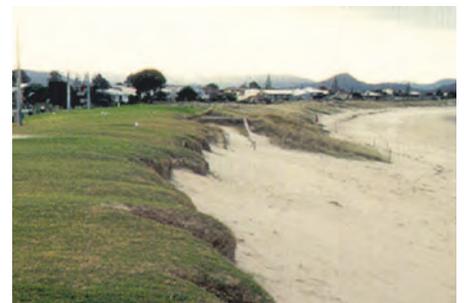
Whangamata Esplanade area, showing the difference between modified and restored dunes.

Note: The natural dune in the background is less eroded than the modified dune in the foreground.

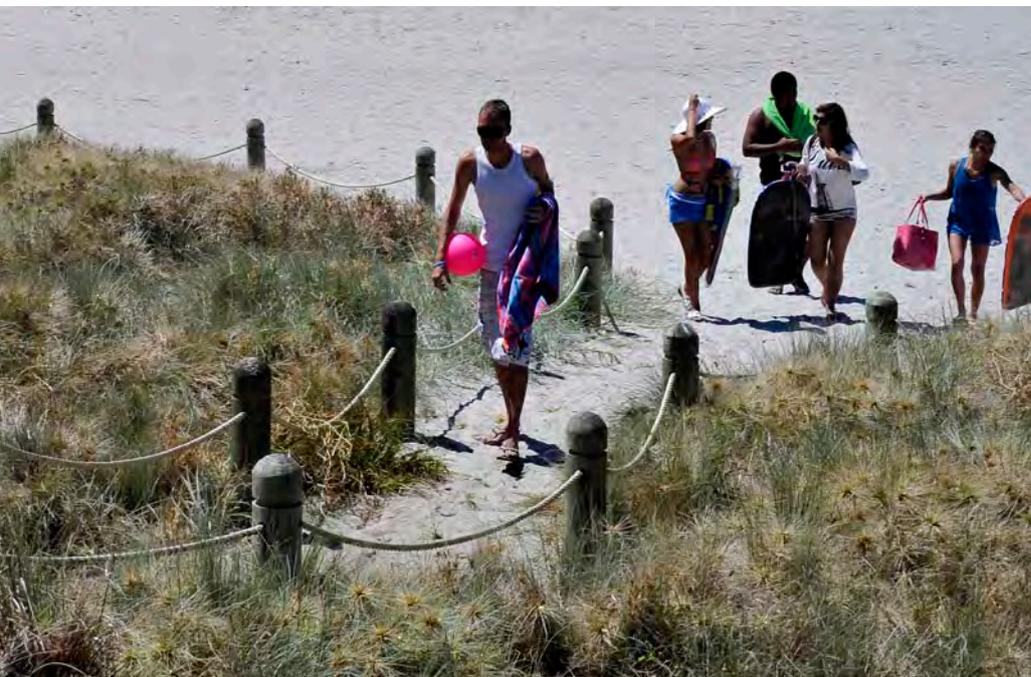
Dune accessway protecting vegetation.

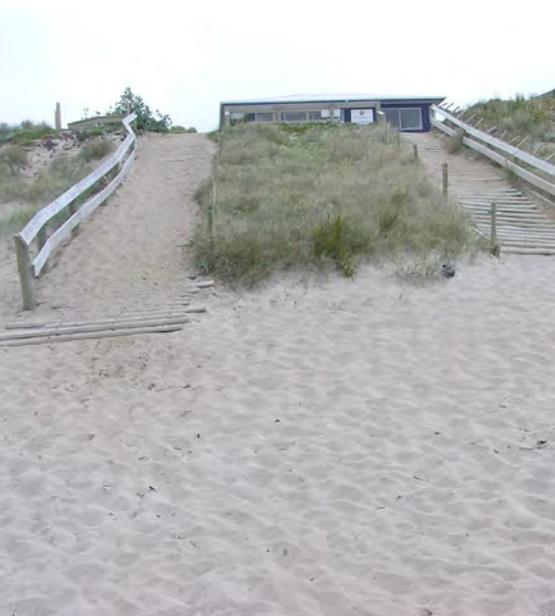
Accessway at Tairua protecting beachcare work.

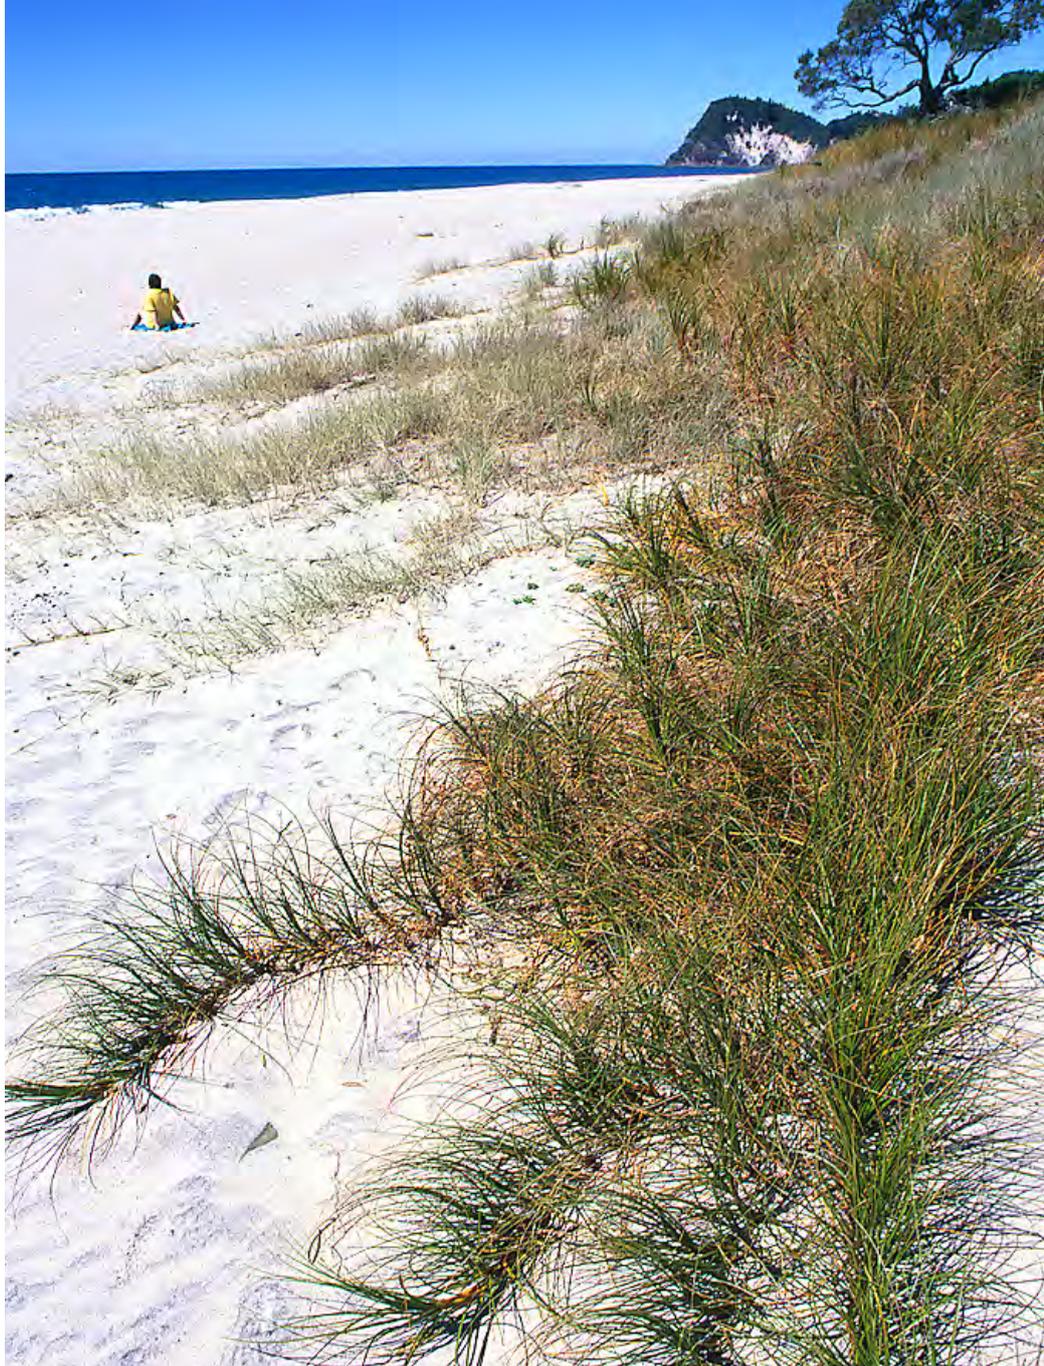
A good cover of native sand binding grasses growing on dunes at Whiritoa.

The primary objective of this work is to restore an adequate cover of spinifex and pingao, to ensure natural dune building and repair and prevent wind erosion. These sand grasses will not prevent wave erosion and are not intended for this purpose. However, they are critical if dunes are to naturally repair after such erosion.
