A GUIDE TO WAIKATO DUNES

Waikato

REGIONAL COUNCIL

INSIDE FRAGILE

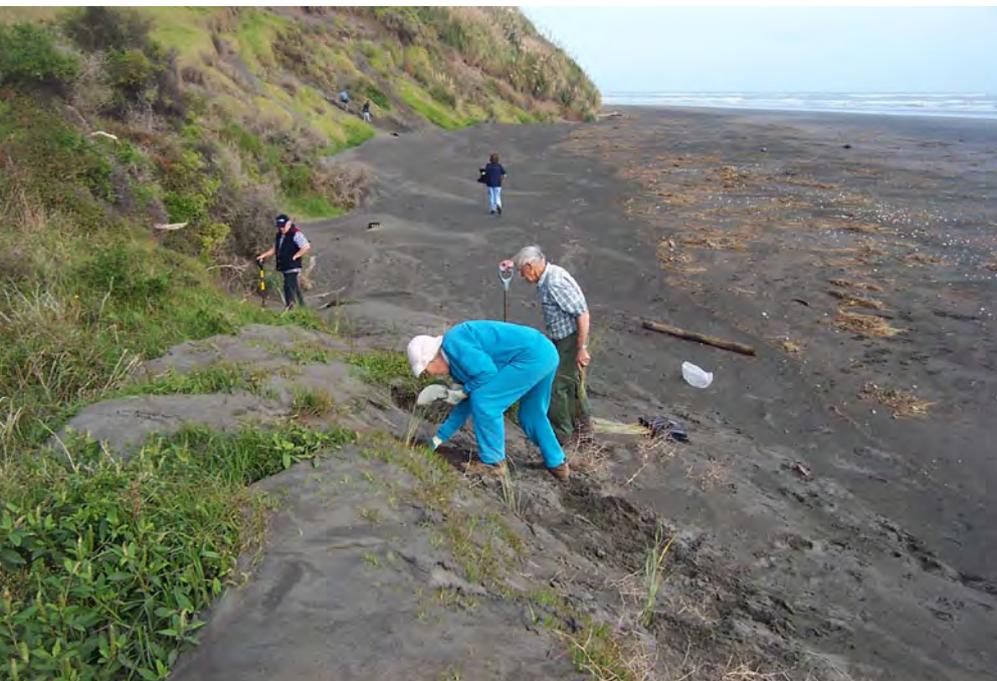
Dune restoration at Whaingaroa.

The restoration of sand grass zones usually involves some or all of the following

- Identify any human activities causing vegetation disruption.
- Appropriately manage these activities to prevent further damage.
- Where required, remove any clay fill and repair dune damage.
- Re-establish a good cover of spinifex and pingao by plantings and/or fertilisation of existing stands.
- Where required, ensure the sand grasses are protected from human disturbance by the use of dune accessways and signage.

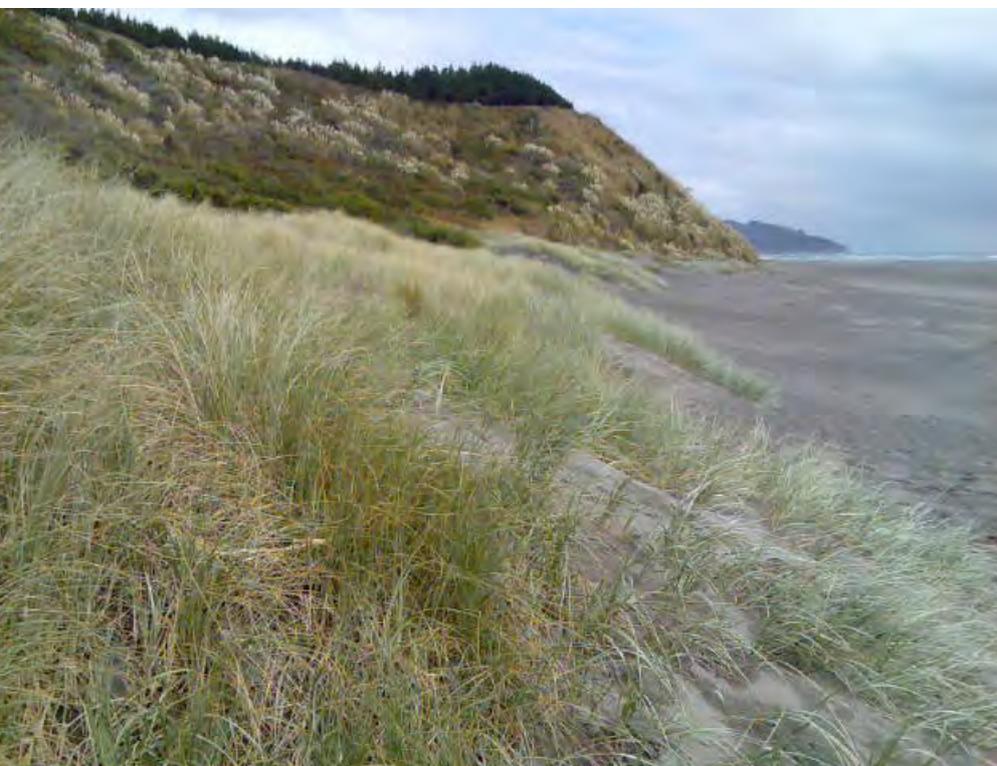
After shot of dunes at Whaingaroa.

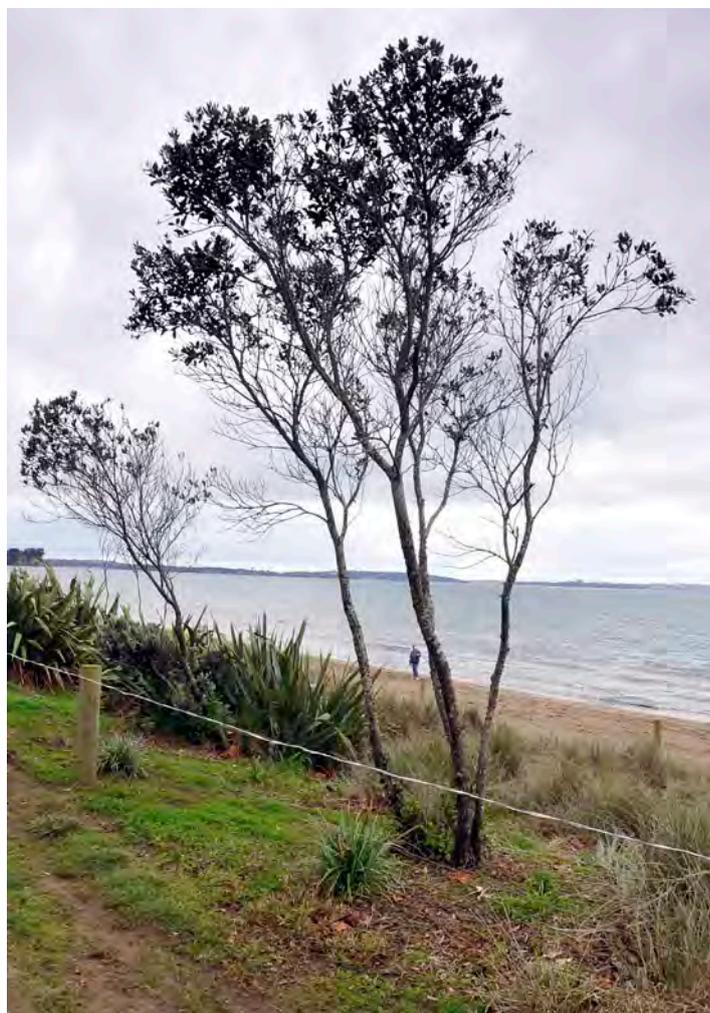
Trees on the frontal dune damaged by erosion at Whitianga.

It is not appropriate, for instance, to plant trees or shrubs in sand grass areas seaward of the dune crest. These species will be subject to salt burn or undermining by erosion in such areas.

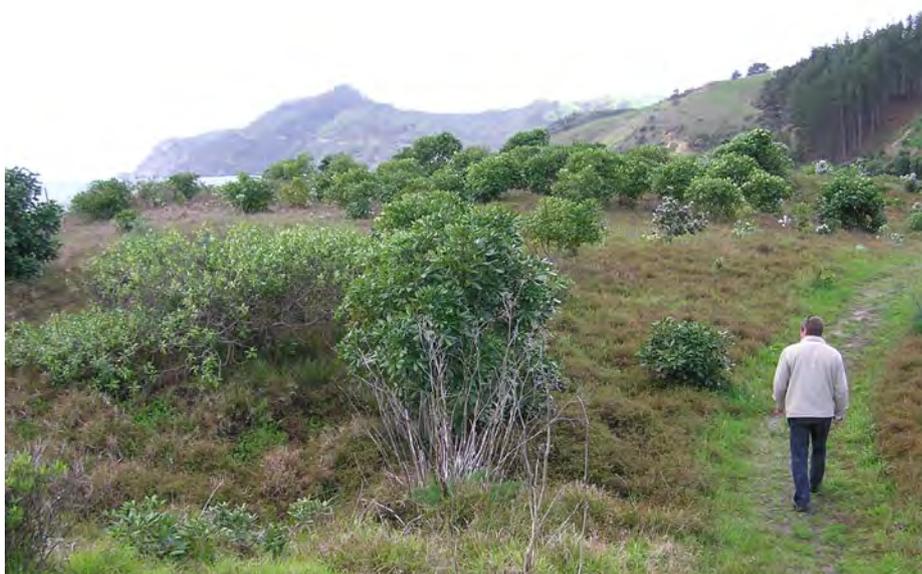
Well restored back dune area at Kuaotunu.

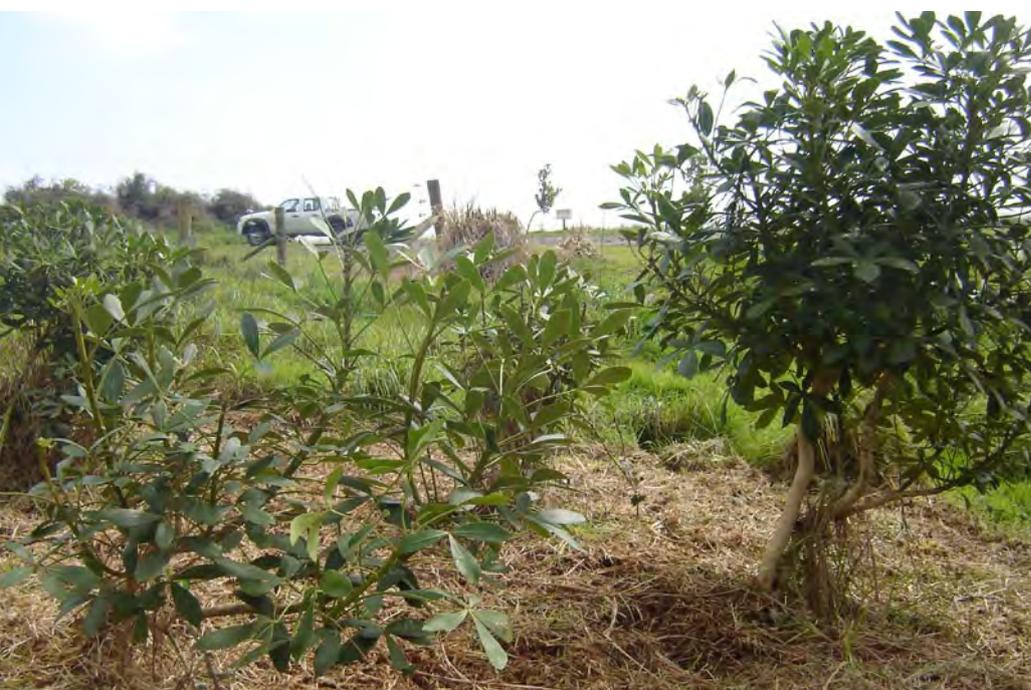
Well established Houpara (coastal five-finger) shrubs from an earlier trial in the back dune area at Whaingaroa.

In initial stages of restoration, when there is not much shelter, it is important to use hardy species, such as karo, cottonwood, taupata and coastal five finger (though the latter species is very susceptible to rabbit browsing). Flax and cabbage tree can also often be established in earlier stages.
