Assessment of the ecological condition of lakes in the Waikato region using LakeSPI – 2010

Prepared by:
Tracey Edwards, Mary de Winton, John Clayton
National Institute of Water and Atmospheric Research (NIWA)

For:
Environment Waikato
PO Box 4010
HAMILTON EAST

**NIWA Client Report: HAM2010-065
June 2010**

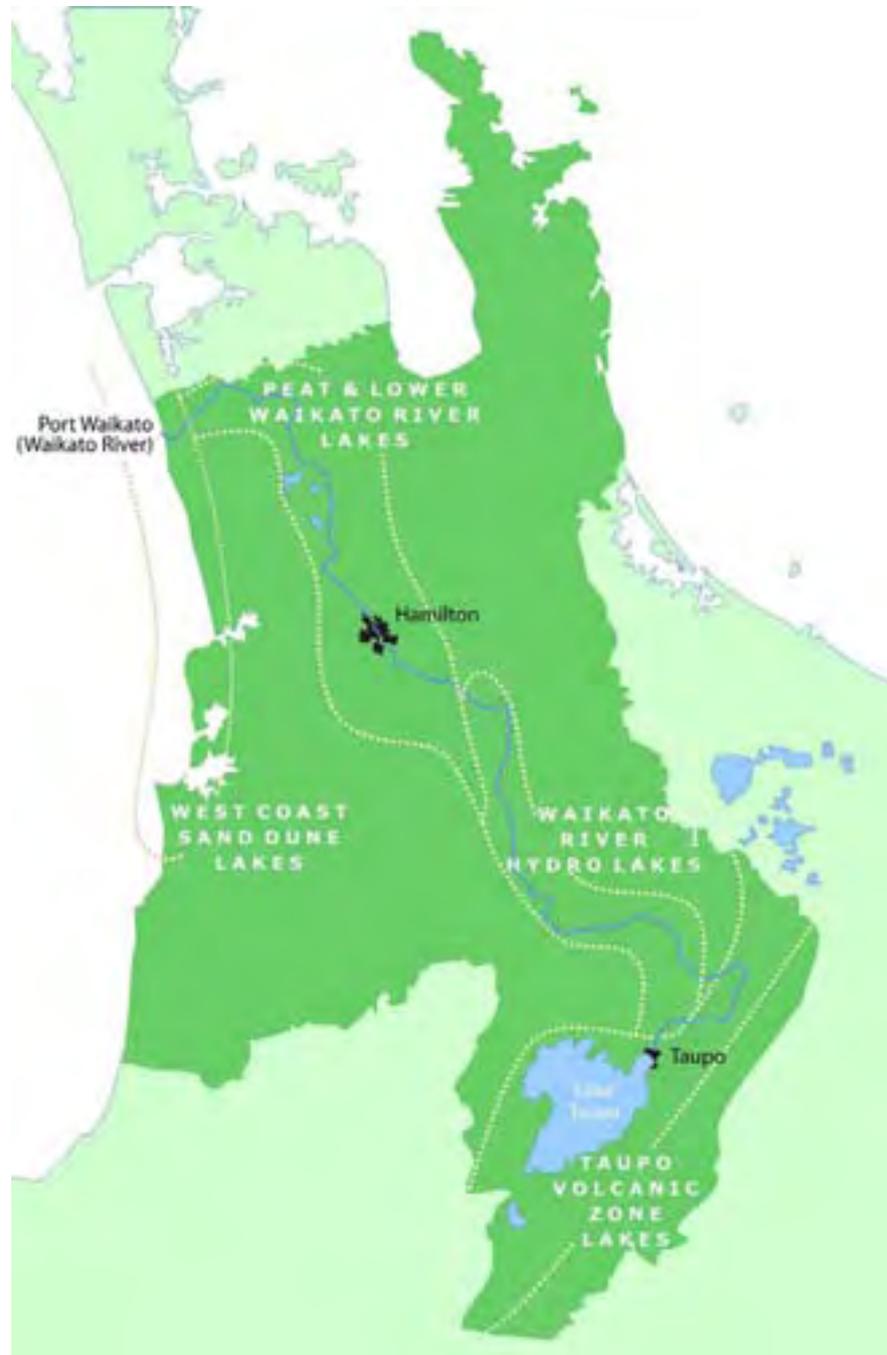
Figure 1: Location of lake groups within the Waikato Region; including dune lakes along the west coast, peat lakes in the lower Waikato basin, riverine lakes associated with the northern reach of the Waikato River, hydro lakes in the Waikato River system and lakes in the Taupo volcanic zone (source – Environment Waikato).

Fifty-two Waikato lakes in total have been assessed using LakeSPI. The location of lakes is indicated in Figure 1 and includes peat influenced lakes within the Waikato basin, riverine lakes adjacent to the northern reach of the Waikato River, hydroelectric lakes along the Waikato River system, dune lakes located along the West Coast and lakes within the Taupo volcanic zone. The lakes vary in size and depth (Table 1).

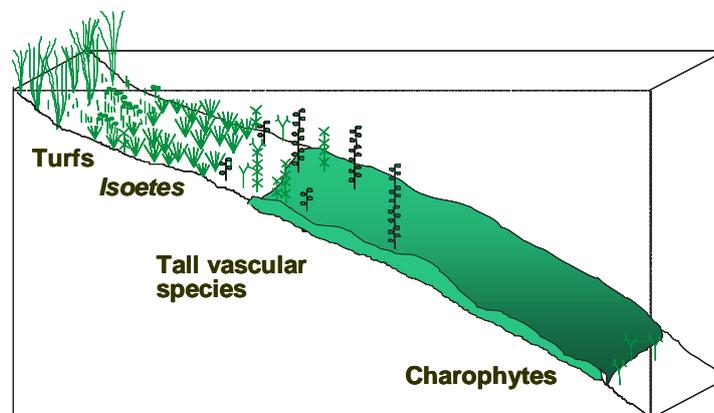
Figure 2: Depth profile illustrating the main components of native lake vegetation.

In a pristine state, lakes in the Waikato Region would have once contained a diverse range of native plant species down to a depth determined by water clarity. For many of the Waikato shallow lakes it is likely that plant growth would have occurred across the entire lake bottom at some stage during their development and maturation (Figure 2). Today, Lake Serpentine North and Lake Rotopounamu are the only known remaining examples of Waikato lakes that remain in an all-native vegetated state.

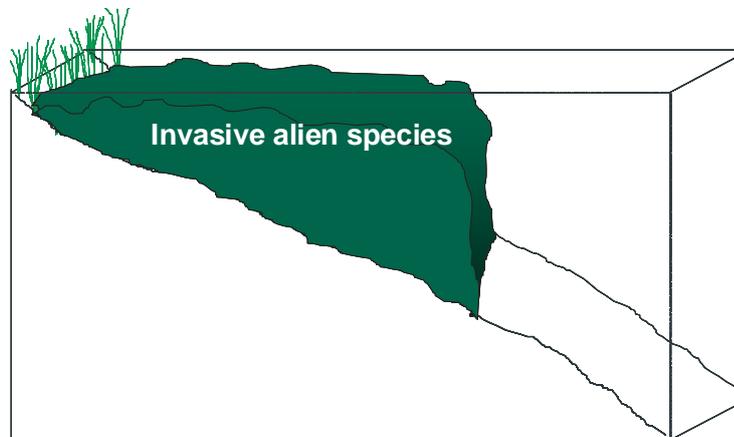
Figure 3: Depth profile illustrating the potential impact of invasive species.

With the introduction of invasive submerged plant species over the past 150 years, native plants in most lakes were displaced by invasive weed species, which often formed tall mono-specific weed beds (Figure 3). Some west coast dune lakes (Lake Taharoa, Puketi, Rotoroa and Parkinson) remain in this state and are vulnerable to vegetation collapse. Many of the Waikato lakes have now proceeded to the next and, often final stage where de-vegetation has occurred (Figure 4). Although invasive species are not favourable in terms of overall lake condition, the presence of any submerged plants in a lake is preferable to none, because they mitigate many of the symptoms of eutrophication (e.g., lock-up nutrients, maintain water clarity, compete with phytoplankton).

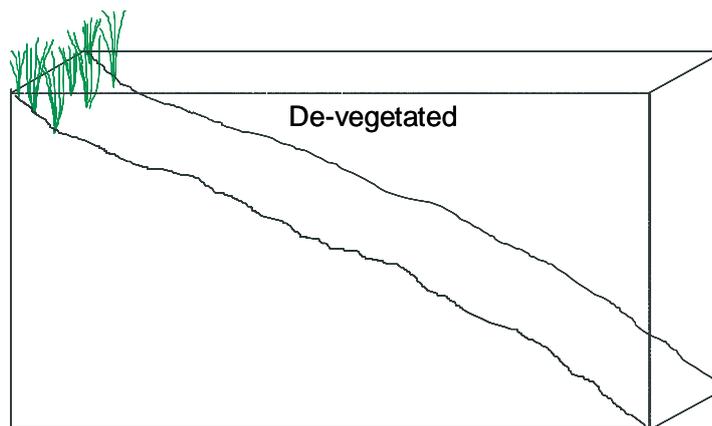
Figure 4: Depth profile illustrating a de-vegetated lake.

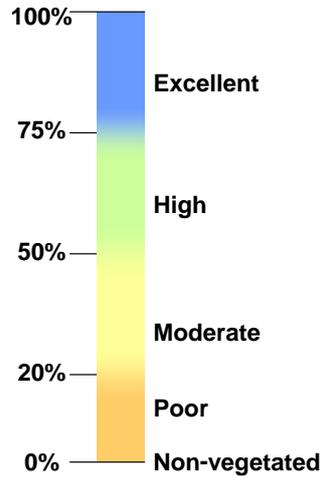
Note: These categories are imposed on a continuum scale of scores; therefore we recognise some flexibility in the placement of lakes with scores close to the transition between categories. Lake placement in these cases will be made using expert opinion based on the current status of the lake and the pressures exerted on it.

Figure 5: LakeSPI indices categorise lakes into five lake condition groups.

For the purposes of ranking and discussing results, lakes have been categorised into five main groups based on the LakeSPI Index. Lakes are grouped as being in an 'excellent', 'high', 'moderate', 'poor', or 'non-vegetated' condition (Figure 5). These new lake groupings support an MfE initiative to ensure national consistency in

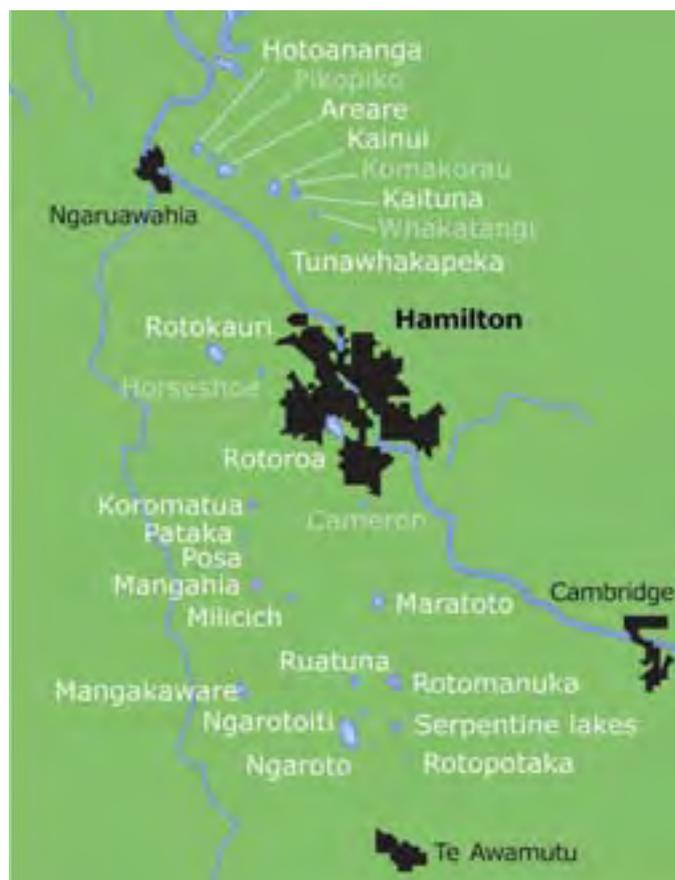
Figure 5: Location of peat lakes within the Waikato Region with assessed lakes shown in bold white type (source – Environment Waikato).

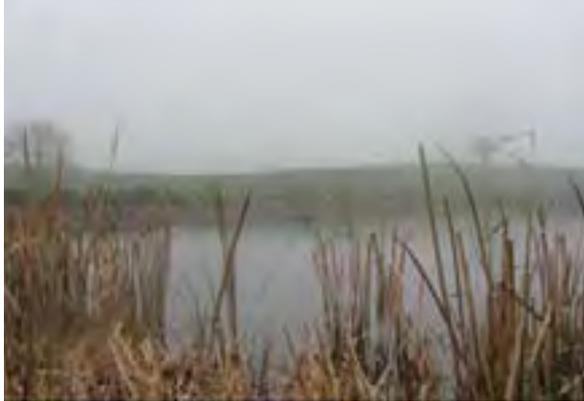
3.1.1 Lake Areare

Lake condition: Non-vegetated
 Stability: Stable
 Lake type: Peat
 Maximum depth: 5.1 m

Due to a lack of historic data, the timing of submerged vegetation disappearance from Lake Areare is unknown. A 1991 survey found only a sparse cover of submerged plants at only one of the five sites surveyed and although a recent survey has not been completed for Lake Areare, no improvements are expected due to the high peat staining of the lake water and lack of major land-use changes since 1991.

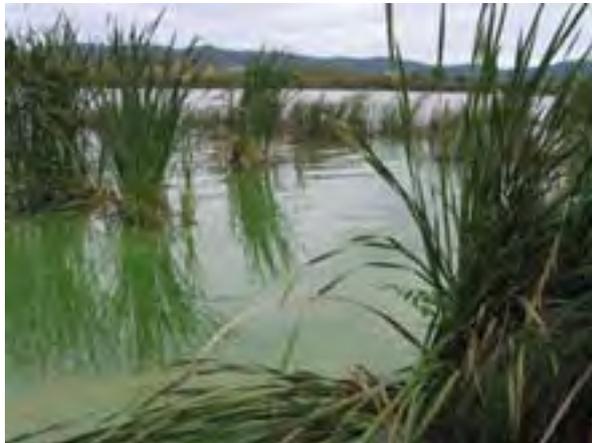
3.1.2 Lake Hotoananga

Lake condition: Non-vegetated
 Stability: Stable
 Lake type: Peat
 Maximum depth: 3 m

Egeria densa dominated the submerged vegetation of Lake Hotoananga from the late 1950's until the early 1990's and during this period the lake remained in an invaded but stable condition. No submerged plants were found in the 2001 LakeSPI survey despite the adequate water clarity noted by divers at that time. Most recently, in 2010, a cyanobacteria algal bloom was noted on the eastern shore and the water was noticeably turbid. The charophyte *Nitella* aff. *cristata* formed low covers (<25%) to a depth of 1 m amongst the reeds beds of *Eleocharis sphacelata*, and *Potamogeton ochreatus* was also seen. However, because submerged vegetation was not present at the majority of sites investigated, this lake scored default LakeSPI values of 0%.

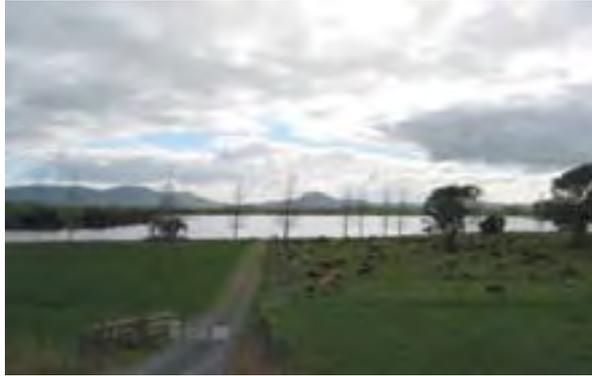
3.1.3 Lake Kainui (D)

Lake condition:	Non-vegetated
Stability:	Stable
Lake type:	Peat
Maximum depth:	6.7 m

A strongly coloured peat lake, Lake Kainui is likely to have provided poor habitat for submerged plants in pre-European times as well as historically. It was first investigated by NIWA staff for the presence of submerged vegetation in 1983 and again in 1991 and no submerged plant species were found. The 2005 assessment found charophytes (*Nitella* aff. *cristata*) at covers exceeding 10% at three of the five sites investigated, and therefore the lake generated a moderate LakeSPI score (Table 5). It was noted however, that slight fluctuations in plant development would have a significant influence on future scores and results for such a lake should be considered indicative only.

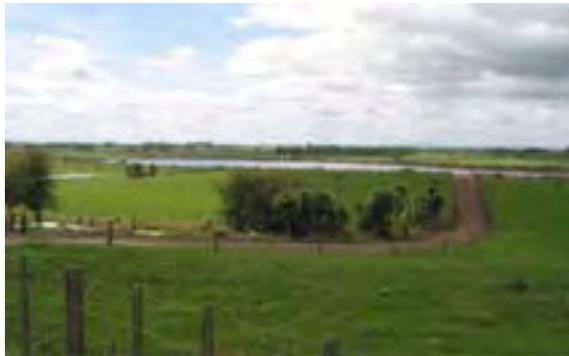
3.1.4 Lake Kaituna (B)

Lake condition:	Non-vegetated
Stability:	Stable
Lake type:	Peat
Maximum depth:	1.3 m

This lake has peat-stained waters and high levels of suspended matter. It was first investigated by NIWA staff in 1992 and no submerged plant species were found. Since then major willow clearance works and native riparian planting have been undertaken in the lake margins, together with land practice methods to reduce nutrient run-off from the surrounding agricultural catchment.

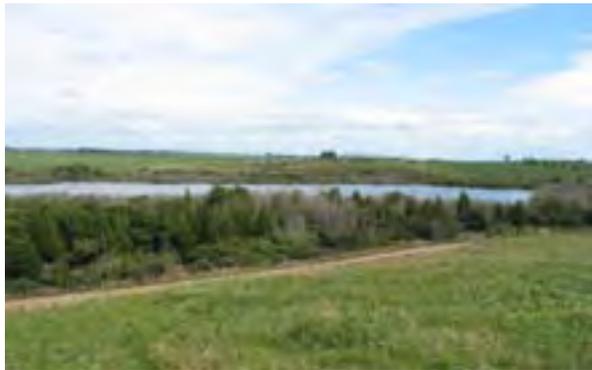
3.1.5 Lake Koromatua

Lake condition: Non-vegetated
 Stability: Stable
 Lake type: Peat
 Maximum depth: 1.2 m

Lake Koromatua has peat-stained waters that would have naturally constrained the growth of submerged plants. Until recent times the lake received direct agricultural discharges and was considered hypereutrophic. Water level was also affected by drainage in the area. In 1991 NIWA staff found no submerged plants during a survey of six sites and concluded that poor water clarity and the lakes shallow nature (0.8 m depth) explained their absence. In recent years agricultural inputs have been diverted, the lake level has been raised, willows controlled and native riparian plantings has been made.

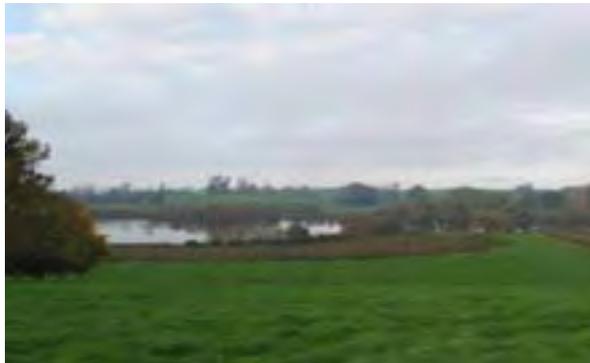
3.1.6 Lake Mangakaware

Lake condition:	Non-vegetated
Stability:	Declining
Lake type:	Peat
Maximum depth:	4.8 m

During the most recent visit in 2010, submerged plants exceeded 10% cover at fewer than half of the surveyed sites, generating a default LakeSPI Index of 0% (Table 8). *Nitella* aff. *cristata* and *Potamogeton ochreatus* grew within a narrow zone down to 1 m depth, and *Egeria densa* was also recorded. Earlier, in 2005, sparse vegetation comprising six species was described over wider depths of up to 1.8 m. The presence of the invasive weed *Egeria densa* has now been confirmed within the lake for in excess of nineteen years, but has not had a high invasive impact (Table 8), while the more benign weed *Elodea canadensis* was recorded for the first time in 2005.

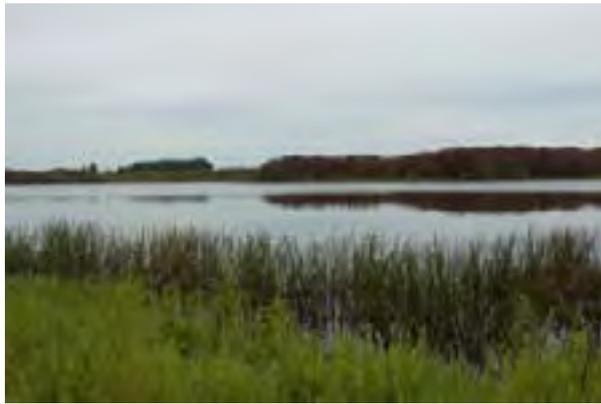
3.1.7 Lake Mangahia

Lake condition: Non-vegetated
 Stability: Stable
 Lake type: Peat
 Maximum depth: 1.5 m

In 1992 no submerged vegetation was recorded and it was considered that the low water clarity due to strong peat staining made conditions unsuitable for plants. The NIWA survey in 2007 again did not record any submerged vegetation. Koi carp were observed in 2008 (NIWA records) and are likely to further reduce the suitability of conditions for submerged vegetation development.

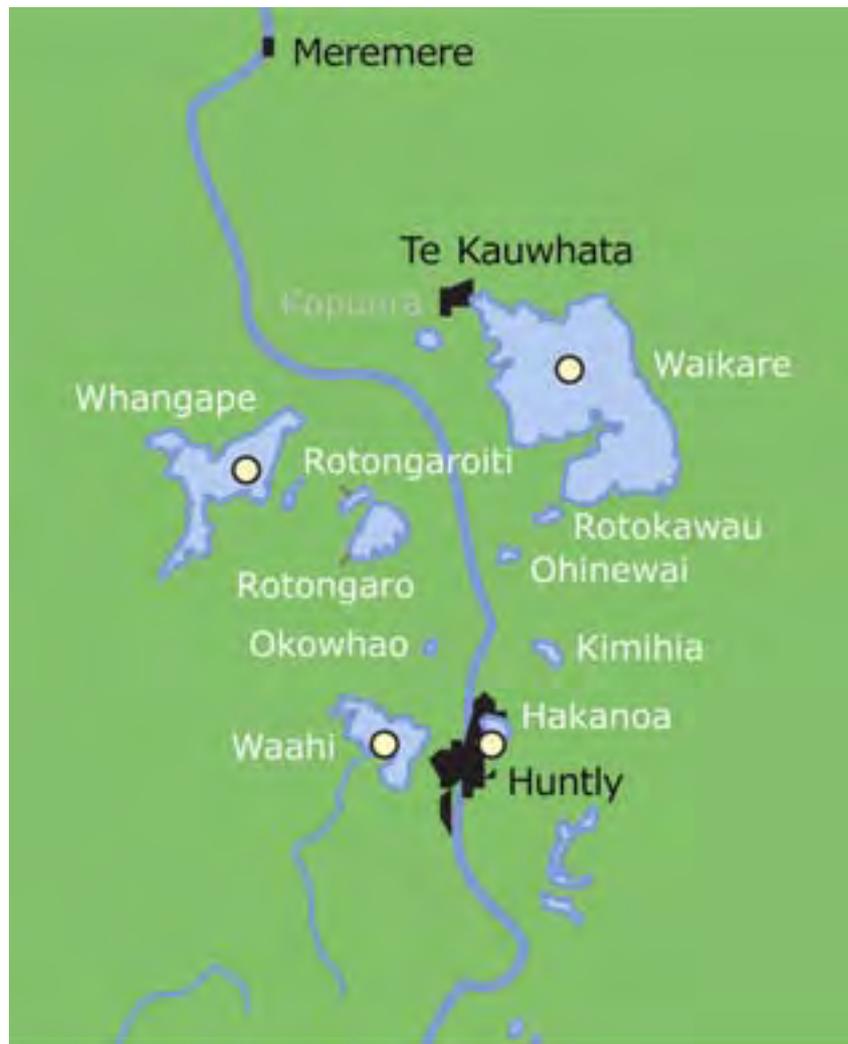
Figure 6: Location of Riverine lakes within the Waikato Region with assessed lakes shown in bold white type (source – Environment Waikato).

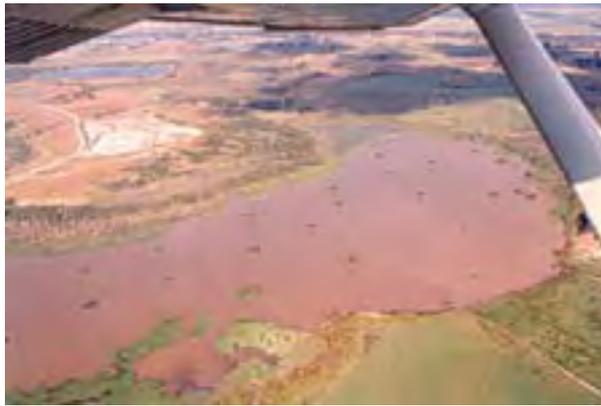
3.2.2 Lake Kimihia

Lake condition:	Non-vegetated
Stability:	Stable
Lake type:	Riverine
Maximum depth:	3.3 m

In 1958 Mason and Moar collected *Egeria densa* from Lake Kimihia, and suggested this infestation was the primary source for *E. densa* spread through the Waikato River system (Mason 1960). LakeSPI results show lake condition continued to decline from then and by 1991, no submerged vegetation remained in Lake Kimihia. Continuing high levels of turbidity make it unlikely that the status of this lake has changed in recent years.

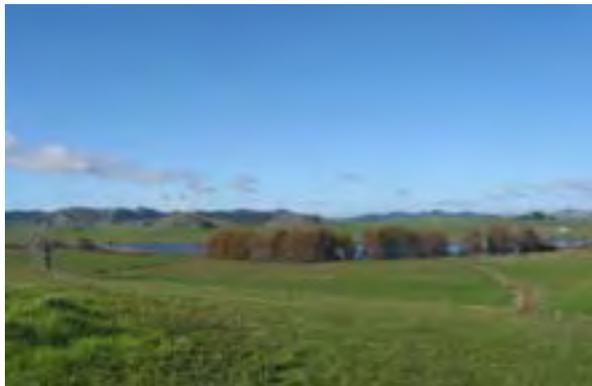
3.2.3 Lake Ohinewai

Lake condition: Non-vegetated
 Stability: Stable
 Lake type: Riverine
 Maximum depth: 4.5 m

During a survey of Lake Ohinewai in 1981, *Egeria densa* was recorded as covering over 80% of the lake bottom (WVA, 1981). LakeSPI results show lake condition continued to decline from then, and by 1991 no submerged vegetation remained. Today Lake Ohinewai remains de-vegetated.

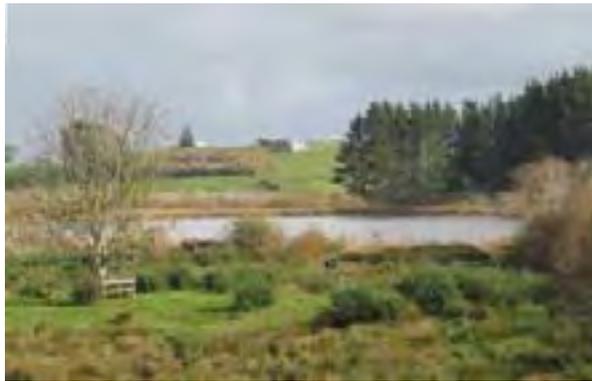
3.2.4 Lake Okowhao

Lake condition: Non-vegetated
 Stability: Stable
 Lake type: Riverine
 Maximum depth: 2.2 m

This lake is now de-vegetated following a period of dominance by the invasive weed *Egeria densa* from at least 1981 to 1991. The most recent 2009 survey found no submerged plant species.

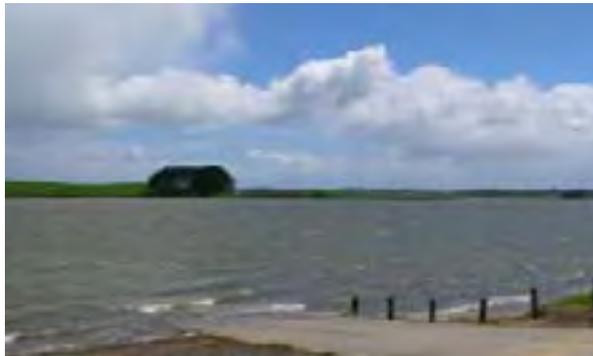
3.2.7 Lake Waahi

Lake condition:	Non-vegetated
Stability:	Stable
Lake type:	Riverine
Maximum depth:	5 m

Aquatic vegetation in Lake Waahi has undergone major changes in species composition and abundance since 1870 when first records were made by Kirk (1870). Kirk’s 1870 description for this lake noted “more copious vegetation” than Lakes Whangape and Waikare. By the late 1930s and 1940s local residents noted extensive weed beds, which prevailed until the late 1970s (Clayton & de Winton 1989), with *Egeria densa* dominating in the latter years. During the late 1970s a major decline occurred in the submerged aquatic vegetation and the lake has remained predominantly devegetated ever since. Most recently, in 2010 submerged plants were restricted to sparse ($\leq 5\%$ cover) milfoil fringes at the extreme shore edge (< 0.3 m depth), while offshore stands of the reed *Eleocharis sphacelata* were also greatly reduced in extent.

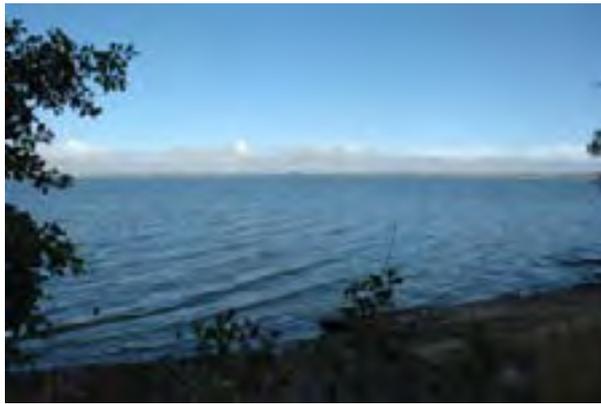
3.2.8 Lake Waikare

Lake condition: Non-vegetated
 Stability: Stable
 Lake type: Riverine
 Maximum depth: 2 m

Early historic investigations of Lake Waikare by Kirk (1871) suggest that the lake was in ‘pristine’ condition, resulting in a LakeSPI Index of 100%. By 1978 (>100 years later), the LakeSPI Index had dropped to 24% and the invasive weed species, *Egeria densa* was having a marked impact. Water level changes, turbid waters and pest fish are likely to have been contributing factors to a weed bed collapse in the late 1970’s/early 1980’s (Champion et al. 1993). Presently Lake Waikare supports no submerged vegetation.

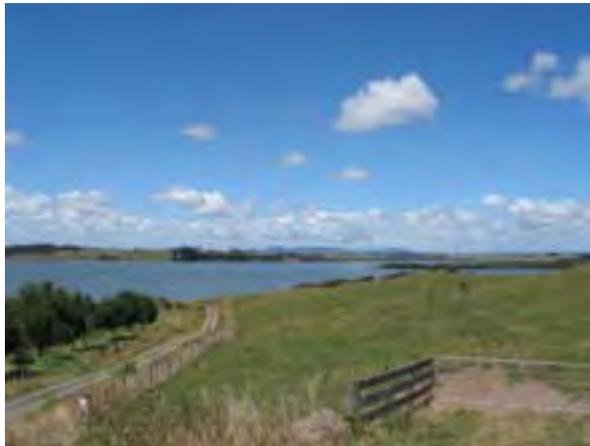
3.2.9 Lake Whangape

Lake condition: Non-vegetated
 Stability: Stable
 Lake type: Riverine
 Maximum depth: 2.7 m

Today, Lake Whangape remains in a highly impacted condition with a LakeSPI Index of 0%. Previously the invasive weed species *Ceratophyllum demersum*, which is ranked the worst submerged weed in New Zealand, was having a major impact on the lake, but weed beds have now crashed leaving the lake de-vegetated. The pristine state, close to that described by Kirk (1871), would have comprised a diverse vegetation, extending across the entire bed of the lake.

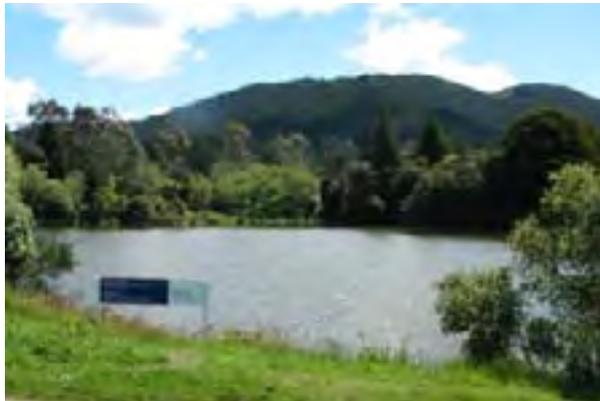
3.3.1 Lake Ngahewa

Lake condition: Poor
 Stability: Improving
 Lake type: Volcanic
 Maximum depth: 7.5 m

Since being listed as essentially de-vegetated in 2004, submerged vegetation in Lake Ngahewa has made a partial recovery and now exceeds a 10% cover making it possible to generate a LakeSPI score. Although the presence of *Lagarosiphon major* has resulted in a moderately high Invasive Impact score, this invasive presence is still considered preferable to a de-vegetated state.

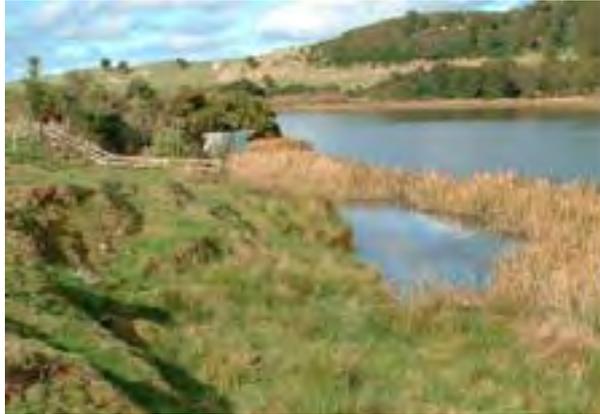
3.3.2 Lake Opouri

Lake condition: High
 Stability: Improving
 Lake type: Volcanic
 Maximum depth: 25 m

The lake retains moderate plant biodiversity, with the only invasive weed, *Elodea canadensis*, being of low occurrence and cover during the present assessment. Comparing the recent assessment with surveys made in the 1980's showed there was a reduction in charophytes, a 2 m decrease in vegetation depth extent and a large reduction in invasive impact by *E. canadensis*. While the Native Condition Index remained similar over the 20 years, the Invasive Impact Index dropped, leading to a higher LakeSPI score in 2004. This lake vegetation appears to have similarities to nearby Lake Okaro, where lake anoxia has apparently caused root death and detachment of *E. canadensis* shoots at various intervals (Clayton et al. 2005).

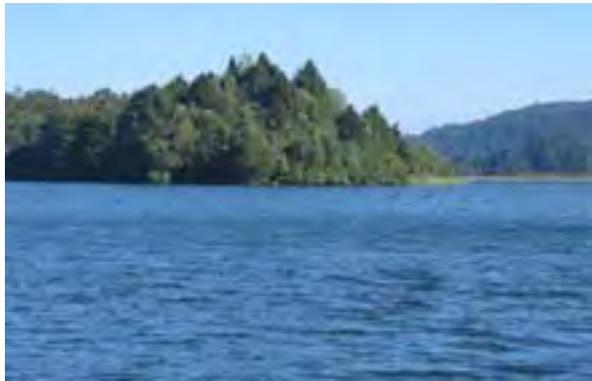
3.3.3 Lake Rotoaira

Lake condition:	Moderate
Stability:	Declining
Lake type:	Volcanic
Maximum depth:	14.6 m

LakeSPI scores show the overall condition of Lake Rotoaira declining from the impact of invasive weed species. In 1979 invasive weeds (*Elodea canadensis*, *Potamogeton crispus* and *Ranunculus trichophyllus*) had a moderate impact on the LakeSPI score. *Lagarosiphon major* and *Ceratophyllum demersum* were introduced into the lake in the 1980's and 90's (respectively) and resulted in a further large increase in the Invasive Impact Index and reduction in LakeSPI score. Since then, while further invasive impact has been small, the Native Condition Index has decreased more substantially due to the partial loss of deeper native charophyte meadows. Other elements of native vegetation remain, such as the species-rich turfs found at moderately exposed shorelines.

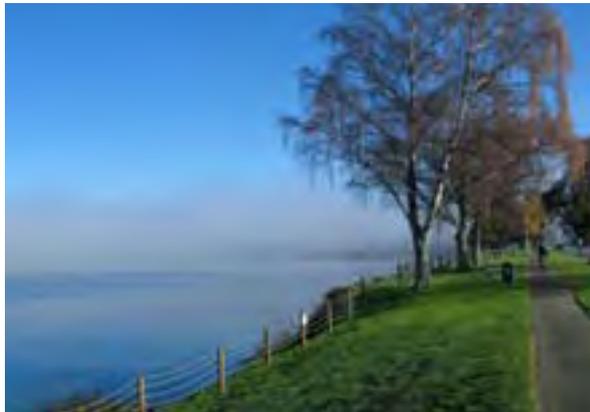
3.3.5 Lake Taupo

Lake condition: Moderate
 Stability: Declining
 Lake type: Volcanic
 Maximum depth: 162.8 m

Elodea canadensis and *Lagarosiphon major* have been present in Lake Taupo since the 1960's and *Ceratophyllum demersum* was first recorded in Lake Taupo in 1980 (Howard-Williams and Davies 1980). Since then, *C. demersum* has progressively impacted upon lake condition. The ability of this species to occupy deep water and displace charophyte meadows means that future LakeSPI scores are likely to decline further. This lake would benefit from an updated assessment and further attention to establishing suitable baseline sites, given the size and diversity of the lake.

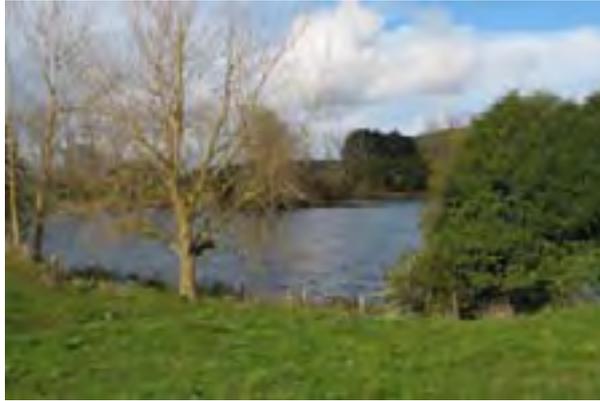
3.3.6 Lake Tutaeinanga

Lake condition:	Non-vegetated
Stability:	Declining
Lake type:	Volcanic
Maximum depth:	11 m

The submerged vegetation in Lake Tutaeinanga has decreased significantly since being last surveyed in 2004 and it is now essentially de-vegetated. Occasional shoots of *Egeria densa* and *Potamogeton ochreatus* still persist but as covers do not exceed 10% at all but one site this lake now fails to generate a LakeSPI Index.

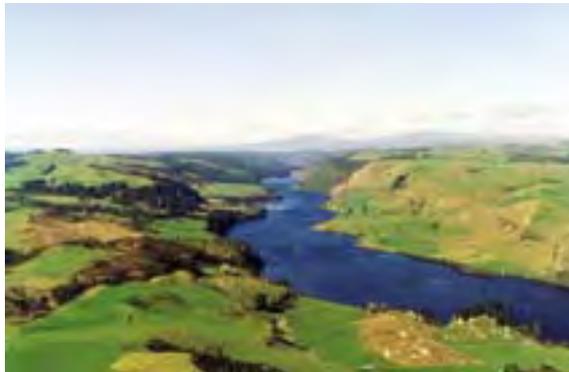
3.4.1 Lake Arapuni

Lake condition: Poor
 Stability: -
 Lake type: Hydro
 Maximum depth: 49 m

Lake Arapuni is the seventh hydro lake downstream of Taupo. Like most of the Waikato hydro lakes, *Ceratophyllum demersum* dominates the submerged vegetation with weed beds recorded to a depth of 9 m. A low Native Condition Index reflects the presence of submerged turf species recorded at four of five of the sites surveyed.

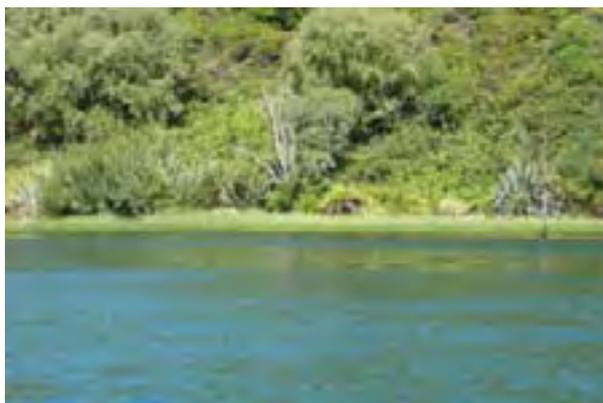
3.4.2 Lake Aratiatia

Lake condition: Moderate
 Stability: -
 Lake type: Hydro
 Maximum depth: 11 m

Lake Aratiatia is the first hydro lake downstream of Taupo and is the only Waikato River hydro lake that still supports native submerged plant communities at most of the sites surveyed, resulting in a moderate Native Condition Index. Invasive weed beds were prominent at all sites with *Lagarosiphon major*, *Egeria densa* and *Ceratophyllum demersum* respectively, being the dominant invasive species at the time of this survey.

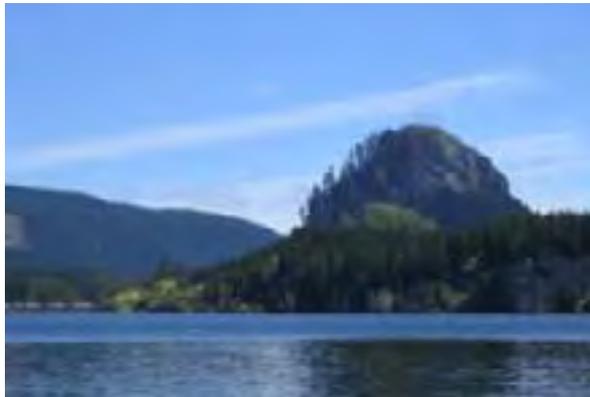
3.4.3 Lake Atiamuri

Lake condition: Poor
 Stability: -
 Lake type: Hydro
 Maximum depth: 31 m

The third hydro lake downstream of Taupo, Lake Atiamuri has tall, dense weed beds of *Ceratophyllum demersum* and *Egeria densa* recorded down to a depth of 12 m. This high level of impact by invasive species has resulted in the highest Invasive Impact Index of 99% for any lake in this report.

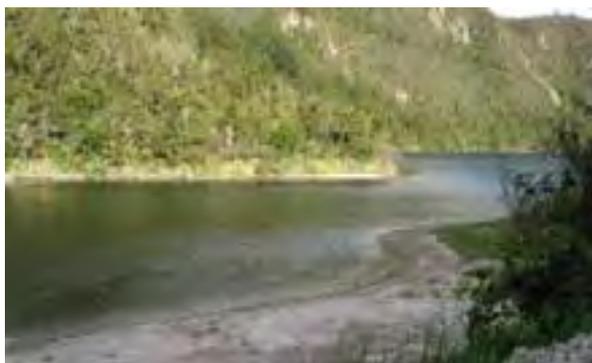
3.4.4 Lake Hinemaiaia (B)

Lake condition:	Non-vegetated
Stability:	Declining
Lake type:	Hydro
Maximum depth:	15 m

Hinemaimaia (B) is the lower of three dammed water bodies in a hydro-scheme constructed from 1939. It currently supports a low and patchy vegetation cover and is a poor environment for plant growth due to sediment instability, occasional turbid flows and frequent disturbance.

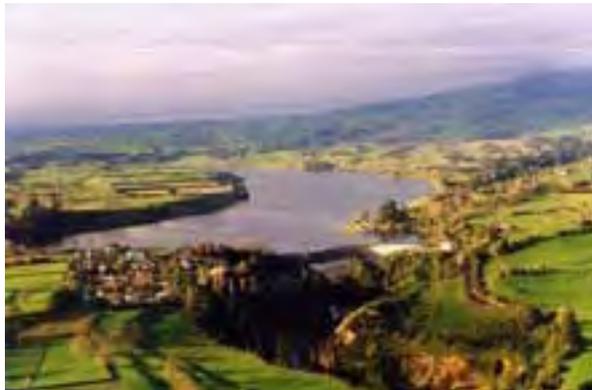
3.4.5 Lake Karapiro

Lake condition: Poor
 Stability: Stable
 Lake type: Hydro
 Maximum depth: 34 m

Lake Karapiro is the eighth and final Waikato hydro lake downstream of Taupo and is solely dominated by *Ceratophyllum demersum*. Invasive weed problems within Lake Karapiro have been in the spotlight of recent years with extensive annual weed control (up to 100 ha) currently being carried out during autumn in preparation for the World Rowing Championships on this lake in 2010. The extremely high invasive impact on the lake by *C. demersum* and the lack of native plant species has resulted in Lake Karapiro generating one of the lowest LakeSPI scores (equal with Lake Maraetai) in this report.

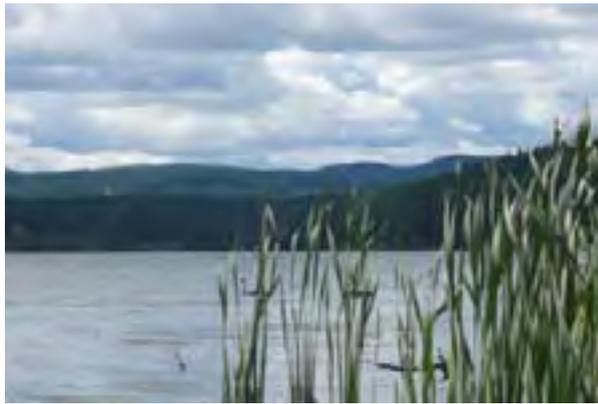
3.4.6 Lake Maraetai

Lake condition: Poor
 Stability: Stable
 Lake type: Hydro
 Maximum depth: 68 m

The fifth hydro lake downstream of Taupo, Lake Maraetai is dominated by dense weed beds of *Ceratophyllum demersum* and this has resulted in it generating one of our lowest LakeSPI scores (equal with Lake Karapiro) recorded for any of the Waikato lakes so far surveyed in this report. *C. demersum* and *Egeria densa* have been present in Lake Maraetai since at least 1966 but at that time the less invasive *Elodea canadensis* would have been the dominating species (Gibbs and Wilson 1966).

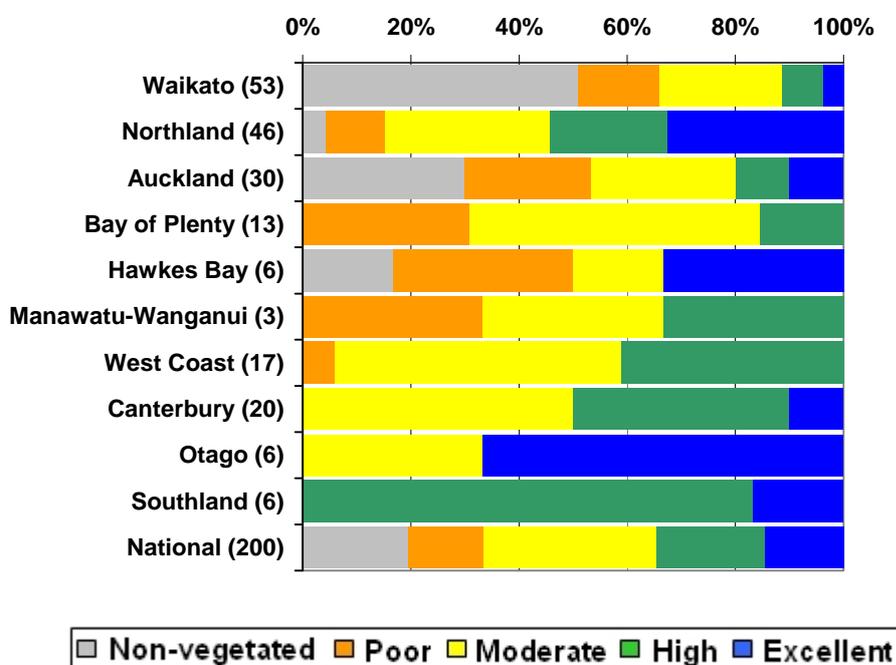
Figure 11: Proportions of lakes that fall into the five LakeSPI categories, showing total and regional differences, with number of lakes shown in parenthesis.

The Waikato Region has a high proportion of non-vegetated lakes compared to other regions or nationally (Fig. 11). In most situations this represents the most degraded state of a lake, where water quality conditions have deteriorated to the point where growth of submerged plants can no longer be supported.
