# Taupo, Waikato and Waipa Management Zones Leap Day Flood Event

February 29 to March 5, 2004

## Final Technical Report

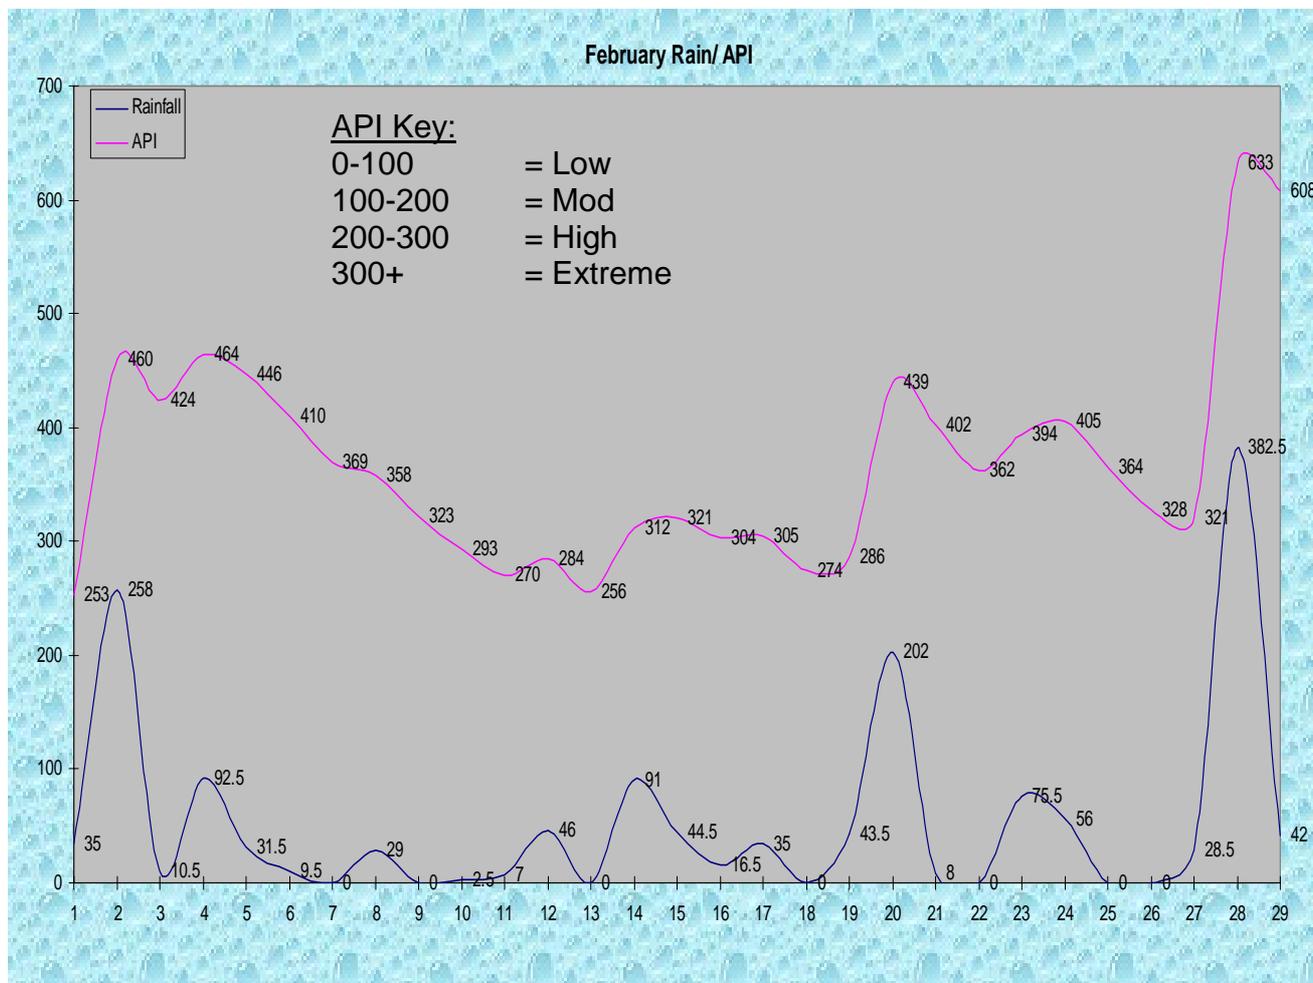
- The API doubled from 321 to 650 as a result of the event (Figure 1). Anything above 300 in the Waikato/Waipa catchment is regarded as “extreme”, meaning that

**Figure 1: The Antecedent Precipitation Index (API) and rainfall for the Waikato Hydro System. Data courtesy of MRP.**

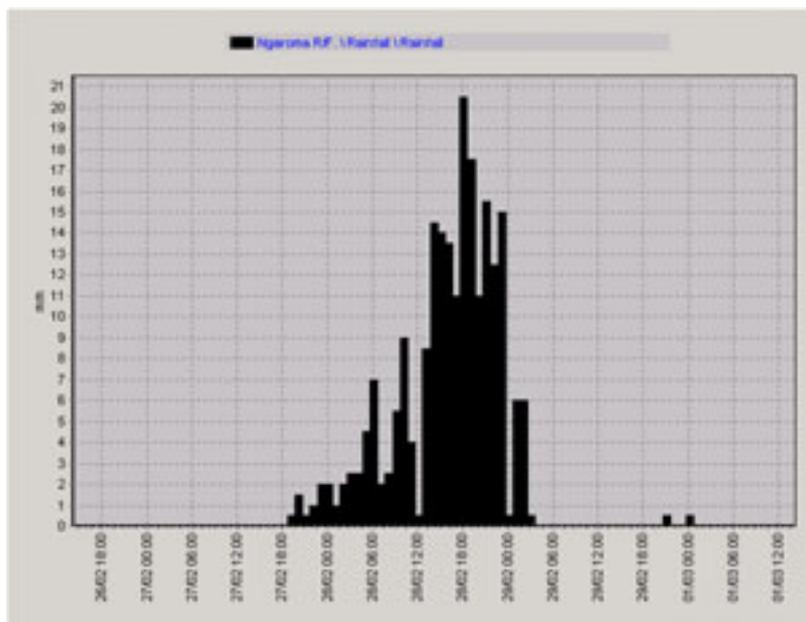
month on February 1 and 15 respectively. Ngaroma's rainfall graph (which indicates upper Waipa River levels) is pictured. Here rainfall intensities were at 8 mm/hr or greater over a 10 hour period, also indicating the persistency of the event.

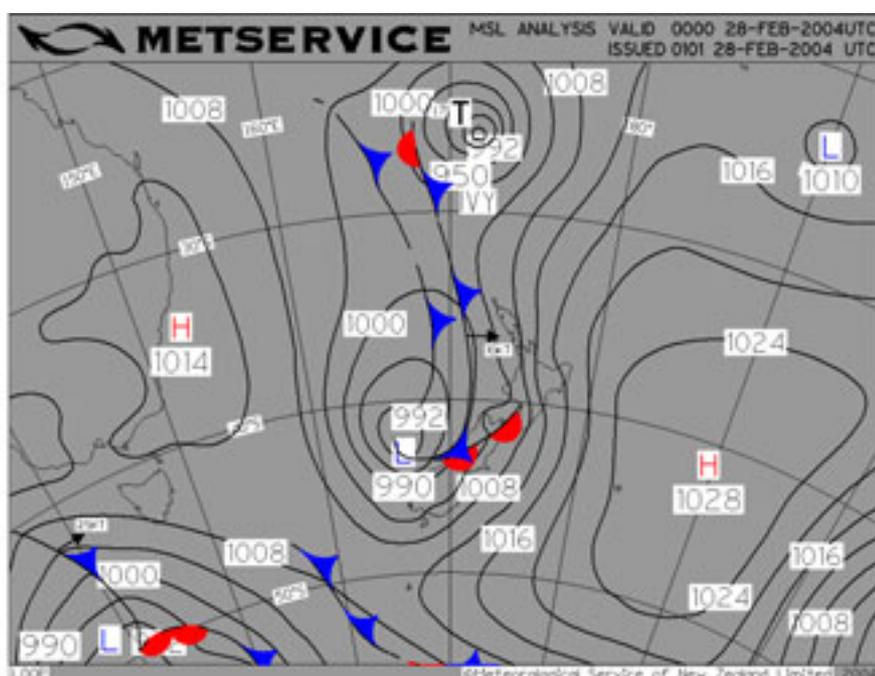
**Figure 2: Weather chart showing the location of the main frontal system that brought the heavy rain. Cyclone Ivy is to the north.**

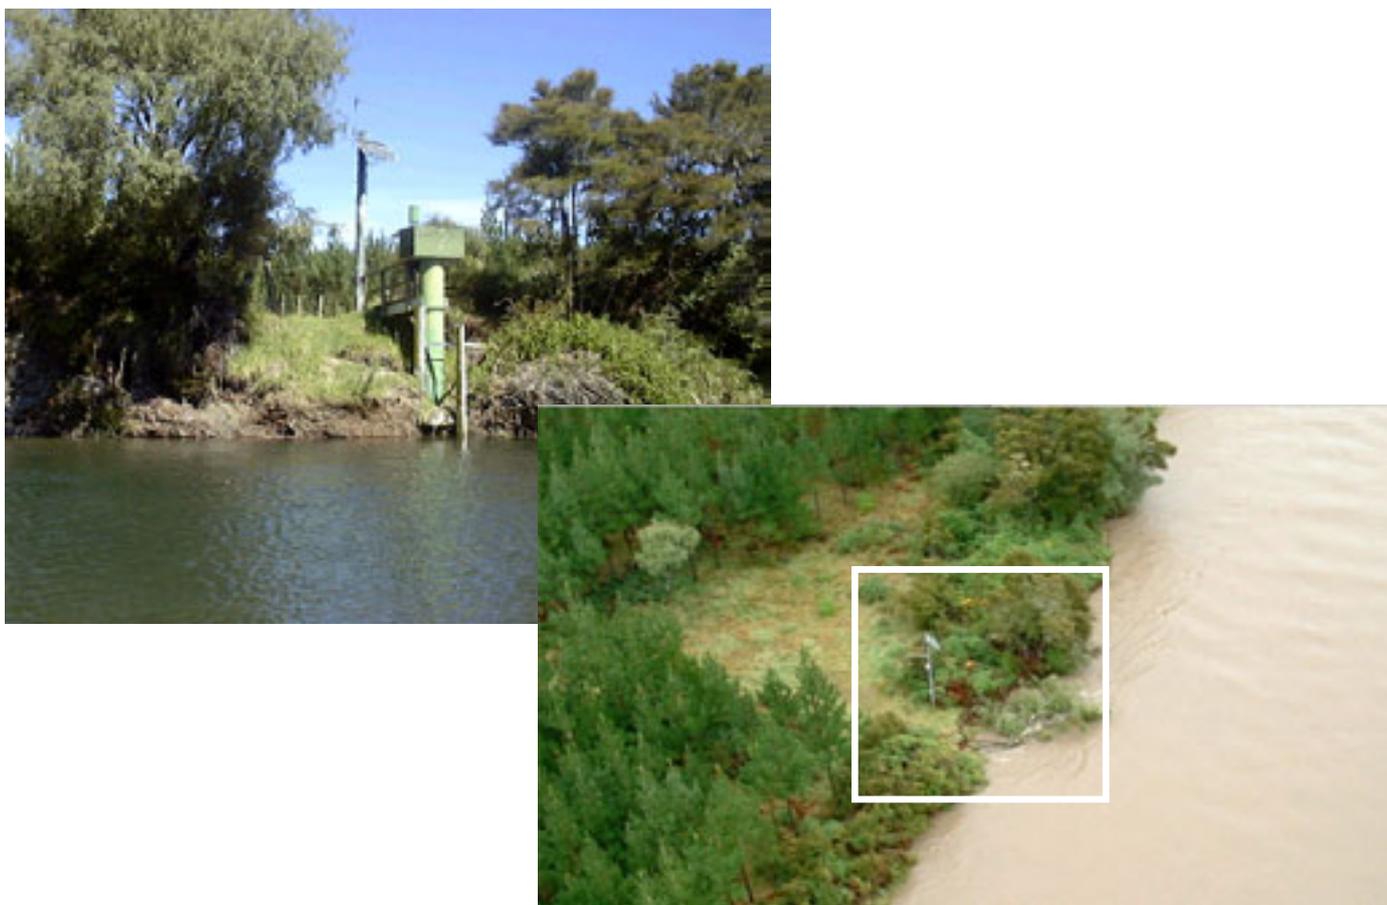
Unfortunately the recorder tower was destroyed during the flood due to debris and high flows (Figure 3). This resulted in false high water level and NIWA staff have since surveyed the flood level at 2.46 m, not the 3.5 m as indicated by the recorder. NIWA staff have since installed another recorder which is now operating.

**Figure 3: Before and after photos of the Tuaranga Taupo river level recorder that was destroyed in the event.**

An investigation has been commissioned to find a solution. If one is not found, it is likely that a new station will have to be installed upstream of the Awakino Gorge so that radio transmission can be improved.

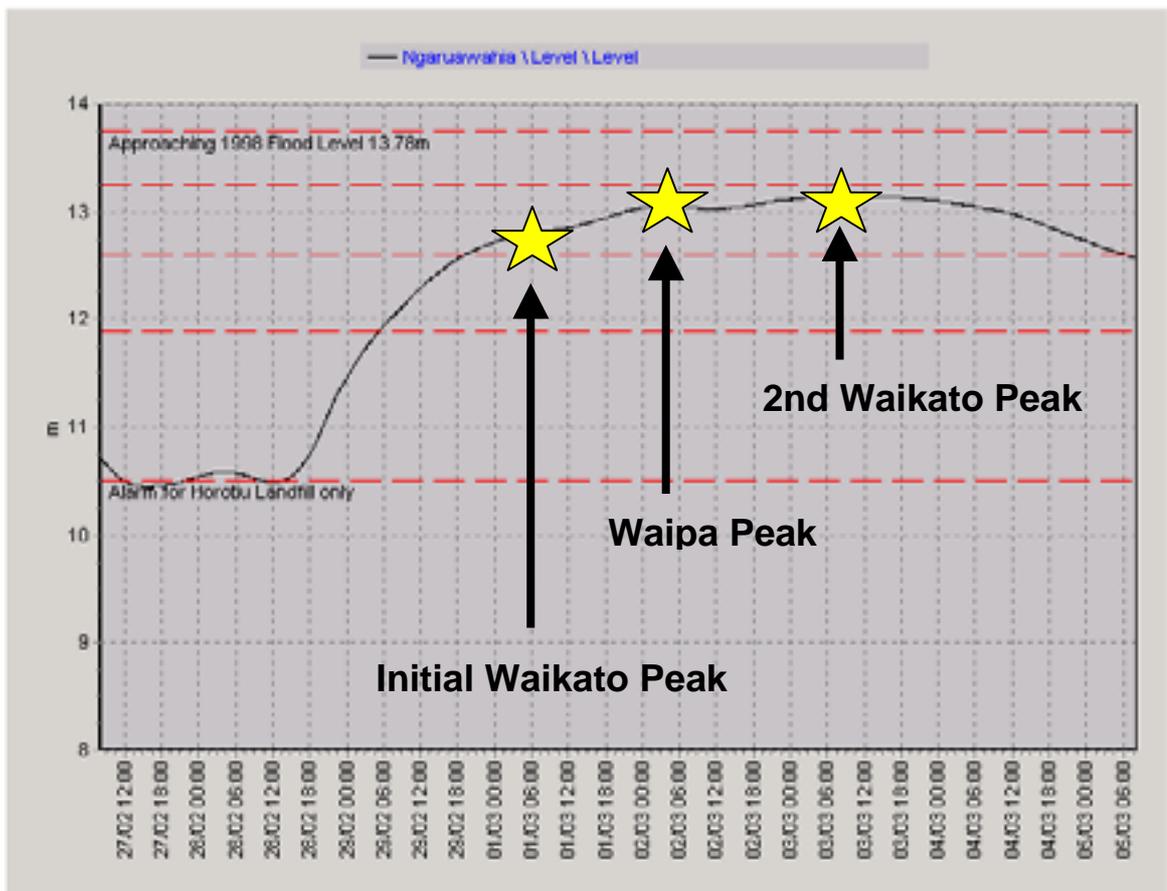
The Ngaruawahia hydrograph (below) indicates three distinctive peaks. The first peak represents the initial Waikato River peak, the second the Waipa River peak and the third the second Waikato River peak (after outflows from Karapiro were increased following the passing of the Waipa peak). The second peak also indicates the effect of further rain on the night of Tuesday March 2. If the Waipa River peak had coincided with the second Waikato River Peak, and/or the second rainfall event had delivered more rain than what actually occurred, then flows and levels in the lower Waikato could have been very similar to the 1998 flood event.

Figure 4: The Ngaruawahia hydrograph clearly showing three distinctive flood peaks.

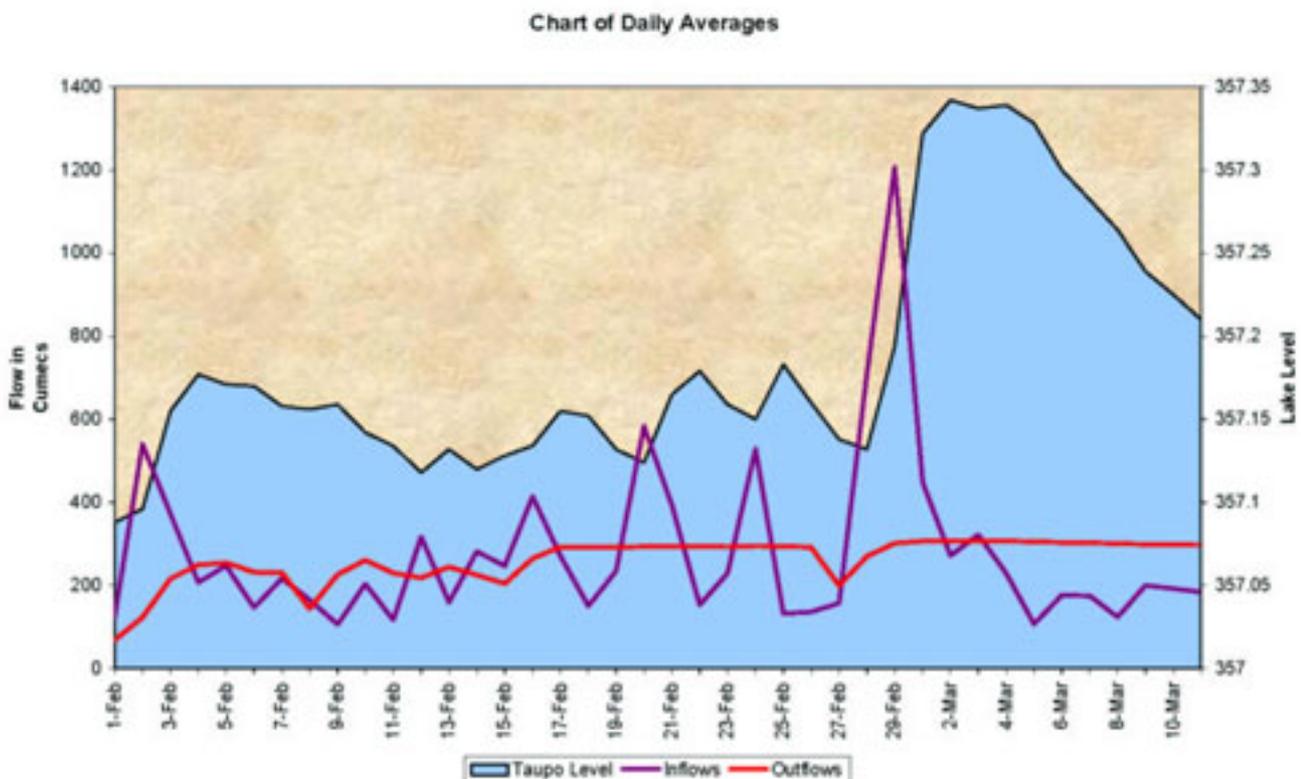
- The peak level recorded in this event was 357.35 metres (14 cm below the 1998 peak level of 357.49 metres). It rose 22 cm during the event at a maximum rate of 11 cm/day (or 0.45 cm/hr).

- Lake Taupo Compensation Claims Act level was not exceeded (357.39 m).
- TPD diversions were turned out at 4.00am on Sunday, February 29 when it became clear the MCL for Lake Taupo would be exceeded.

**Figure 5: Plot of Lake Taupo’s level, tributary inflows, and gate outflows.**

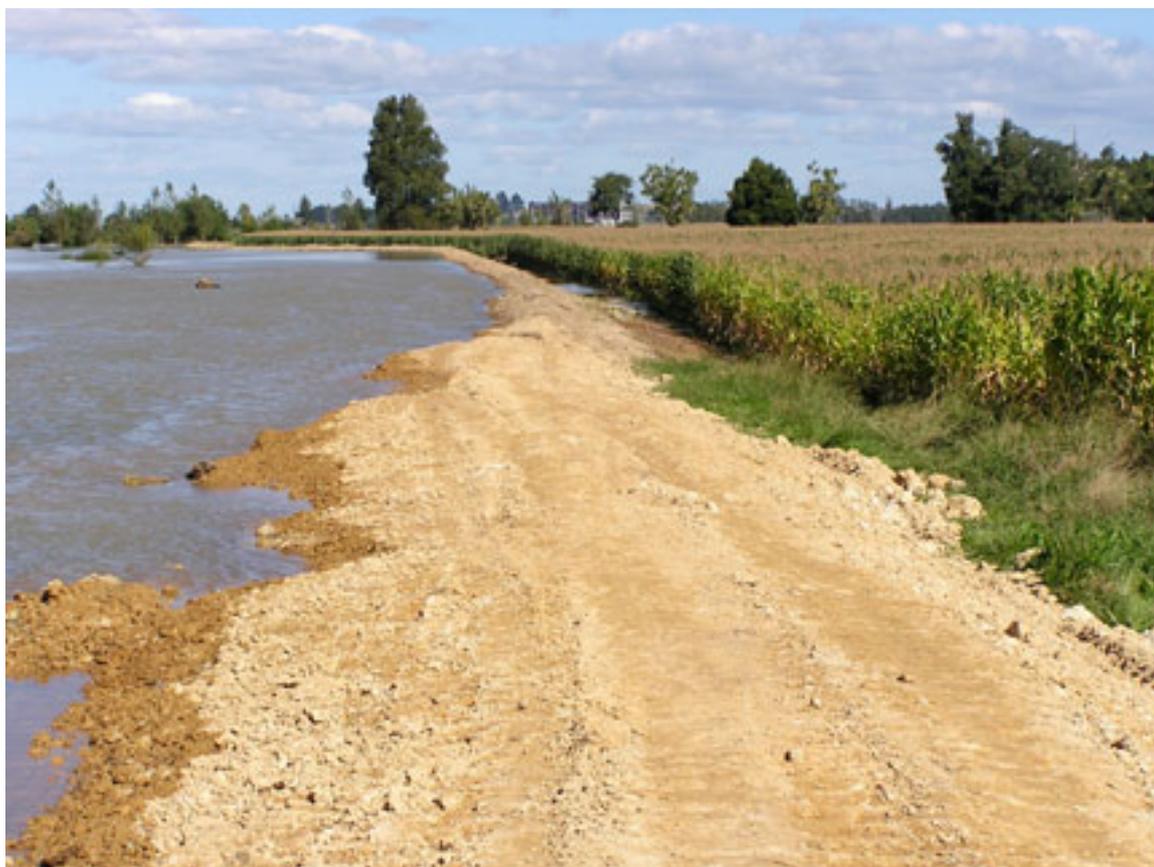
**Figure 6: A newly built private stopbank adjacent to the Waikato River near Mercer (view looking south towards the old Meremere Power Station). Note the difference in elevation between the maize crop and the river level.**

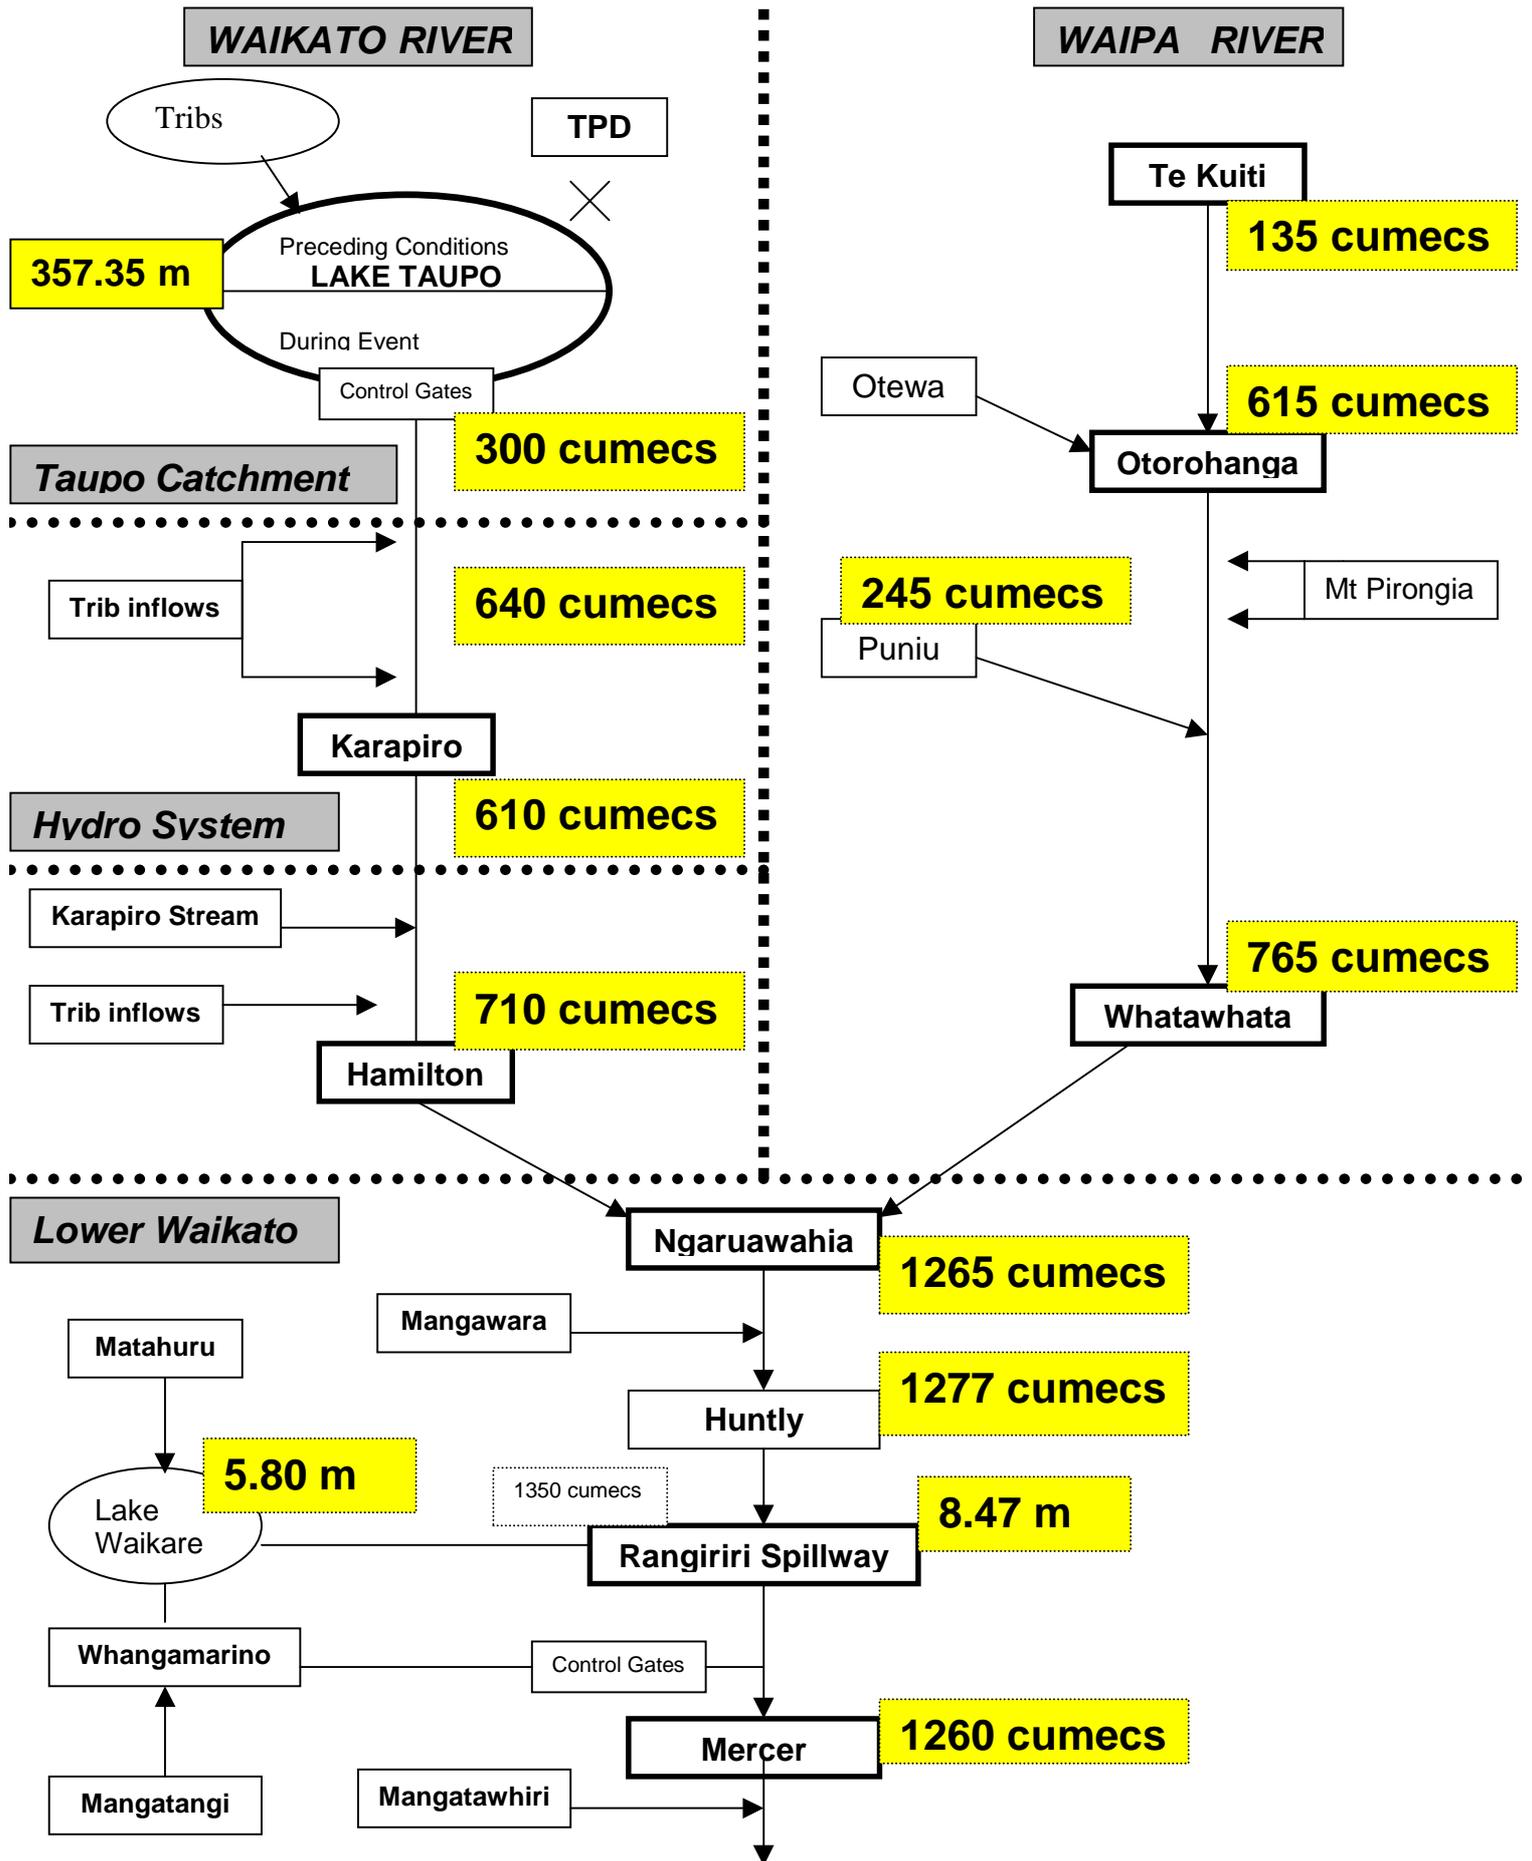
Figure 7: Peak Flows: Leap Day Flood Event

A general overview of peak flows recorded across the Waikato and Waipa River Systems is presented on the next page.

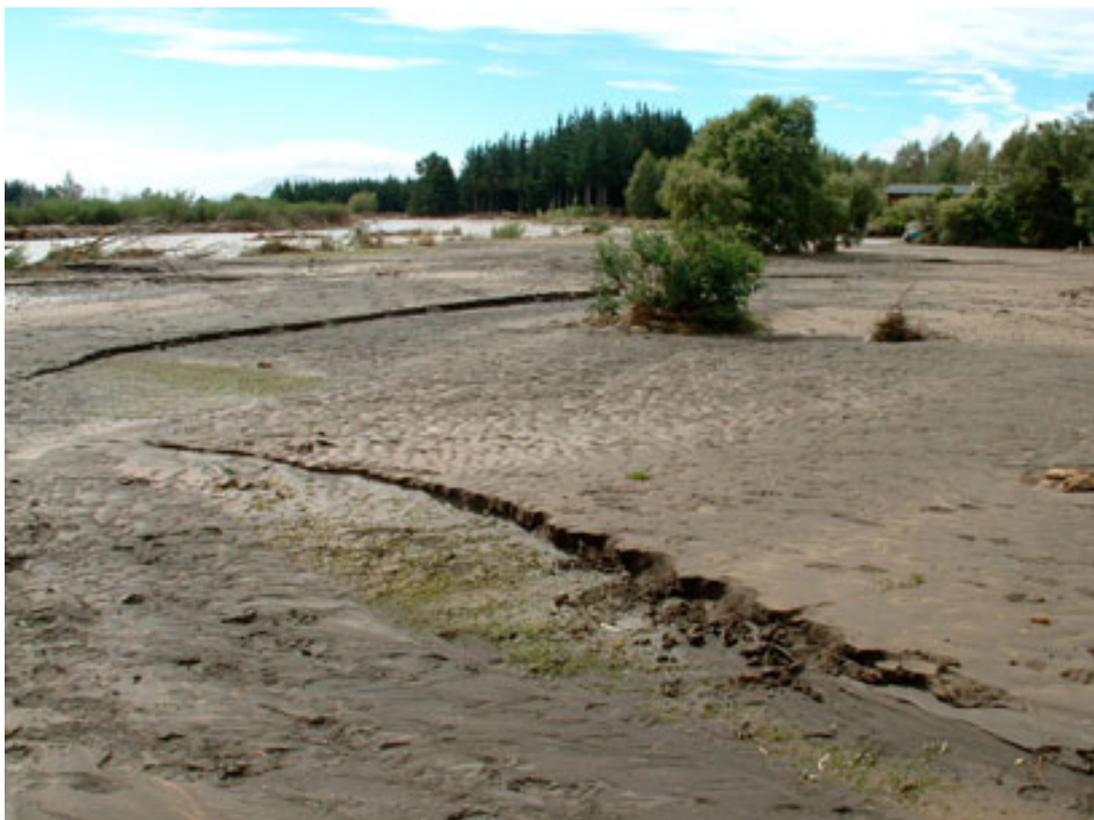
**Figure 8: Lower Tongariro River looking downstream from the State Highway 1 bridge. Note the widespread deposition of silt.**

Post flood it was evident that there was a high risk of further erosion damage and inundation should further high flows be experienced and emergency works were justified. Consequently the Emergency Provisions under section 330 of the Resource Management Act were invoked in order to carry out the following works:

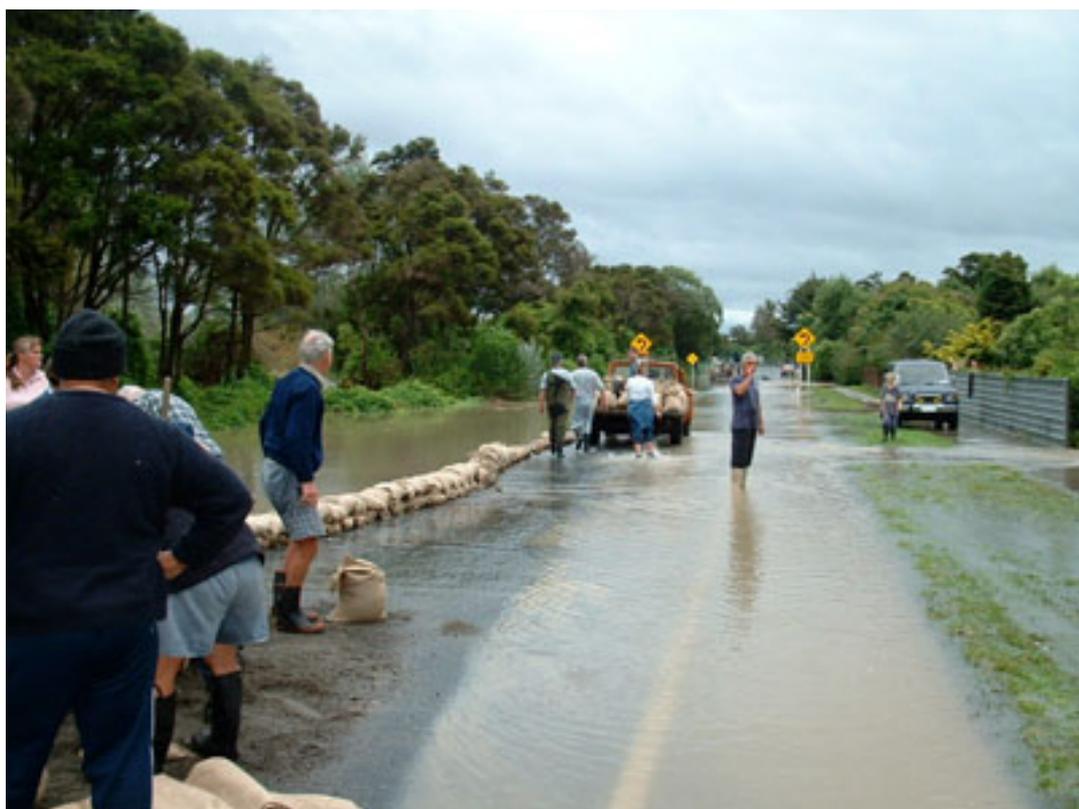
- Inundation of floodwater onto several properties adjacent to SH 1. Damage was minimised by the use of sandbags.
- High water levels adjacent to Heuheu Parade. Again damage was avoided by sandbagging.
- Severe bank erosion adjacent to SH 1 (right bank).

**Figure 9: Local residents sandbag SH1 at Oruatua.**

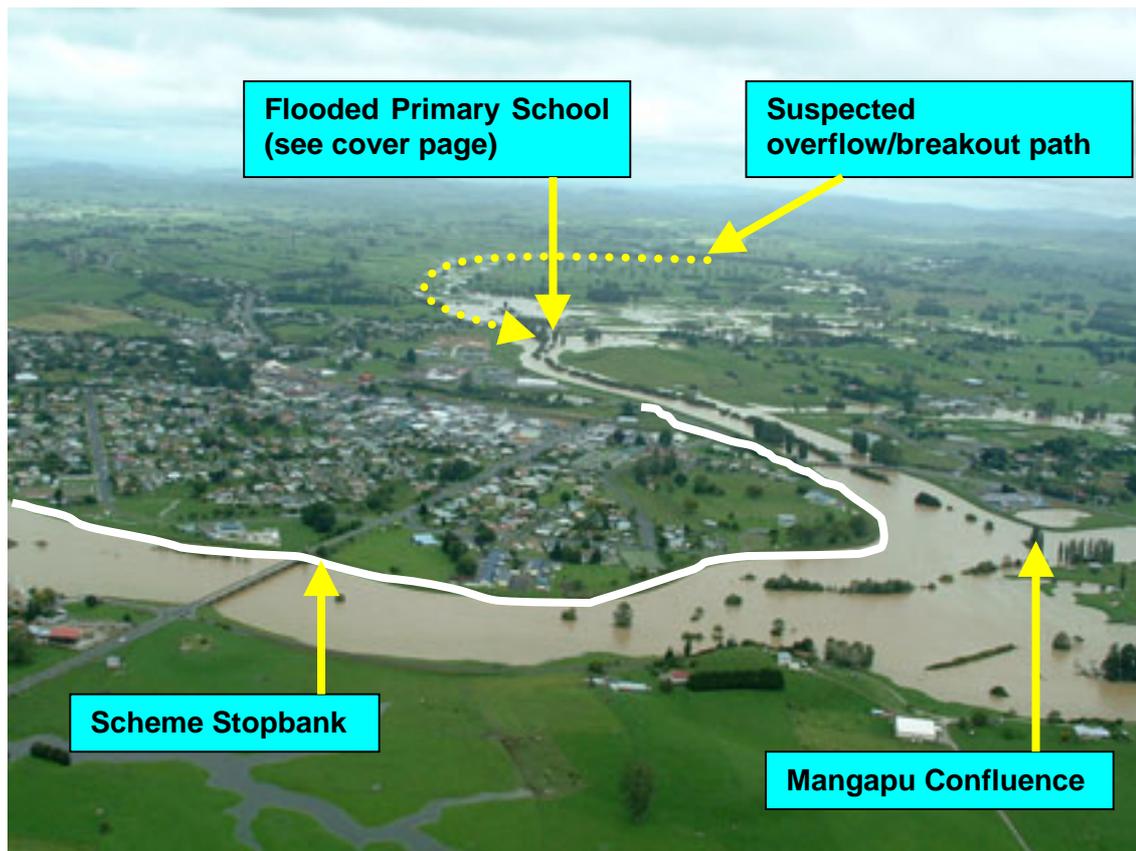
Figure 10: View looking eastwards over Otorohanga township showing the extent of flooding and points of interest.
