Catchment Environmental Monitoring Report: 2007/08

Prepared by:
Sally Grant, Claire Kotze and Reece Hill

For:
Environment Waikato
PO Box 4010
HAMILTON EAST

19 January 2009

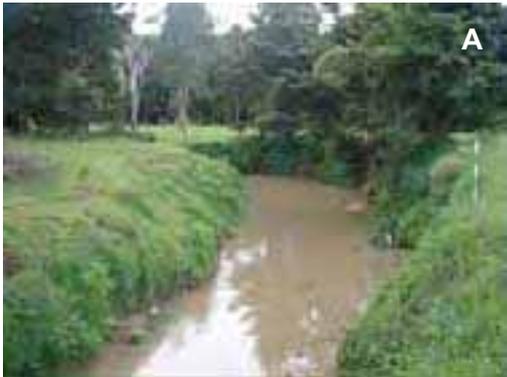
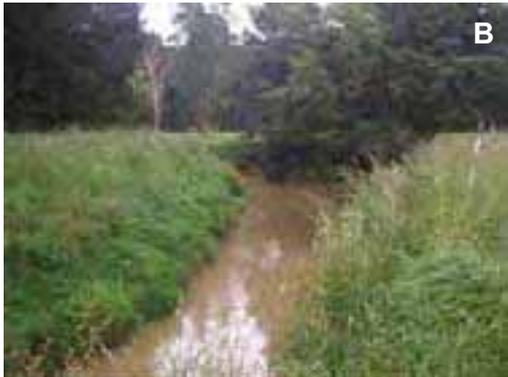
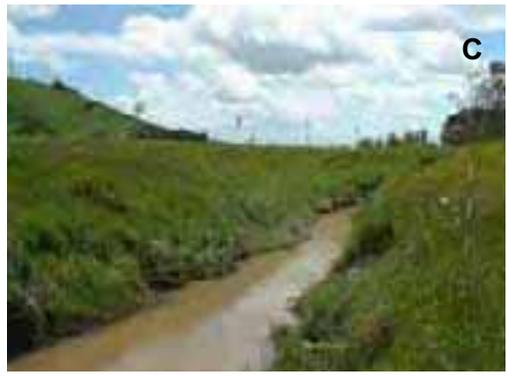
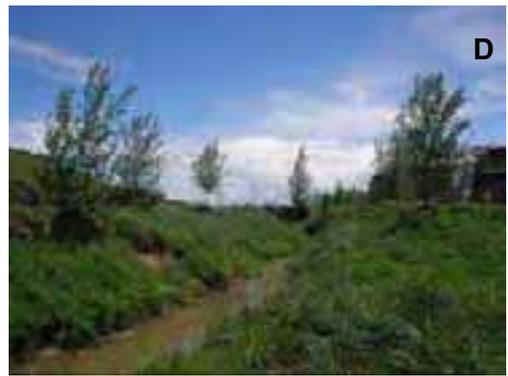
A photograph of a stream flowing through a grassy area. The water is brownish. The banks are covered in green grass. A white marker is visible on the right bank. The photo is labeled 'A' in the top right corner.

A photograph of the same stream at the same location in 2007/08. The water is brownish. The grass on the banks appears slightly taller and more dense. A white marker is visible on the right bank. The photo is labeled 'B' in the top right corner.
Assessment 2 at 750m

A photograph of a stream flowing through a grassy area. The water is brownish. The banks are covered in green grass. The sky is blue with white clouds. The photo is labeled 'C' in the top right corner.

A photograph of the same stream at the same location in 2007/08. The water is brownish. The grass on the banks appears slightly taller and more dense. The sky is blue with white clouds. The photo is labeled 'D' in the top right corner.

Figure 7: Matahuru Stream photo point examples of visual change.

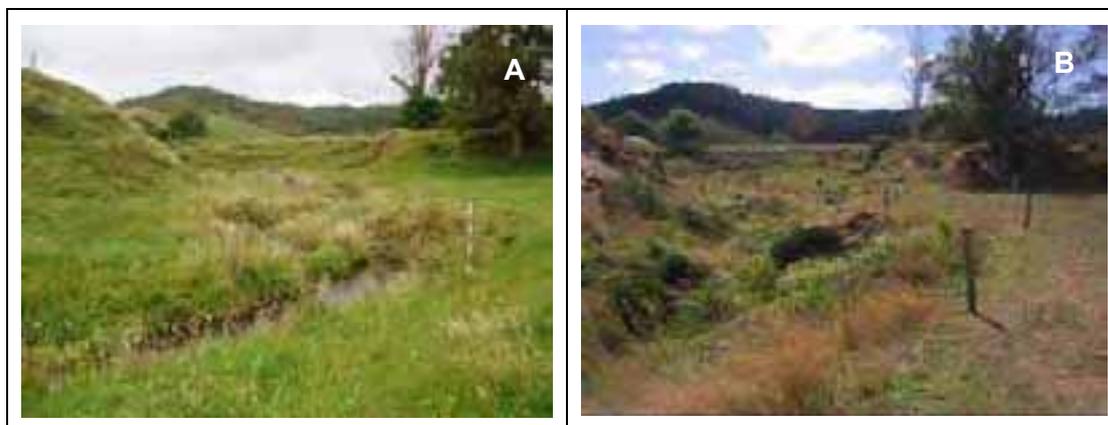
Six 1km samples of stream were assessed giving a total of 30 photos for the Pokaiwhenua catchment (Appendix 4). The initial baseline photos from 2003/04 are in the left column with the most recent photos from 2007/08 in the column on the right. Large sections of the photo assessment have not been fenced, and so little change is evident. However the sections which have been fenced have developed vegetation which is shading the water (Figure 13 a & b). Small areas have had soil conservation planting with mixed success.

Figure 13: Pokaiwhenua Stream photo point examples of visual change, Sample 6 at 750m a) 2003/04; b) 2007/08.

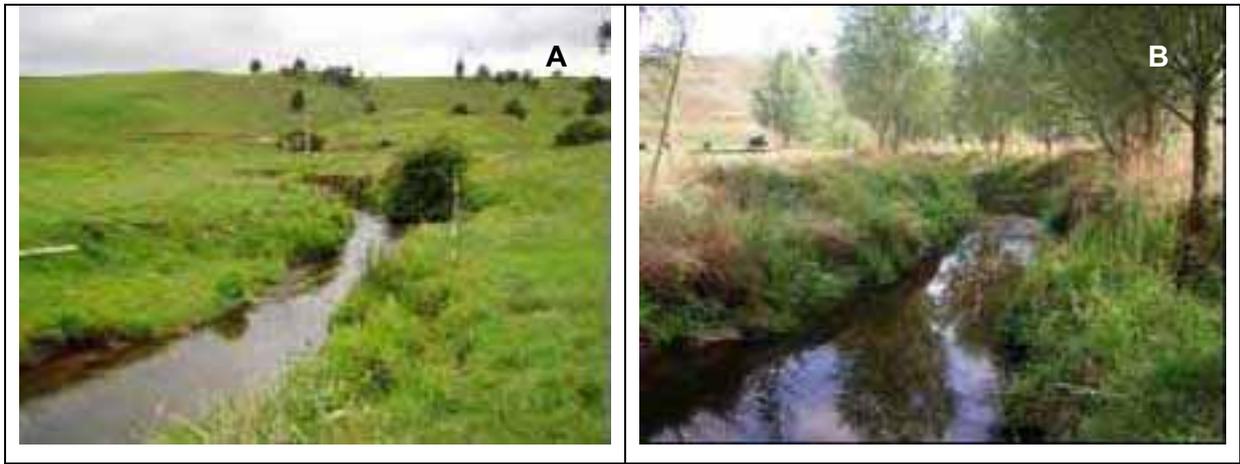
The initial year of assessment was 2003/04 with subsequent assessments completed in 2004/05, 2005/06 and 2007/08. Two 1km samples of stream were assessed giving a total of 10 photos for the Mangare Catchment (Appendix 4). The initial baseline photos from 2003/04 are in the left column with the most recent photos from 2007/08 in the column on the right. The photos in one section of the stream indicate little change in riparian characteristics during the monitored period due to little to no riparian fencing or planting. However, the other section of stream showed significant change where the assessed reach has been fenced and planted with willow poles on both banks (Figure 19 a & b).

Figure 19: Mangare Stream photo point examples of visual change at Sample 1, 750m a) 2003/04; b) 2007/08.
