The Condition of 43 Lakes in the Waikato Region Using LakeSPI

Prepared by:
Tracey Edwards, John Clayton, Mary de Winton
(National Institute of Water & Atmospheric Research Ltd.)

For:
Environment Waikato
PO Box 4010
HAMILTON EAST

**NIWA Client Report: HAM2008-089
May 2008**

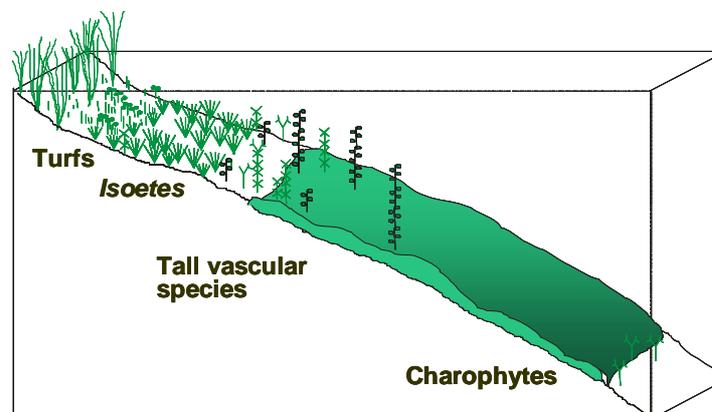
Figure 1: Depth profile illustrating the main components of native lake vegetation.

In a pristine state, lakes in the Waikato Region would have once contained a diverse range of native plant species down to a depth determined by water clarity. For many of the Waikato shallow lakes it is likely that plant growth would have occurred across the entire lake bottom at some stage during their development and maturation (Figure 1). Today, there are very few Waikato lakes that remain in an all-native vegetated state, and the Serpentine (Rotopiko) Lakes are the best remaining examples.

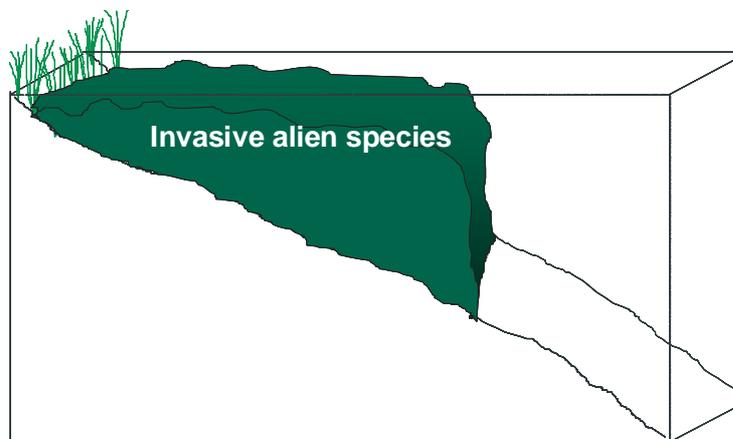
Figure 2: Depth profile illustrating the potential impact of invasive species.

With the introduction of invasive submerged plant species during the mid 1900's, native plants in most lakes were displaced by invasive weed species, often forming tall monospecific weed beds (Figure 2). Some west coast dune lakes (Lake Taharoa, Puketi, Rotoroa and Parkinson) remain in this state and are vulnerable to collapse. Many of the Waikato lakes have now proceeded to the next and, often final stage where de-vegetation has occurred (Figure 3). Although invasive species are not favourable in terms of overall lake condition, the presence of any submerged plants in a lake is preferable to none, because they mitigate many of the symptoms of eutrophication (e.g., lock-up nutrients, maintain water clarity, compete with phytoplankton).

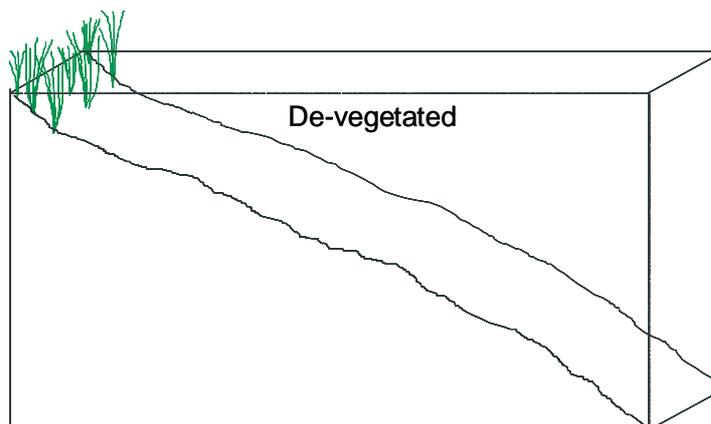
Figure 3: Depth profile illustrating a de-vegetated lake.

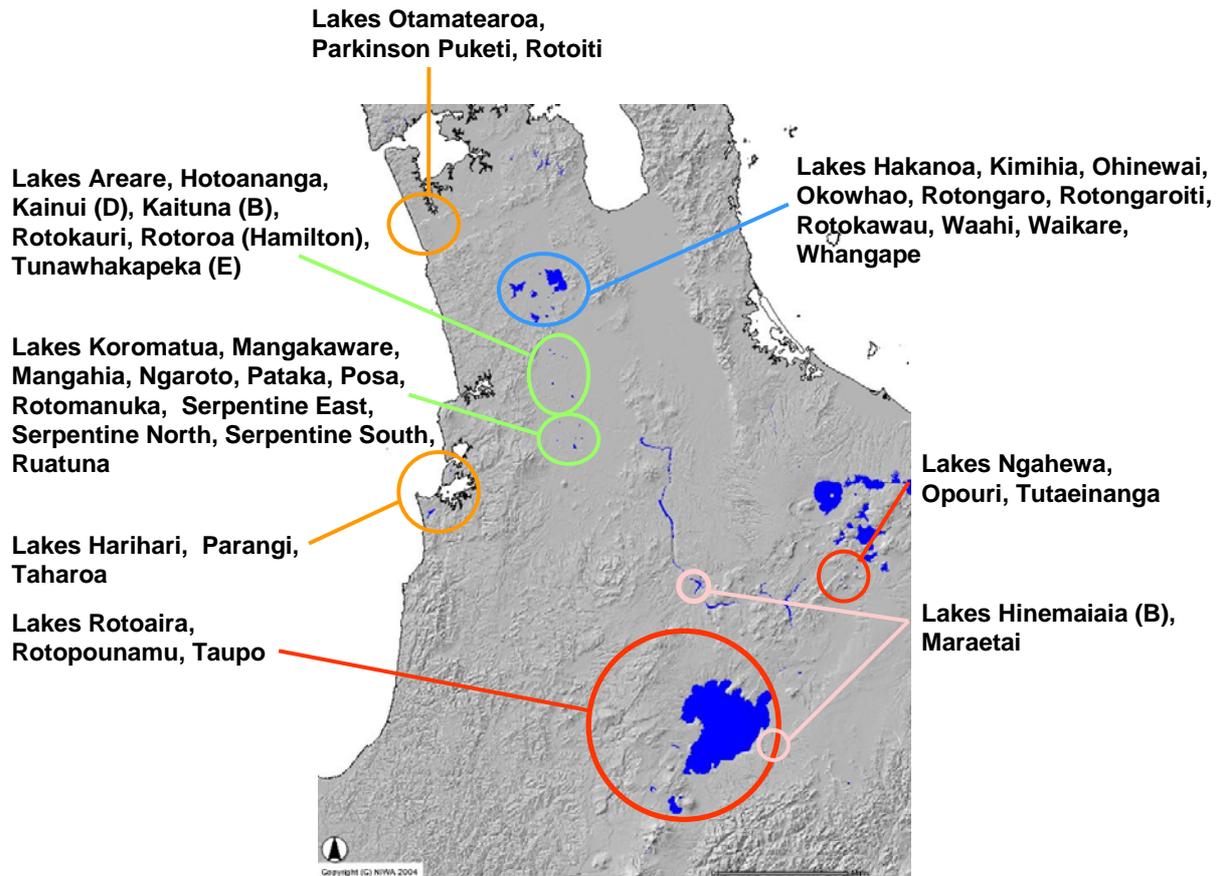
Figure 4: Location of lake groups within the Waikato Region; orange are dune lakes, green are peat lakes, blue are riverine lakes, red are lakes in the volcanic zone and pink arrows mark the two hydro lakes surveyed.

Forty-three lakes in total have been selected for LakeSPI assessment. The location of lakes is indicated in Figure 4 and includes dune lakes along the West Coast, riverine lakes adjacent to the northern reach of the Waikato river, Peat influenced lakes within the Waikato basin and lakes within the Taupo volcanic zone. The lakes also vary in size and depth (Table 3.1).
