Assessment of the Ecological Condition of Lakes in the Waikato Region using LakeSPI - 2009

Prepared by:
Tracey Edwards, Mary de Winton, John Clayton
NIWA

For:
Environment Waikato
PO Box 4010
HAMILTON EAST

**NIWA Client Report: HAM2009-064
May 2009**

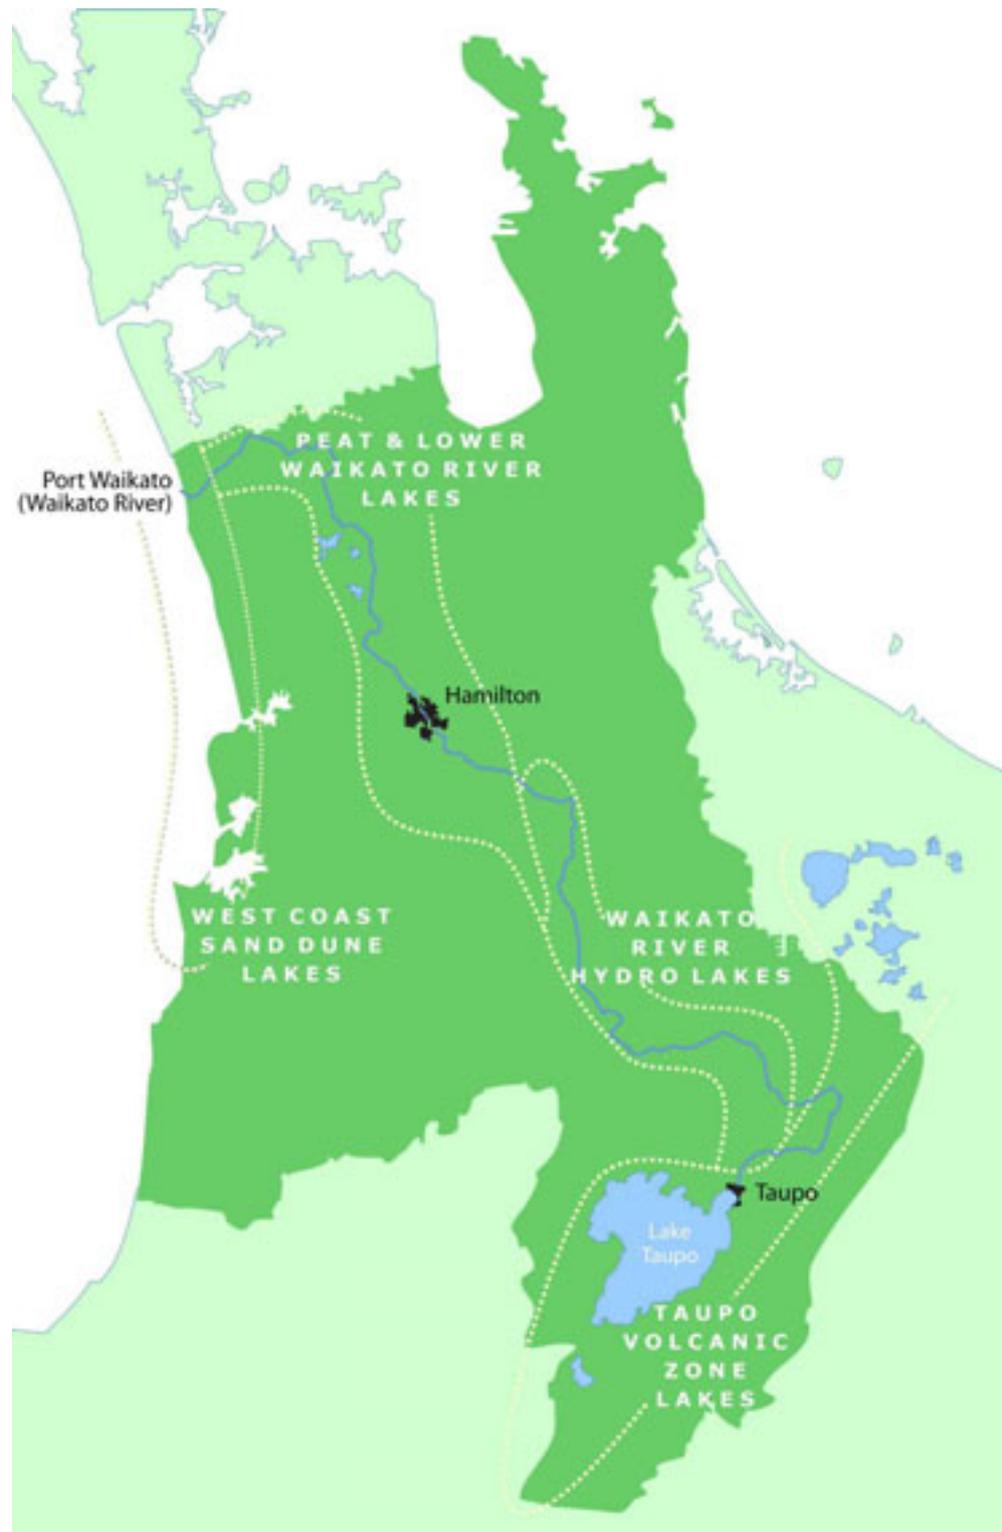
Figure 4: Location of lake groups within the Waikato Region; including dune lakes along the west coast, peat lakes in the lower Waikato basin, riverine lakes associated with the northern reach of the Waikato River, hydro lakes in the Waikato River system and lakes in the Taupo volcanic zone (source – Environment Waikato).

Fifty-two lakes in total have been assessed using LakeSPI. The location of lakes is indicated in Figure 4 and includes peat influenced lakes within the Waikato basin, riverine lakes adjacent to the northern reach of the Waikato River, hydroelectric lakes

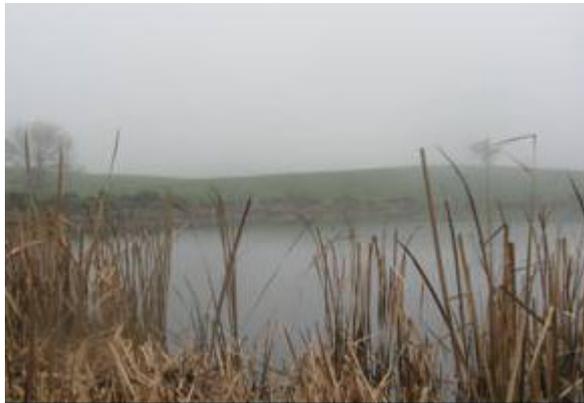
4.1.1 Lake Areare

Lake condition: Non-vegetated
 Stability: Stable
 Lake type: Peat
 Maximum depth: 5.1 m

Due to a lack of historic data, the timing of submerged vegetation disappearance from Lake Areare is unknown. A 1991 survey found only a sparse cover of submerged plants at only one of the five sites surveyed and although a recent survey has not been completed for Lake Areare, no improvements are expected due to the high peat staining of the lake water and lack of major land-use changes since 1991.

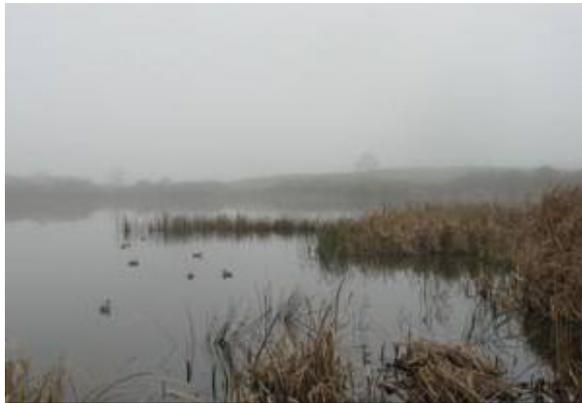
4.1.2 Lake Hotoananga

Lake condition: Non-vegetated
 Stability: Stable
 Lake type: Peat
 Maximum depth: 3 m

Egeria densa dominated the submerged vegetation of Lake Hotoananga from the late 1950's until the early 1990's and during this period the lake remained in an invaded but stable condition. No submerged plants were found in the 2001 LakeSPI survey despite the adequate water clarity noted by divers at that time.

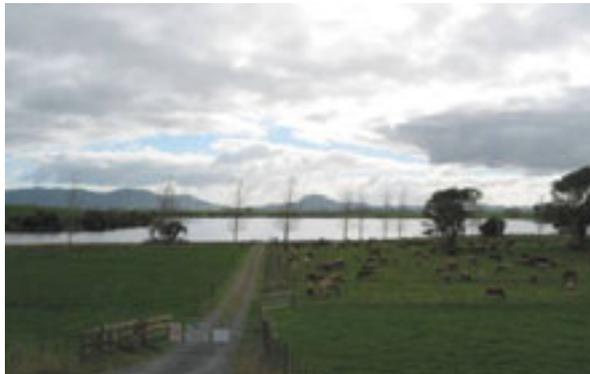
4.1.3 Lake Kainui (D)

Lake condition:	Moderate
Stability:	Stable
Lake type:	Peat
Maximum depth:	6.7 m

A strongly coloured peat lake, Lake Kainui is likely to have provided poor habitat for submerged plants in pre-European times as well as historically. It was first investigated by NIWA staff for the presence of submerged vegetation in 1983 and again in 1991 and no submerged plant species were found. The present assessment found that charophytes (*Nitella* aff. *cristata*) have since developed to covers exceeding 10% at three of the sites investigated, and so the lake generated a moderate LakeSPI score. Whether this recent growth will be sustained is not known, but it may reflect reduced humic colour inputs from the adjacent Kainui peat bog in recent times, following drainage, subsidence and carbon loss in the peat soils.

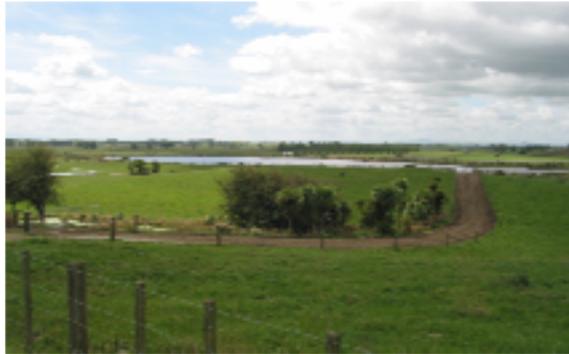
4.1.4 Lake Kaituna (B)

Lake condition:	Non-vegetated
Stability:	Stable
Lake type:	Peat
Maximum depth:	1.3 m

This lake has peat-stained waters and high levels of suspended matter. It was first investigated by NIWA staff in 1992 and no submerged plant species were found. Since then major willow clearance works and native riparian planting have been undertaken in the lake margins, together with land practice methods to reduce nutrient run-off from the surrounding agricultural catchment.

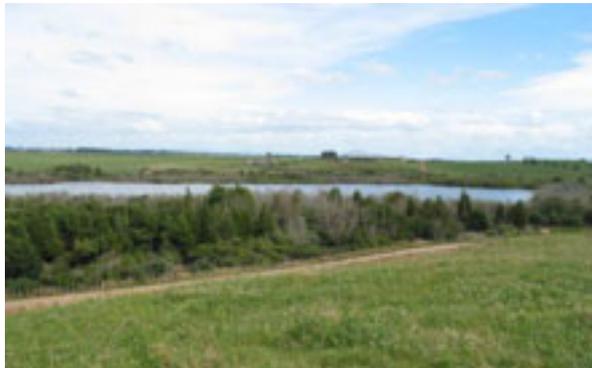
4.1.5 Lake Koromatua

Lake condition:	Non-vegetated
Stability:	Stable
Lake type:	Peat
Maximum depth:	1.2 m

Lake Koromatua has peat-stained waters that would have naturally constrained the growth of submerged plants. Until recent times the lake received direct agricultural discharges and was considered hypereutrophic. Water level was also affected by drainage in the area. In 1991 NIWA staff found no submerged plants during a survey of six sites and concluded that poor water clarity and the lakes shallow nature (0.8 m depth) explained their absence. In recent years agricultural inputs have been diverted, the lake level has been raised, willows controlled and native riparian plantings has been made.

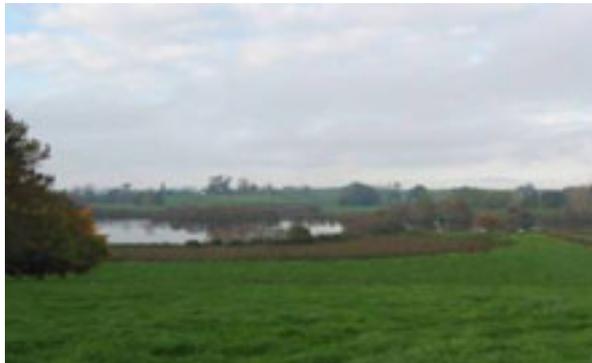
4.1.6 Lake Mangakaware

Lake condition:	High
Stability:	Improving
Lake type:	Peat
Maximum depth:	4.8 m

A relatively diverse vegetation persists within the lake despite the presence of the invasive weed *Egeria densa* for in excess of fourteen years. The most recent survey suggested a reduced impact by this species and a slight expansion by native plants, although the vegetation remains sparse. The weed *Elodea canadensis* was recorded for the first time during the current survey. This species is generally less invasive than *E. densa*.

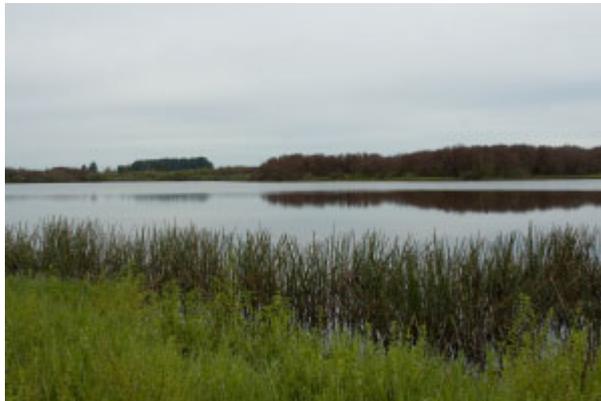
4.1.7 Lake Mangahia

Lake condition:	Non-vegetated
Stability:	Stable
Lake type:	Peat
Maximum depth:	1.5 m

In 1992 no submerged vegetation was recorded and it was considered that the low water clarity due to strong peat staining made conditions unsuitable for plants. The NIWA survey in 2007 again did not record any submerged vegetation. Koi carp were observed in 2008 (NIWA records) and are likely to further reduce the suitability of conditions for submerged vegetation development.

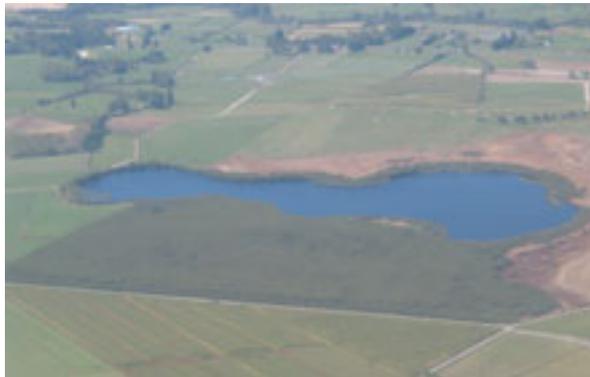
4.1.8 Lake Maratoto

Lake condition: Non-vegetated
 Stability: Stable
 Lake type: Peat
 Maximum depth: 7.1 m

No submerged plants have been recorded previously, although investigations by NIWA staff were made at five sites in 1991. The 2009 survey also found submerged vegetation to be absent.

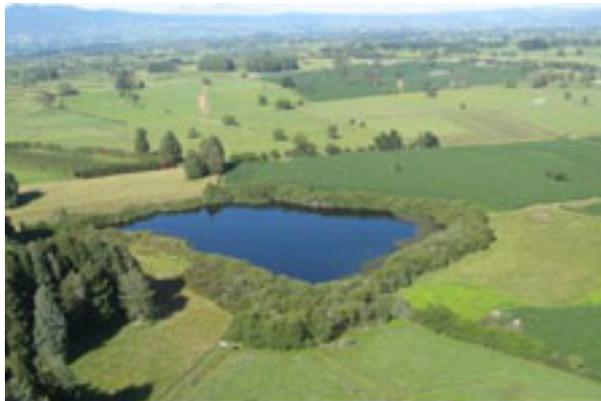
4.1.9 Lake Milicich

Lake condition: Non-vegetated
 Stability: -
 Lake type: Peat
 Maximum depth: 2.2 m

Visited for the first time in 2009, the submerged vegetation was restricted to floating fragments of the alien bladderwort *Utricularia gibba* at some sites, but at covers that did not exceed the 10% required for generating a LakeSPI score. *U. gibba* is a recent invader in the Waikato Region and its performance and likely impacts on future LakeSPI assessments of the regions lakes is not known.

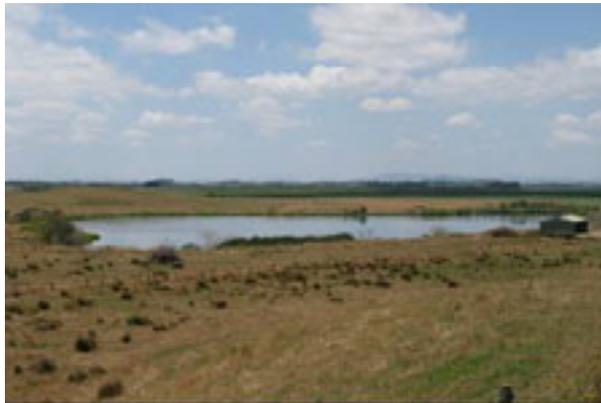
4.1.11 Lake Pataka

Lake condition:	Non-vegetated
Stability:	Stable
Lake type:	Peat
Maximum depth:	5 m

Scattered plants of the native charophyte, *Nitella* aff. *cristata*, were found where shallow habitat (0.5-0.7 m) was available. Much of the rest of the margins comprised floating sumps of marginal plants or *Typha orientalis* that extended to over 0.7 m depth. Low water clarity, including high levels of peat-staining, would restrict the depth extent of submerged plants.

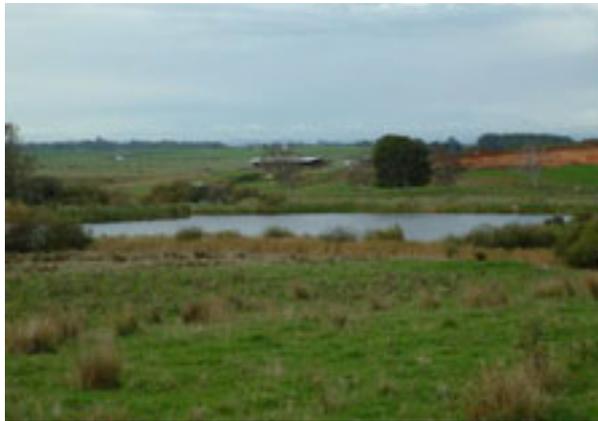
4.1.12 Lake Posa

Lake condition:	Non-vegetated
Stability:	Stable
Lake type:	Peat
Maximum depth:	4 m

No submerged vegetation was found, probably on account of the thick marginal sudds of plants that extended out over open water to depths of up to 2 m, and the low water clarity. This resembles descriptions from earlier surveys (Champion et al. 1993). A substantial increase in water clarity would be necessary for any widespread development of submerged vegetation, given the current extent of floating marginal sudd.

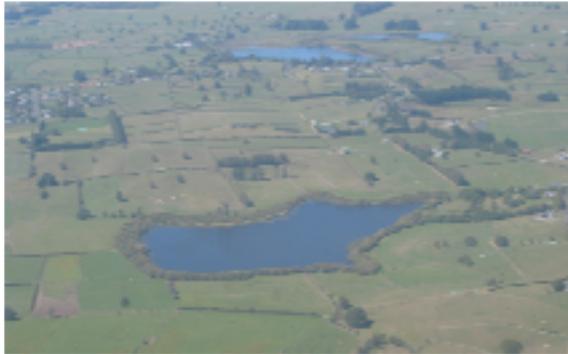
4.1.17 Lake Ruatuna

Lake condition:	Non-vegetated
Stability:	Stable
Lake type:	Peat
Maximum depth:	3.2 m

No plants were found, similar to previous investigations (Champion et al. 1993), and so the lake scores a default of 0. We noted large numbers of empty mussel shells on the lake bed at several sites, but no live mussels were found. This is further indication that the lake was in a better condition in the recent past. Currently, the low water clarity appears the main factor preventing submerged plant development, but the presence of a dead rudd also confirms a population of the herbivorous fish that elsewhere are proven to retard submerged vegetation recovery.

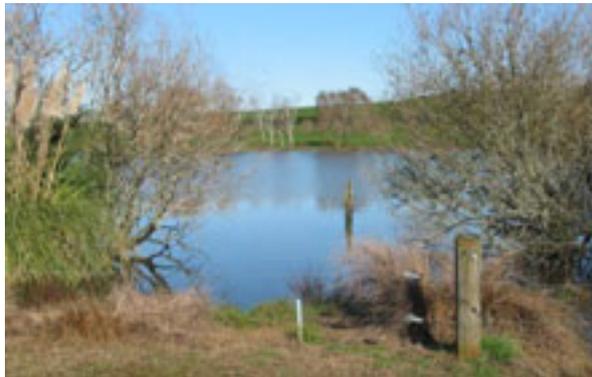
4.1.21 Lake Tunawhakapeka (E)

Lake condition:	Non-vegetated
Stability:	Stable
Lake type:	Peat
Maximum depth:	1 m

Water level was low at the time of the 2007 survey (most sites <0.5 m). As a shallow lake, it is very likely to have supported extensive submerged vegetation in pre-European times. It is currently de-vegetated and so scores a default LakeSPI score of 0%. The sole record of one rooted plant was the introduced pondweed, *Potamogeton crispus*, which is spread as seed by waterfowl.

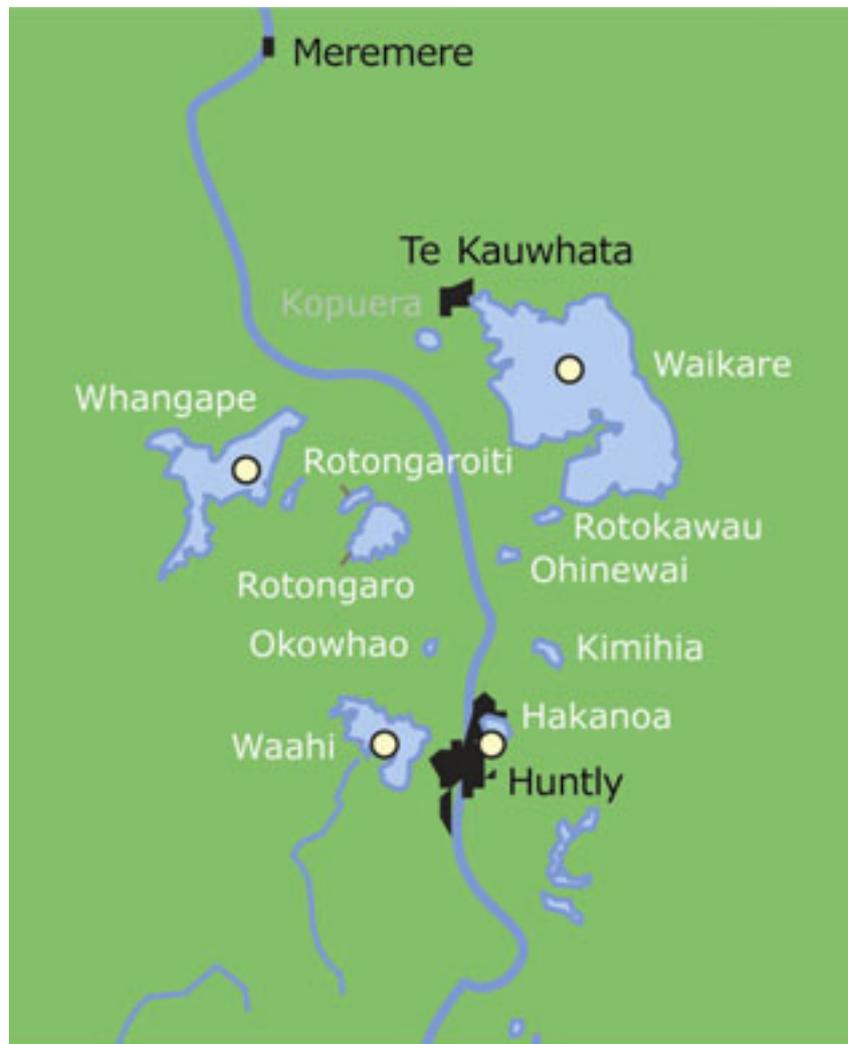
Figure 6: Location of Riverine lakes within the Waikato Region with assessed lakes shown in white type (source – Environment Waikato).

The Waikato Region's nine riverine lakes are part of an extensive wetland system that includes Lakes Whangape, Waahi, Waikare and the internationally important Whangamarino Wetland. All of the riverine lakes are naturally shallow (<5m depth) and exposed, which, following the collapse of submerged vegetation has acted to stabilise them in a highly turbid condition. Of the nine riverine lakes surveyed for this report none of the lakes contained submerged vegetation exceeding covers required for LakeSPI assessment.

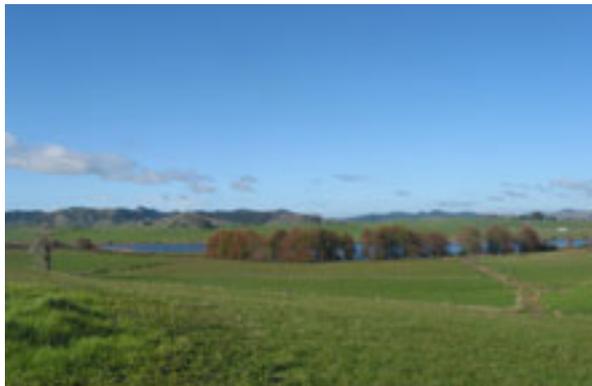
4.2.3 Lake Ohinewai

State	Year	LakeSPI Index (%)	Native Condition Index (%)	Invasive Impact Index (%)
Pristine	1800s	97	93	0
Historical data	1958	97	93	0
	1981	26	27	85
	1983	11	0	93
	1991	0	0	0
Present day	2008	0	0	0

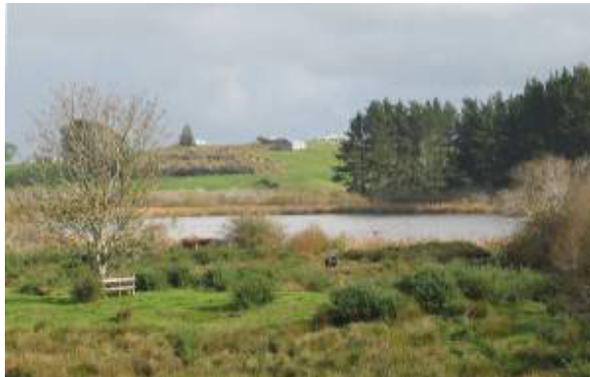
4.2.4 Lake Okowhao

State	Year	LakeSPI Index (%)	Native Condition Index (%)	Invasive Impact Index (%)
Pristine	1800s	94	86	0
Historical data	1986	16	11	87
	1991	24	14	78
	2005	0	0	0
Present day	2009	0	0	0

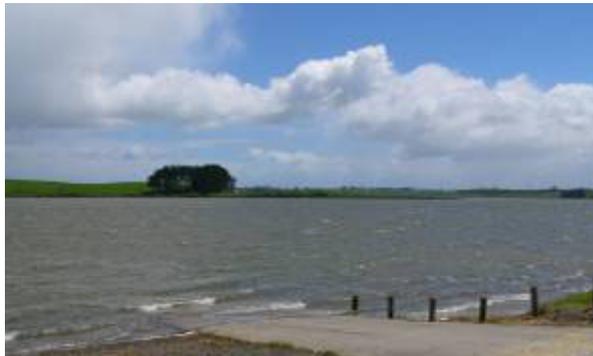
4.2.7 Lake Waahi

State	Year	LakeSPI Index (%)	Native Condition Index (%)	Invasive Impact Index (%)
Pristine	1800s	100	100	0
Historical data	1976	18	5	85
Present day	2005	0	0	0

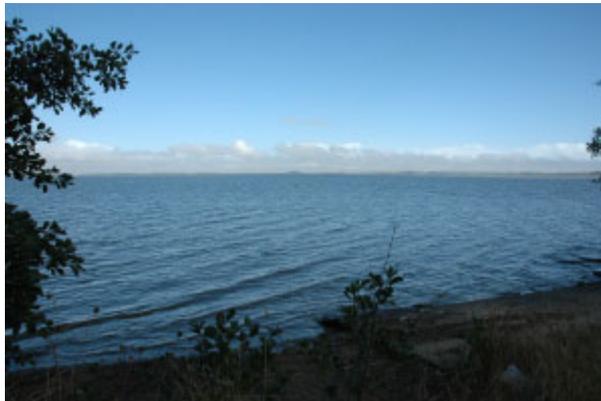
4.2.8 Lake Waikare

State	Year	LakeSPI Index (%)	Native Condition Index (%)	Invasive Impact Index (%)
Pristine	1800s	100	100	0
Historical data	1871	100	100	0
	1978	24	29	85
	1984	0	0	0
	1992	0	0	0
	1993	0	0	0
	2001	0	0	0
Present day	2008	0	0	0

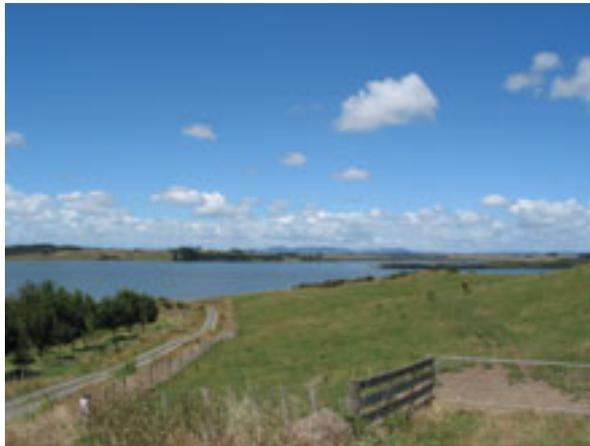
4.2.9 Lake Whangape

State	Year	LakeSPI Index (%)	Native Condition Index (%)	Invasive Impact Index (%)
Pristine	1800s	100	100	0
Historical data	1869	100	100	0
	1958	26	29	81
	1982	24	21	81
	1991	9	0	93
	2001	3	0	100
Present day	2005	0	0	0

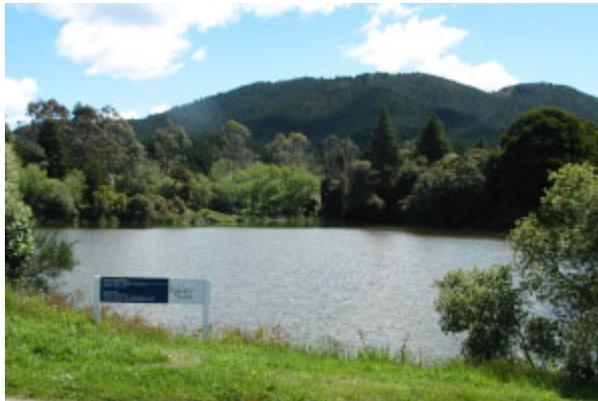
4.3.1 Lake Ngahewa

State	Year	LakeSPI Index (%)	Native Condition Index (%)	Invasive Impact Index (%)
Pristine	1800s	90	81	0
Historical data	1973	78	57	0
	1989	15	5	81
	2004	0	0	0
Present day	2008	29	26	67

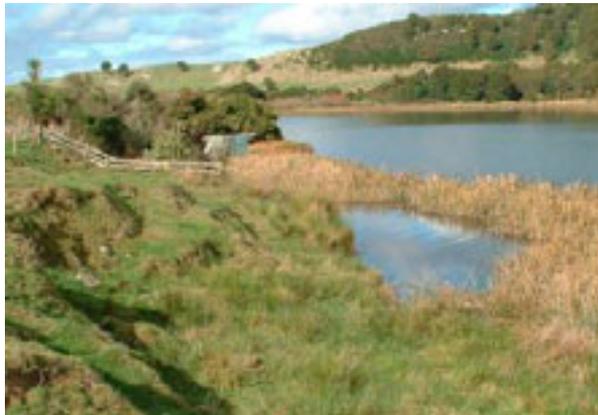
4.3.2 Lake Opouri

State	Year	LakeSPI Index (%)	Native Condition Index (%)	Invasive Impact Index (%)
Pristine	1800s	88	80	0
Historical data	1984	34	30	54
	1989	30	23	62
Present day	2004	58	33	4

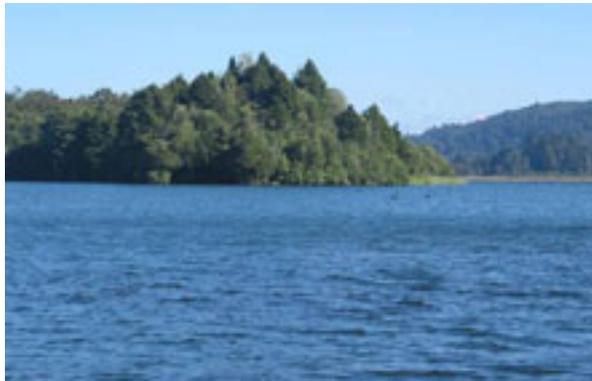
4.3.3 Lake Rotoaira

State	Year	LakeSPI Index (%)	Native Condition Index (%)	Invasive Impact Index (%)
Pristine	1800s	100	100	0
Historical data	1979	51	68	67
	1999	32	46	83
	2003	27	39	86
Present day	2007	23	27	90

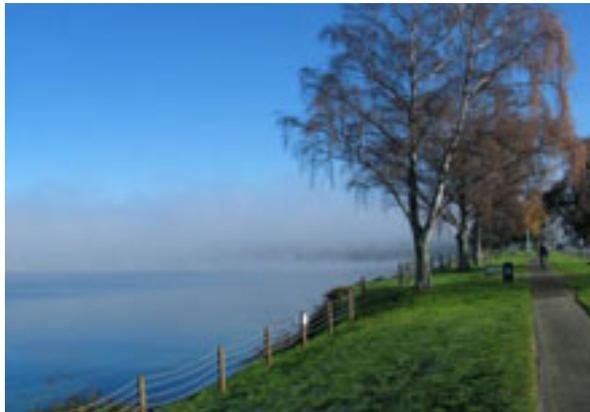
4.3.5 Lake Taupo

State	Year	LakeSPI Index (%)	Native Condition Index (%)	Invasive Impact Index (%)
Pristine	1800s	100	100	0
Historical data	1977	54	67	59
	1991	54	67	59
Present day*	2002	36	47	78

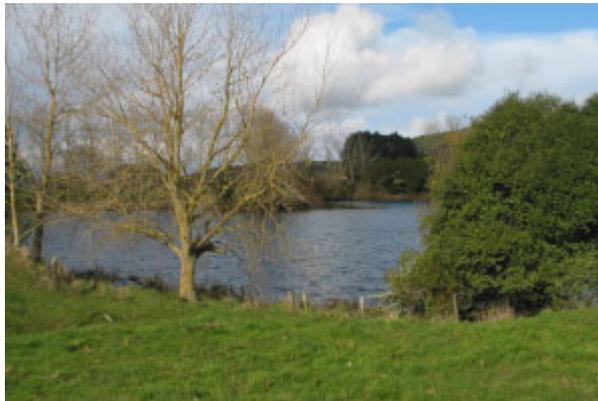
4.3.6 Lake Tutaeinanga

State	Year	LakeSPI Index (%)	Native Condition Index (%)	Invasive Impact Index (%)
Pristine	1800s	94	87	0
Historical data	2004	52	35	23
Present day	2008	0	0	0

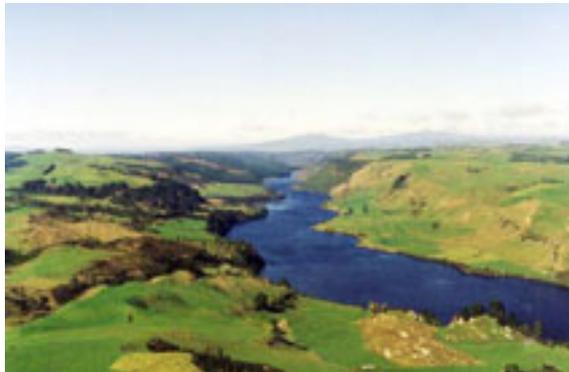
4.4.1 Lake Arapuni

State	Year	LakeSPI Index (%)	Native Condition Index (%)	Invasive Impact Index (%)
Potential condition		96	93	0
Present day	2009	12	9	97

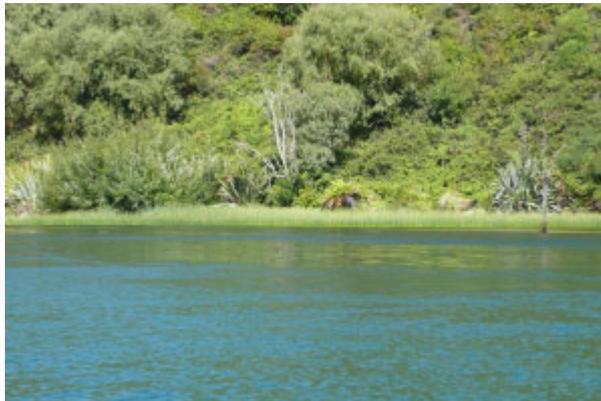
4.4.2 Lake Aratiatia

State	Year	LakeSPI Index (%)	Native Condition Index (%)	Invasive Impact Index (%)
Potential condition		95	92	0
Present day	2009	27	39	84

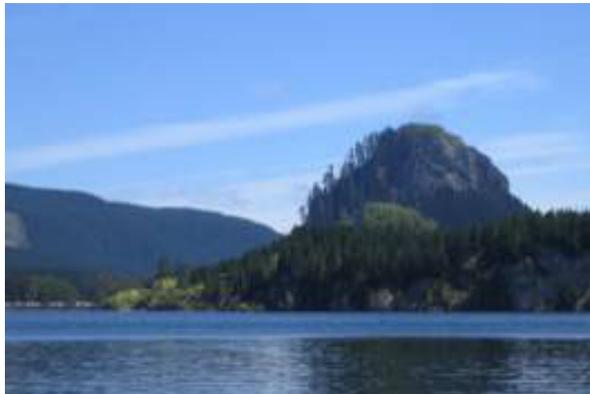
4.4.3 Lake Atiamuri

State	Year	LakeSPI Index (%)	Native Condition Index (%)	Invasive Impact Index (%)
Potential condition		96	93	0
Present day	2009	12	3	99

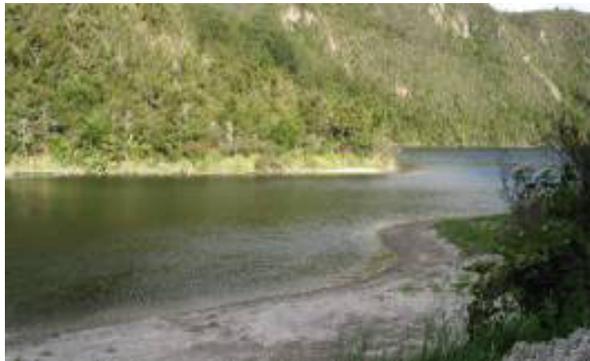
4.4.4 Lake Hinemaiaia (B)

State	Year	LakeSPI Index (%)	Native Condition Index (%)	Invasive Impact Index (%)
Potential condition		96	93	0
Historic	1982	45	37	41
Present day	2005	0	0	0

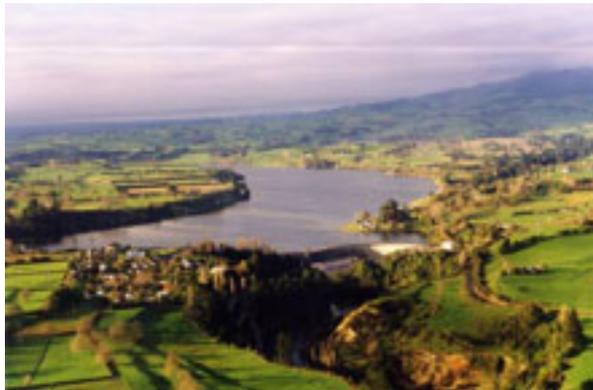
4.4.5 Lake Karapiro

State	Year	LakeSPI Index (%)	Native Condition Index (%)	Invasive Impact Index (%)
Potential condition		96	93	0
Historic	2001	10	5	92
Present day	2009	9	3	97

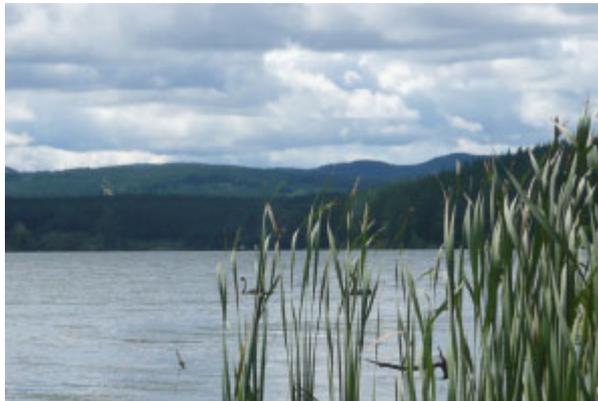
4.4.6 Lake Maraetai

State	Year	LakeSPI Index (%)	Native Condition Index (%)	Invasive Impact Index (%)
Potential condition		96	93	0
Historic	2008	8	1	99
Present day	2009	9	3	97

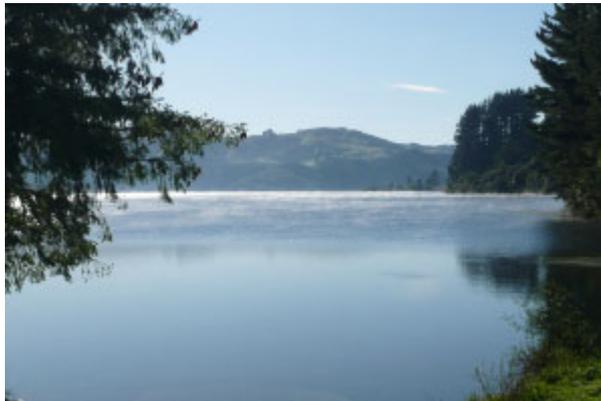
4.4.7 Lake Ohakuri

State	Year	LakeSPI Index (%)	Native Condition Index (%)	Invasive Impact Index (%)
Potential condition		96	93	0
Present day	2009	14	9	96

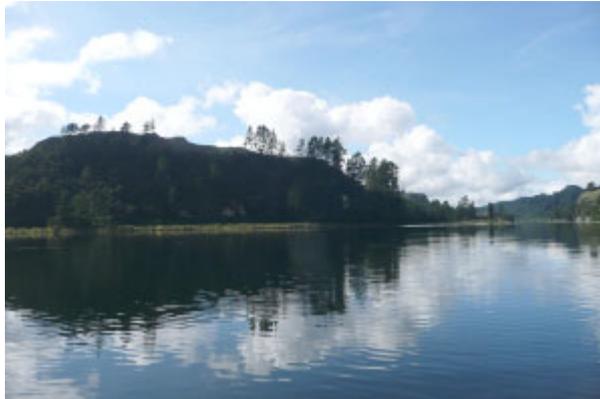
4.4.8 Lake Waipapa

State	Year	LakeSPI Index (%)	Native Condition Index (%)	Invasive Impact Index (%)
Potential condition		96	93	0
Present day	2009	12	9	96

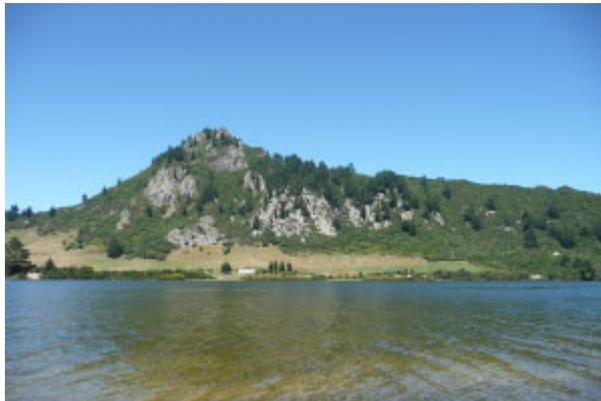
4.4.9 Lake Whakamaru

State	Year	LakeSPI Index (%)	Native Condition Index (%)	Invasive Impact Index (%)
Potential condition		96	93	0
Present day	2009	10	8	96

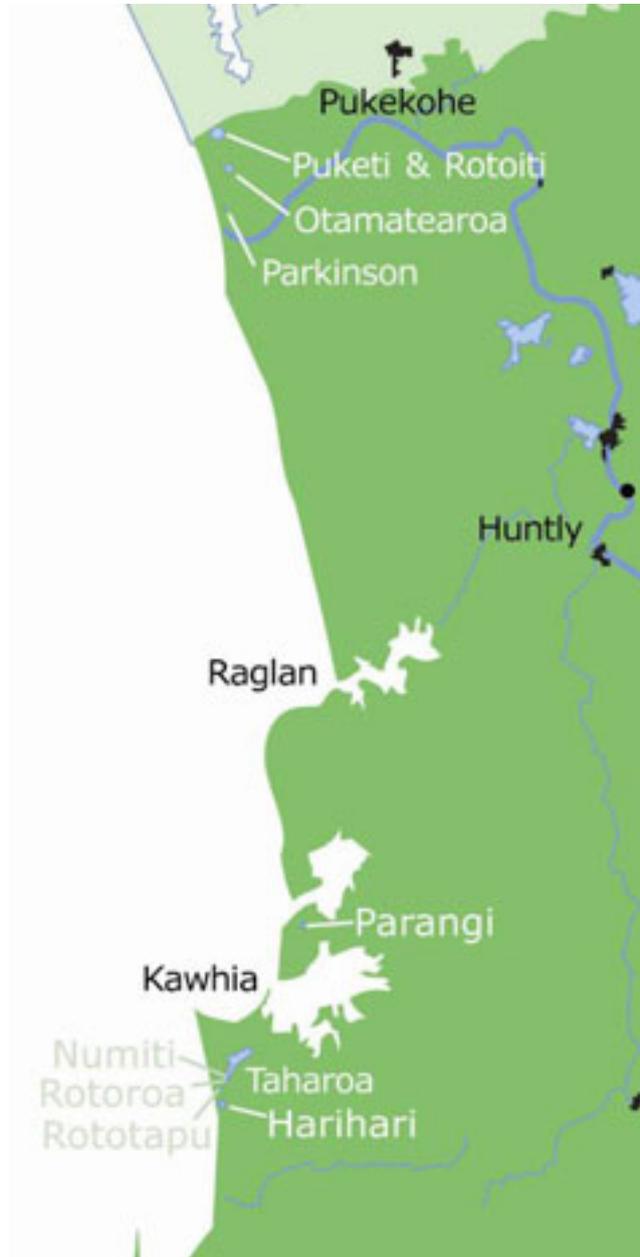
Figure 9: Location of West Coast sand dune lakes within the Waikato Region with assessed lakes shown in white type (source – Environment Waikato).

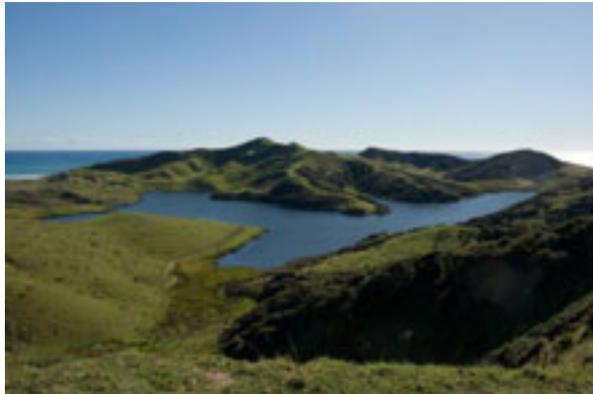
4.5.1 Lake Harihari

Lake condition: Moderate
 Stability: Stable
 Lake type: Dune
 Maximum depth: 8 m

There is no historical vegetation data for Lake Harihari, but recent assessments are similar, suggesting the lake is relatively stable. During the current assessment, *Elodea canadensis* was widespread but did not dominate the vegetation and a rich assemblage of native plants was present. Other invasive species *Potamogeton crispus* and *Juncus bulbosus* were uncommon, and probably originated from seed introduced via wildfowl.

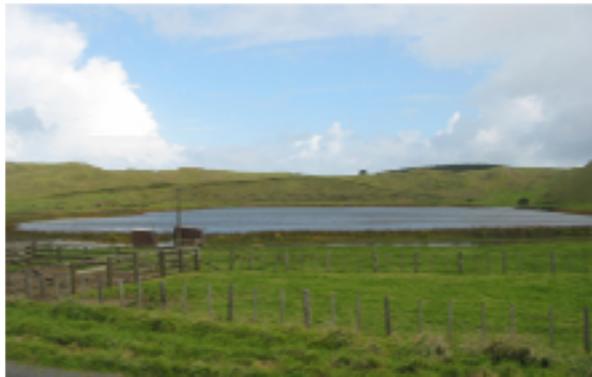
4.5.2 Lake Otamatearoa

Lake condition: Poor
 Stability: Stable
 Lake type: Dune
 Maximum depth: 5 m

The low present day LakeSPI Index reflects the presence of *Ceratophyllum demersum*, the most invasive weed, which was introduced some time after 1996. Limited areas still supported remnant charophytes and the invasive species *Elodea canadensis*, which has been present since at least 1950 (Cunningham et al. 1953). Also observed were the threatened plants *Myriophyllum robustum*, *Ranunculus macropus* and *Utricularia australis* amongst the emergent vegetation around the lake margin.

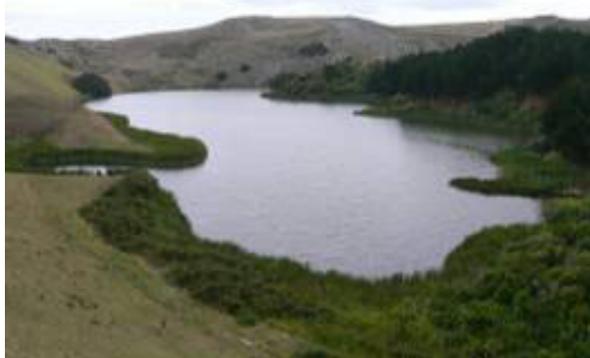
4.5.3 Lake Parangi

Lake condition: Moderate
 Stability: -
 Lake type: Dune
 Maximum depth: 17.6 m

Elodea canadensis formed an invasive weed bed around the lake to a maximum depth of 3.6 m while native species *Potamogeton ochreatus* and *Myriophyllum triphyllum* are also present and contributed to a moderate LakeSPI Index. There are no historical vegetation data available for Lake Parangi therefore we can draw no conclusions about lake stability.

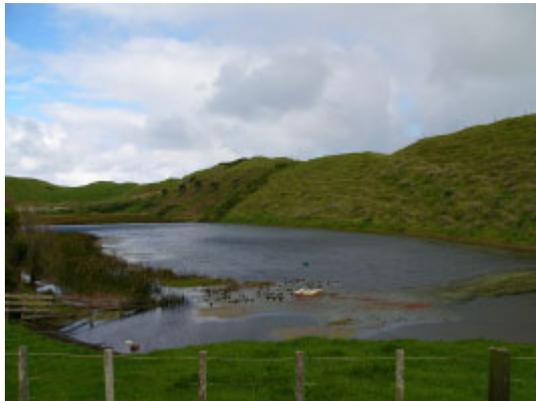
4.5.4 Lake Parkinson

Lake condition: Moderate
 Stability: Declining
 Lake type: Dune
 Maximum depth: 8 m

This lake has been re-invaded by the exotic weed *Egeria densa* since 1996, which now dominates the vegetation although a narrow fringe of charophytes was sometimes present beyond the main depth extent of weed beds. Previously (1976-1981), the lake was the subject of a successful restoration project, which involved the removal of *E. densa* through stocking of grass carp, followed by netting and rotenone removal of exotic fish. Re-establishment by extensive native vegetation was documented within 5 years of grass carp removal (Tanner et al. 1990a). LakeSPI scores calculated at this time (1986-87) are close to the estimated pristine condition, but with the re-introduction of *E. densa*, LakeSPI scores have once again declined.

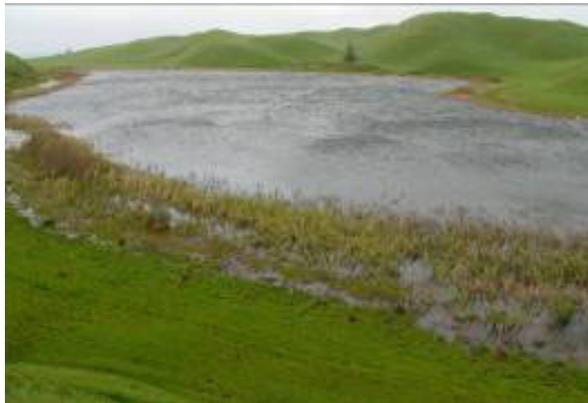
4.5.5 Lake Puketi

Lake condition:	Moderate
Stability:	Stable
Lake type:	Dune
Maximum depth:	7 m

This lake has been dominated by the invasive weed *Egeria densa* for at least 17 years and the LakeSPI Index of 21% is reduced by the high Invasive Impact Index. Previously, the lake is likely to have supported charophyte dominated vegetation, as described in neighbouring Thompson’s Lake (Lake Whatihua) by Cunningham et al. (1953). The dominance by *E. densa* and stressful conditions observed for submerged vegetation (e.g., epiphytic burdens) suggested the lake may be at risk of a vegetation decline.

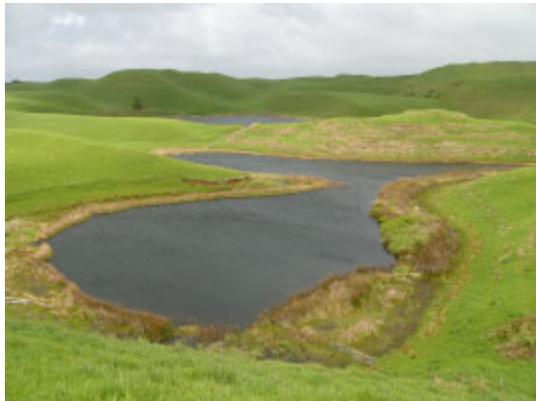
4.5.6 Lake Rotoiti

Lake condition:	Moderate
Stability:	Stable
Lake type:	Dune
Maximum depth:	7 m

The invasive weed, *Egeria densa*, is the dominant plant in Lake Rotoiti and has been for at least 17 years. Prior to this the lake is likely to have supported charophyte dominated vegetation similar to that described in neighbouring Thompsons Lake by Cunningham et al. (1953).

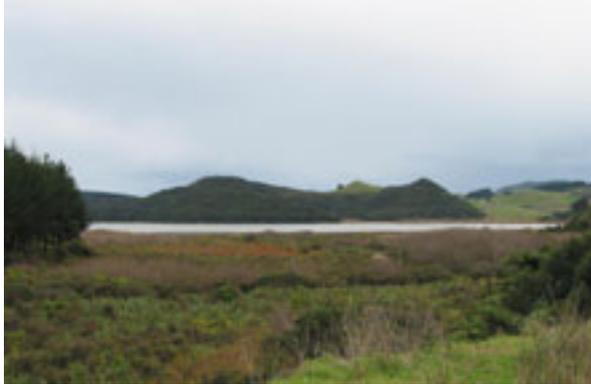
4.5.7 Lake Taharoa

Lake condition:	Moderate
Stability:	Declining
Lake type:	Dune
Maximum depth:	9.2 m

Invasive weed species, *Lagarosiphon major* and *Elodea canadensis*, have had a marked impact on the native plant communities, but areas with native character persist. The extensive shallow margins in the lake support a large vegetated area.

In 2007 the depth extent of plants was 1.5 to 2.5 m shallower than 2001, indicating a sustained reduction in the water clarity of the lake. Large amounts of unattached plants seen at this time also suggest a recent stressful period for plant survival. The LakeSPI score decreased only slightly between the two surveys, reflecting the compensating effect between decreased Native Condition Index and decreased Invasive Impact Index.
