Estuarine vegetation survey : Coromandel and Te Kouma Harbours

Prepared by:
Meg Graeme M.Sc (Marine Science)
Natural Solutions – Marine and Terrestrial Ecologists Ltd

June 2009

Natural Solutions Contract Report 09/088

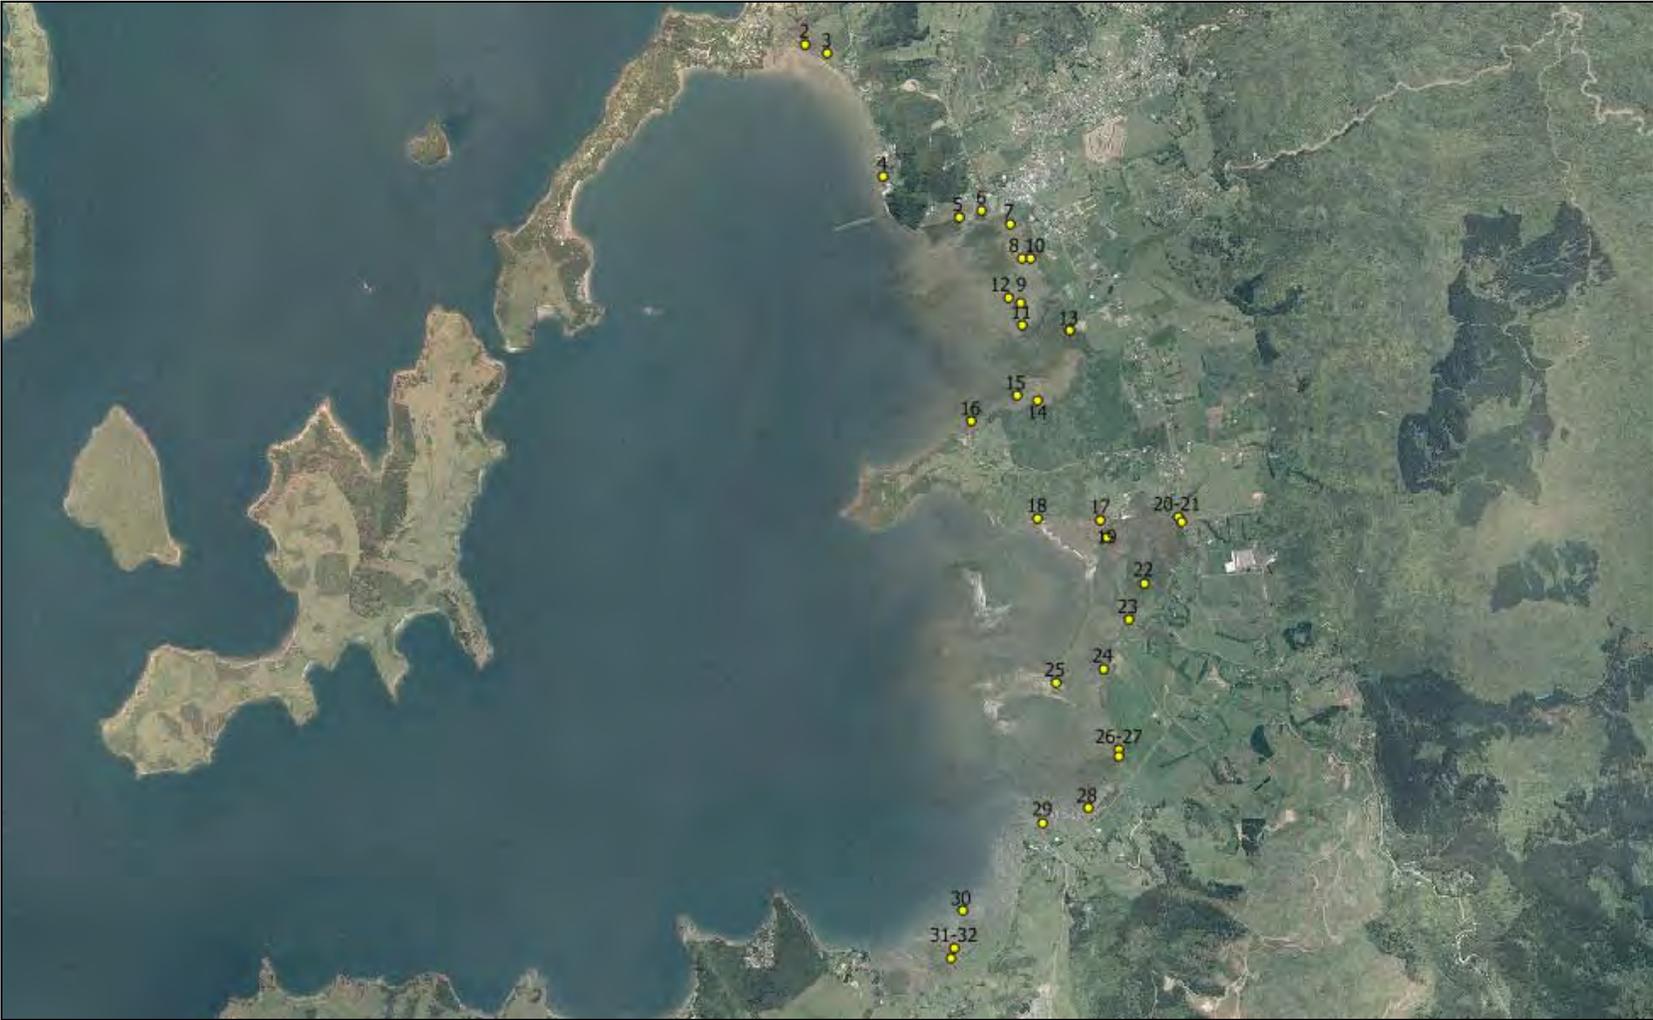
Figure 1: Coromandel Harbour site localities mentioned in this report. The numbers refer to the location of the following figures.

Coromandel Harbour is described clockwise from the north (Wyuna Peninsula). See Figure 1 for a map showing the site names and figure numbers mentioned below. A table of GPS points of the figure locations is in Appendix 1. True left bank (TLB) and true right bank (TRB) refer to the side of a river when facing downstream.

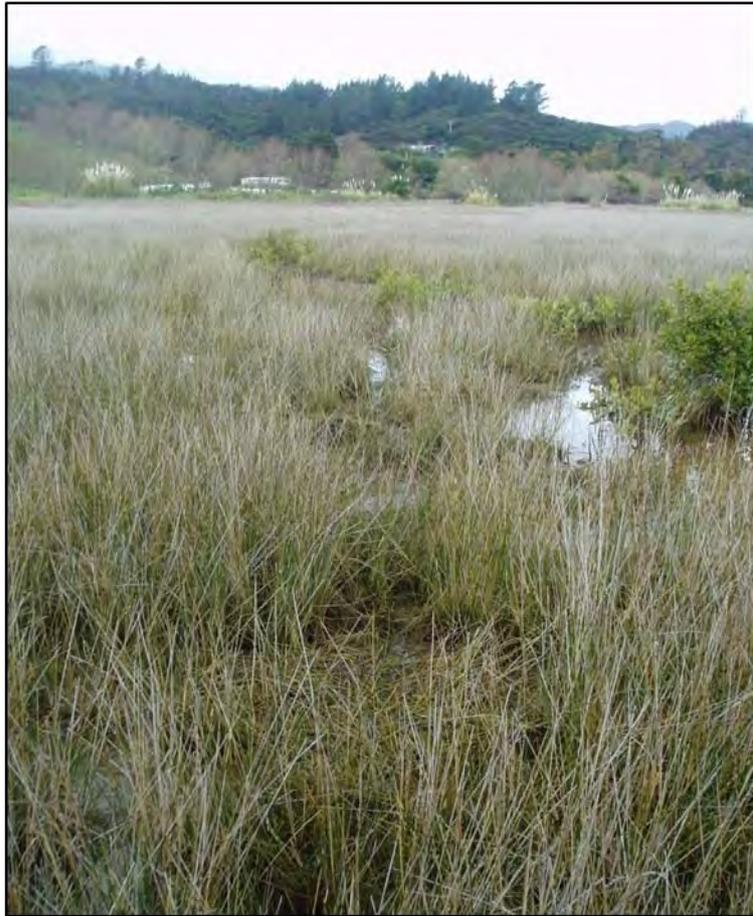
Figure 2: Patches of sea rush were found pulled up by pukeko in the Long Bay wetland. Here mangroves line a minor watercourse through the rushland.

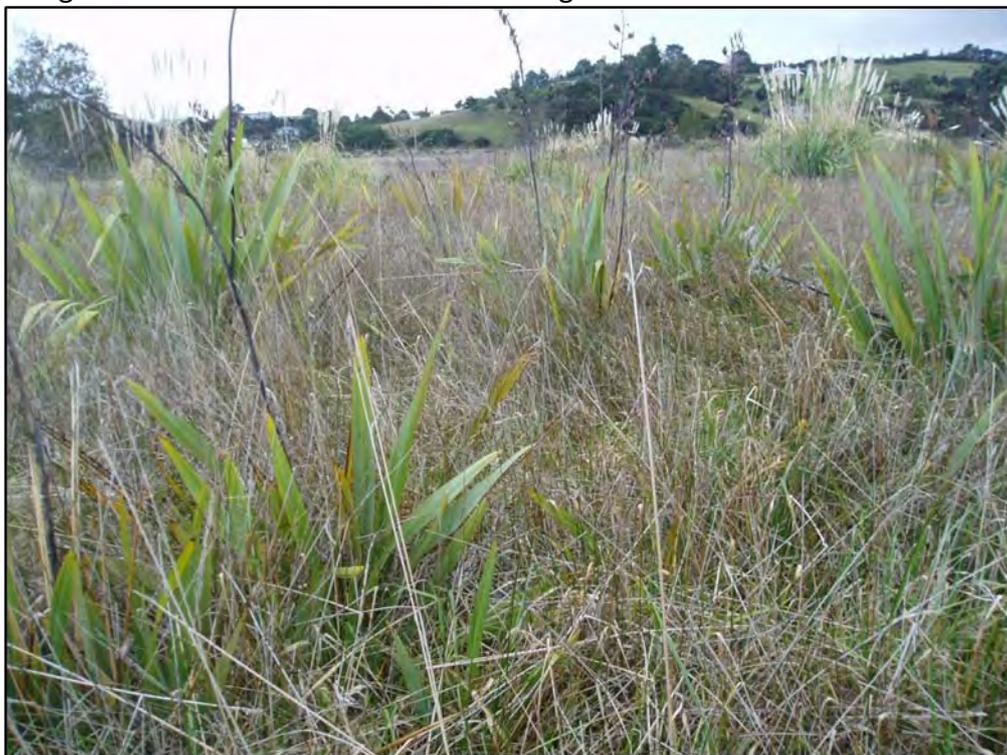
Figure 3: Rushland at the south end of 'Long Bay wetland' becomes interspersed with tall fescue, flax and pampas as the tidal influence reduces.

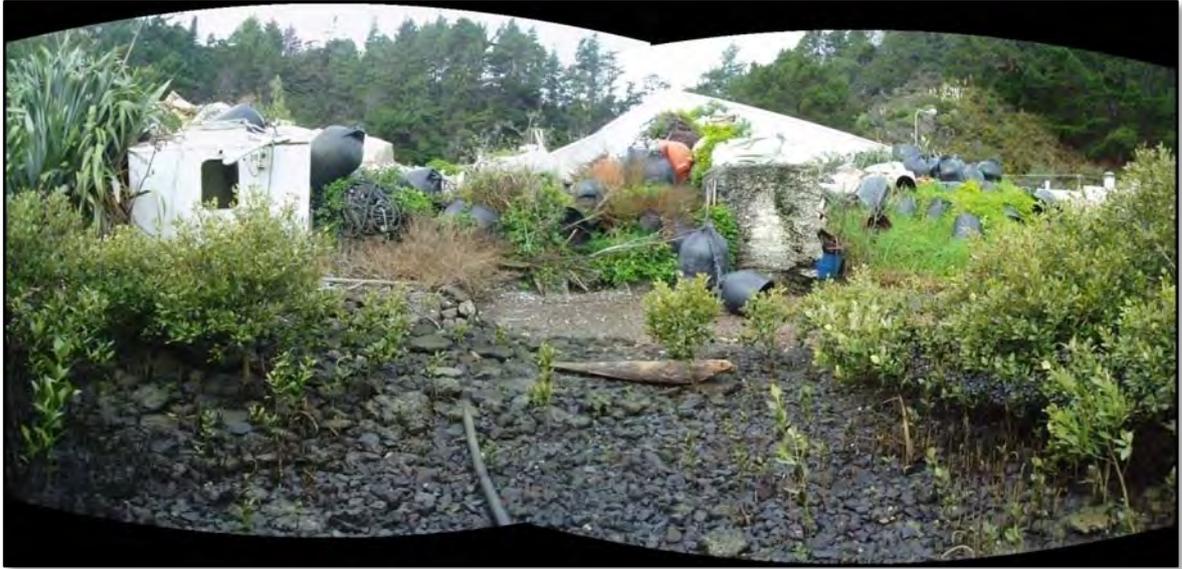
Seaward of the causeway, a narrow band of mangroves lines the armoured coastline around to the oyster processing factory. Inappropriate disposal of inorganic and garden rubbish is a big issue in this area (see Figure 4). Mangroves extend around the foreshore to the wharf. Mangroves then are not encountered until **Jack's Point** where the main town mangal (mangrove forest) starts. There is little back-swamp vegetation due to the reclamation that abuts up hard into the mangroves. Infilling is still continuing here with a number of small sites found where sediment had been dumped into the mangrove edge (see Figure 5 and Figure 6).

Figure 4: Plastic rubbish, machinery, metal and weeds form the coastal edge around housing and the oyster processing plant.

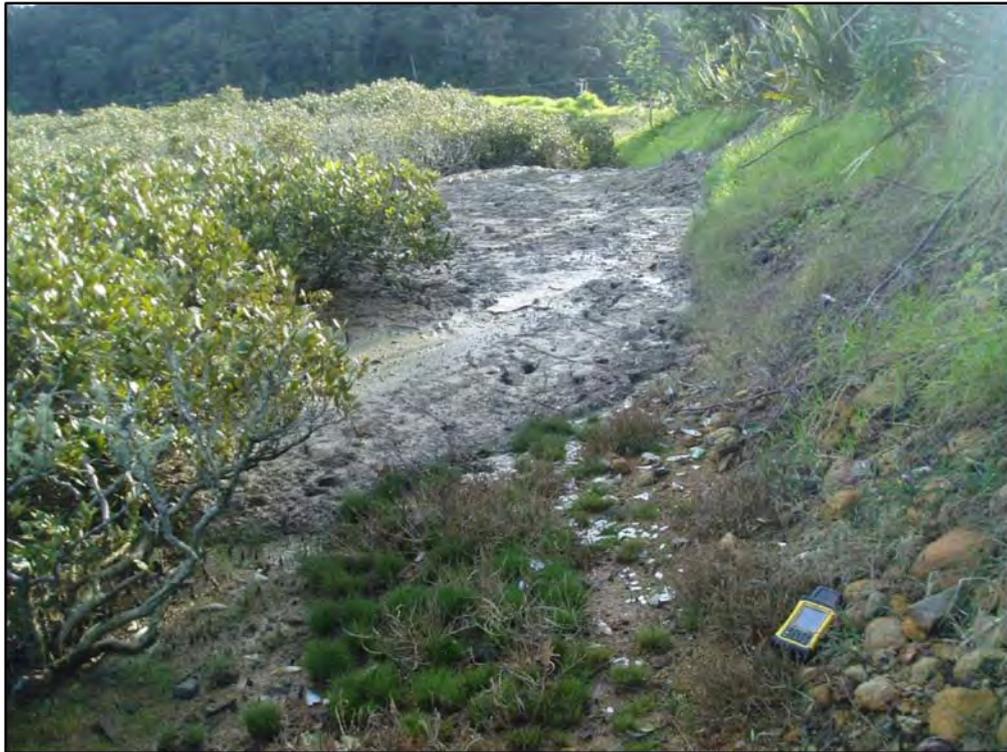
Figure 5: Mud (cleared from the boat ramp?) dumped along the mangrove edge over a thin sea meadow zone.

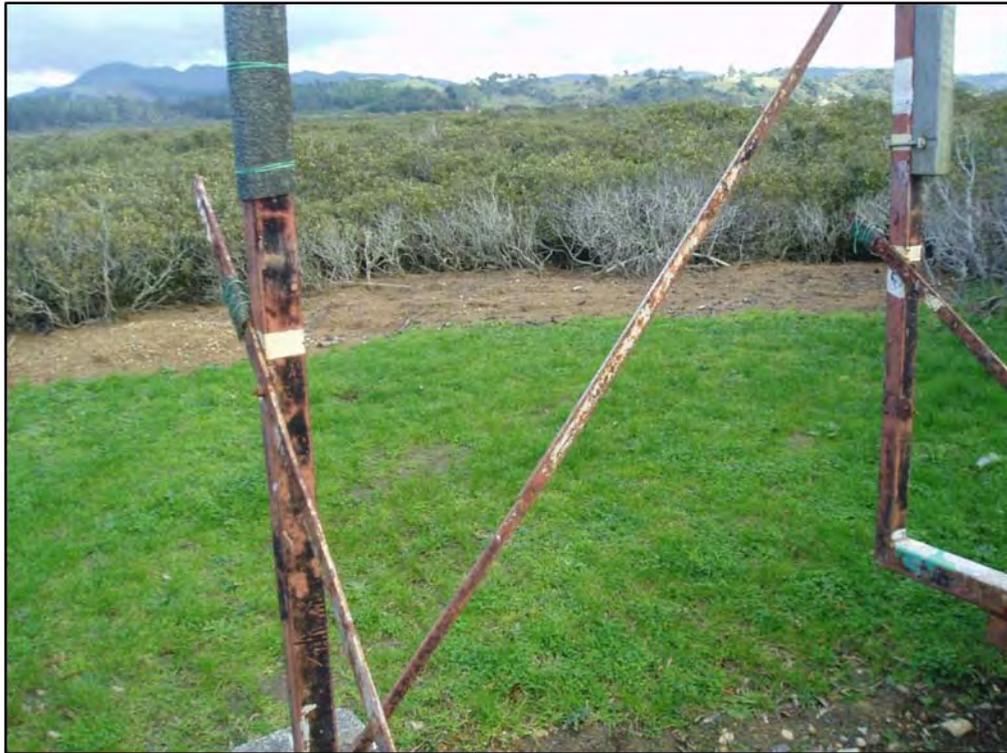
Figure 6: More sediment dumped along the edge of mangroves.

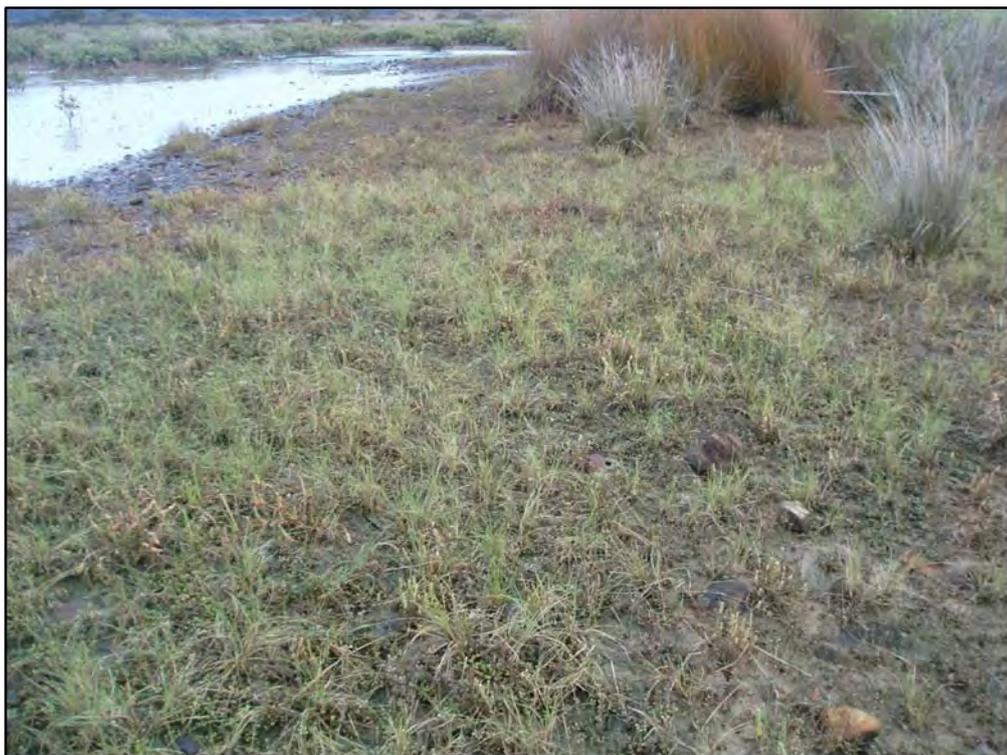
Figure 7: Sea meadow (including sea primrose and glasswort) are common on these coarse outwash fans. The light green grass was unidentified but could be young saltwater paspalum.

12. Work with landowners to protect and restore degraded estuarine areas north of the Waiau river mouth and at the turnoff to Te Kouma settlement.
13. Monitor the shingle fan shown in Figure 7 to determine the species of the light green grass/sedge and its interaction with the sea meadow species also present.

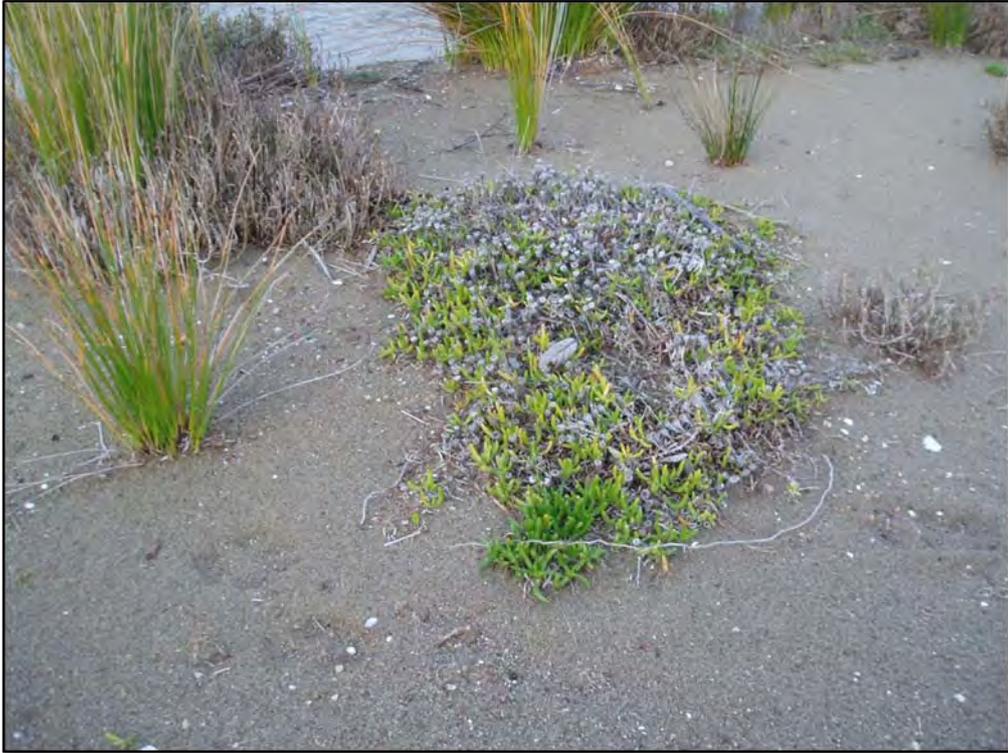
Figure 8: Native iceplant, glasswort and knobby clubrush on a chenier bank.

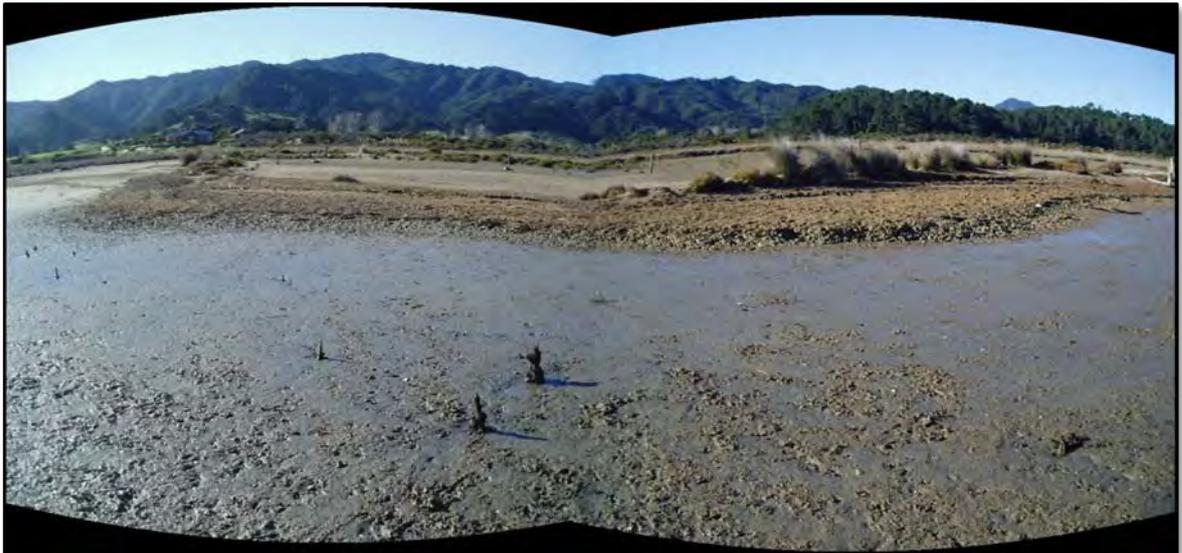
South of the **Whangarahi Stream** mouth, a diverse estuarine vegetation sequence develops. An extensive area of seagrass occurs between the low to mid tide level, extending almost to Preece's Point and inland between the two main mangals (on the southern outwash fan of the Whangarahi Stream mouth and either side of the Huaroa Stream mouth). New Zealand dotterel were noted feeding on the open sandy mudflats and inshore patchy seagrass beds. Banded rail footprints were seen along and within the outer mangrove edge. Behind the protection of the mangroves is a mosaic of rush/sedgeland, sea meadow, spartina and saltwater paspalum communities. The largest areas of sea meadow are found on open shingle outwash fans (Figure 7) and chenier banks (Figure 8). Scattered mangroves occur within the outer rush/sedgeland fringe presumably where waves have washed seedlings in. Spartina has been sprayed

Figure 9: The eroding frontal edge of a sprayed spartina patch that established either side of a chenier.

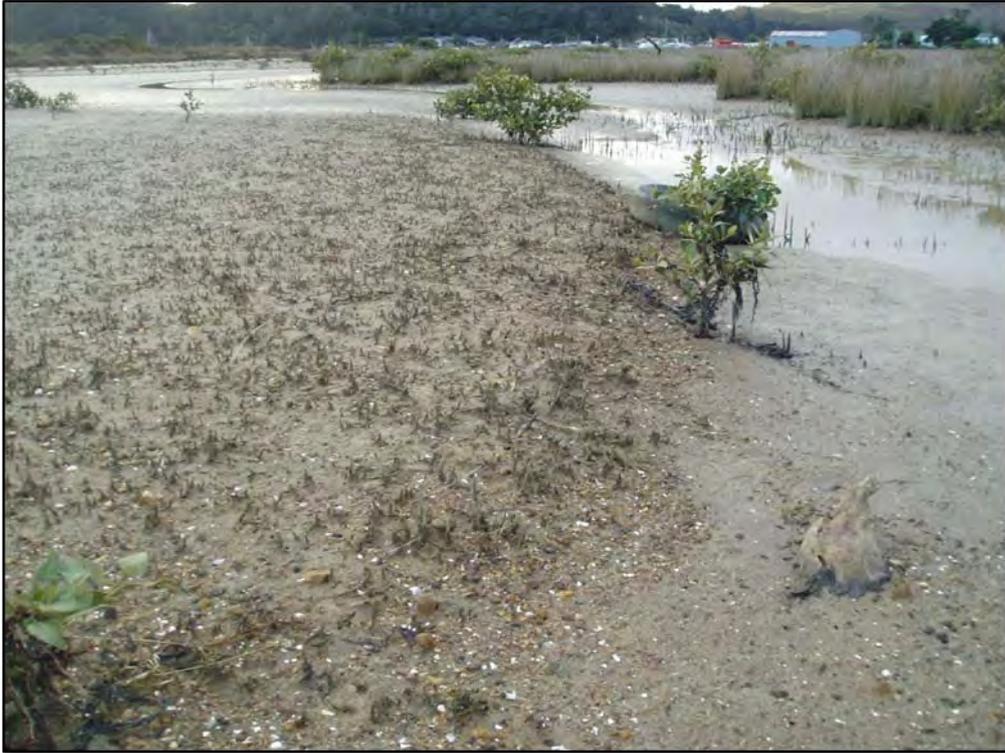
here (Figure 9 and Figure 10), and there has generally been a good kill with only scattered plants still remaining within the sprayed areas (e.g. Figure 11). In some cases, mangroves have colonised the raised beds left behind by the sprayed spartina, and have also established in the lee of spartina patches (e.g. Figure 12). A number of small uncontrolled spartina sites were also found. Saltmarsh ribbonwood is found as thin bands along the back of the rush/sedgeland from the Whangarahi Stream around to the base of Preece's Point. Fernbird were heard within the saltmarsh ribbonwood. A remnant patch of manuka swamp still survives as a point extending out into the harbour but is threatened by the infilling that has occurred around it.

Figure 10: A sprayed spartina patch showing the level of sediment build up within the root mass. Mangroves are also common around the edge of the spartina patch and rushland behind where their seedlings would have been washed and lodged by the tides.

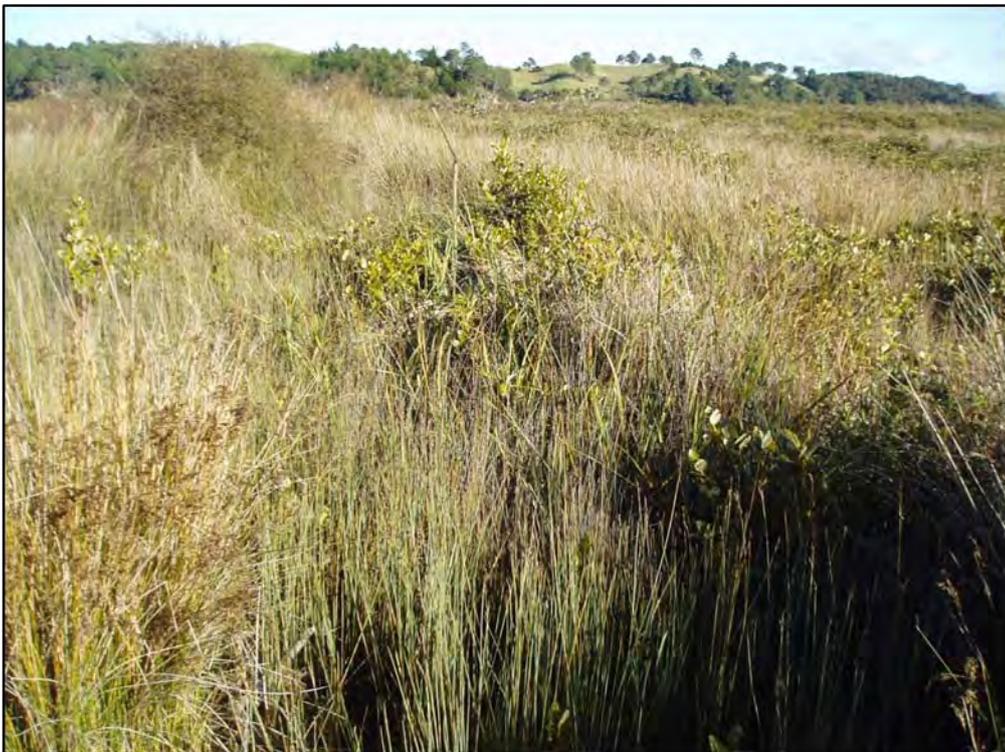
Figure 11: Spartina has invaded a small patch (~8x6m) of rush/sedgeland and scattered mangroves.

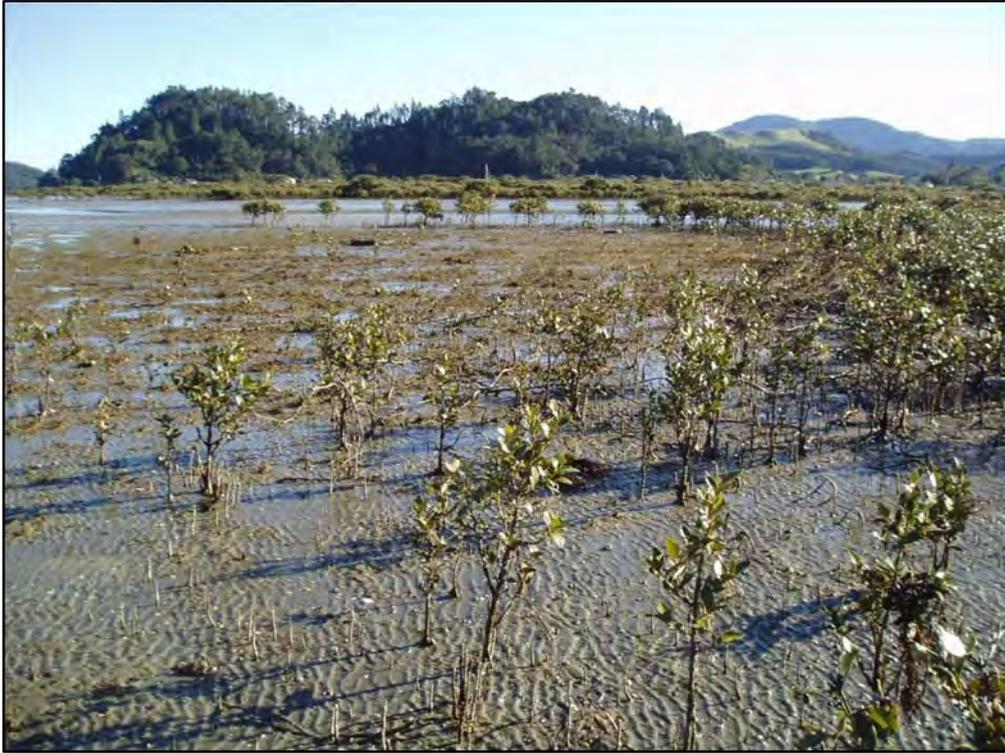
Figure 12: Mangroves established in the lee of a spartina patch (now sprayed and disintegrating).

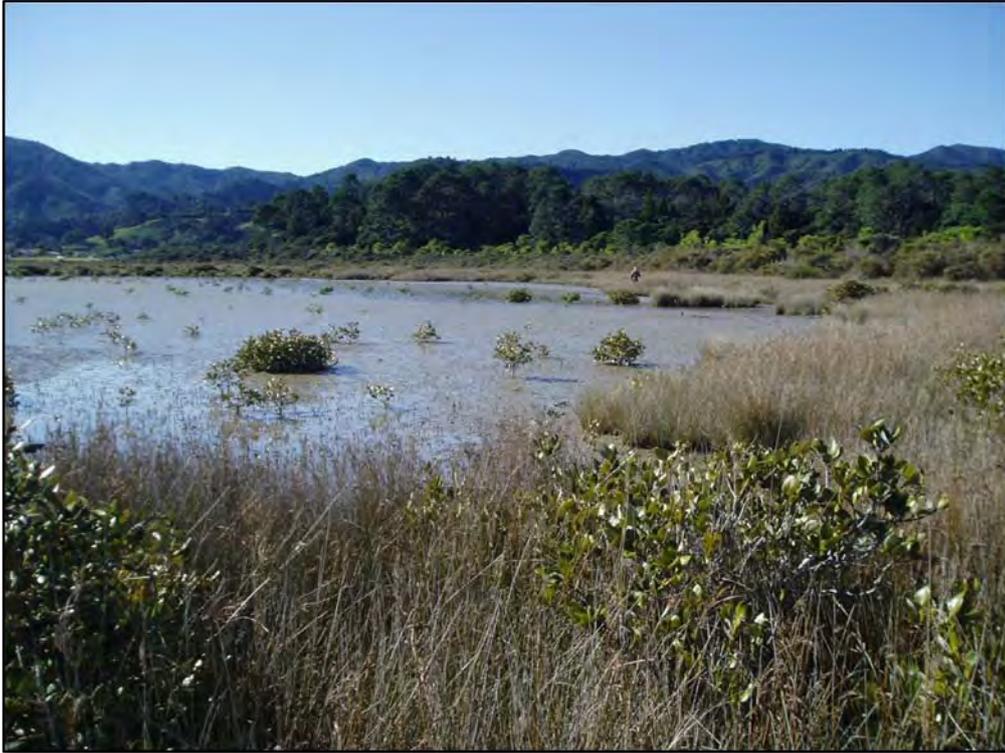
Figure 14: scattered mangroves and a band of sea rush front coastal swamp forest (coastal shrub daisy, swamp coprosma, manuka and cabbage trees).

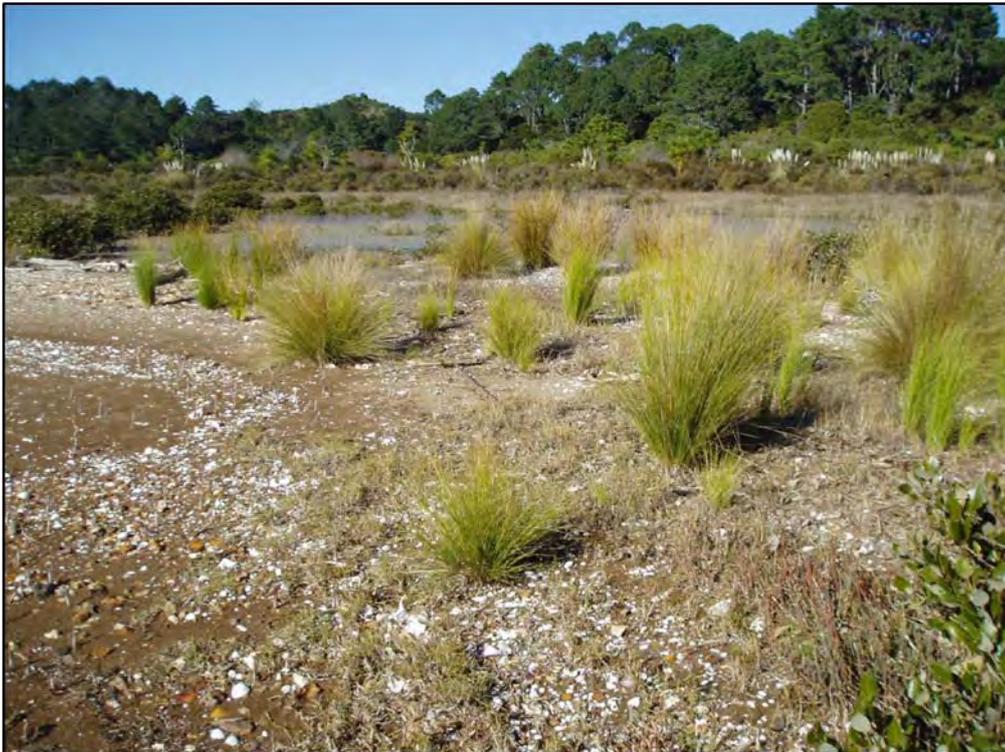
Figure 15: Silver spear grass on a chenier with saltwater paspalum (some frosted) in the foreground.

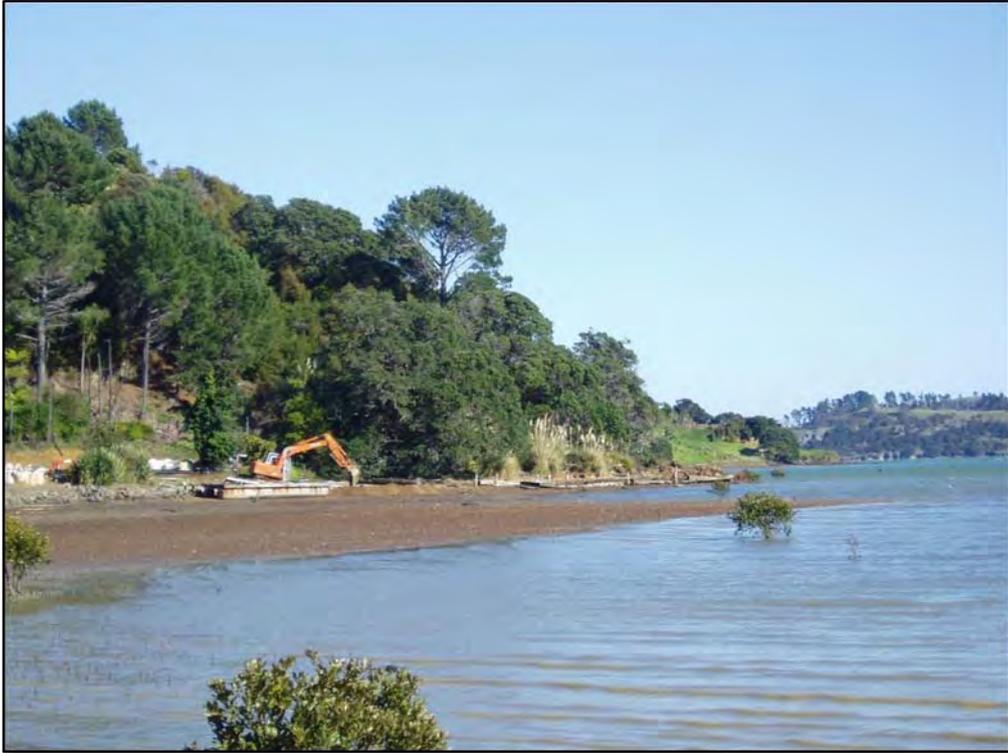
At the mouth of the **Huaroa** and neighbouring streams a mosaic of freshwater and estuarine species intermingle behind the main mangal (Figure 13). A large area of straggly glasswort is mixed with short mangroves, before the open mud flats at the junction with **Preece's Point**. Along the side of Preece's Point and behind the open mudflats is a band of rushland that grades into freshwater coastal swamp forest (Figure 14). The common species here are coastal daisy, swamp coprosma, manuka and cabbage trees. More chenier ridges occur along the edge of Preece's Point. Figure 15 shows coastal spear grass dominating a chenier with saltwater paspalum along the lower edge of the chenier. Patches of saltwater paspalum here were frosted. Saltmarsh ribbonwood is present amongst the rushland behind the cheniers. The estuarine vegetation narrows dramatically at the westward end of the cheniers, with only sporadic patches of sea rush, oioi or a few mangroves noted along the outer coastal edge of the point. Aquaculture development has infilled some of the CMA and created an artificial edge (Figure 16).

Figure 16: The northern side of Preece's Point generally has steep edges to the harbour and as shown here infilling and an artificial edge around the land base aquaculture site.

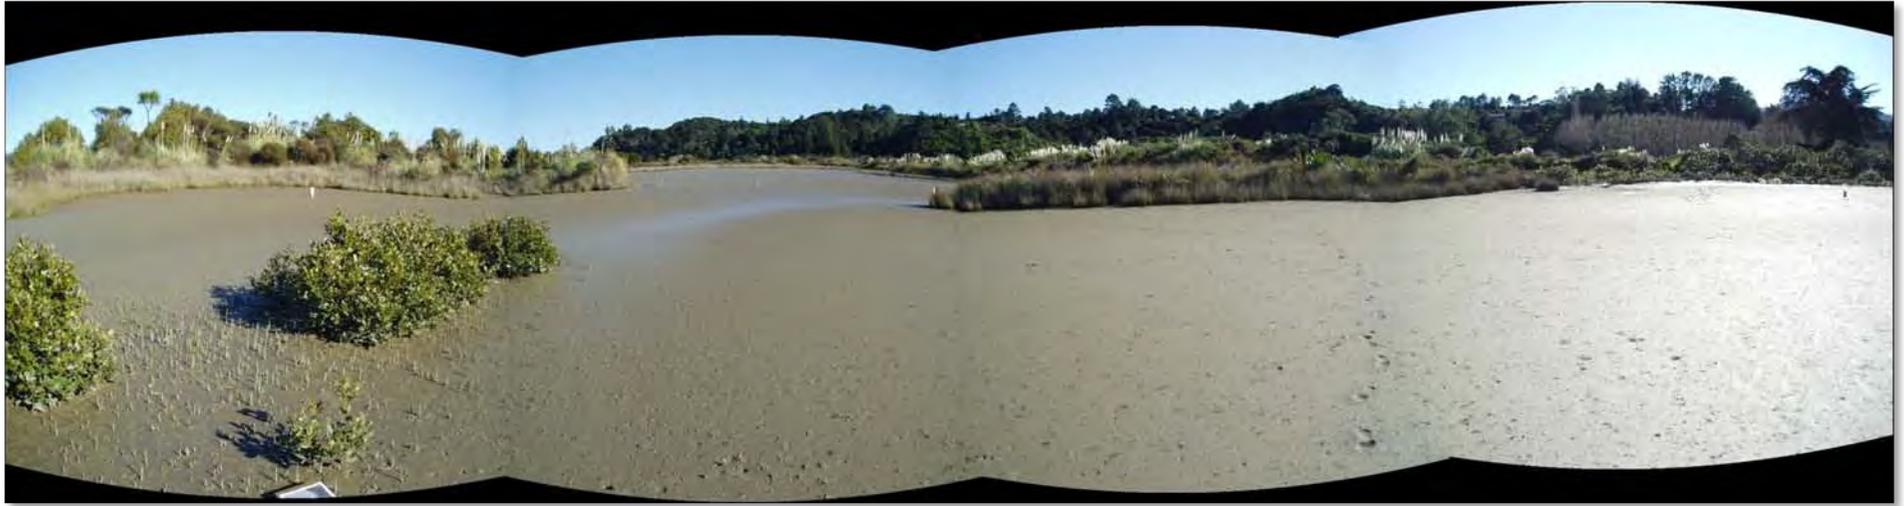
Figure 17: View over relict chenier ridges with coastal forest and wilding pine along Preece's Point as a backdrop.

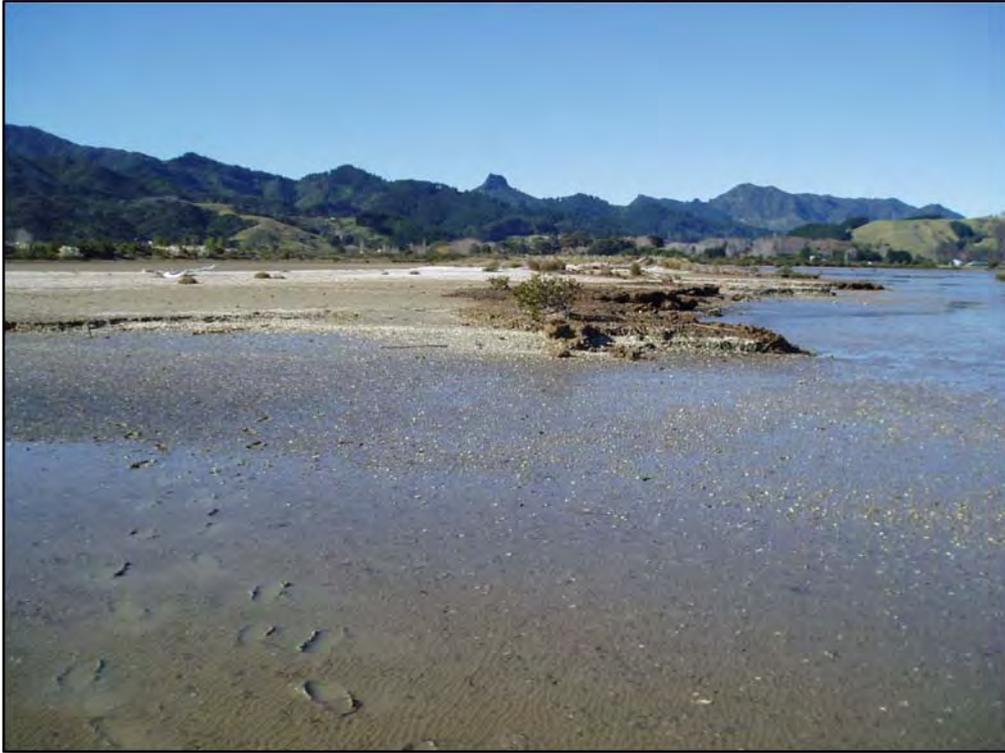
Figure 18: An eroding outer chenier edge. Mangroves and sea rush are eroding out of the front of the chenier as it moves landward.

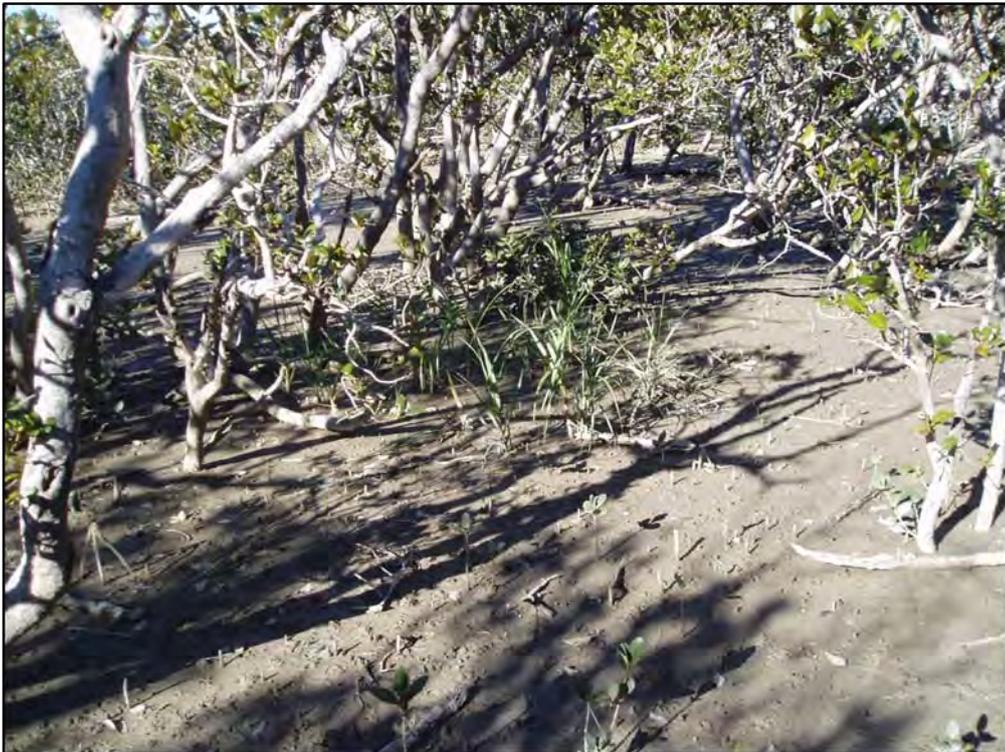
Figure 19: Spartina growing under tall mangroves along the lower bank of the stream channel immediately south of Preece's Point.

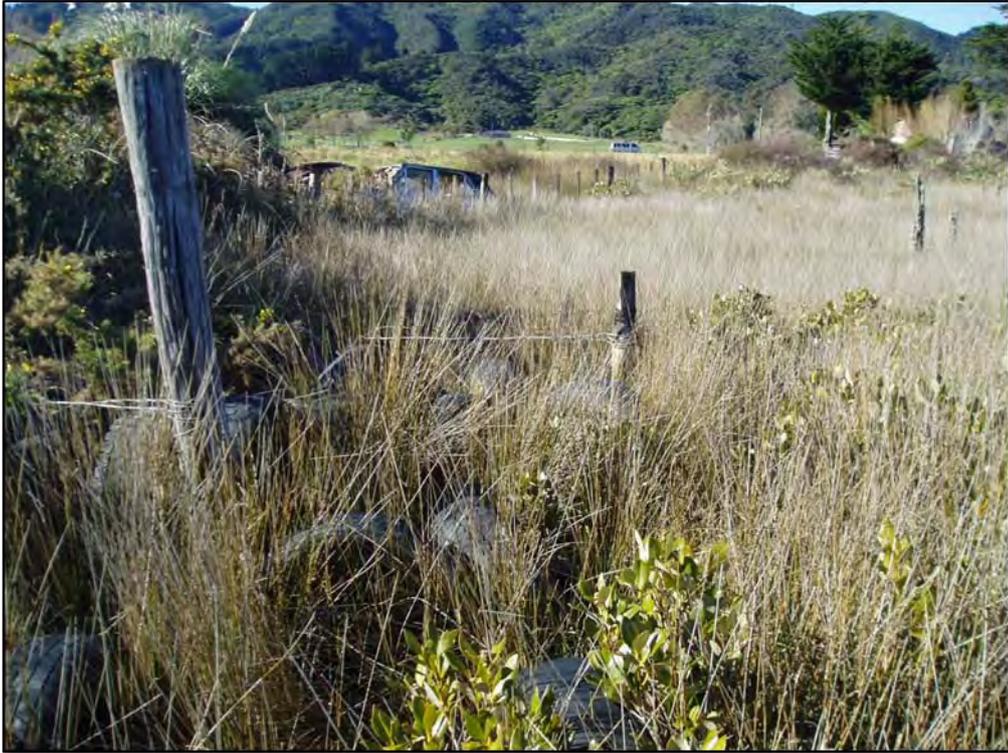
Figure 20: Dumped cars and tyres along the harbour edge.

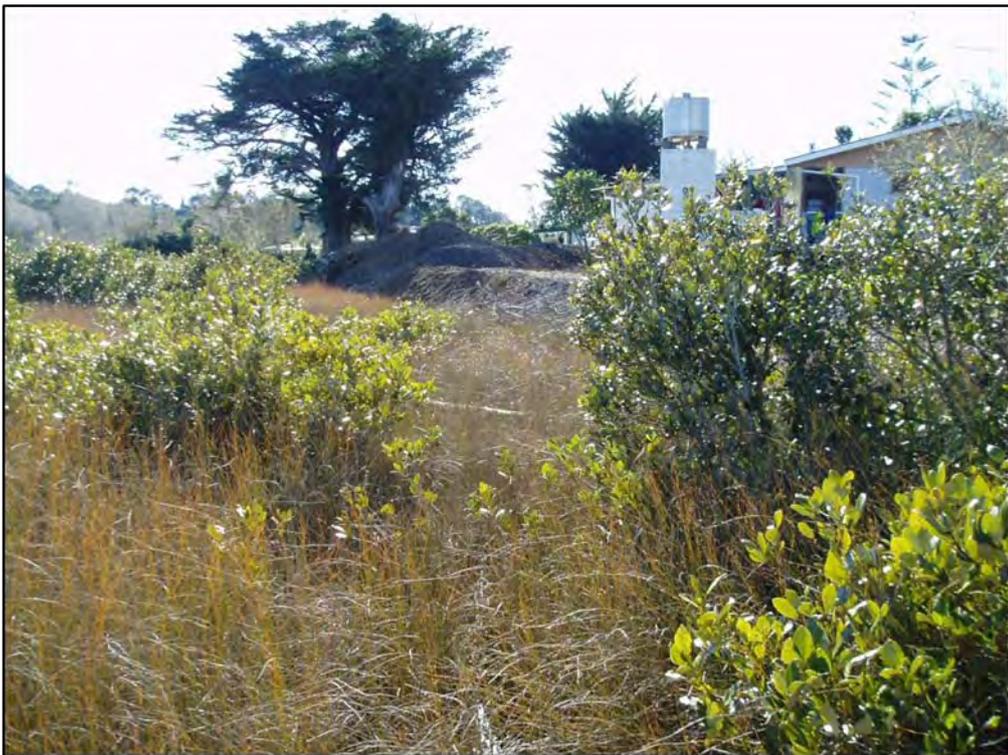
Figure 21: Fill being placed along the coastal edge into oioi and mangroves.

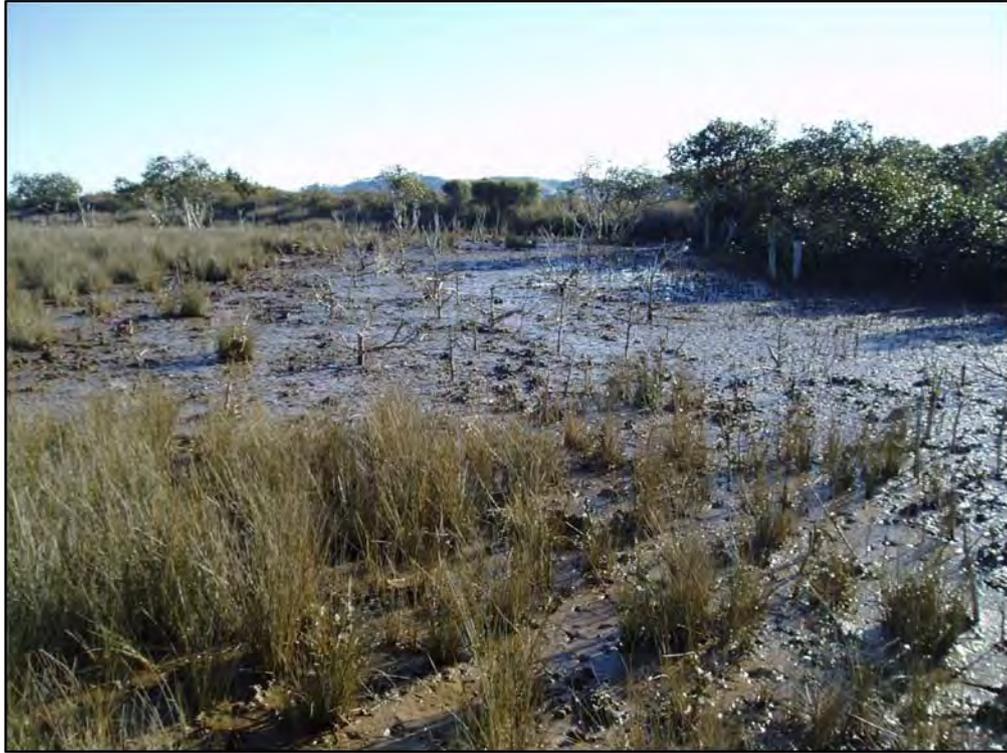
Figure 22: Mangroves have been selectively grazed out here and the ground deeply pugged.

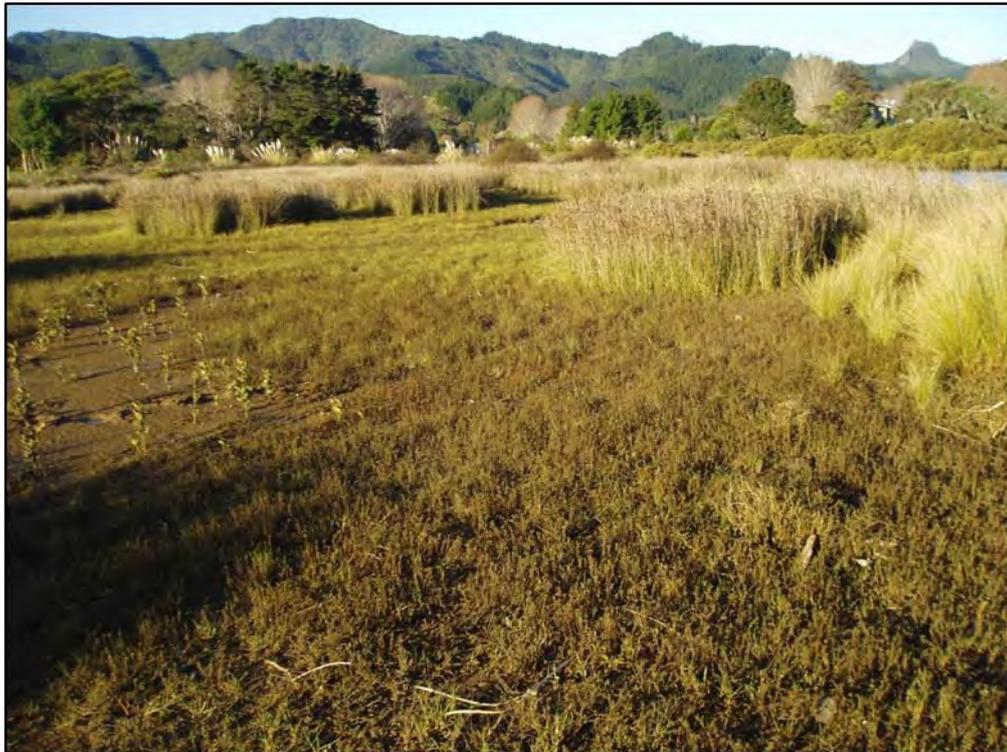
Figure 23: Saltwater paspalum (light green) invading sea primrose (bronze low vegetation). Sea rush, coast spear grass and glasswort are also present at the mouth of the Waiiau River.

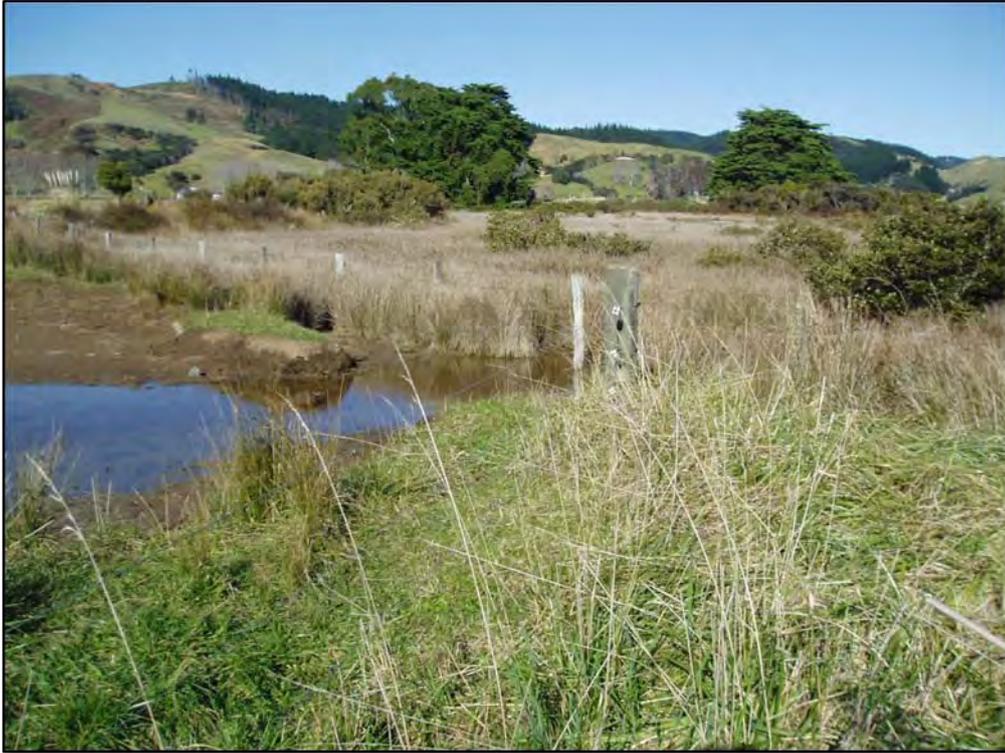
South of the Waiau River much of the relict chenier ridge complex is farmed, including the low-lying swales with sea rush and sea meadow (Figure 24). The land edge is often eroded where it is not buffered by mangroves or a chenier. There are active cheniers offshore with large seagrass beds generally seaward, and mangroves landward within their shelter (Figure 25). Around the mouth of a stream, a dense mangal has established. Sign of small-scale mangrove clearance is evident along the inner northern edge. Along the southern bank of the stream mouth, tall fescue grades into knobby clubbrush, sea rush and oioi, which grades into sea meadow. The lower tidal limit of the sea meadow is invaded by saltwater paspalum, which in turn grades into mangroves (Figure 26). Nearby is a patch of dead mangroves with no obvious reason for their death (Figure 27). Spartina is also intermingled with the mangroves and sea meadow here. A patch of grass/sedge was found at the mouth of a small stream south of Figure 27. This could be the invasive *Carex divisa*, but without a seed head it was hard to identify.

Figure 24: The remnant chenier complex near the Coromandel airfield is partially being farmed. This photo shows the effect of grazing on the estuarine vegetation.

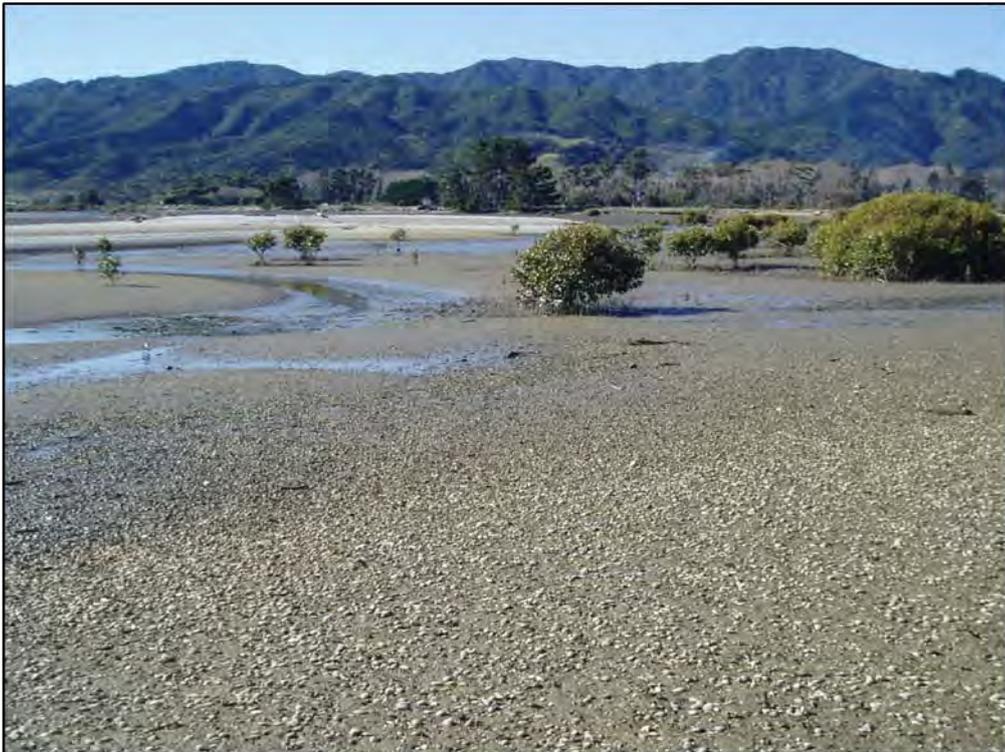
Figure 25: A shell chenier moving onshore over mud flats. Mangroves have established along the mainland edge sheltered by the chenier.

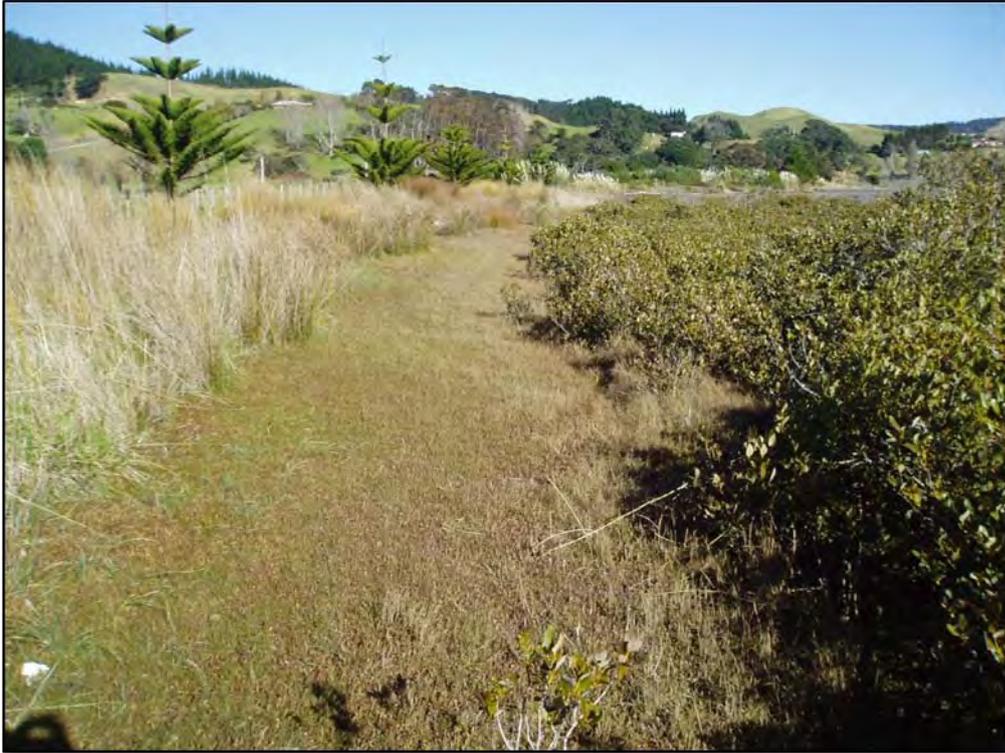
Figure 26: This photo shows a coastal sequence from mangroves to saltwater paspalum, which then intermingles with sea meadow (remuremu, sea primrose and arrow grass, then sea rush, oioi and knobby rush, with tall fescue on the higher ground.

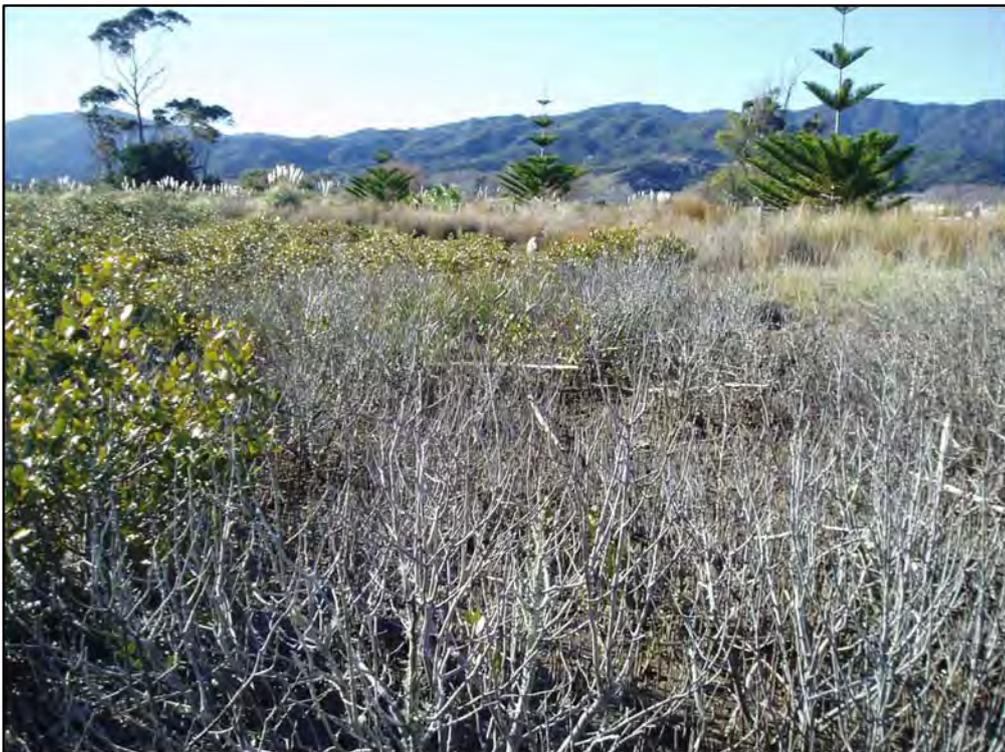
Figure 27: Spartina is present between the patch of dead mangroves and live mangroves and extends inland into sea meadow.

6. Encourage landowners to protect and restore pockets of historic coastal wetland and floodplain forest.
7. Identify the sedge found south of Figure 27 (Coromandel Harbour) and in Figure 36 (Te Kouma Harbour) to determine whether it is the highly invasive *Carex divisa*.
