Estuarine vegetation survey : Coromandel and Te Kouma Harbours

Prepared by:
Meg Graeme M.Sc (Marine Science)
Natural Solutions – Marine and Terrestrial Ecologists Ltd

June 2009

Natural Solutions Contract Report 09/088

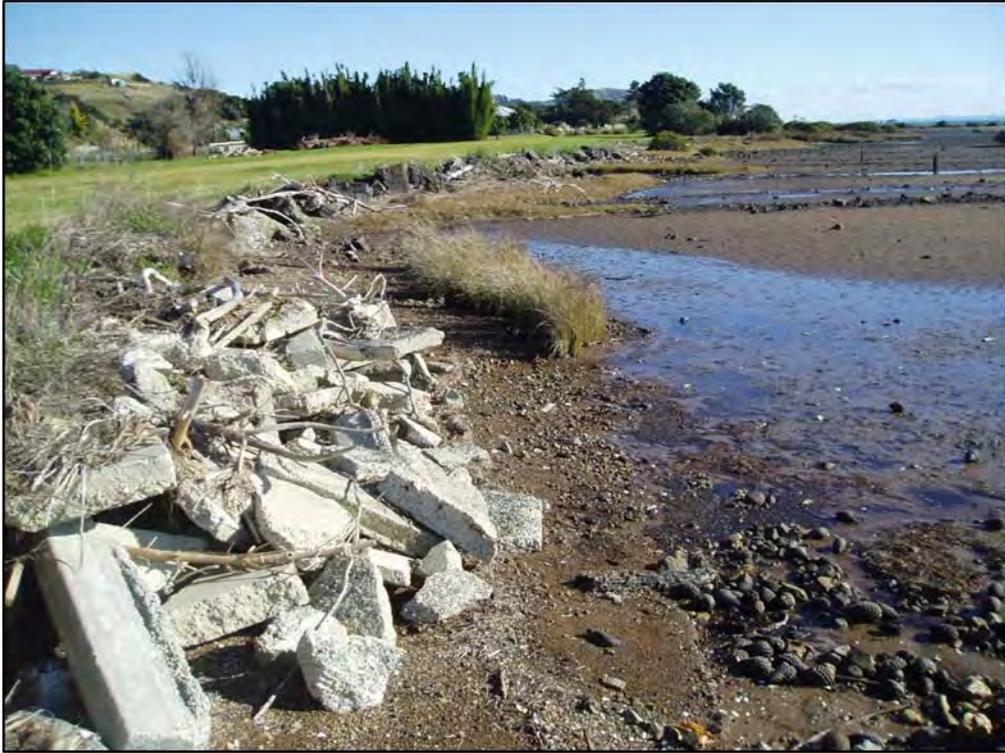
Further south a narrow stretch of land lies between the state highway and the coastal edge. There are only a few mangroves here and the coastal edge is subsequently open to erosion. Concrete rubble has been placed along this eroded edge (Figure 28). A high mound of sediment with decaying root masses is still present where a large spartina patch was sprayed. Mangroves are more prevalent around the mouth of the **Awakanae Stream**. The oyster farm base is sited on the TLB of the stream. Activity and storage of equipment directly on the coastal edge has resulted in the loss of the saltmarsh ribbonwood zone (Figure 29).

Figure 28: Concrete rubble has been dumped along this section of eroding coastal edge where mangroves are not present to buffer the wave energy. Note the old fence line and gravel ridges.

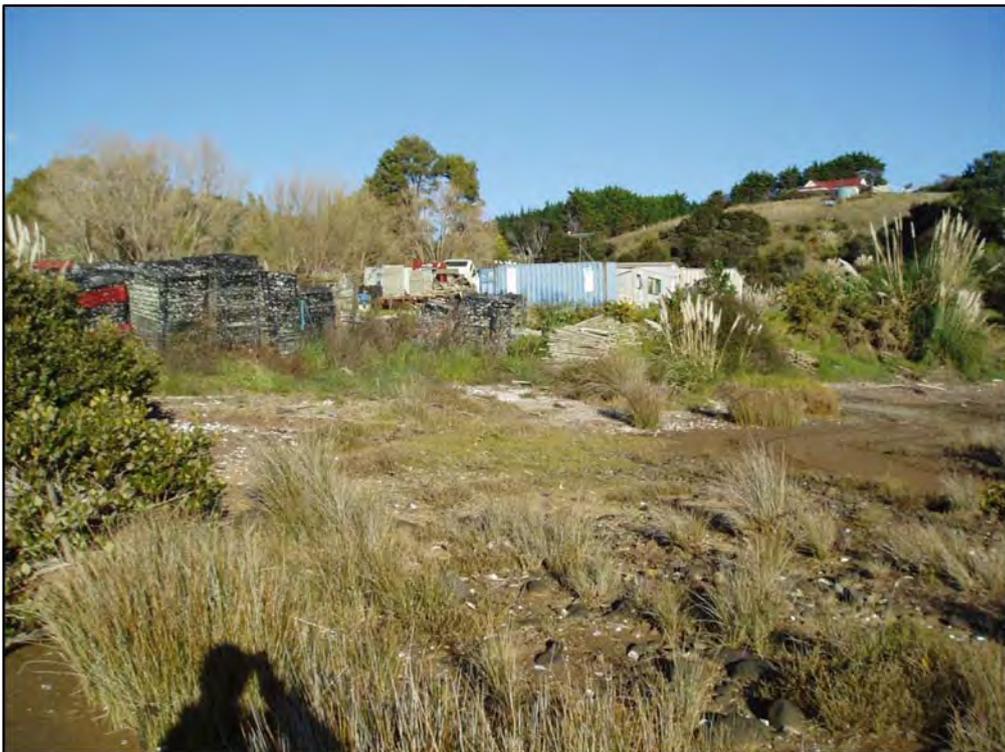
Figure 29: Activity here is associated with oyster farming. Note the inappropriately placed equipment right on the foreshore over the saltmarsh ribbonwood zone.

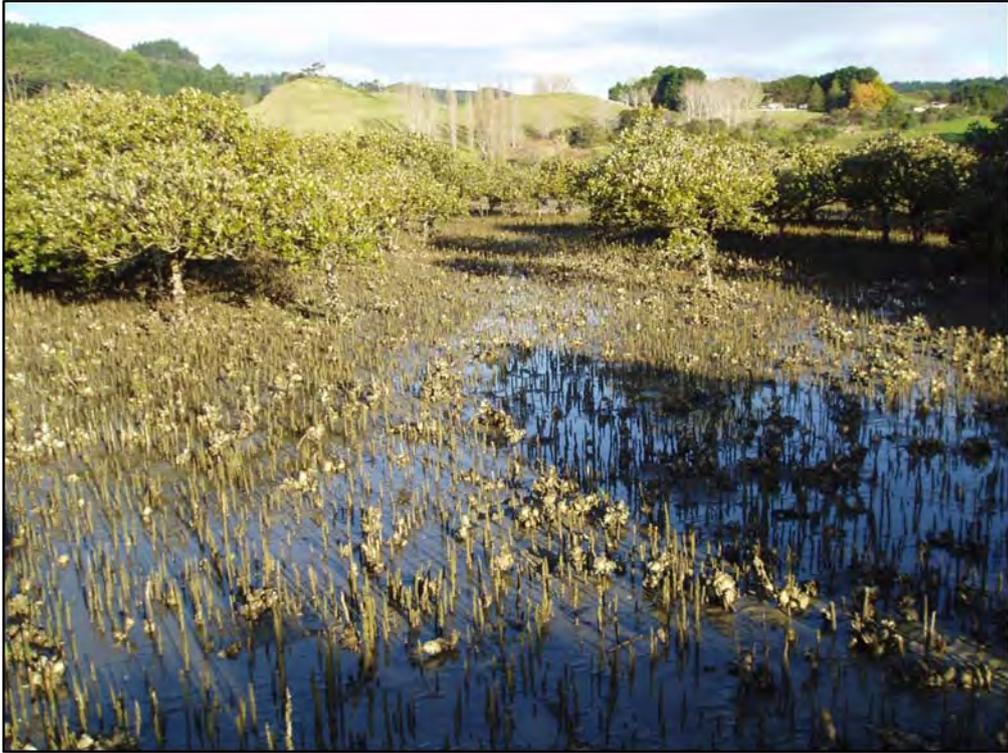
Figure 30: Pacific oysters amongst mangrove pneumatophores (breathing roots).

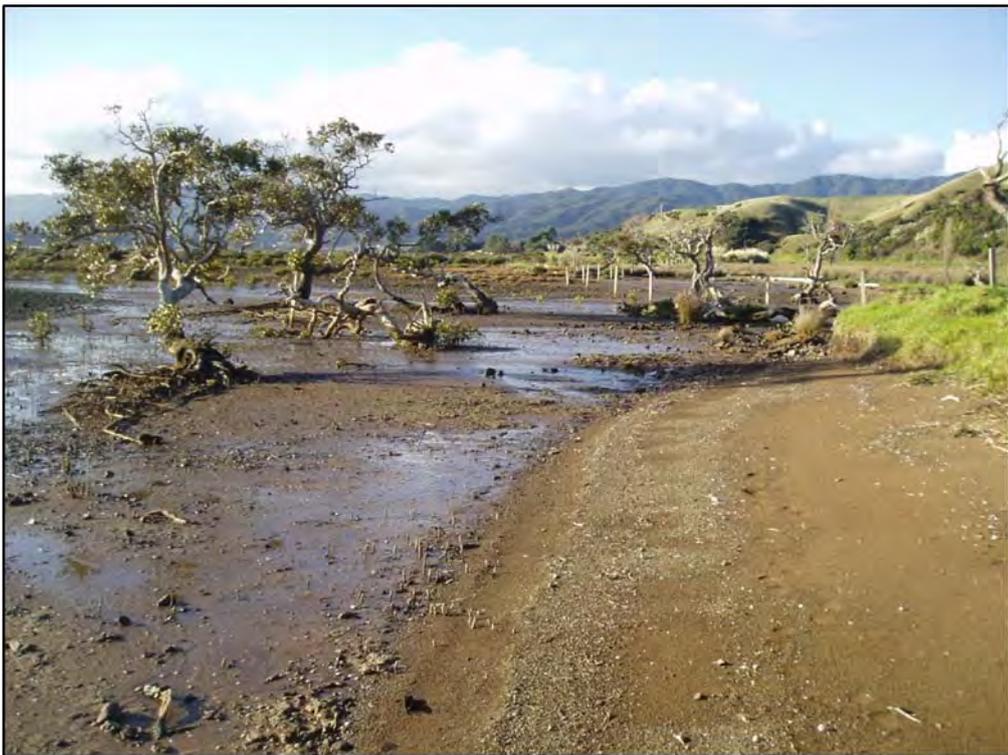
Figure 31: Old mangroves with eroded bases probably due to a combination of chenier landward movement and wave erosion.

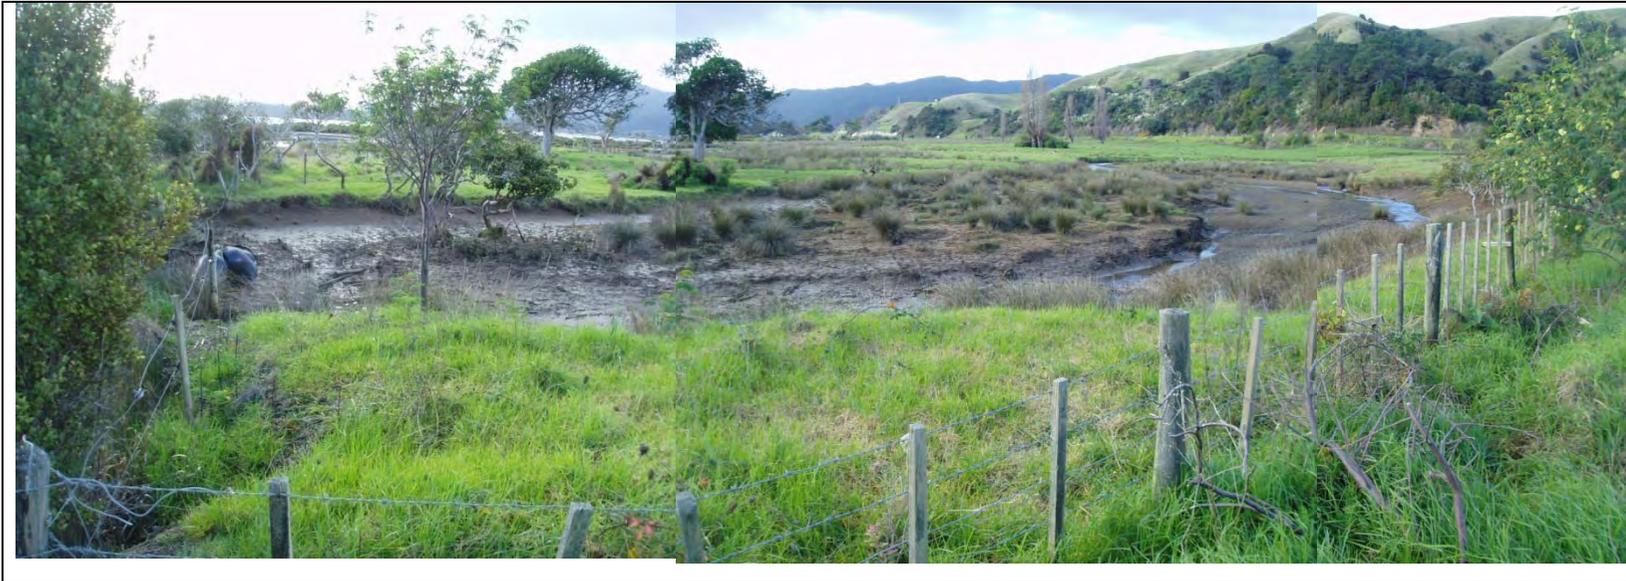
Figure 32: Grazing within the CMA beside the Te Kouma Road turnoff.

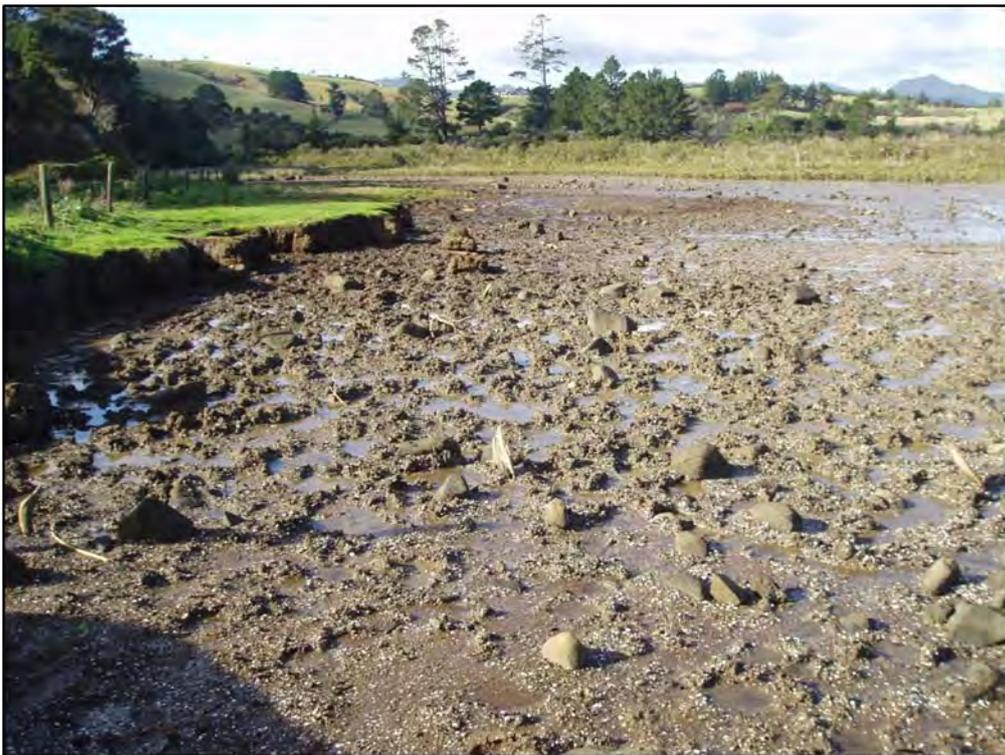
A boulder bank and pa site marks the northern entrance to the harbour (Figure 34). Only the occasional small mangrove occurs along the rocky northern outer bays. A family of seven bottlenosed dolphins (with a young animal) were encountered out here. No other estuarine vegetation was noted until the main mangal at the head of the harbour. Farm fencing needs addressing here as stock have free access to the CMA. Figure 35 shows an area of CMA which is pugged and grazed by stock.

Figure 35: Uncontrolled stock access to the CMA has resulted in pugging, vegetation disturbance and bank erosion along the northern side of the harbour.

14. Work with the landowner/s to protect and restore the degraded northern coastal edge.

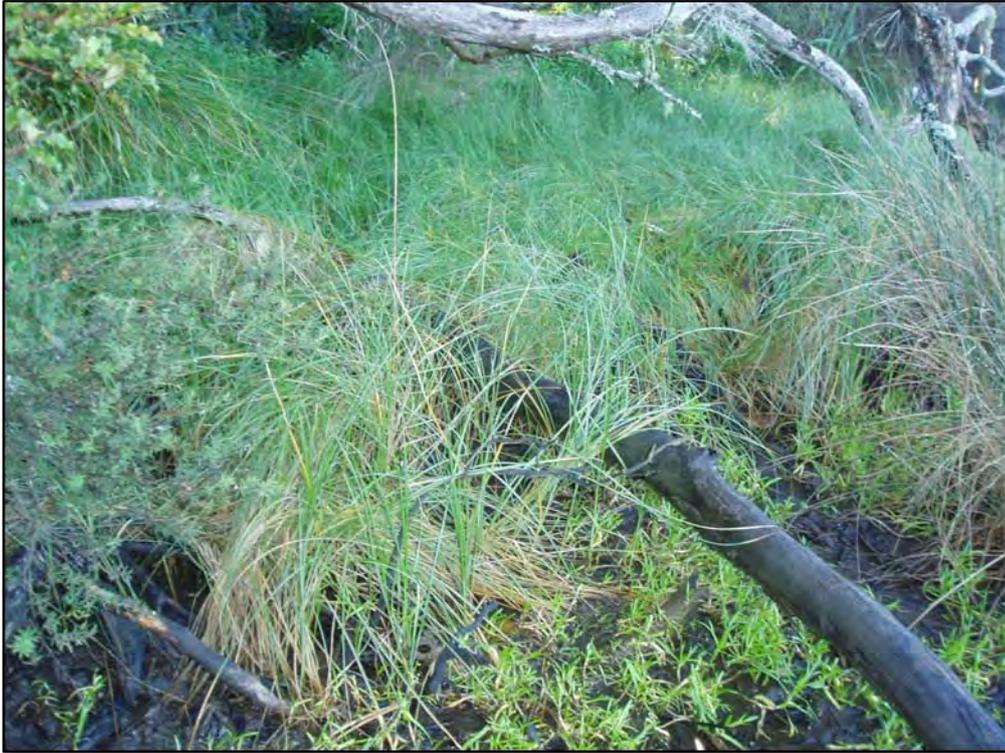
Figure 36: The invasive *Carex divisa*? along the salt-freshwater interface (note the yellow-green bachelors button in the foreground).

6. Encourage landowners to protect and restore pockets of historic coastal wetland and floodplain forest.
7. Identify the sedge found south of Figure 27 (Coromandel Harbour) and in Figure 36 (Te Kouma Harbour) to determine whether it is the highly invasive *Carex divisa*.

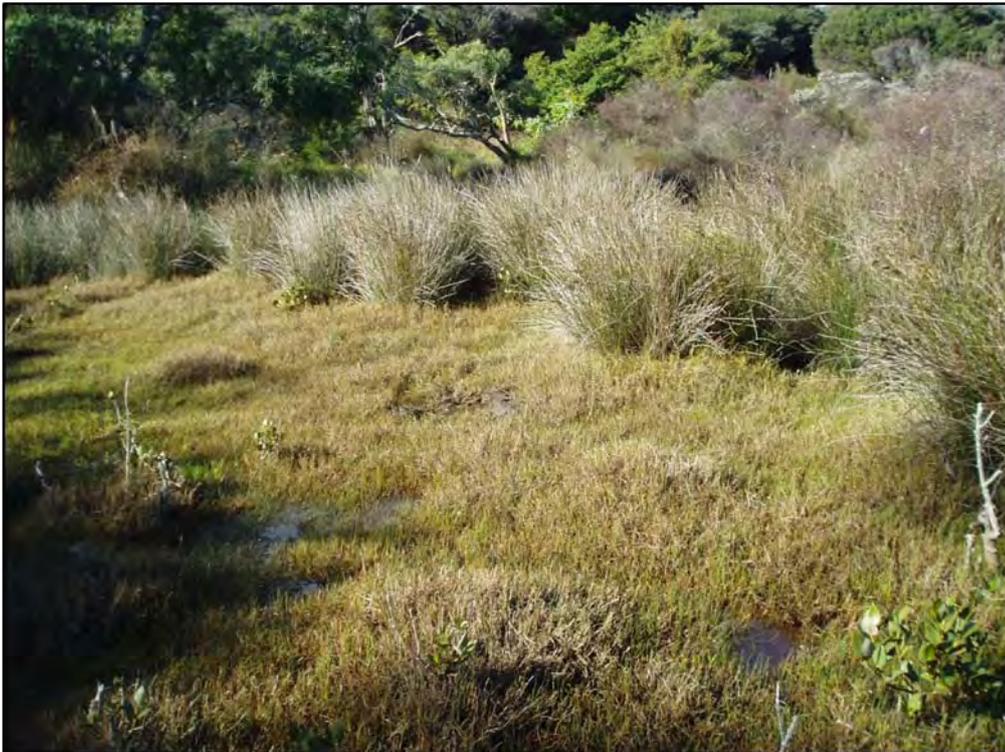
Figure 37: Frosted saltwater paspalum intermixed with sea meadow is backed by sea rush and then saltmarsh ribbonwood before grading into regenerating coastal forest.

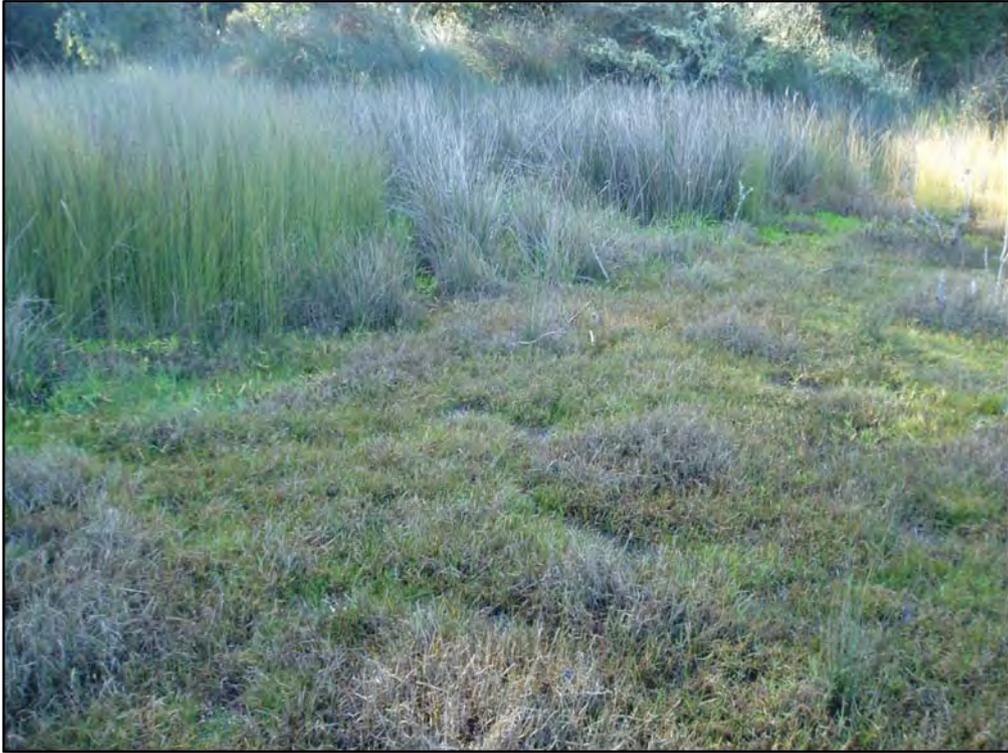
Sea meadow occurs along the land edge and either side of the stream channel draining the northern end of the wetland (Figure 38). The sea meadow and mangroves grade into some sea rush, a few bushes of saltmarsh ribbonwood and then freshwater wetland and a patch of coastal forest. Figure 36 shows a sedge (the invasive *Carex divisa*?) at the freshwater boundary with the estuary. Saltwater paspalum is present amongst the sea meadow and under mangroves (Figure 37). It appears the saltwater paspalum out in the open has been frosted, with the majority of the plants looking dead, although the sea meadow species seem to have been unaffected.

Figure 38: Sea meadow (sea primrose, remuremu, slender clubrush, arrow grass and bachelors button) forms a carpet backed by oioi and sea rush.

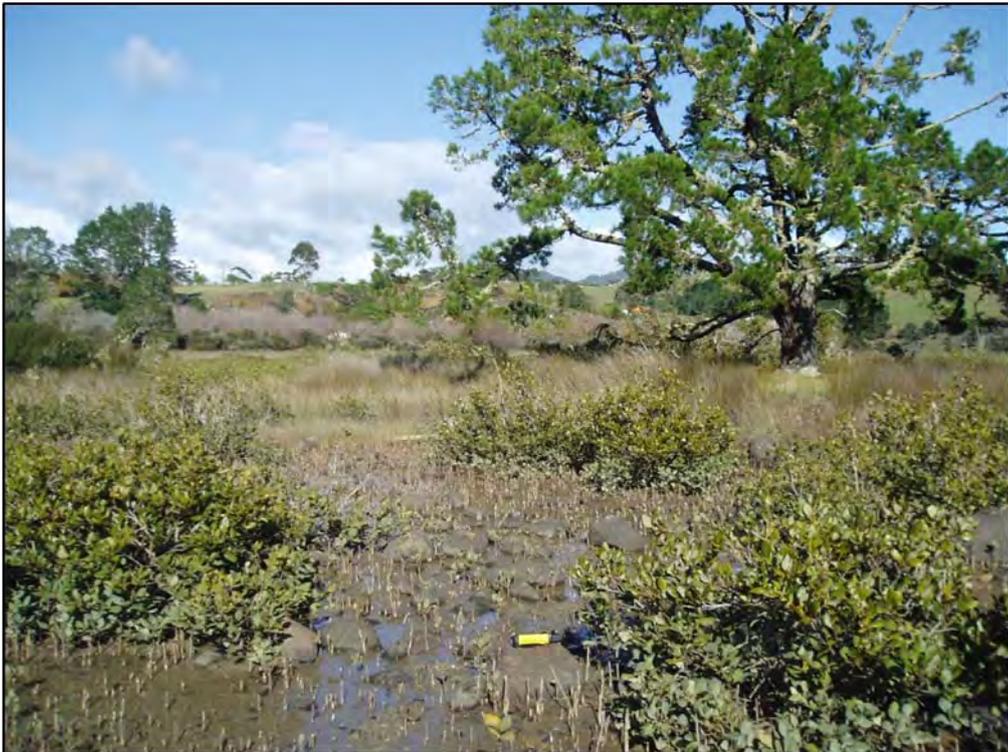
Figure 39: A lone wilding pine grows on a spit protruding into an open mangrove zone.

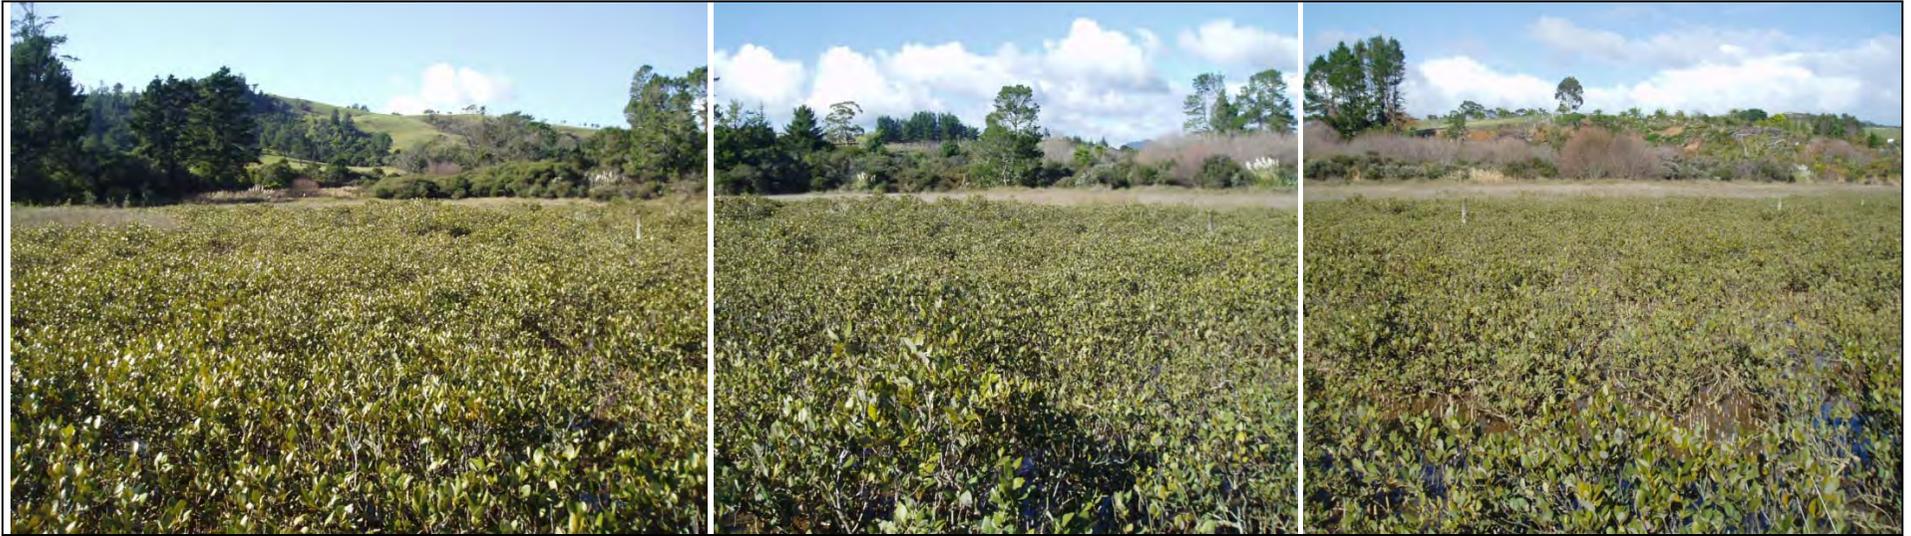
Figure 40: View over mangroves and sea rush to a raupo, manuka and willow freshwater swamp.

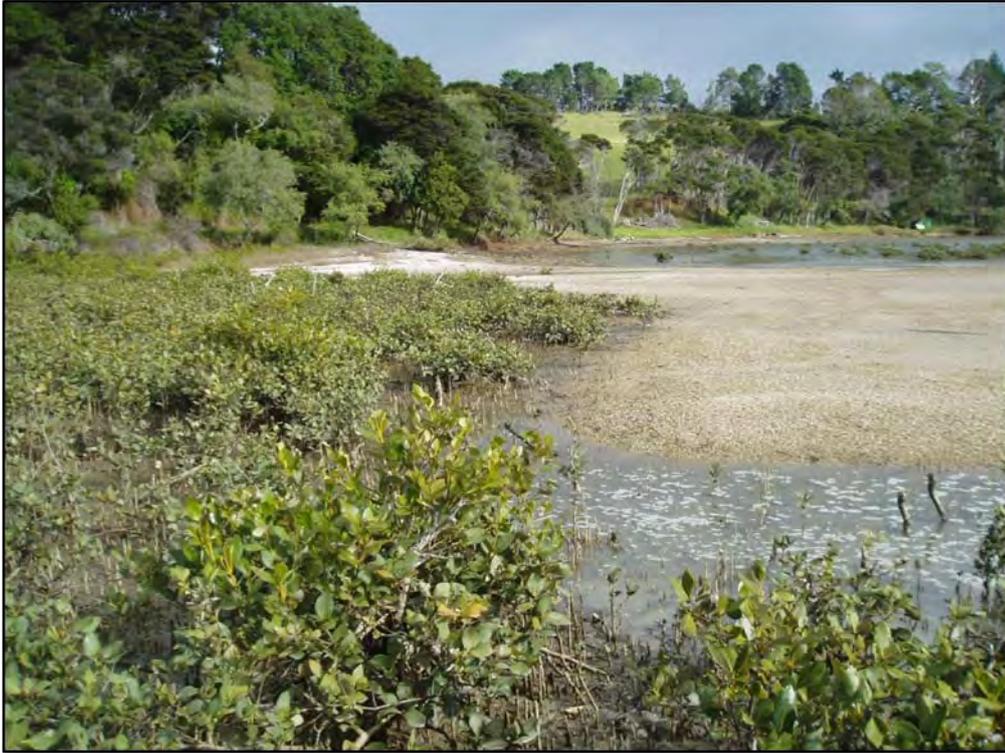
Figure 41: This shell chenier ridge provides shelter for mangroves to establish in its lee. Banded rail footprints were found in the mangroves here.

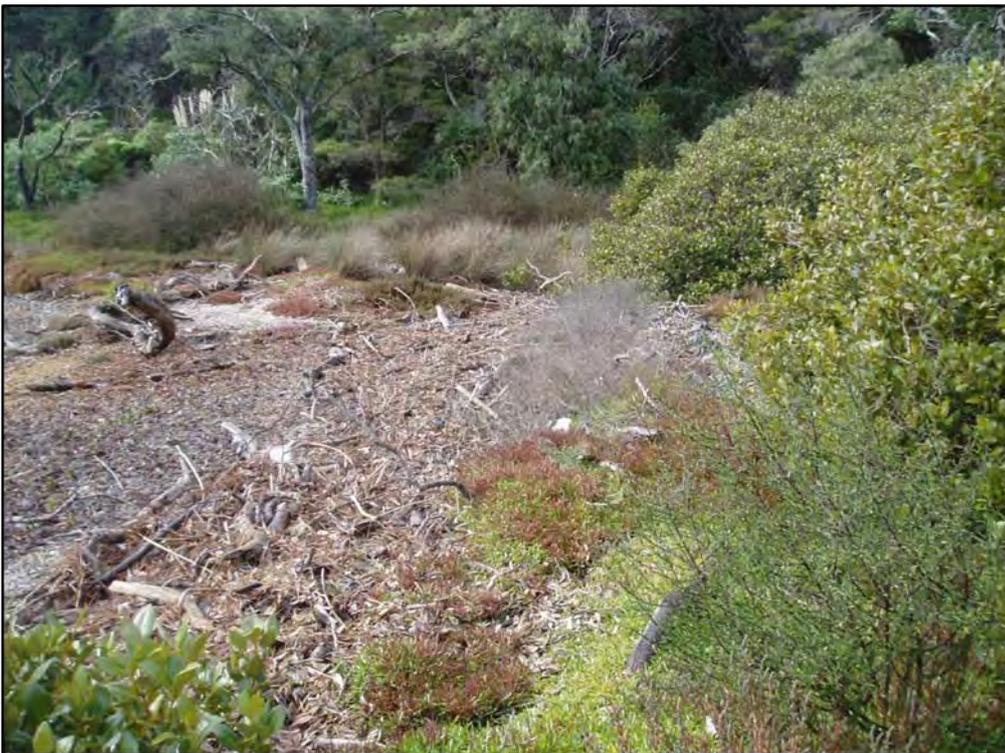
Figure 42: This shell beach collects a lot of driftwood and supports saltmarsh ribbonwood, sea rush, glasswort, remuremu and is being invaded by buffalo grass. Mangroves are found seaward and within the beach complex. The coastal forest is characterised by kowhai and pohutukawa.
