# Piako catchment ecological monitoring 2012

Prepared by:  
Paul Franklin, Brenda Bartels  
(National Institute of Water & Atmospheric Research Ltd)\_

For:  
Waikato Regional Council  
Private Bag 3038  
Waikato Mail Centre  
HAMILTON 3240

NIWA Client Report No: HAM2012-070  
Report date: June 2012  
NIWA Project: EVW12203

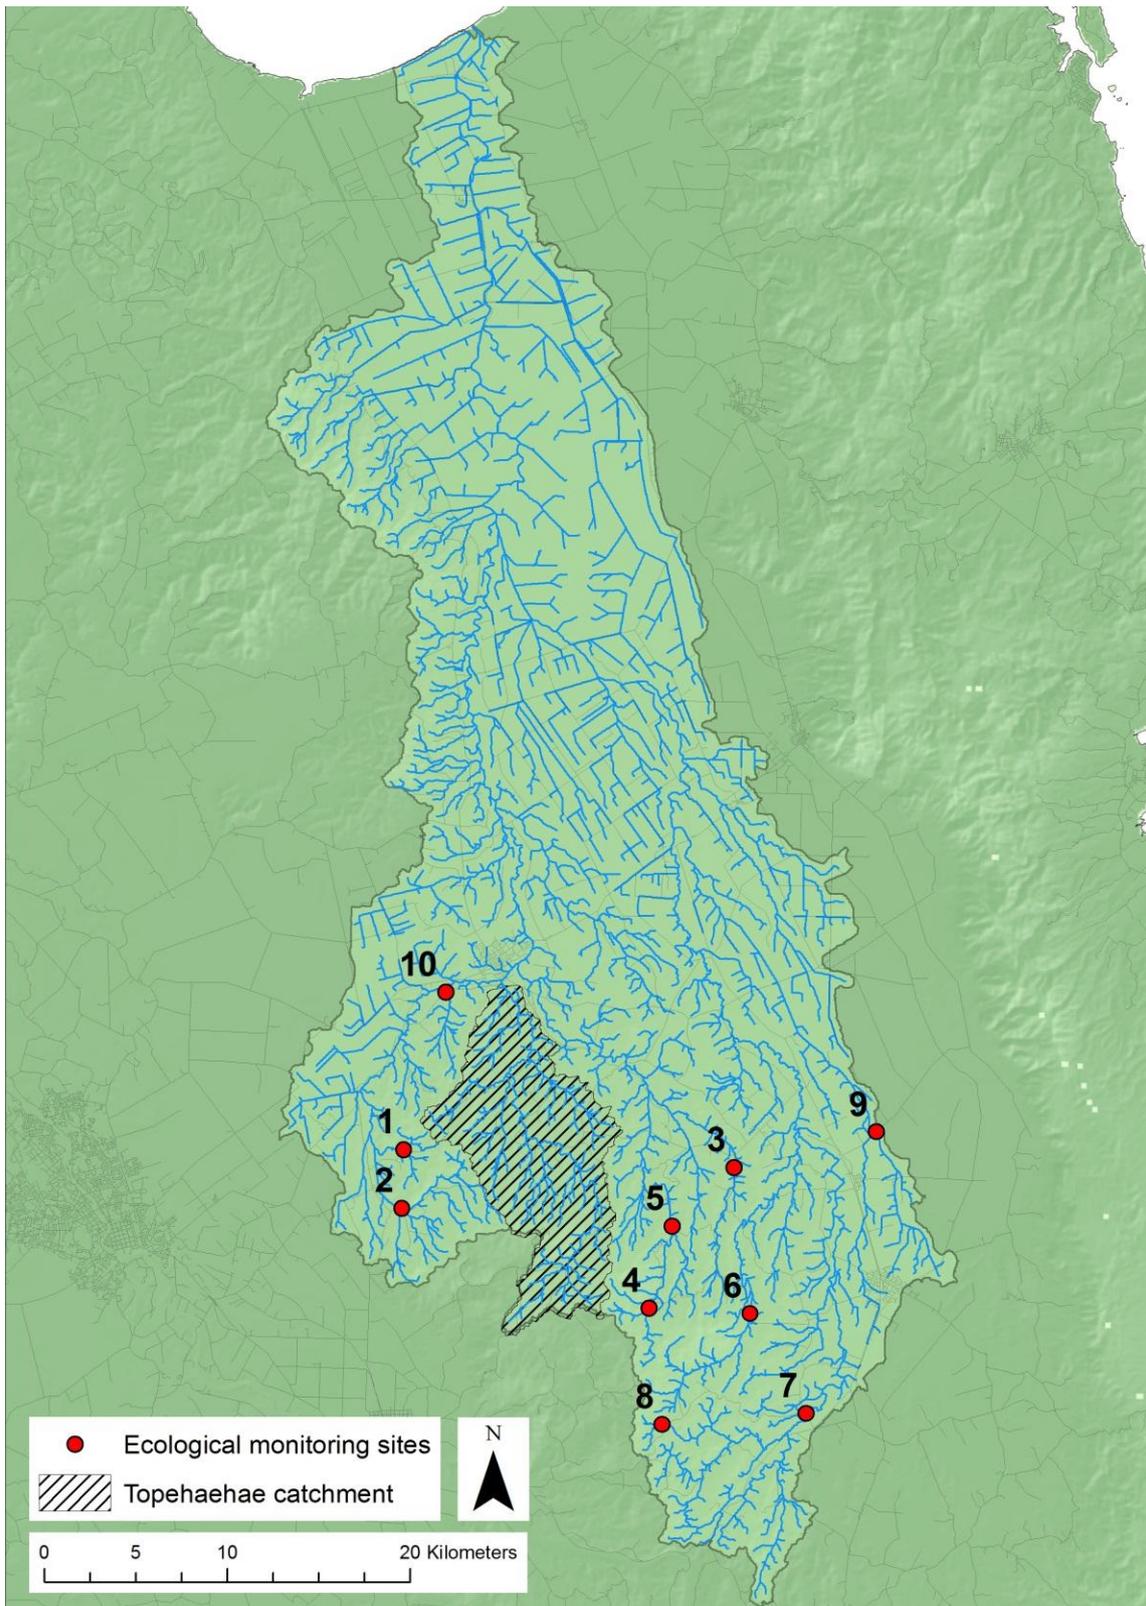
**Figure 2.1: Map the Piako catchment showing the location of the ten ecological monitoring sites.**

Ten monitoring sites were selected throughout the main sub-catchments of the upper Piako catchment on the basis of representativeness of differing habitat types (Table 2-1; Figure 2.1). The Topehaehae catchment was excluded from consideration at the request of WRC due to the known influence of the Morrinsville water supply dam. All sites were sampled between 13 and 17 February 2012.

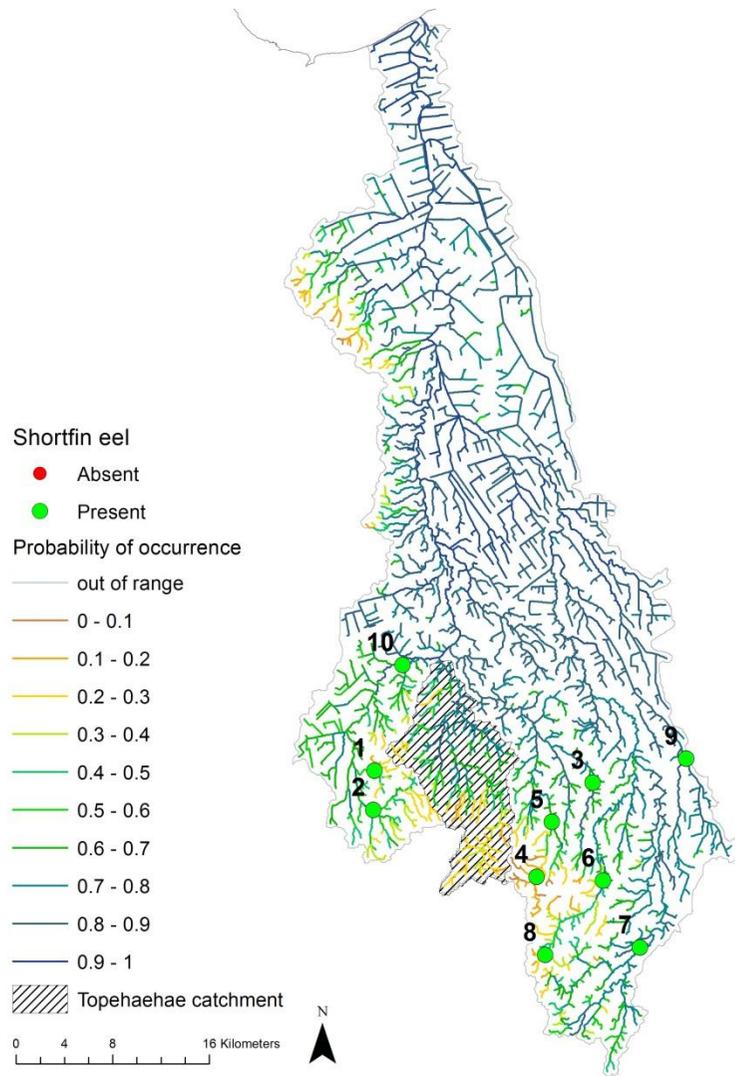
**Figure 3.2: Presence and absence of shortfin eels during this survey relative to predicted probability of capture.**

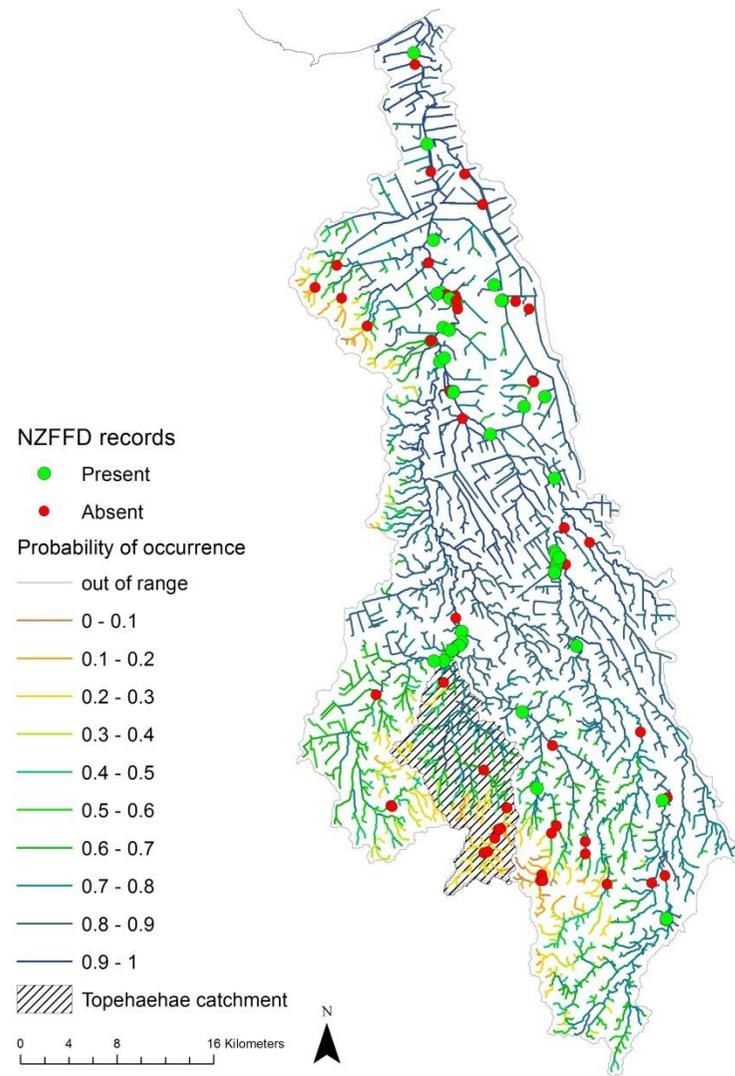
**Figure 3.3: Presence and absence of shortfin eels in the Piako catchment based on NZFFD records (Dec 2011).**

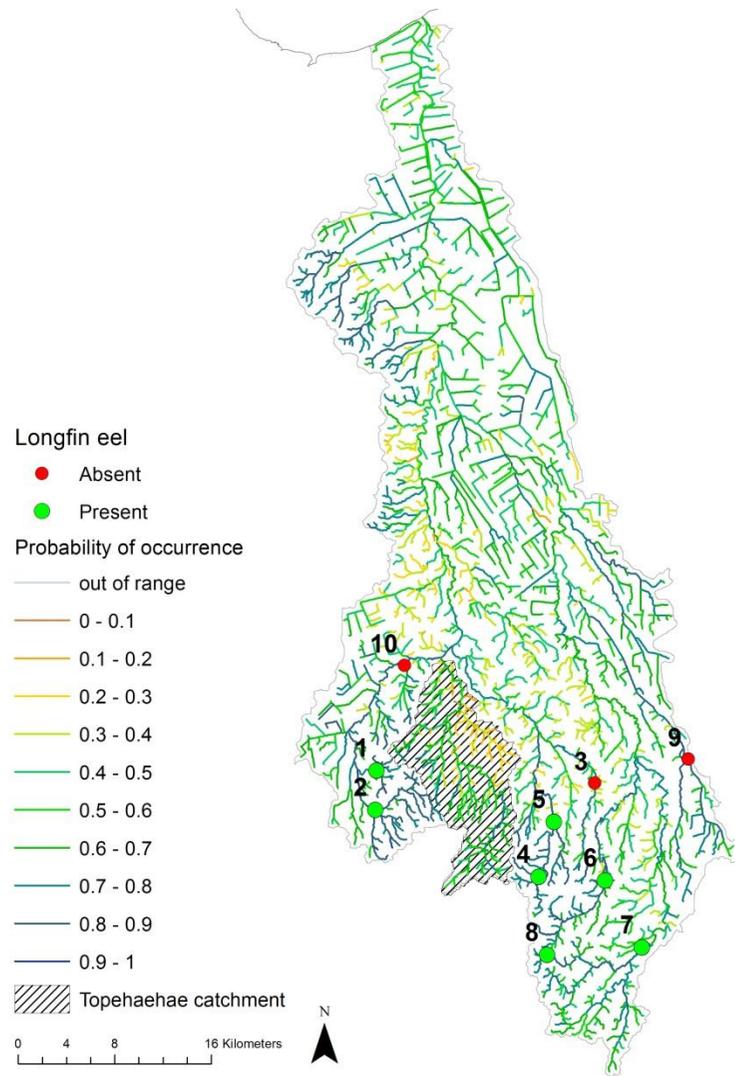
**Figure 3.4: Presence and absence of longfin eels during this survey relative to predicted probability of capture.**

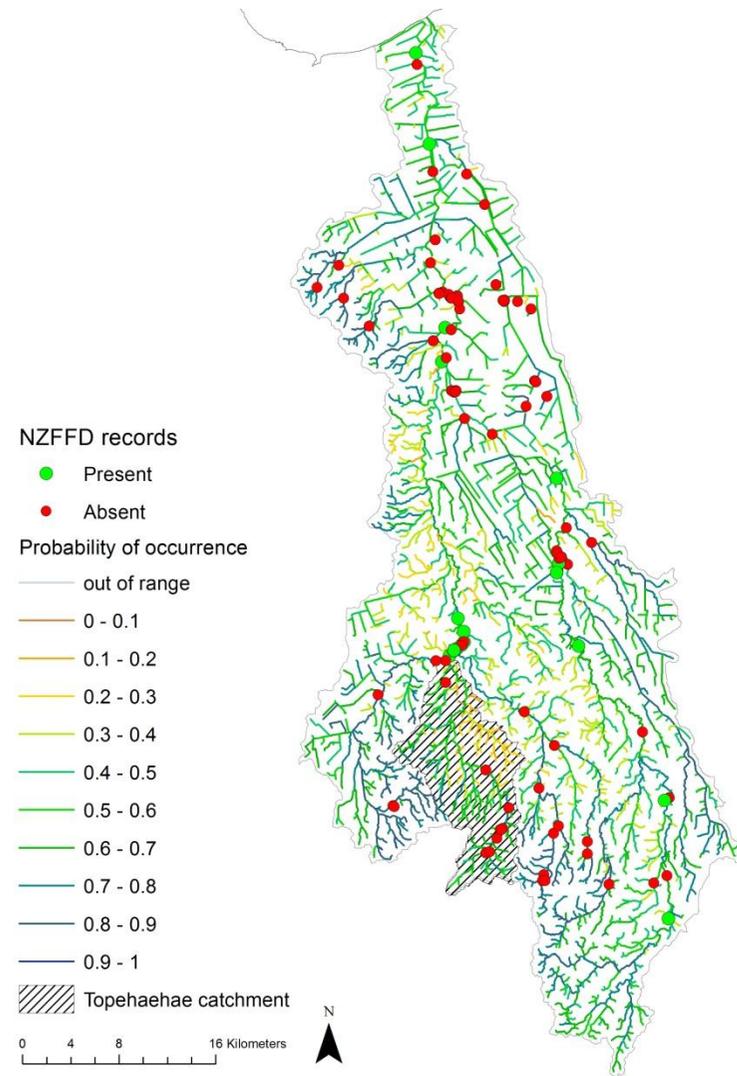
**Figure 3.5: Presence and absence of longfin eels in the Piako catchment based on NZFFD records (Dec 2011).**

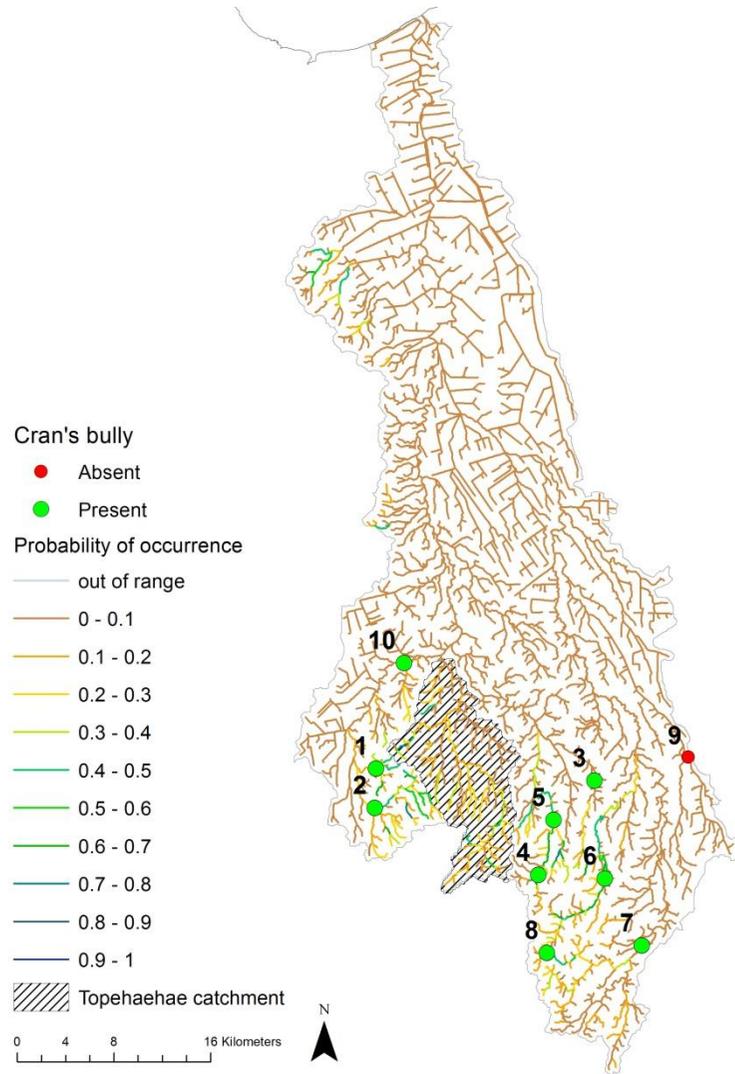
**Figure 3.6: Presence and absence of Cran's bully during this survey relative to predicted probability of capture.**

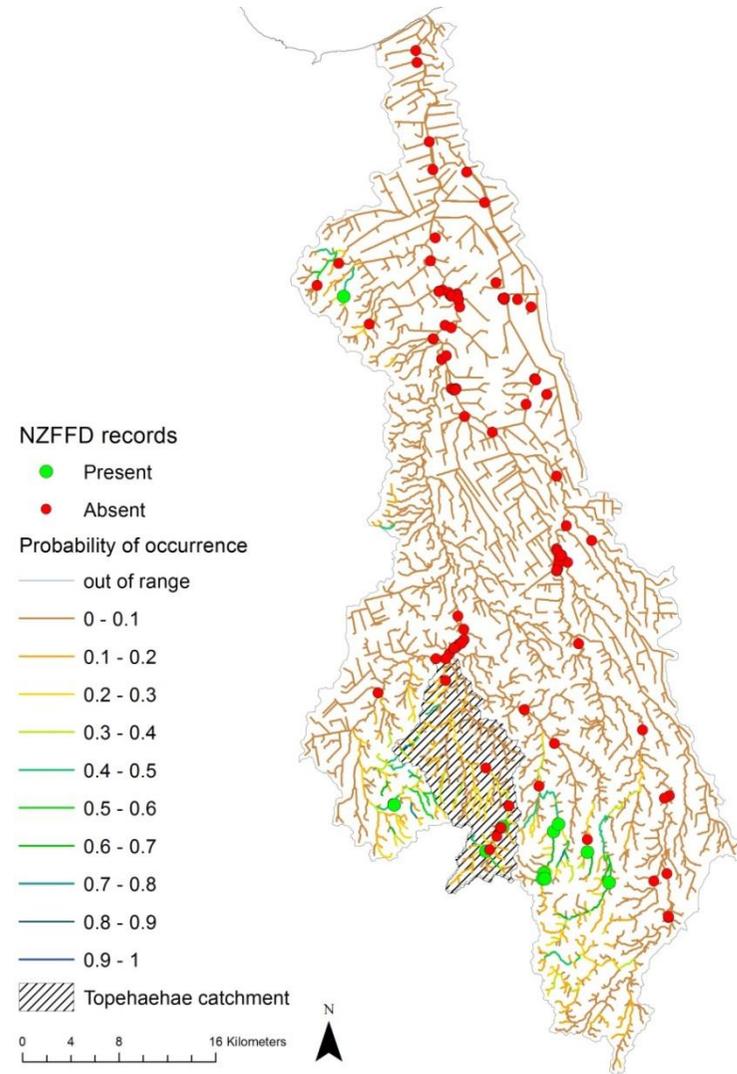
**Figure 3.7: Presence and absence of Cran's bully in the Piako catchment based on NZFFD records (Dec 2011).**

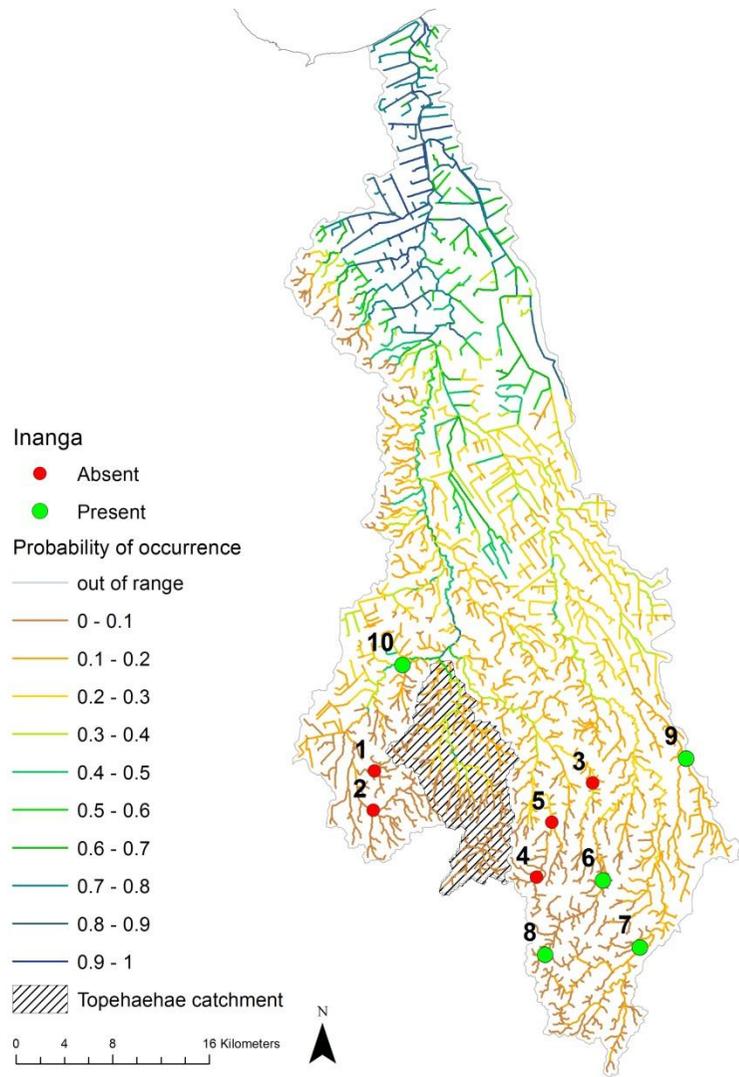
**Figure 3.8: Presence and absence of inanga during this survey relative to predicted probability of capture.**

of inanga than may have been expected (Figure 3.8; Figure 3.9). The maximum size recorded (141 mm) suggests that some of these fish are maturing at two or even three years of age, rather than the usual one, giving them greater opportunity to continue their inland migration (Figure 3-1).

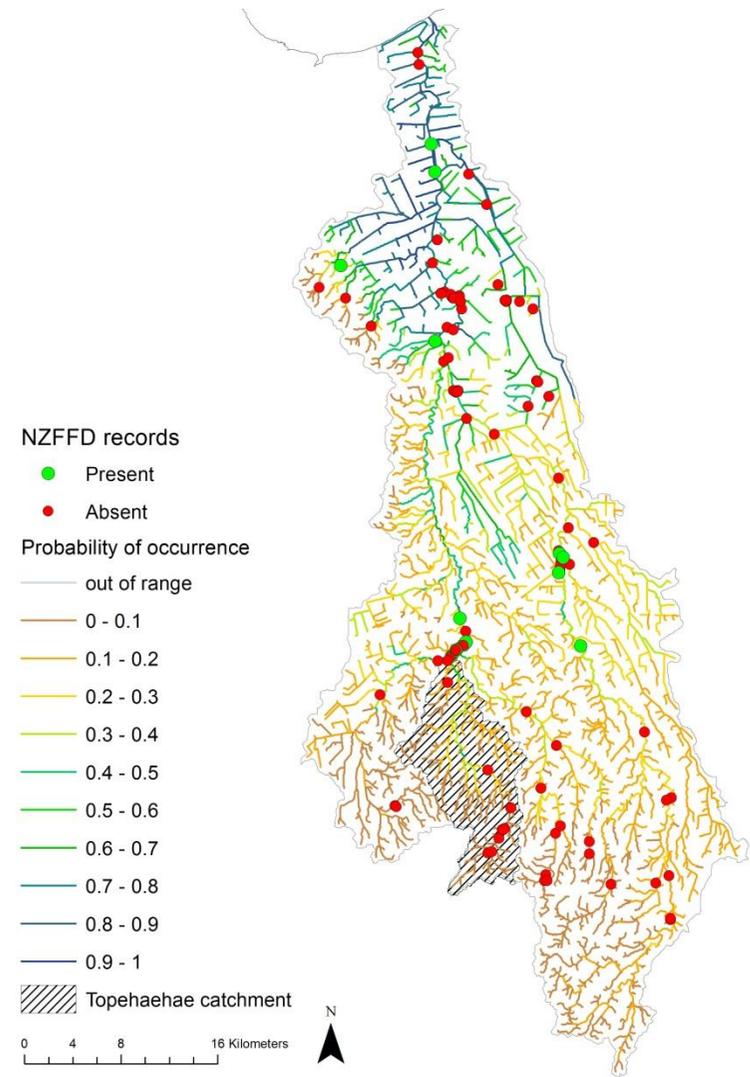
**Figure 3.9: Presence and absence of inanga in the Piako catchment based on NZFFD records (Dec 2011).**

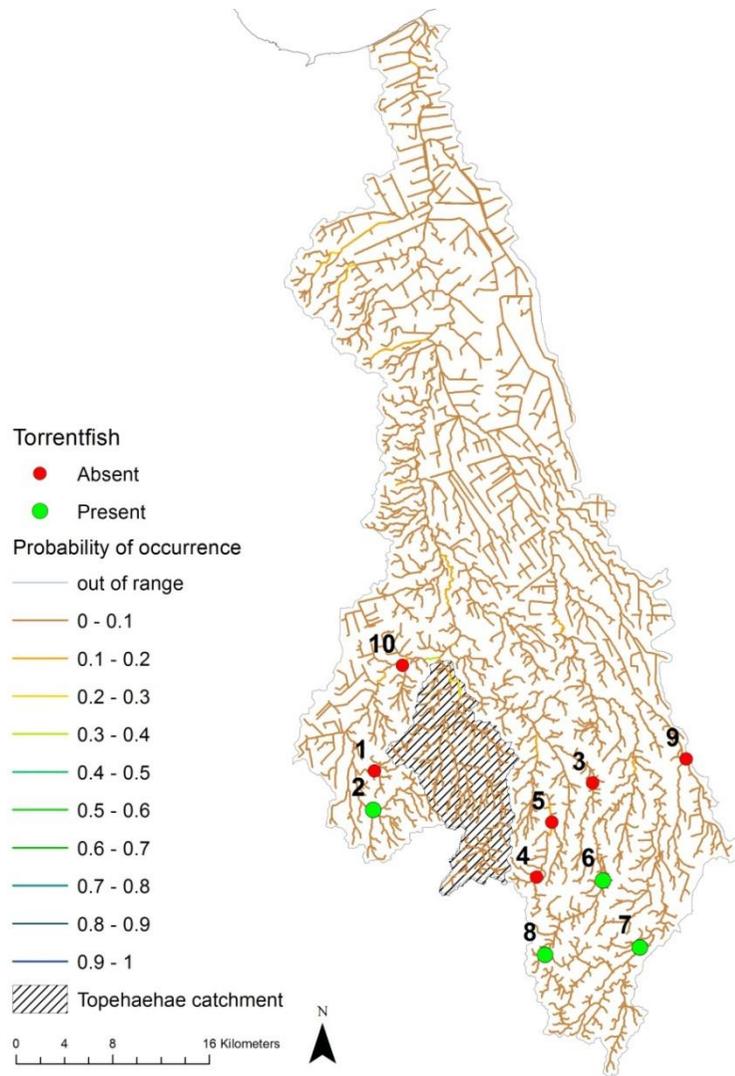
**Figure 3.10:** Presence and absence of torrentfish during this survey relative to predicted probability of capture.

The next most commonly occurring species was torrentfish (*Cheimarrichthys fosteri*), which was recorded at four sites (Table 3-1; Figure 3.10). This is also a diadromous species and its presence at these four sites further confirms the existence of good downstream connectivity. Torrentfish display a strong preference for fast flowing water in riffles over gravel and cobble. This habitat preference can make them susceptible to the effects of low flows, but also explains the relatively low abundance and low predicted probability of capture (Figure 3.10). There were previously very few records of torrentfish in the Piako catchment (Figure 3.11), particularly this far inland, making this an important finding. The torrentfish captured ranged in size from 25 mm (Site 7) to 136 mm (Site 8), with the average length being approximately 85 mm.

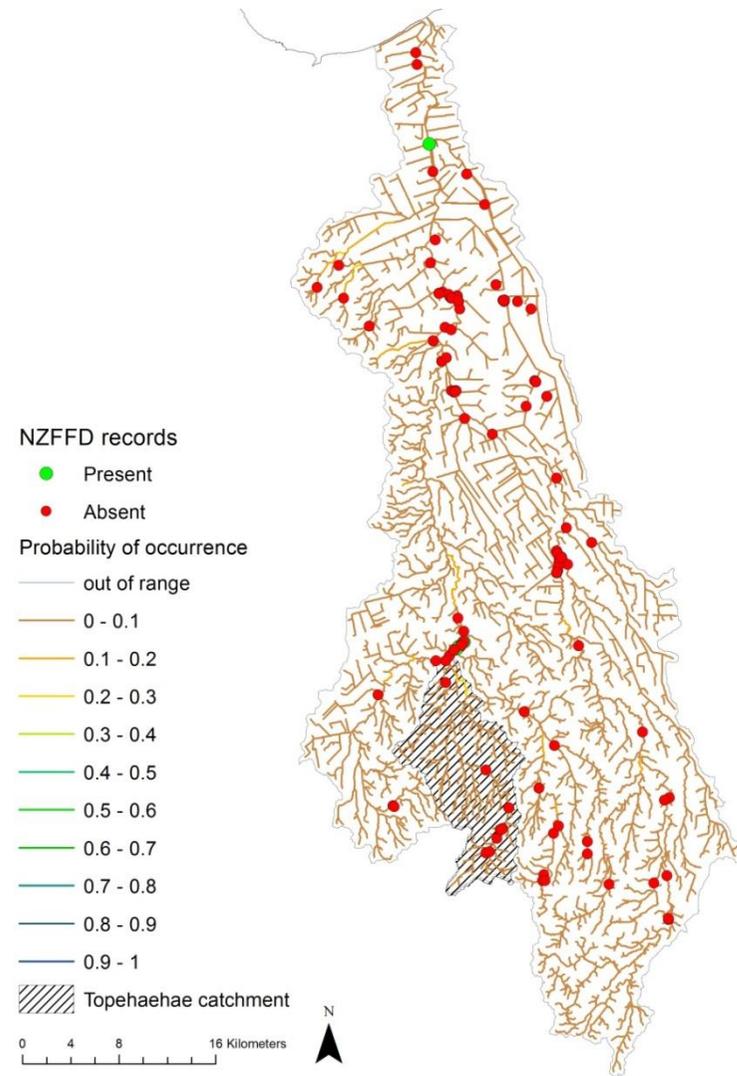
**Figure 3.11:** Presence and absence of torrentfish in the Piako catchment based on NZFFD records (Dec 2011).

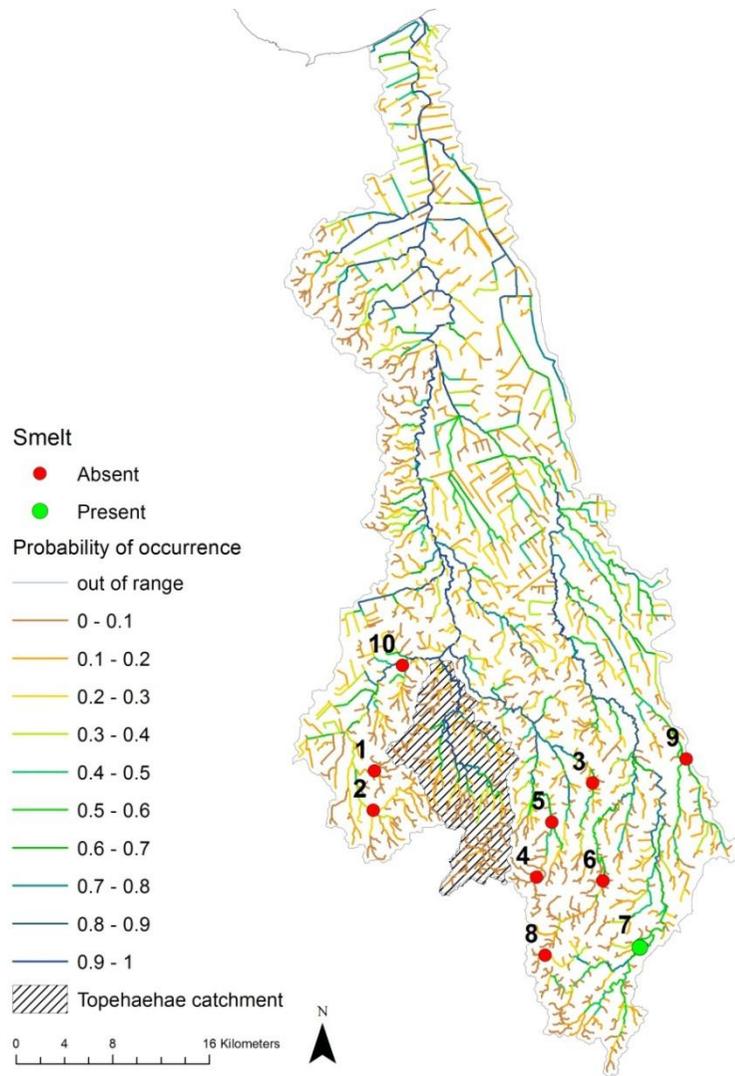
**Figure 3.12: Presence and absence of smelt during this survey relative to predicted probability of capture.**

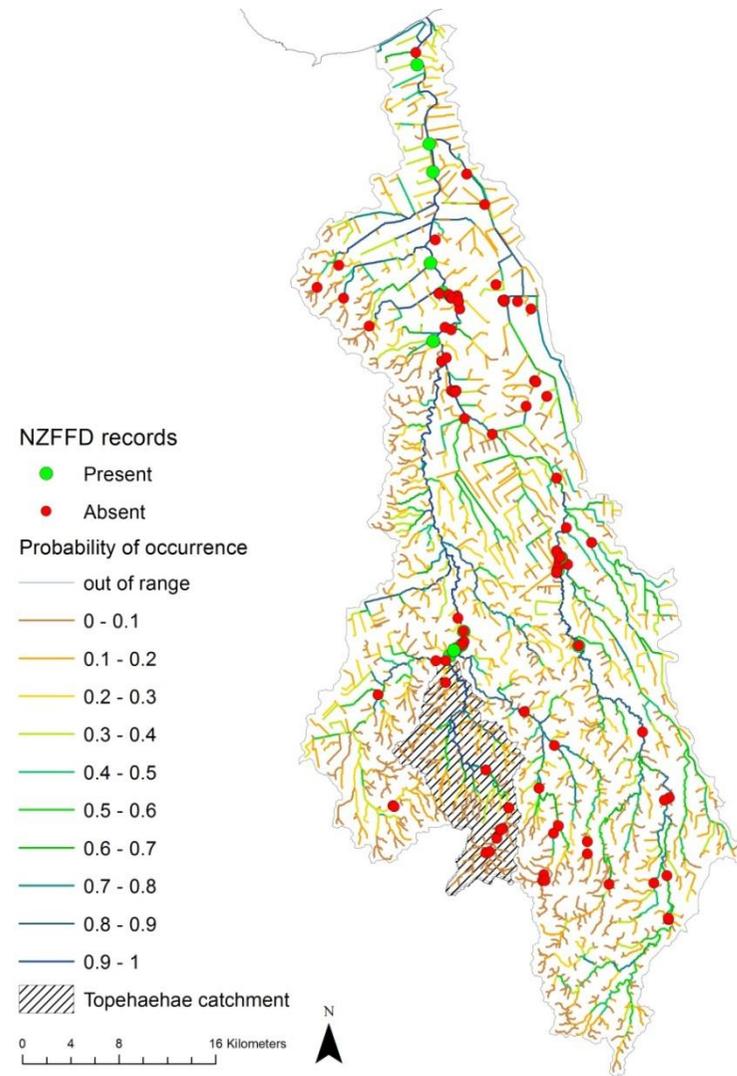
**Figure 3.13: Presence and absence of smelt in the Piako catchment based on NZFFD records (Dec 2011).**

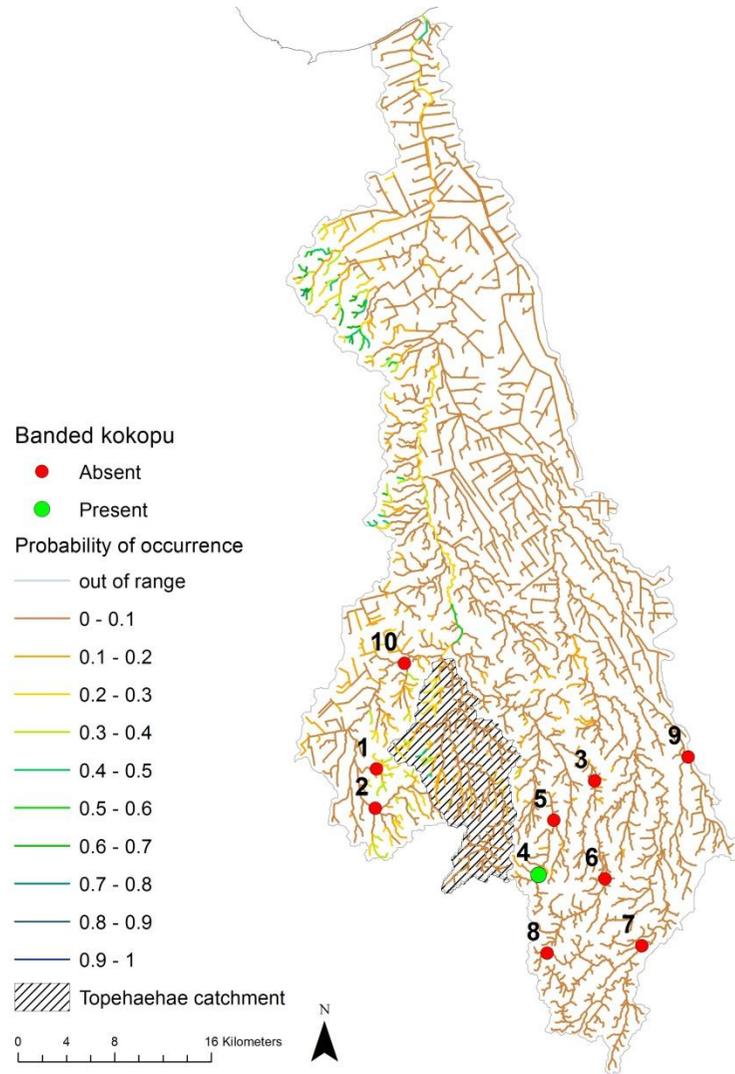
**Figure 3.14:** Presence and absence of banded kokopu during this survey relative to predicted probability of capture.

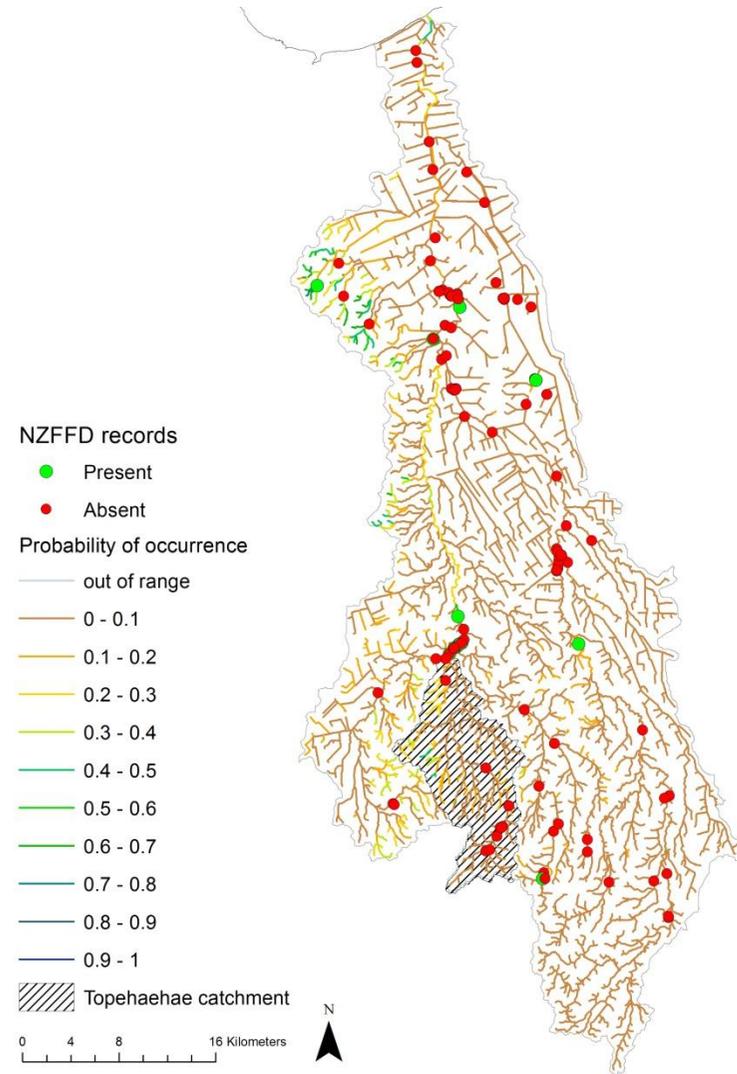
**Figure 3.15:** Presence and absence of banded kokopu in the Piako catchment based on NZFFD records (Dec 2011).
