Estuarine vegetation survey - Aotea Harbour

Prepared by:
Meg Graeme M.Sc (Marine Science)
Natural Solutions – Marine and Terrestrial Ecologists Ltd

For:
Waikato Regional Council
Private Bag 3038
Waikato Mail Centre
HAMILTON 3240

July 2012

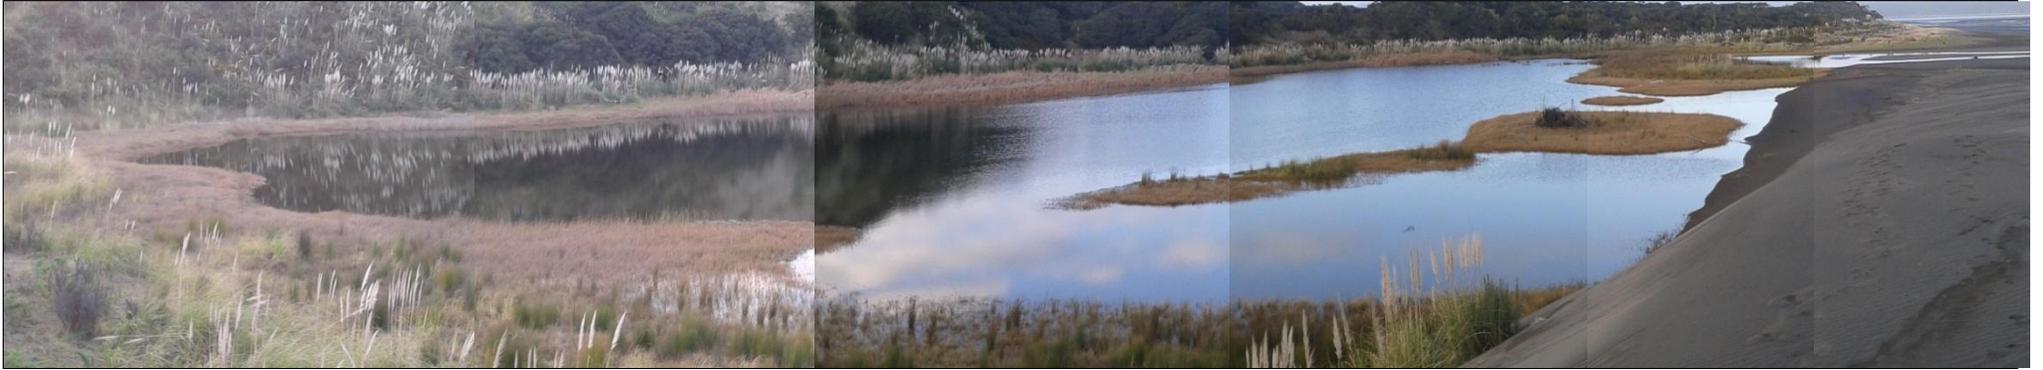
Figure 3: A view from the sand dunes over the Korua Bay dune lake. Most of the light brown vegetation is frosted saltwater paspalum except for the raupo in the middle background.

The saltwater paspalum was frosted following a particularly cold spell of weather. This will reduce its growth rate but will not kill the grass.

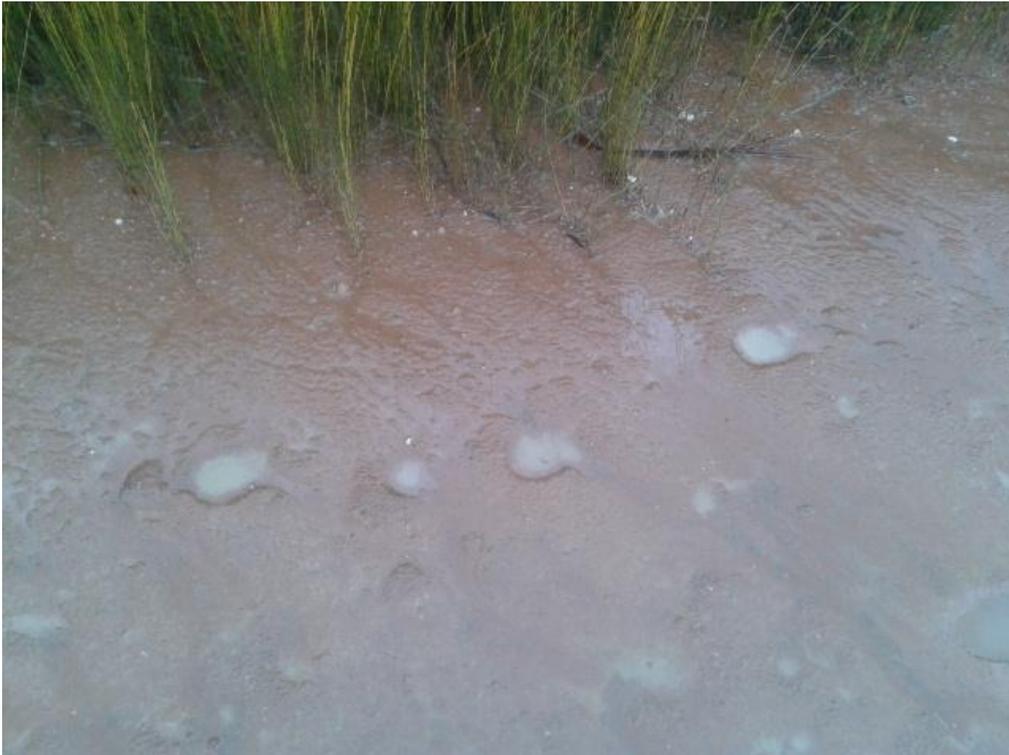
Figure 10: Silt settled out in dimples on firm sand.

Banded rail were heard calling in the **Puketutu Stream** embayment. The sea was quite stormy the day before and fine sediment was noted to have recently settled out in divets in the mudflats here (Figure 10). Pig rooting in the rushland (sea rush, oioi and some three square) was also noted in this embayment (Figure 11 and Figure 12).

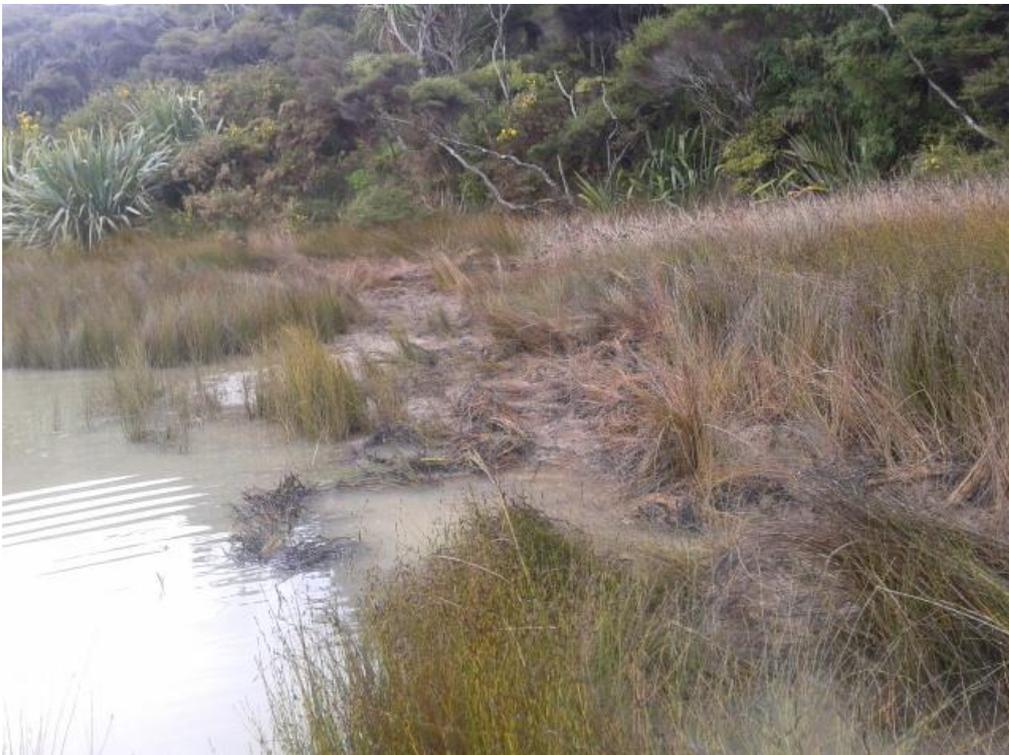
Figure 11: Pig rooting in oioi and three square.

Feral goats and pigs are an issue around the harbour margins as they hinder natural regeneration of the riparian vegetation. Pig rooting can also cause elevated sedimentation and spread weeds. Very few goats or pig sign was noted during the survey however it would be wise to control them around the harbour.

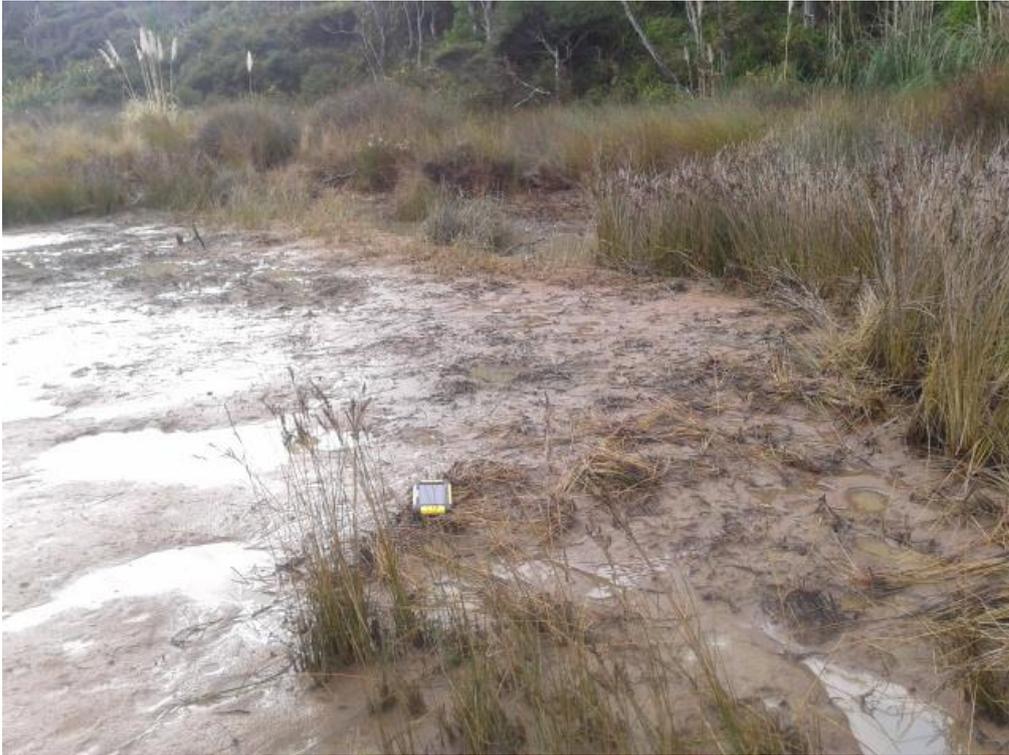
Figure 12: Photo of uprooted sea rush and holes in sediment from pig rooting.

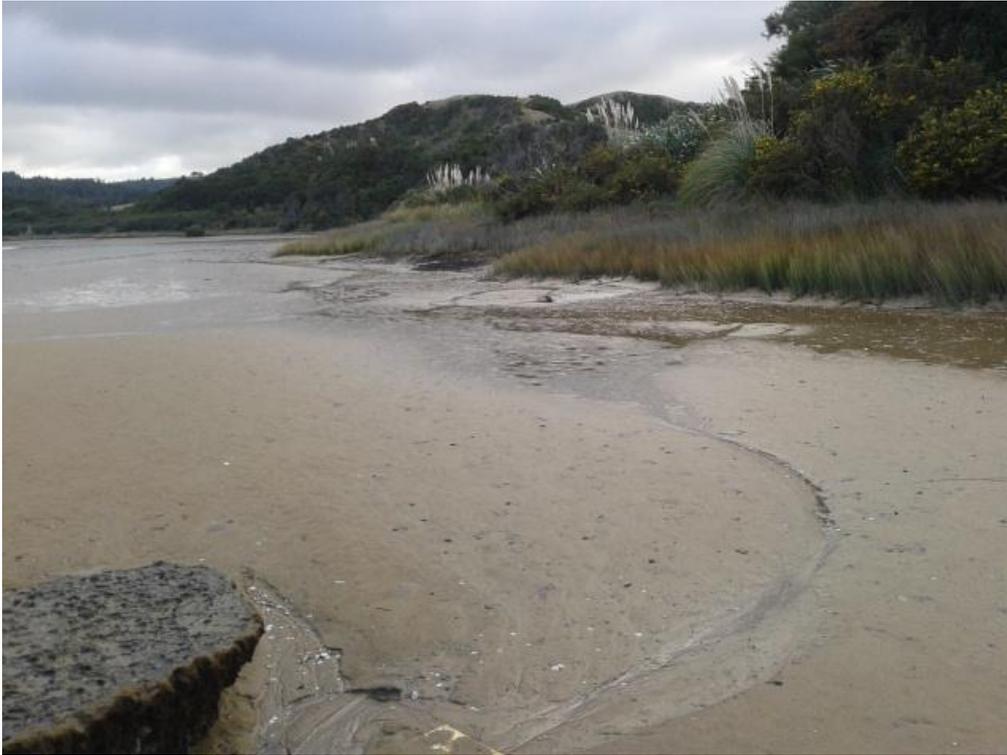
Figure 20: This photo shows an eroded sea rush edge between two healthy oioi edges.

Further along the coastline opposite the two islands, the sea rush edge is noticeably eroded however neighbouring oioi is unaffected (Figure 20). Past the islands, the rush zone (oioi only) is actively eroding and there are old stumps seaward of the rush zone. Sea primrose was found in places with oioi and a few coast spear grasses on rocky outcrops.

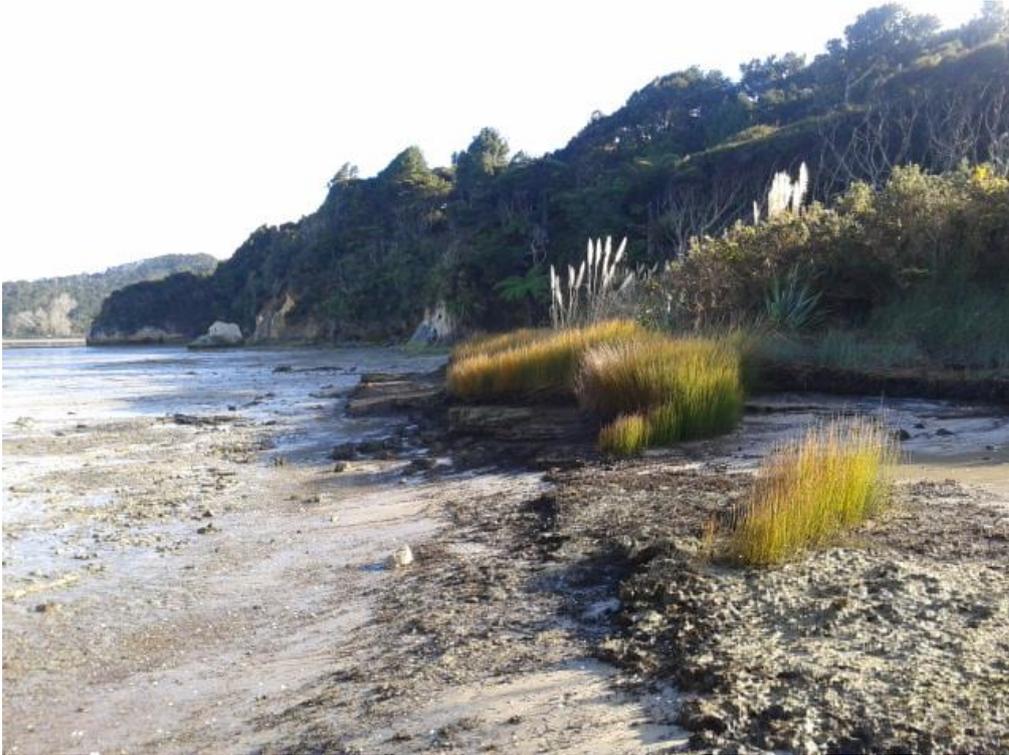
Figure 22: An eroded oioi edge at Mowhiti Point.

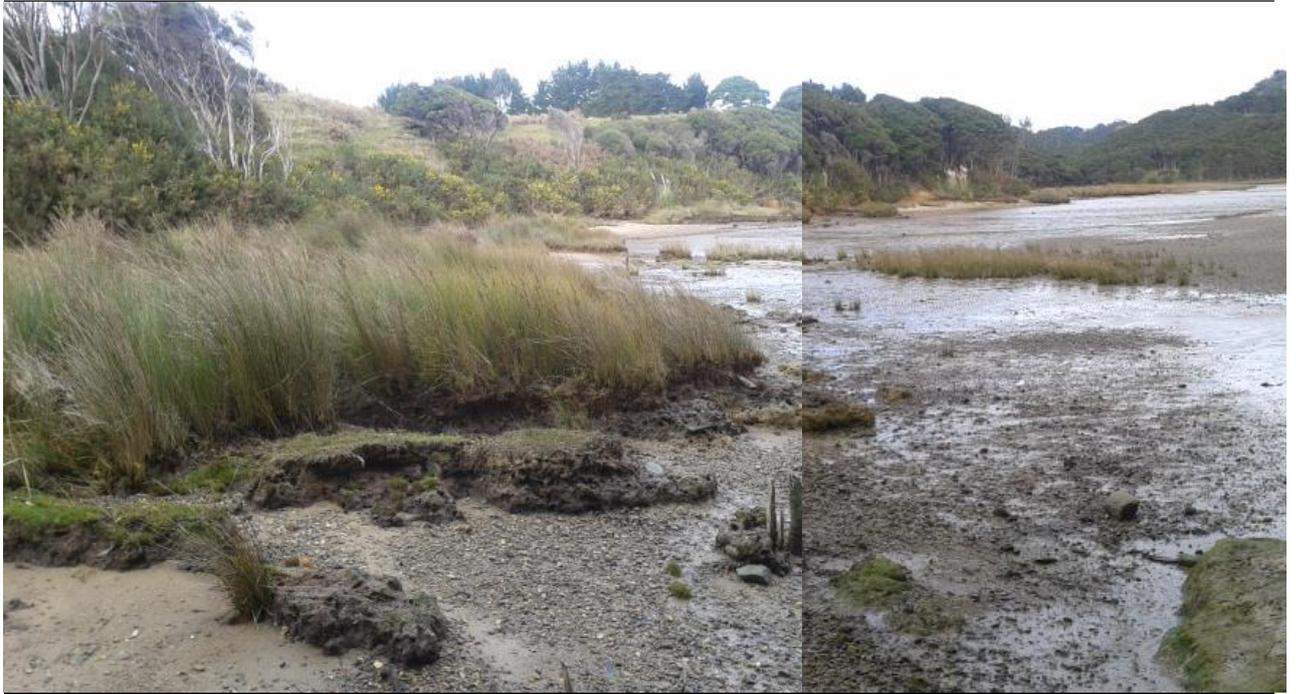
Figure 28: An eroded rush and sea meadow edge. Sea meadow species present include slender clubrush, remuremu, *Leptinella squalida* subsp. *squalida* and *Lilaeopsis novae-zelandiae*.

Further south along the coast at the mouth to the **Kaingata Stream** embayment there is a rock stack, and behind this is an eroded coastal edge of sea meadow, sea rush and oioi (Figure 28). The farmed edge is not fenced and the sea meadow and rushland is pugged. There is extensive stock pugging and damage to rushland further into the embayment as well as dung along the foreshore and tracks over the mud flats. Saltwater paspalum is associated with the stock pugging. The embayment is quite silty. A small patch of spartina occurs up the top of the embayment that has been recently sprayed but a few plants have survived. There is also quite an extensive sea rush band with some scattered oioi patches, and a background fringe of giant umbrella sedge and raupo swamp. There are very few saltmarsh ribbonwood here and only a few *Coprosma propinqua* had survived the grazing pressure along the coastal edge. A tall kanuka canopy is common around the embayment adjoining the rush/sedgeland however it is heavily grazed underneath (Figure 29). Some more short spartina occurs amongst and in front of sea rush along the outer TLB of the bay. These patches were also recently sprayed but some plants have survived. More sprayed spartina occurs either side of a tall fence extending into the CMA also with some live spartina plants. A rushland continues to line the coastline out of the embayment and around to the more exposed harbour edge.

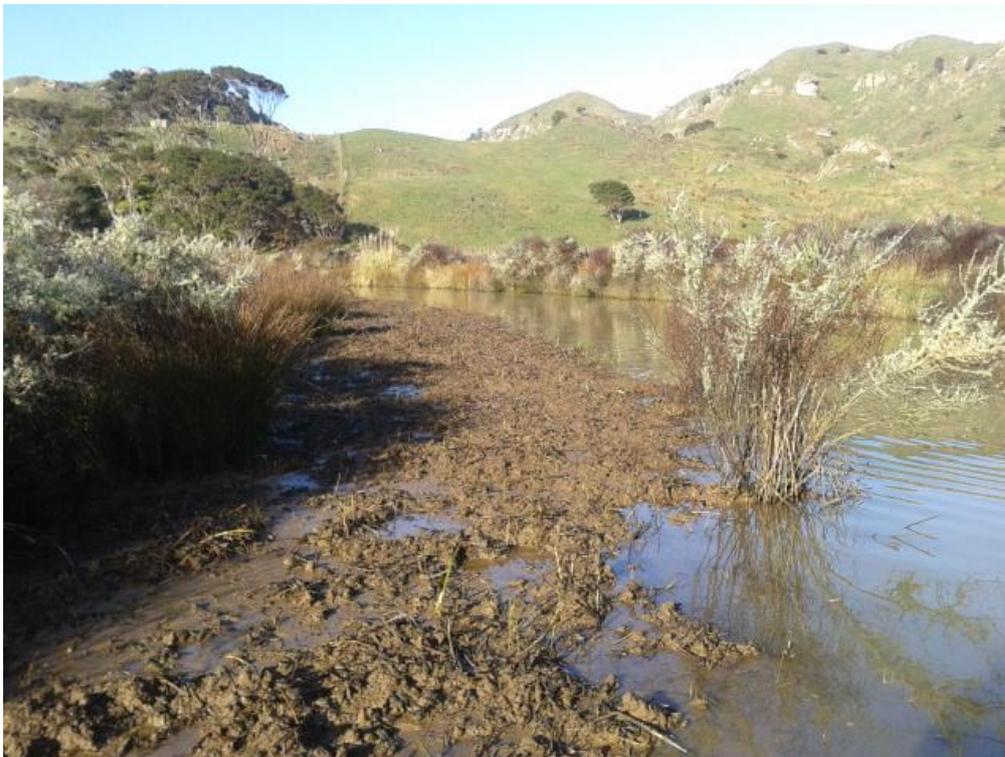
Figure 31: Fresh severe pig rooting of the marsh clubbrush band at the mouth of the Waitaika Stream.

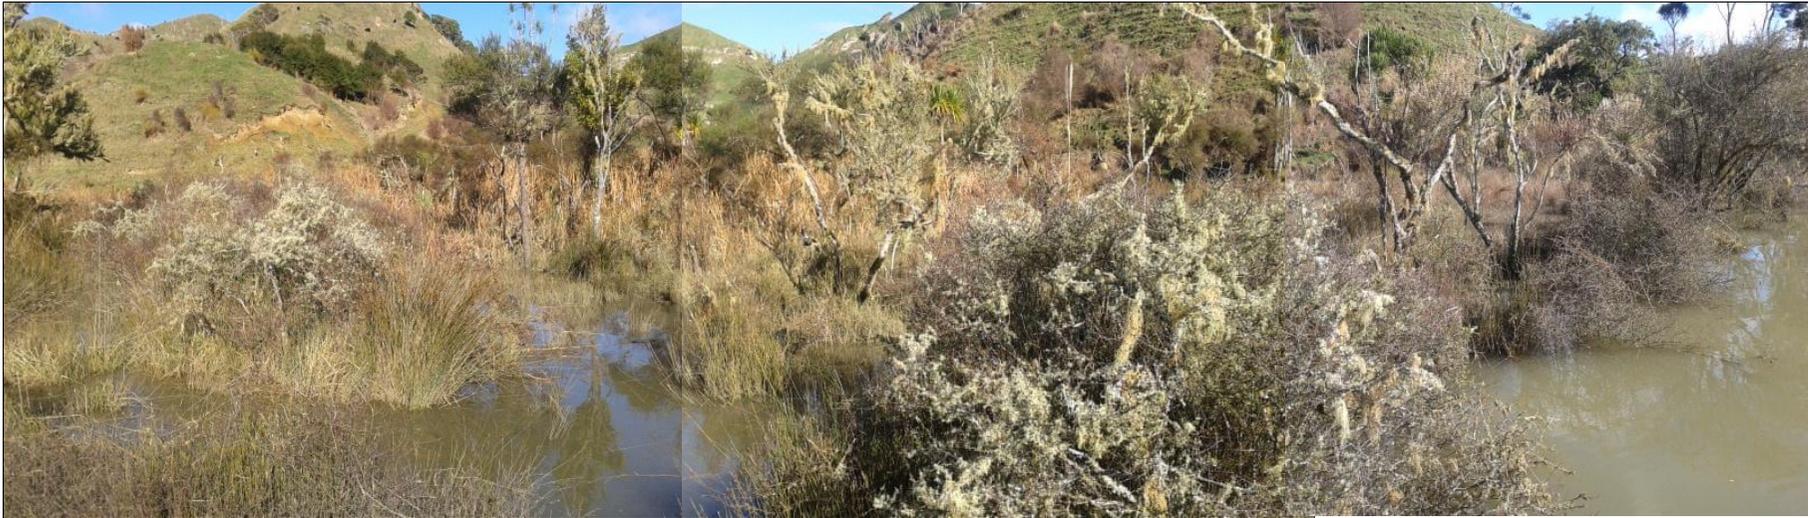
Figure 32: The upper TRB of the Waitaika Stream is lined with *Coprosma propinqua* and coastal shrub daisy with saltmarsh ribbonwood and freshwater wetland behind. This stream bank is severely pugged and grazed by cattle.

The level of direct stock access to the harbour seems to have decreased slightly since the last field survey in 2005. Stock physically damage the harbour vegetation and water quality by pugging sediments and vegetation, grazing vegetation, spreading weed species such as spartina and saltwater paspalum, and defecating directly into the harbour.

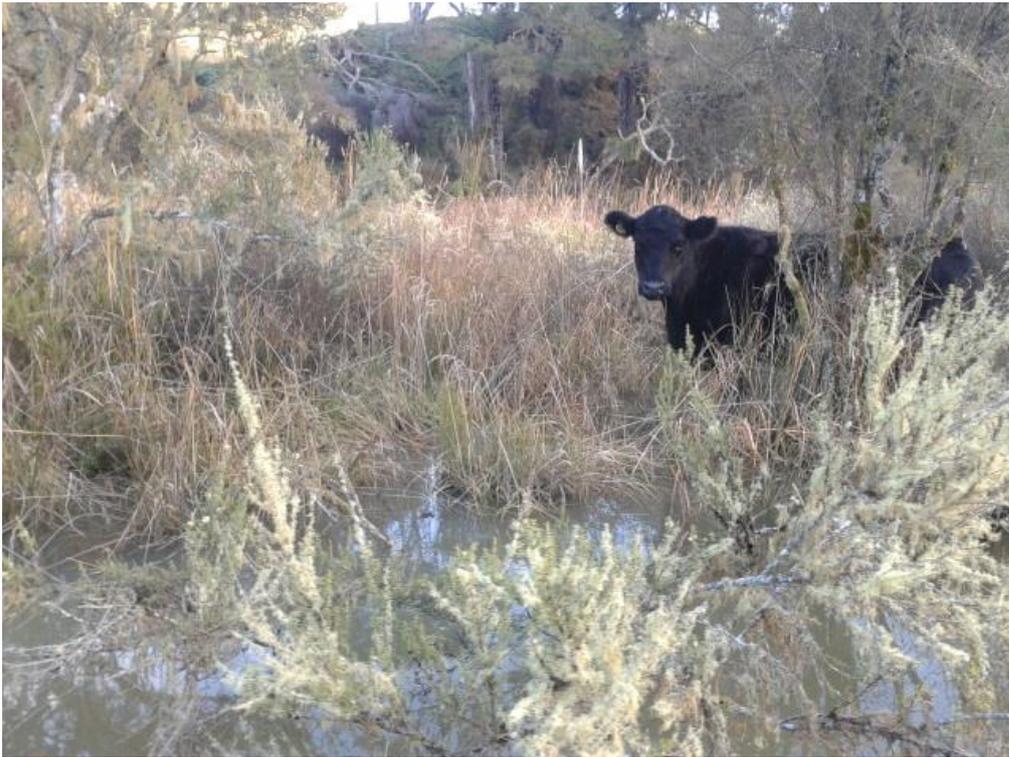
Figure 33: A cow in the wetland along the upper TRB of the Waitaika Stream.

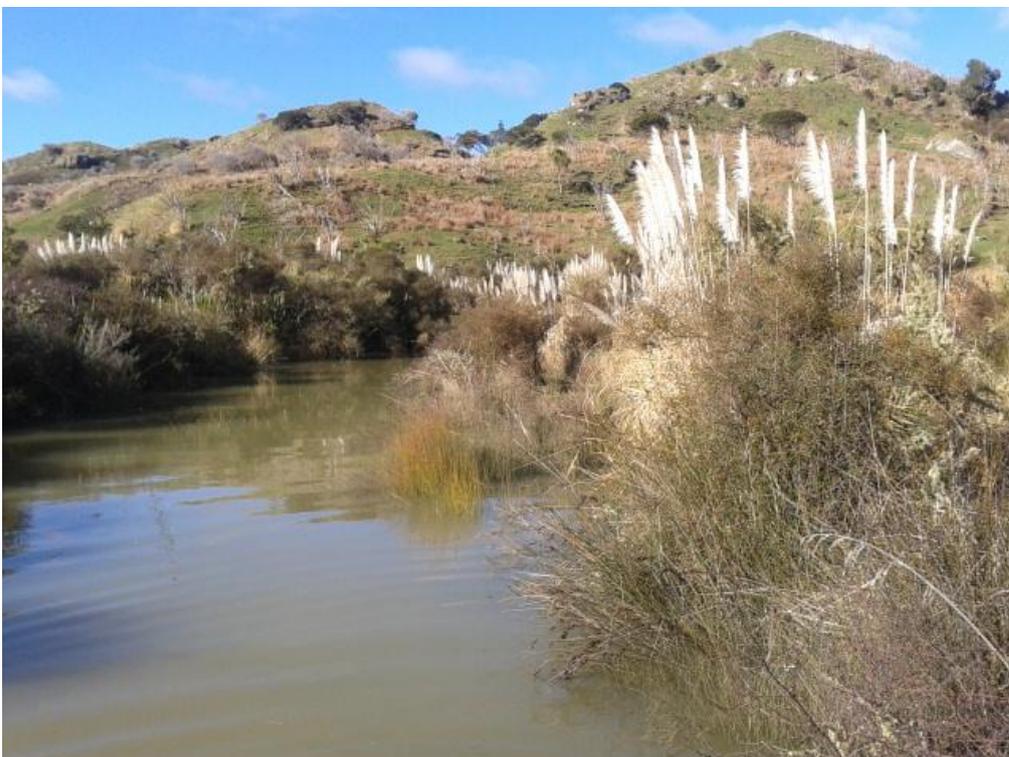
Figure 34: Pampas in the disturbed areas of the wetland along the upper TRB of the Waitaika Stream.

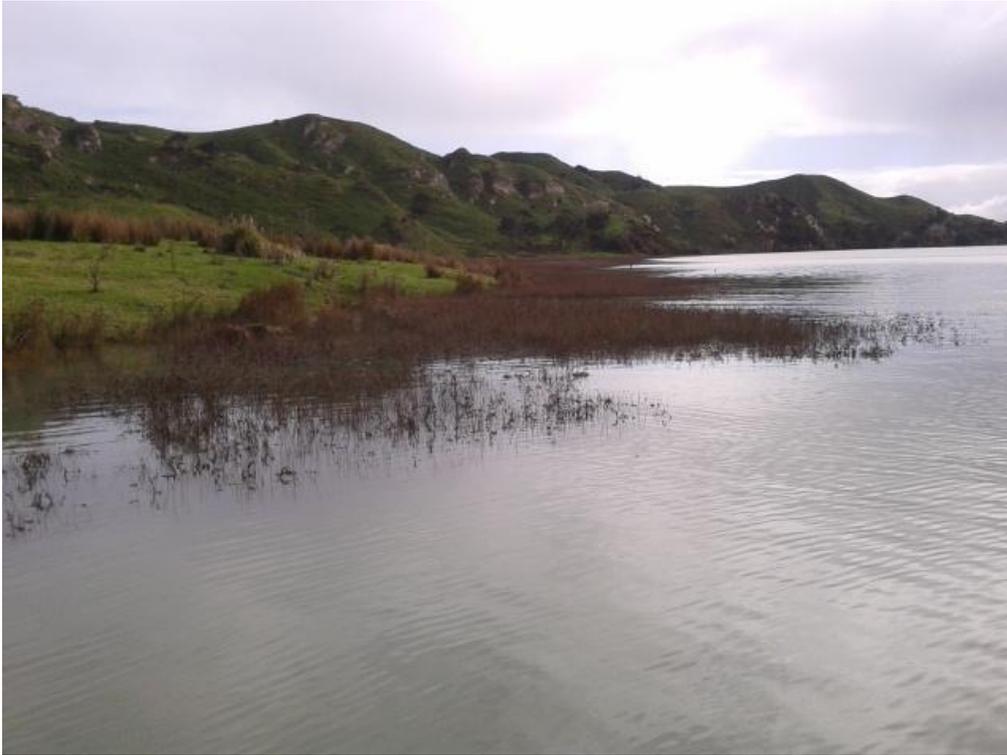
Figure 37: Looking over the TLB of the Waitaika Stream bay out towards Ohau Point which is dominated by sea rush edges. There is no fencing of the estuary here. There are posts of an old fence line out along the seaward edge of sea rush in the distance.

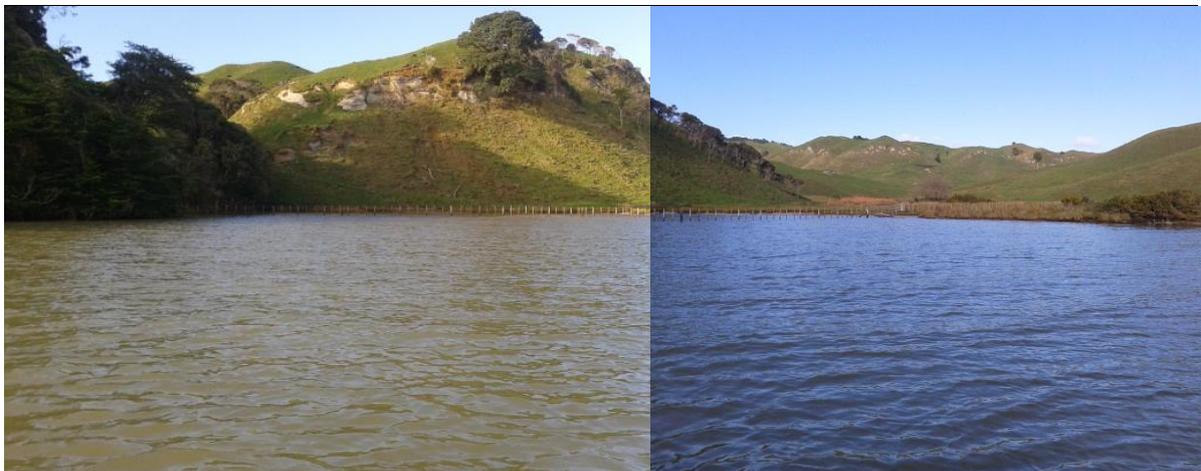
Figure 40: This repeat photo of Figure 14 from 2005 shows a steep eroding hill side and fence across the head of the estuary. There is a lot of saltwater paspalum, often mixed in with sea rush and a large band of saltmarsh ribbonwood half of which is grazed within the paddock.

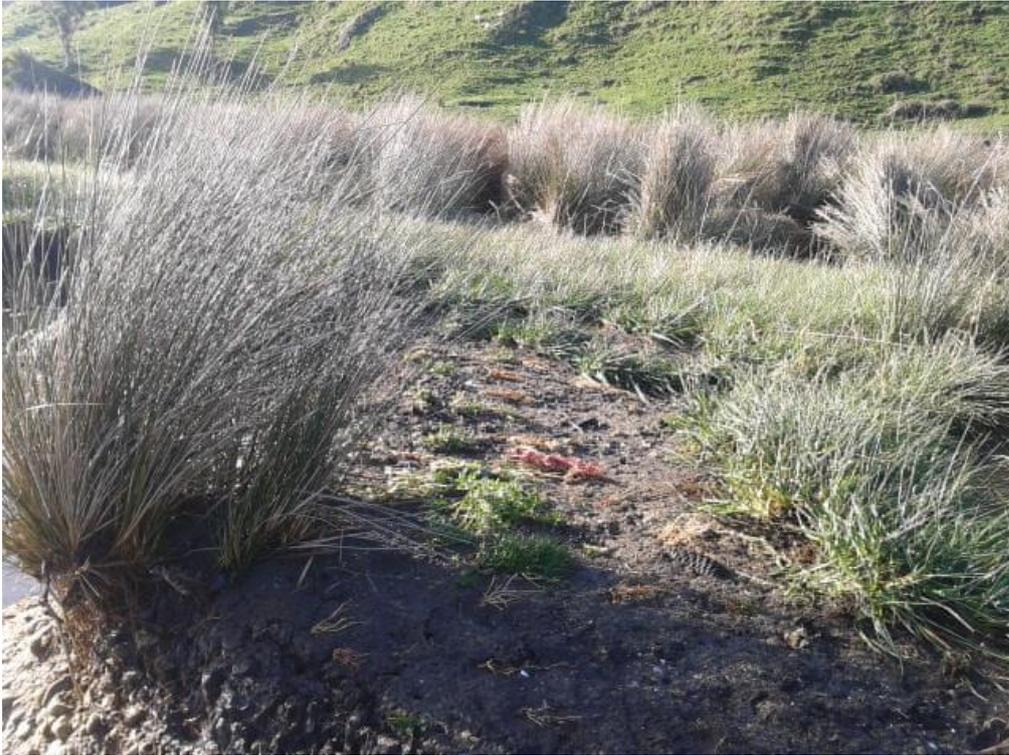
Figure 41: An grazed and exposed edge with sea rush, remuremu, native celery, slender clubrush, *Einadia triandra* and tall fescue. Sea rush, scattered remuremu and saltwater paspalum are in swales landward. Recent high tides had extended inland towards the base of the hill.

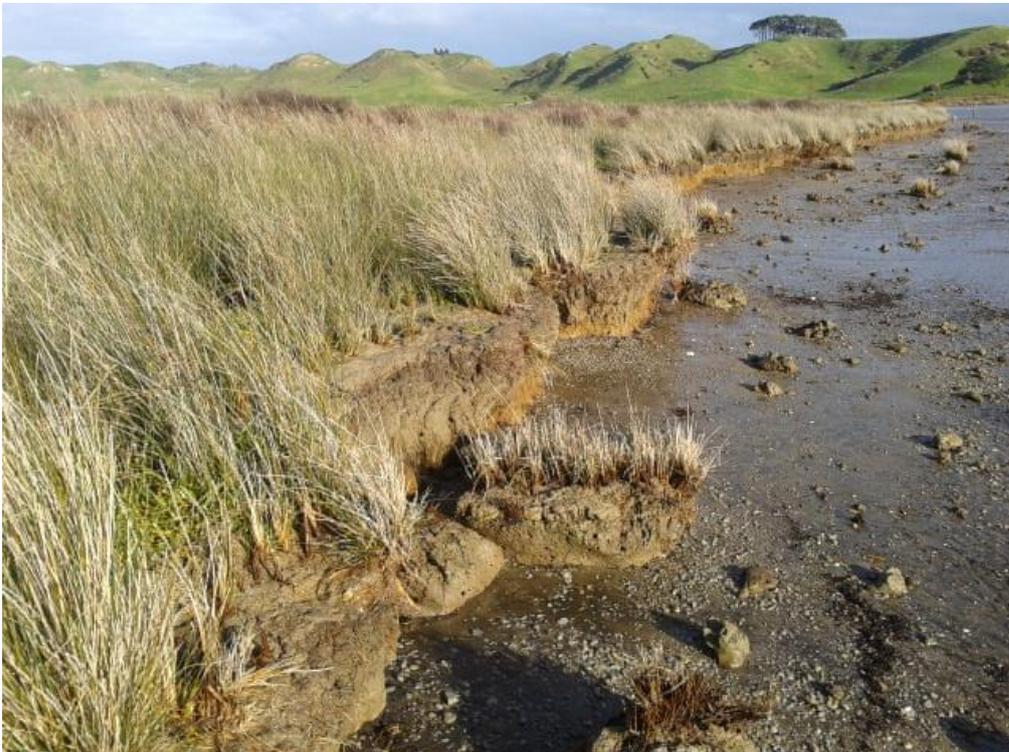
Figure 42: An eroding edge of sea rush and sea meadow backed by saltmarsh ribbonwood in Matakowhai Bay.

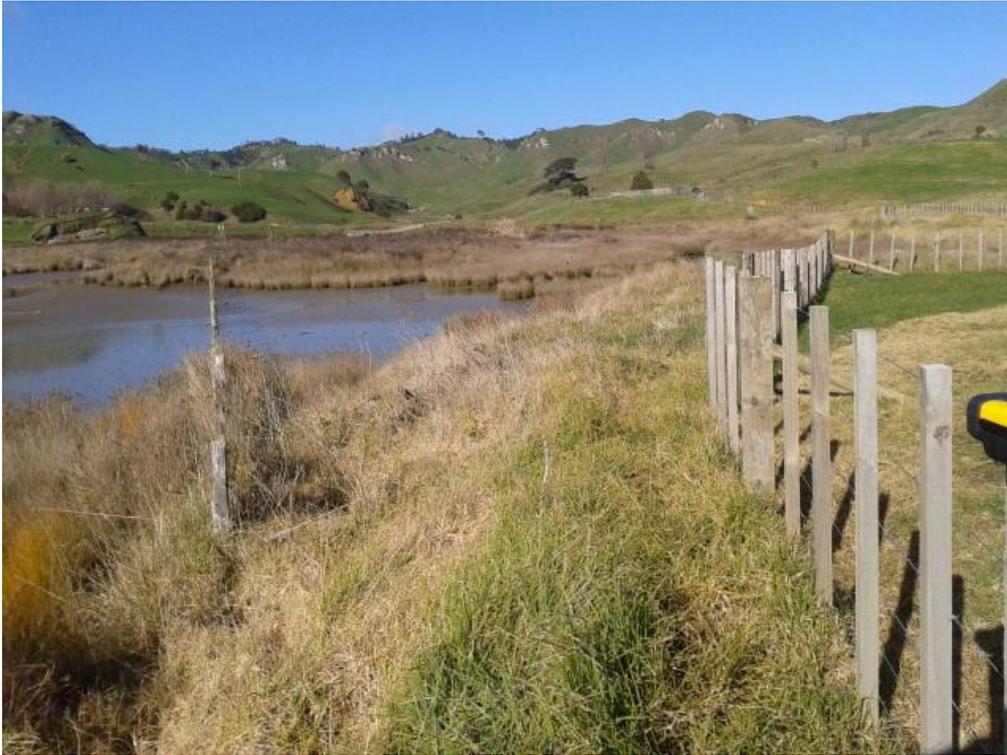
Figure 43: A greatly improved new fence line that protects the harbour from stock intrusion and provides a riparian buffer (unlike the old fence visible in the middle of harbour). Note the saltwater paspalum and kikuyu along the harbour edge have been recently frosted.

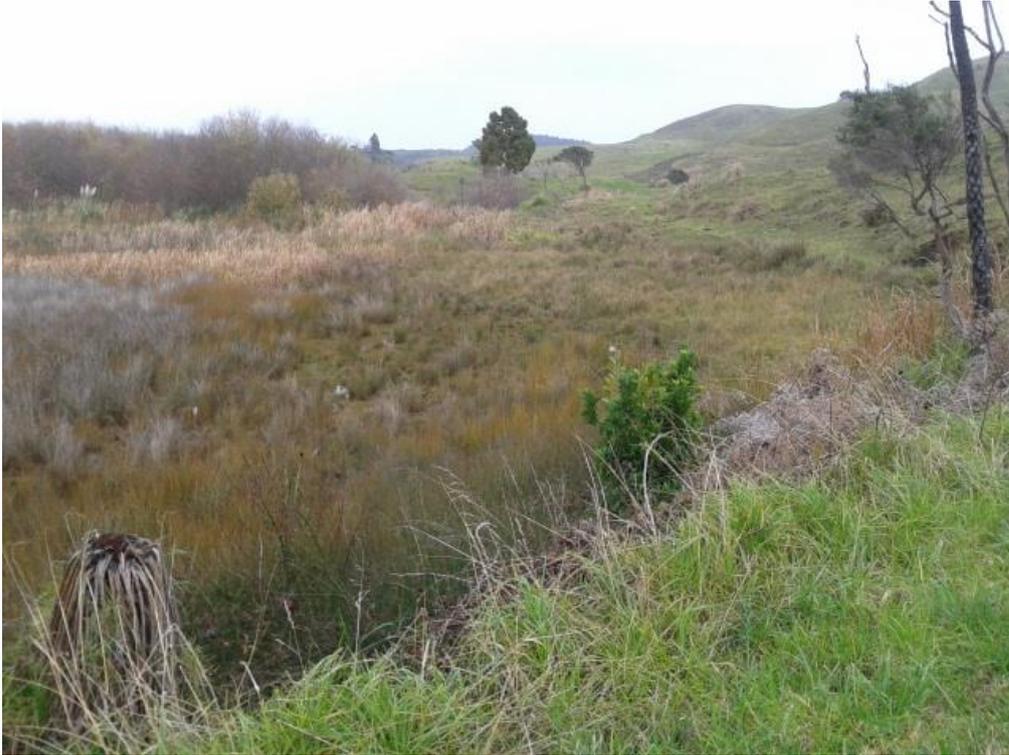
Figure 46: Looking upstream from Morrison Road over an estuarine-freshwater wetland edge that is grazed and pugged. Oioi and sea rush grade up into raupo and willow.

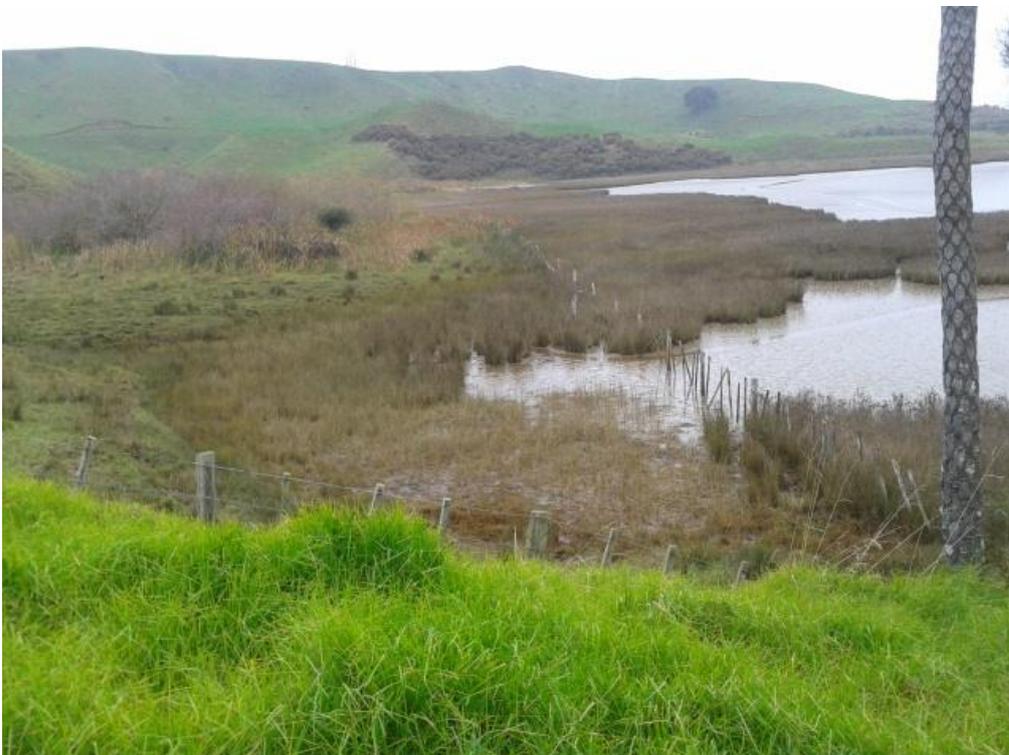
Figure 47: A view looking north from Morrison Road over a partially-fenced harbour margin. The healthy sea rush is less likely to be invaded by exotic plant pests such as saltwater paspalum than the unprotected and disturbed rushland.

Farmland with unfenced margins along streams, freshwater wetlands and the harbour margin do not provide a vegetation buffer that can absorb and filter land run-off, and hence results in elevated levels of sediment, nutrients and pathogens in the harbour. Also large remnant coastal forest trees such as pohutukawa that are not protected by fencing have no replacements with stock restricting forest regeneration.

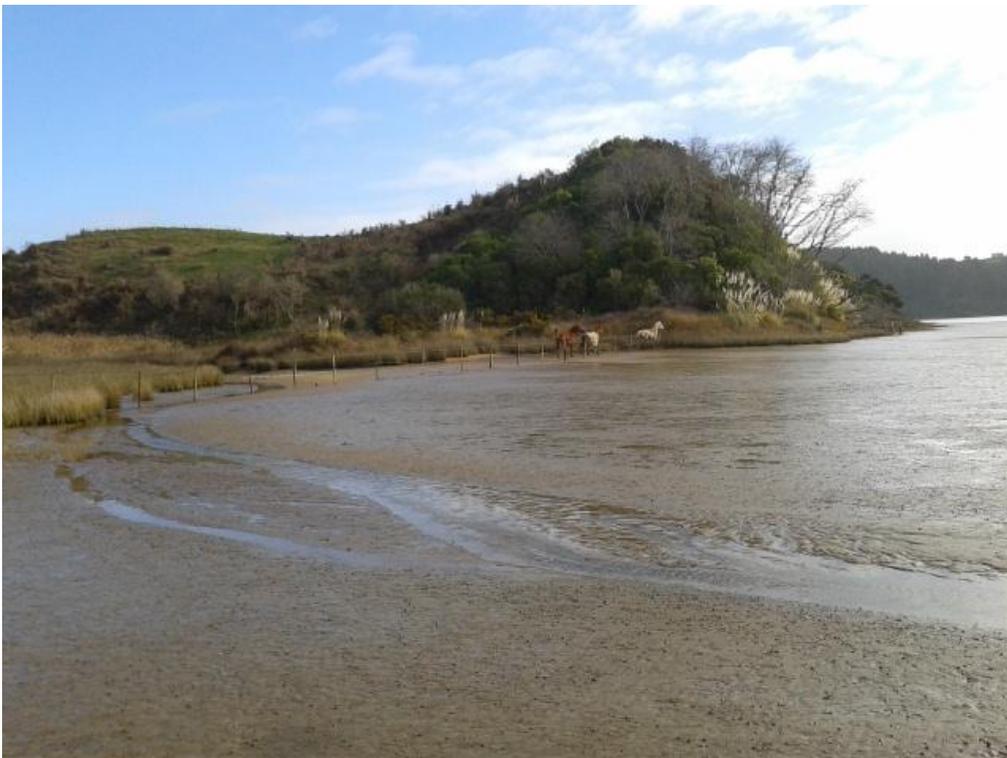
Figure 50: Poor fencing allowing horses out on the harbour flats. Tracks were noted through the rushland and into the remnant mahoe riparian vegetation on the steep coastal faces.

platforms with a few large pohutukawa and macrocarpa along the riparian edge. The farmland is sporadically fenced along this coastline, with some estuarine edges fenced off but landward freshwater wetlands not, leaving them open to pugging and grazing. Cotoneaster was noted along the eroded headland towards the **Okapu** marae. Rushland fringes much of the bay with a spit in front of the marae covered with sea rush and coast spear grass. A large area of saltmarsh ribbonwood with flax and gorse lies in behind. Fernbird were heard here. At the end of the spit is a raised sandy area covered by scattered glasswort that is in pretty poor shape due to 4x4 tracking. Around the bay the road comes in close to harbour edge and there is another 4x4 access point with tracks over the mudflats. Beside the road where the rush isn't thick there is mixed sea meadow with slender clubrush, remuremu, glasswort, sea primrose and scattered sea rush. Figure 44 repeats the Figure 17 photo in the 2005 report and still shows vehicle tracks out in the harbour but no stock tracks. Around the small headland at the Aotea-Morrison Roads intersection is the impounded stream mouth of the **Waitetuna Stream** that does not flush naturally due to the road culvert being too small (see Figure 45 for a repeat of 2005 photo). A thin band of rush extends around the coast line westward from the impounded embayment, becoming thicker around the point towards the head of the next bay. Saltmarsh ribbonwood also backs the rushland within the bay. Upstream of the road the wetland edge is unfenced and the wetland grazed and pugged (Figure 46). Oioi and sea rush grade into raupo and willow. Partially fencing of the estuarine edge on the western seaward side of the road leaves some wetland protected and some grazed and pugged (Figure 47). Here sea rush also grades back into raupo and willow. Further out along the TLB of the bay the rushland becomes very wide in places (Figure 48). Figure 49 shows the three species that compromise the rush/sedgeland community in the harbour. There is poor fencing of the harbour edge around **Kakawa Point** headland. Often where freshwater seepages join the harbour edge the whole wetland is not fenced off leaving the back estuarine vegetation and freshwater wetland vegetation open to pugging and grazing by stock. Two mangroves were found along the outer edge of a sea rush band amongst the more seaward open band of three square. Some mangrove seedlings were present. Horses were noted grazing and tracking the steep banks with some remnant mahoe coastal forest and the large freshwater/estuarine wetland complex at the point (Figure 50).

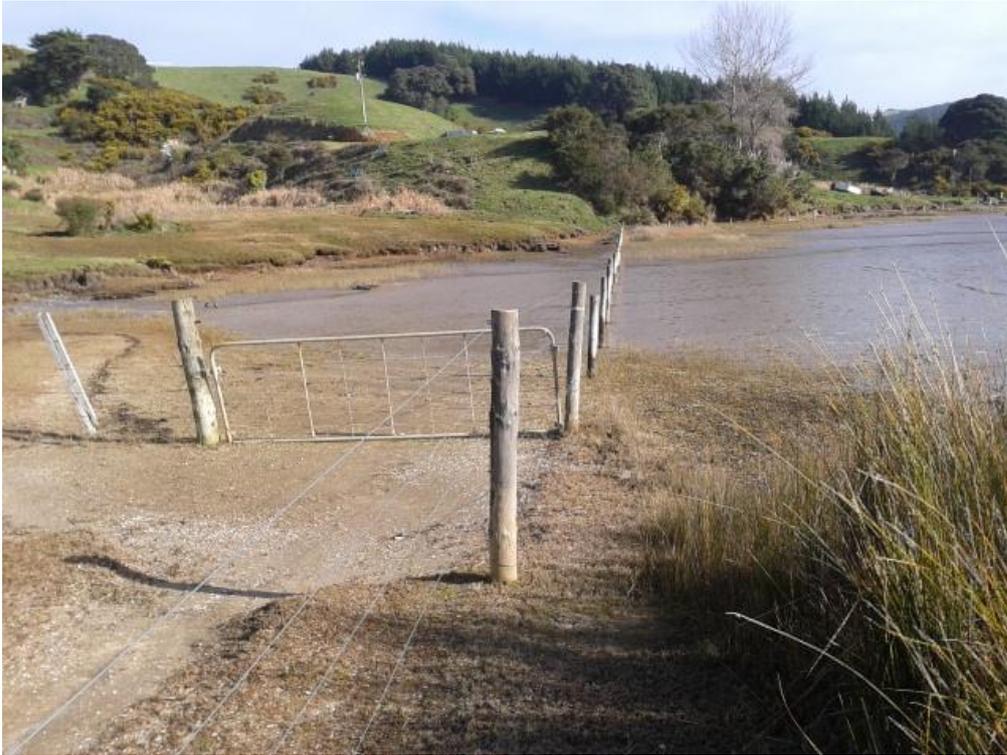
Figure 51: A fence line within the CMA with saltwater paspalum prevalent with three-square and sea rush.

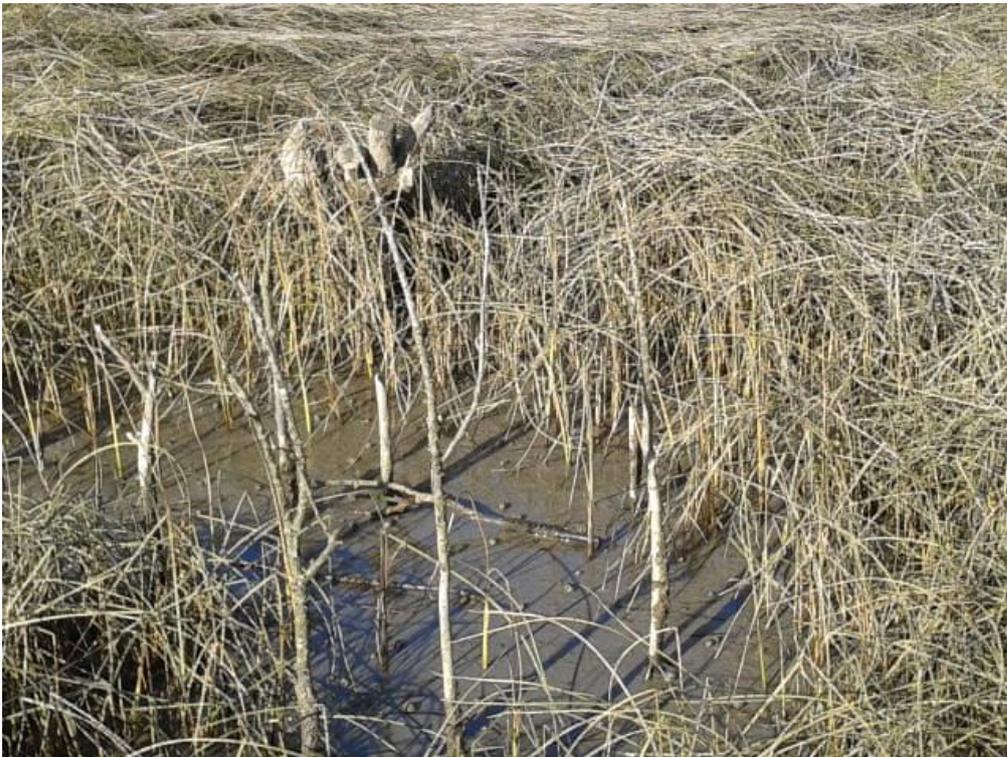
Figure 52: A cut mature mangrove and dead seedlings within a patch of three-square sedge. The sedge dies back annually over winter.
