Estuarine vegetation survey – Kennedy Bay Estuary

Prepared by:
Meg Graeme M.Sc (Marine Science)
Natural Solutions – Marine and Terrestrial Ecologists Ltd

October 2012

Natural Solutions Contract Report 12/108

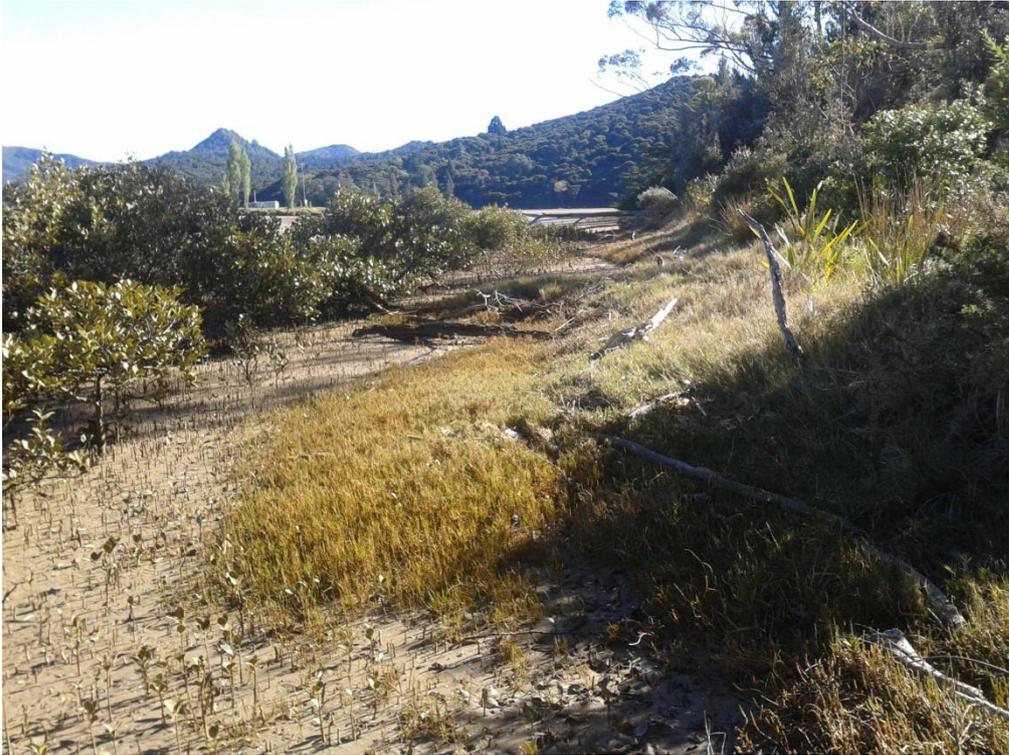
Figure 2: Saltwater paspalum extending from the high tide mark out through a glasswort band. Mangroves are seaward of the glasswort community.

The glasswort band with varying dominance of saltwater paspalum continued along the foreshore behind the mangal (Figure 2). The mangal included adult mangroves and patches of juveniles. There was also a single ~7m tall mangrove towering over the rest of the mangroves. There was quite a bit of wild ginger in from the inner spit foreshore with pine, flax, gorse, knobby clubbrush and pohutukawa, kanuka, manuka and banksia. Further along a constructed pond was encountered behind a kikuyu-dominated edge of the spit. The pond was lined by thick saltwater paspalum and scattered rush at the southern end. The spit edge also had pohutukawa, pine, knobby rush and a patch of marram grass. Mangroves occurred along the seaward side of the kikuyu land edge.

The mangrove band then finished and saltwater paspalum became the predominant community. Figure 2 shows a single large mangrove downstream of an extensive bed of saltwater paspalum. This large bed of saltwater paspalum covered communities of coast spear grass and glasswort along the upper tidal edge and glasswort beds out on the middle intertidal flats. The **Harataunga Stream** channel then cuts into the spit resulting in an eroding pine edge with little estuarine vegetation present (Figure 4). The spit land edge was armoured where the land use changes to pasture and housing. Mangroves and saltwater paspalum were found again immediately downstream of the road bridge. Flounder and many juvenile mullet were seen in the stream.

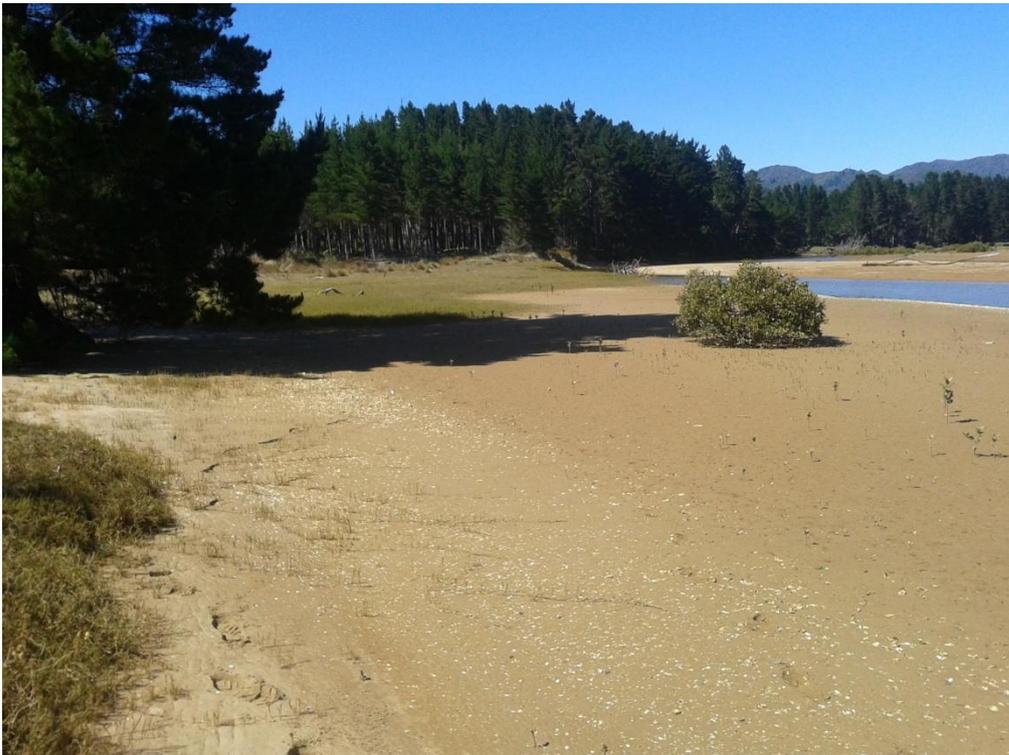
Figure 3: A glasswort bed in the foreground has saltwater paspalum intermingled through it and long runners extending out seaward over the sand flats. The large bed of saltwater paspalum in the background covered communities of coast spear grass and glasswort along the upper tidal edge and glasswort beds out on the middle intertidal flats.

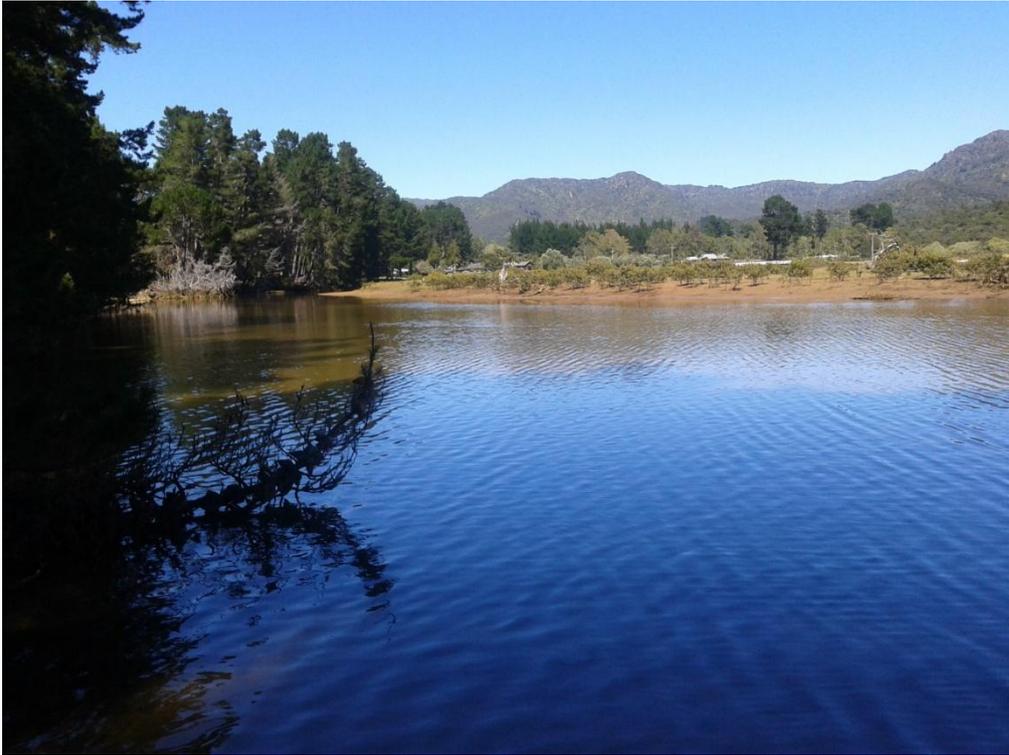
Figure 4: A view looking upstream with an eroding pine edge on the TRB of the Harataunga Stream, and mangroves and dense saltwater paspalum on the outwash plain of the TLB.

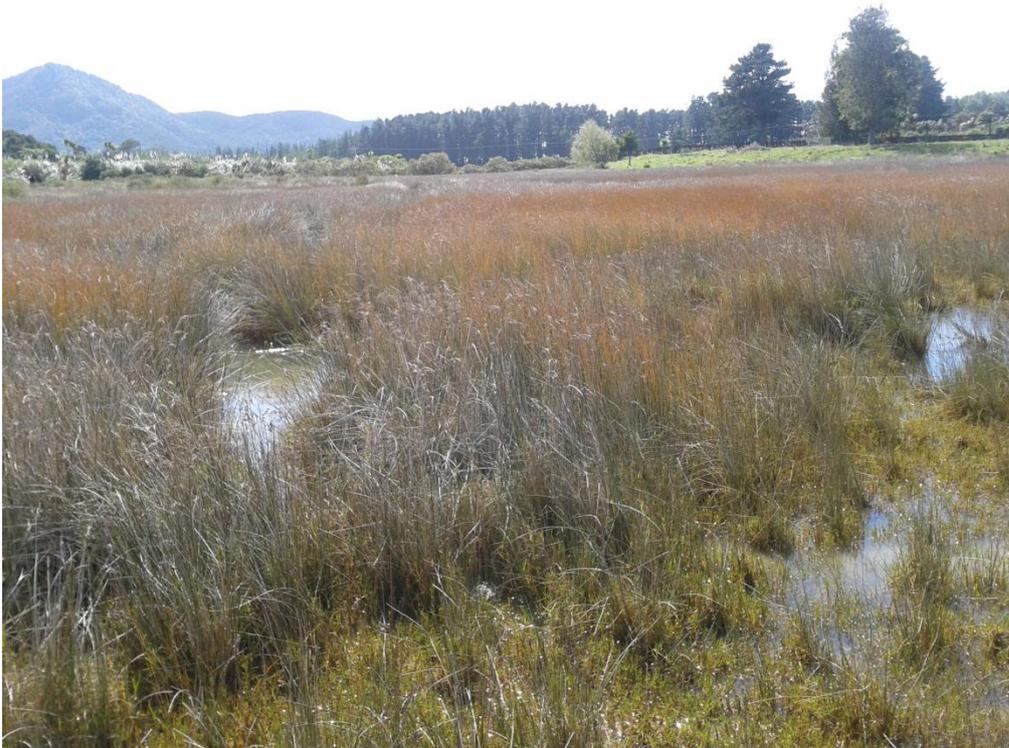
Figure 5: A view looking down the Harataunga Stream towards the Kennedy Bay road bridge. Saltwater paspalum was prevalent throughout the rushland associated with stock tracking.

The line of mangroves with saltwater paspalum behind continued upstream of the road bridge along the true right bank (TRB) of the Harataunga Stream. The estuarine edge then widened out into a large embayment full of sea rush and oioi (Figure 5 & Figure 6). Saltwater paspalum

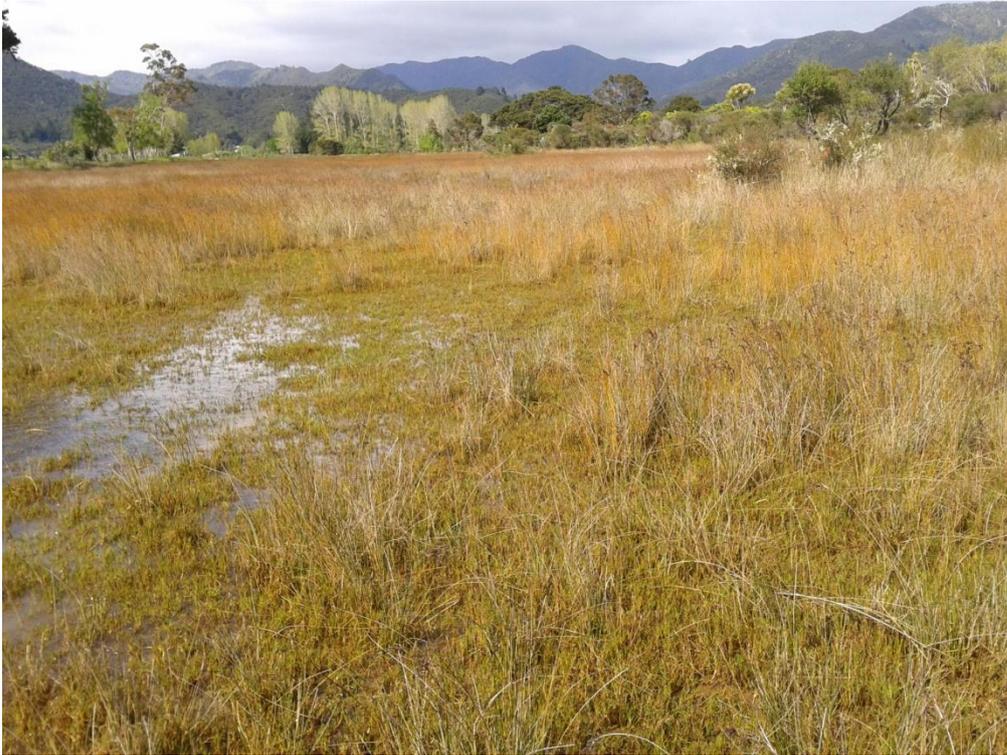
Figure 6: A view looking up into the head of the saltwater paspalum-infested rushland embayment upstream of the Kennedy Bay road on the TRB of the Harataunga Stream

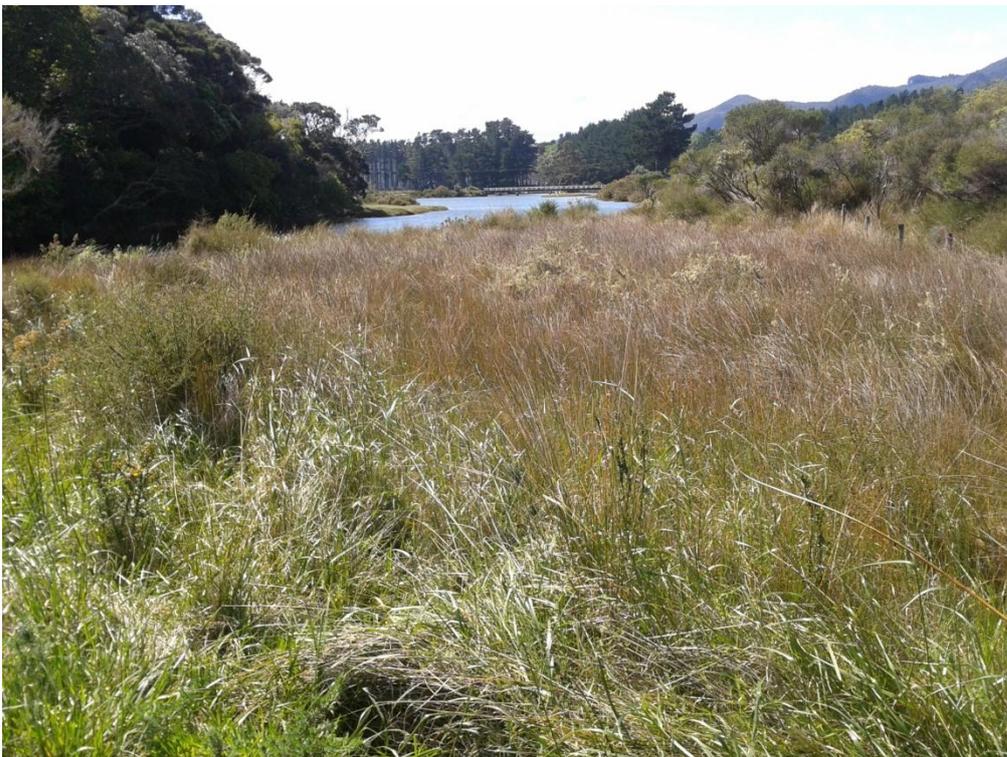
Figure 7: A view looking down the Harataunga Stream from a ridge on the bend. Sea rush, oioi, saltwater paspalum and saltmarsh ribbonwood are on the lower flats with manuka, kanuka, kowhai floodplain forest behind.

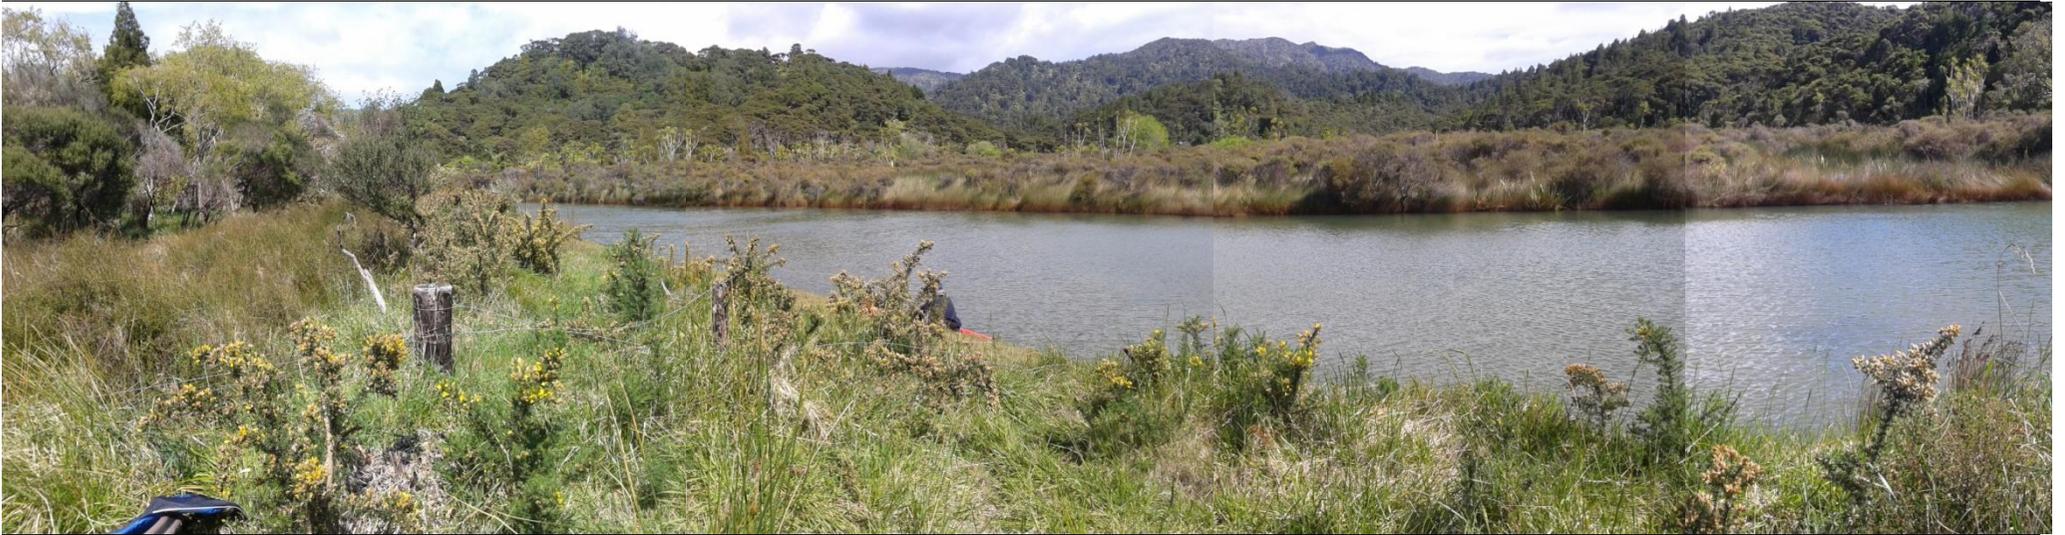
Figure 8: A view from the same vantage point on the river bend as Figure 7 looking over to the large freshwater wetland. The saline influence was restricted to a thin edge of oioi and saltwater paspalum which fringed an otherwise freshwater wetland with sedges, manuka, cabbage trees, flax and Coprosma species.

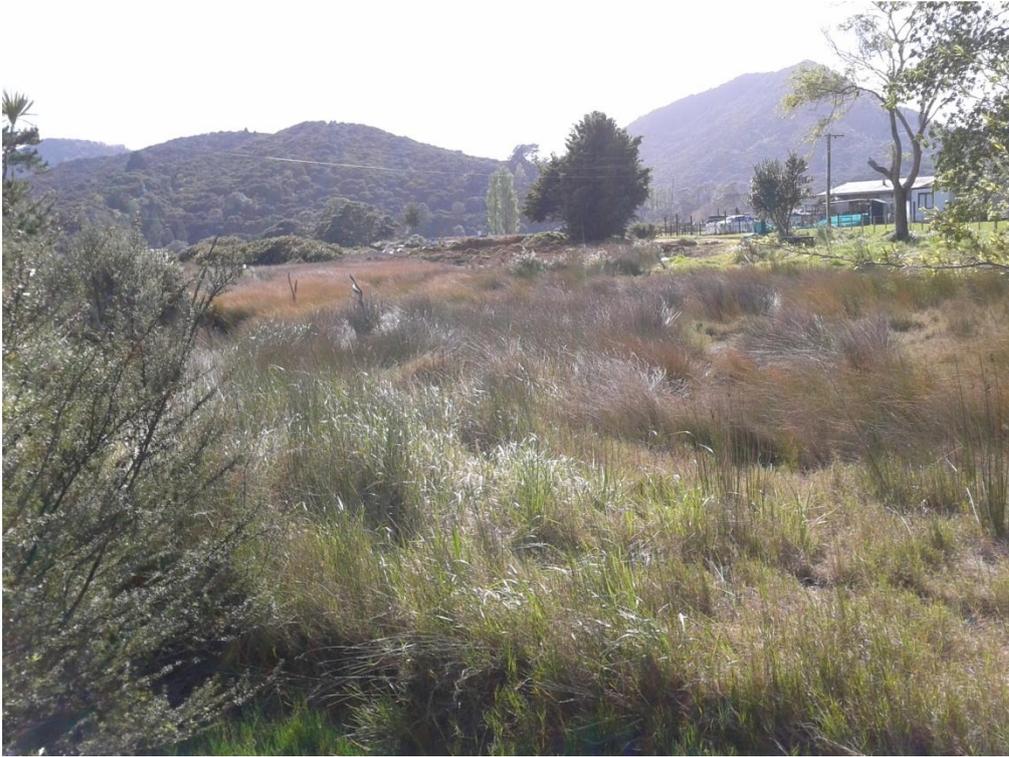
Figure 9: Sea rush and oioi with saltwater paspalum dominating to varying degrees at the head of this small embayment north of the school. Note the clay infill in the middle background seaward of the totara.

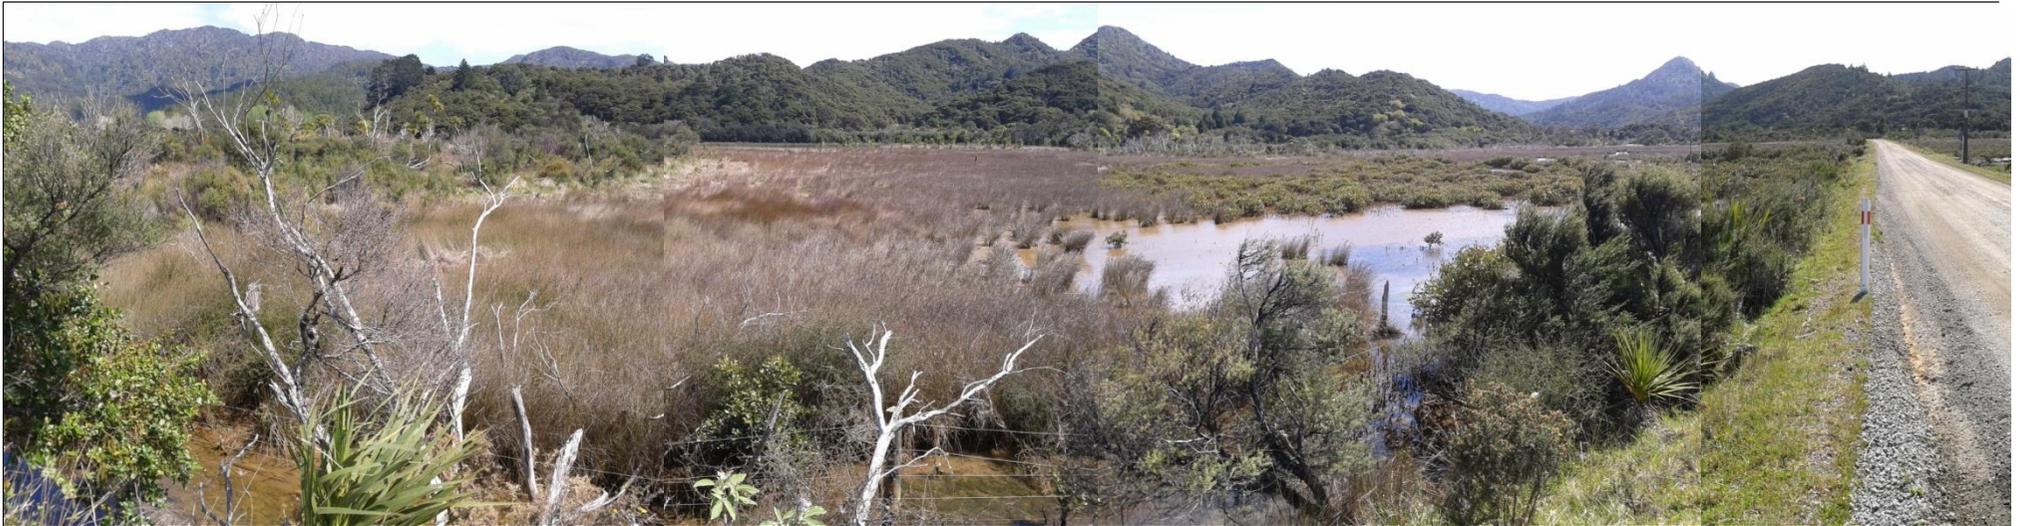
Figure 10: A view over the wetland upstream of the causeway and north of Mangatu Rd showing mangroves on the lower flats and sea rush and oioi covering the higher flats and extending into pasture. Saltmarsh ribbonwood is present in places, particularly around the northern edges. Saltwater paspalum is common, dominating or spreading into the rushland edges where stock tracking is visible. A small patch of seagrass is present in the open pool.

North of the Mangatu Stream (and above the causeway) mangroves covered much of the lower flats with extensive rushland in behind (Figure 10). There was old sign of grazing of the mangroves. Saltwater paspalum was common around the rushland edges where stock tracking was evident. Some work had been undertaken planting the landward margin and trying to fence stock out however with limited success based on the tracking sign and chewed plantings. A dredged drain cut through the wetland. The northern head of the bay seemed less impacted by stock and had a native forest margin. A perched culvert restricts tidal water movement affecting the natural hydrology of the embayment (Figure 11). Banded rail were present in the area and a bittern was seen flying by.

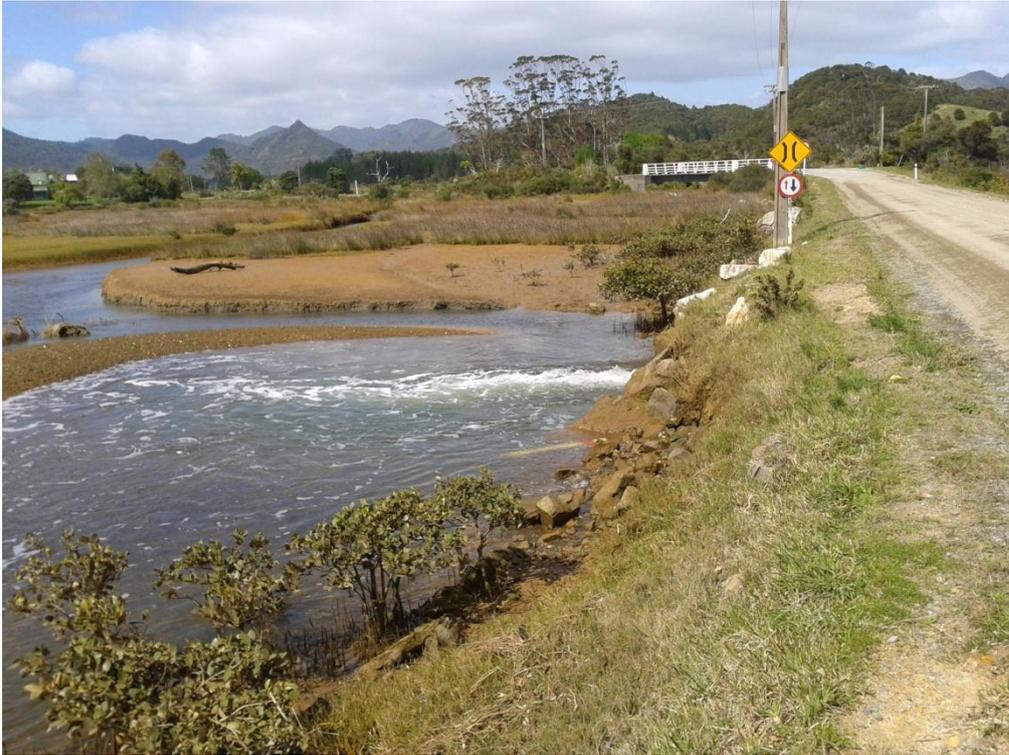
Figure 11: A view of the constricted culvert under Kennedy Bay Road just north of Mangatu Stream.

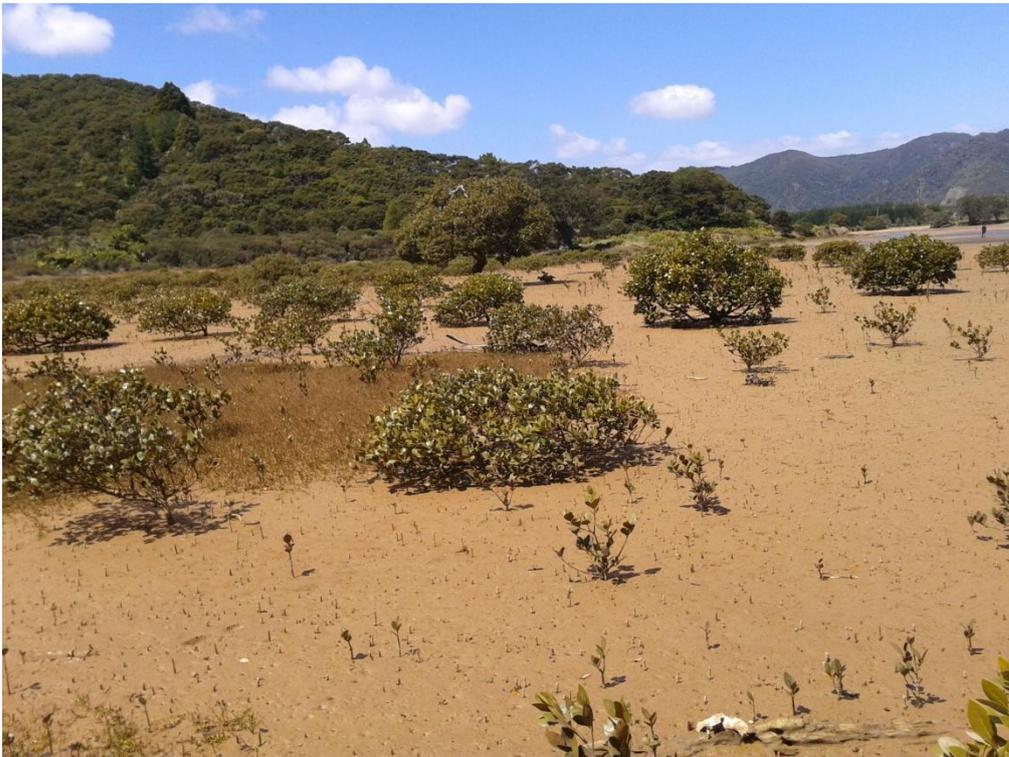
Figure 12: A patch of sea primrose in the foreground with scattered short mangroves and a patch of sea primrose cover the foreground flats with one large mangrove in the centre background.
