June 2014 flood event

Prepared by:
Duncan Grant

For:
Waikato Regional Council
Private Bag 3038
Waikato Mail Centre
HAMILTON 3240

Document #: 4086080

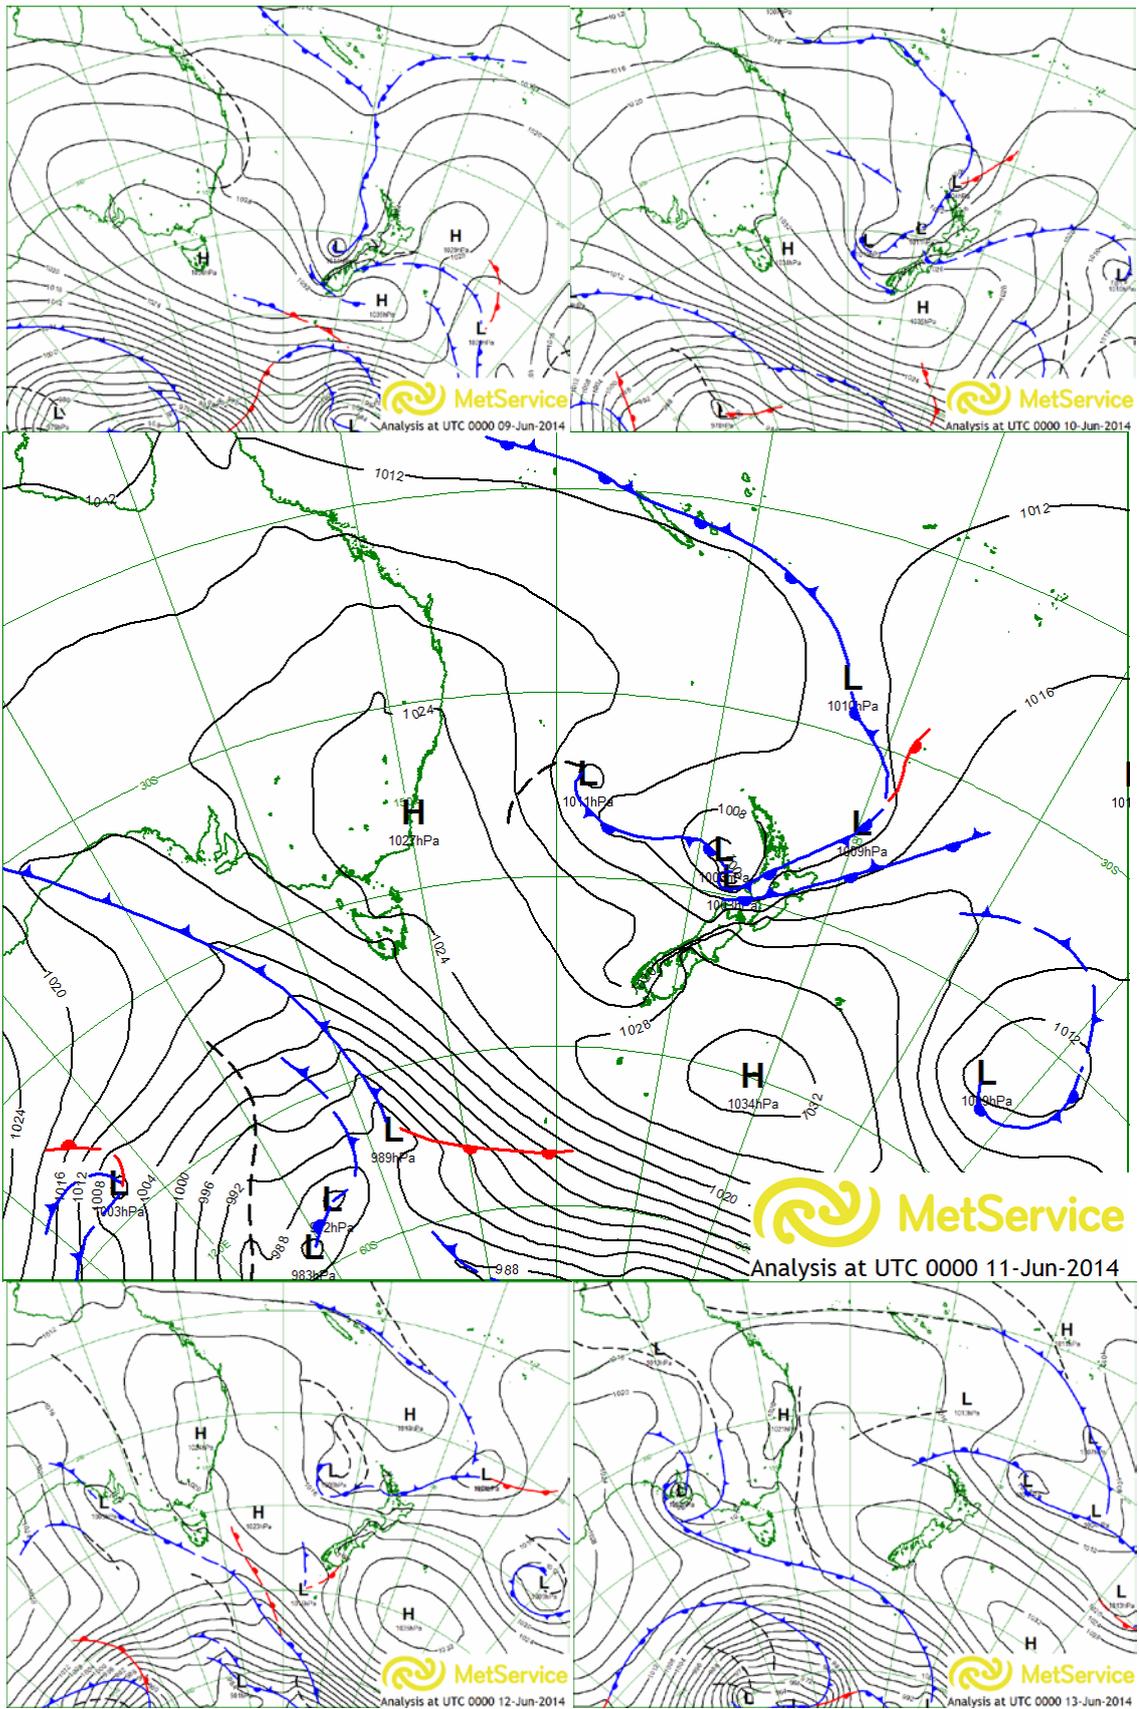
Figure 1: Tasman Sea surface pressure charts for the period 9 June to 13 June 2014
 (Source: MetService)

A deepening low in the Tasman crossed the North Island bringing strong east to northeast winds with associated fronts and heavy rain. Surface pressure charts for the period 9 to 13 June show the passage of the low in Figure 1.

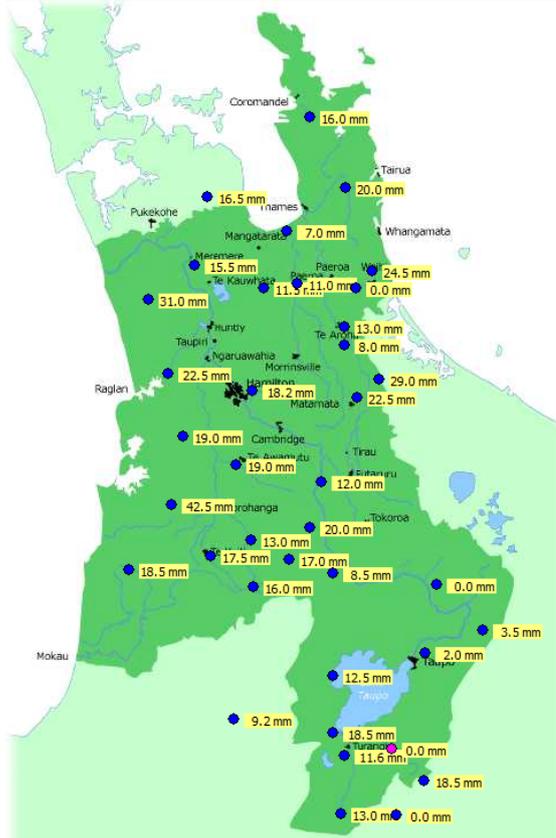
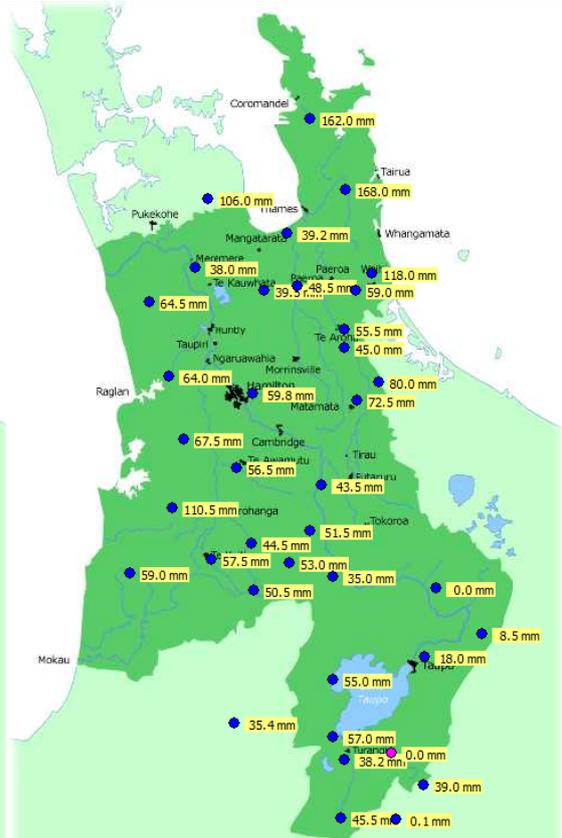
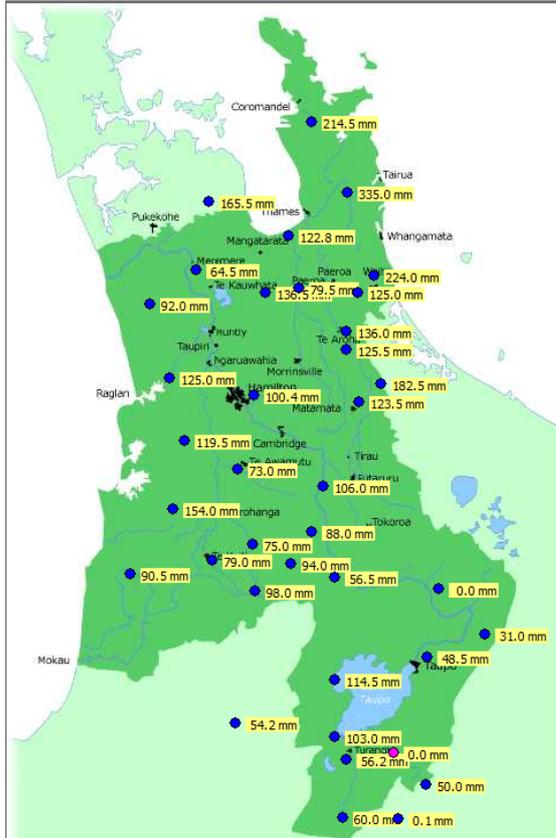
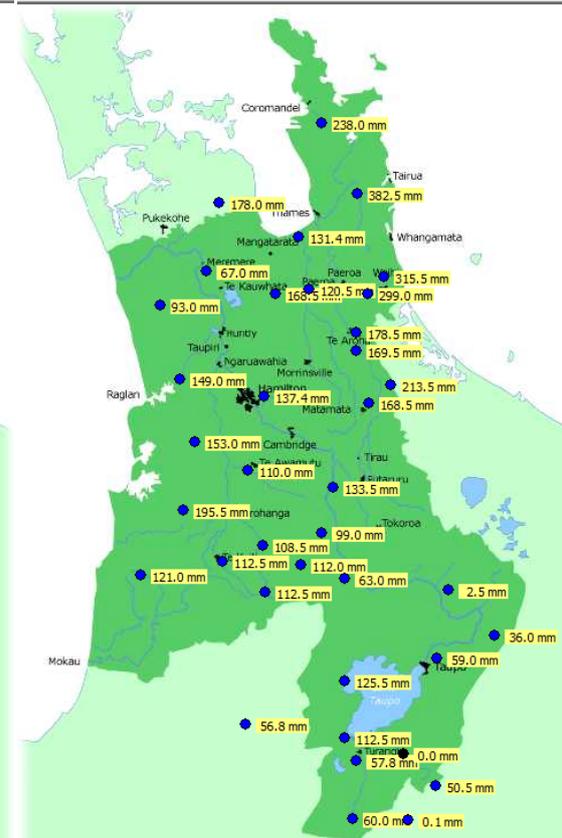
Figure 2: Rainfall totals for the period 00:00 9-13 June 2014 (sourced from Jones, 2014)

The rainfall received at the gauges has typically not been indicative of the scale of flooding at many locations, i.e.: flood levels were high relative to recorded rainfall totals and intensities. An example of this was the northwest Coromandel catchments, suggesting high spatial variation in rainfall and localised high intensity events. Rainfalls recorded over the region for the June 2014 event are described below and detailed in Figure 2 and Table 1.

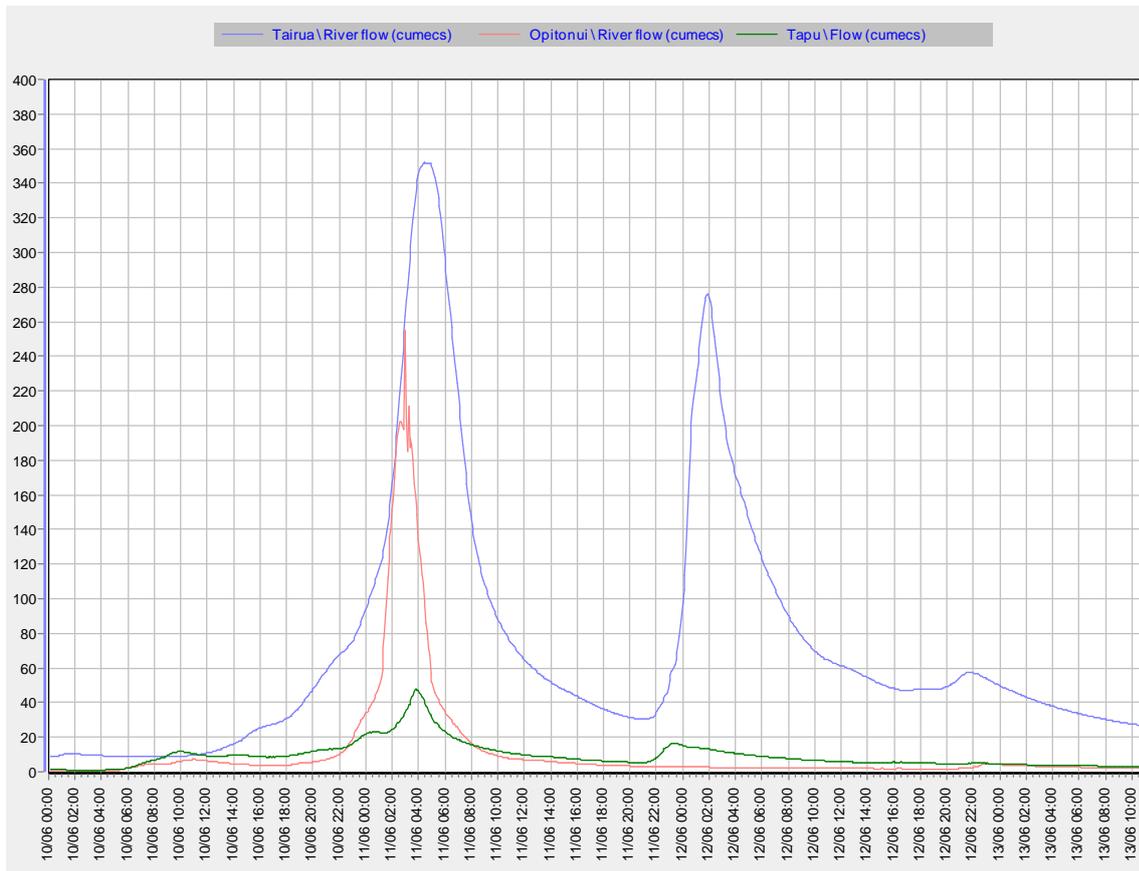
Figure 3: Flows recorded at Tairua, Opiotoni and Tapu gauges sites 10-13 June 2014

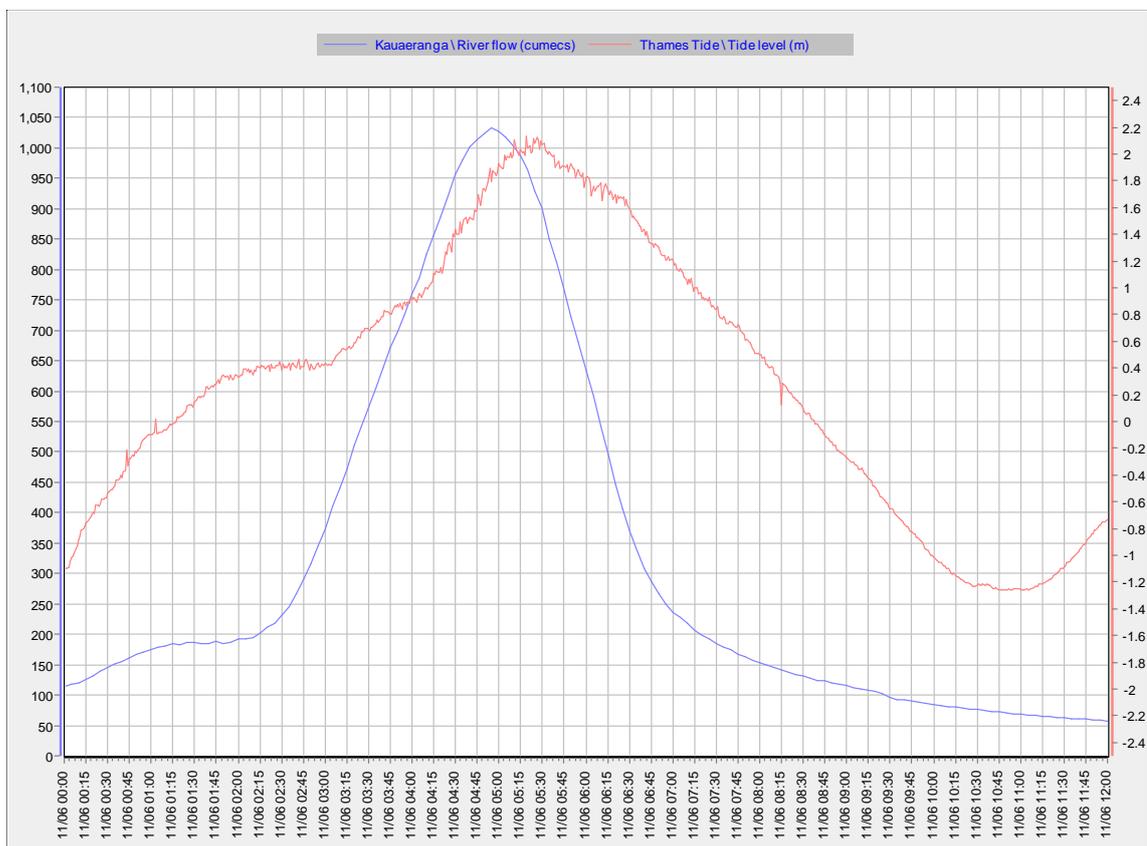
Figure 4: Flow recorded at Kauaeranga gauge and Tararu tide levels midday 10 June to midday 11 June 2014

At the gauge site the flow peaked at 04:55 on 11 June at 1033 m³/s (Figure 4) with a level of 11.77 m. The spillway was likely active for approximately two to three hours in the early hours between 03:00 and 06:00 hours. The high flows coincided with the high tide recorded at the Tararu tide gauge of 2.13 m at 05:19 on 11 June (Figure 4). A significant storm surge component is also noted with water levels 0.5 m to 0.7 m greater than the preceding and following high tides as described in section 4.5.

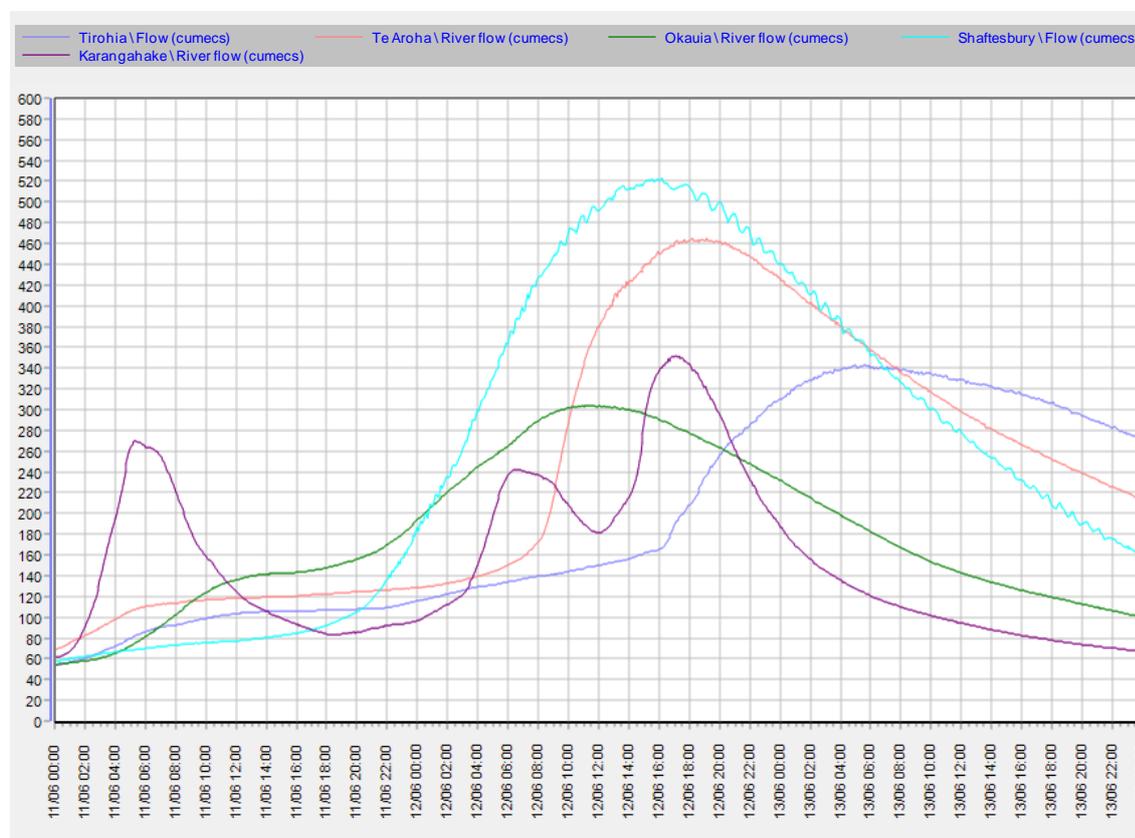
Figure 5: Flows recorded in the Waihou and Ohinemuri Rivers 11 June to 13 June 2014

Very high flows were experienced in the Waihou River during this event with peak flood levels occurring on 12 June (Figure 5).

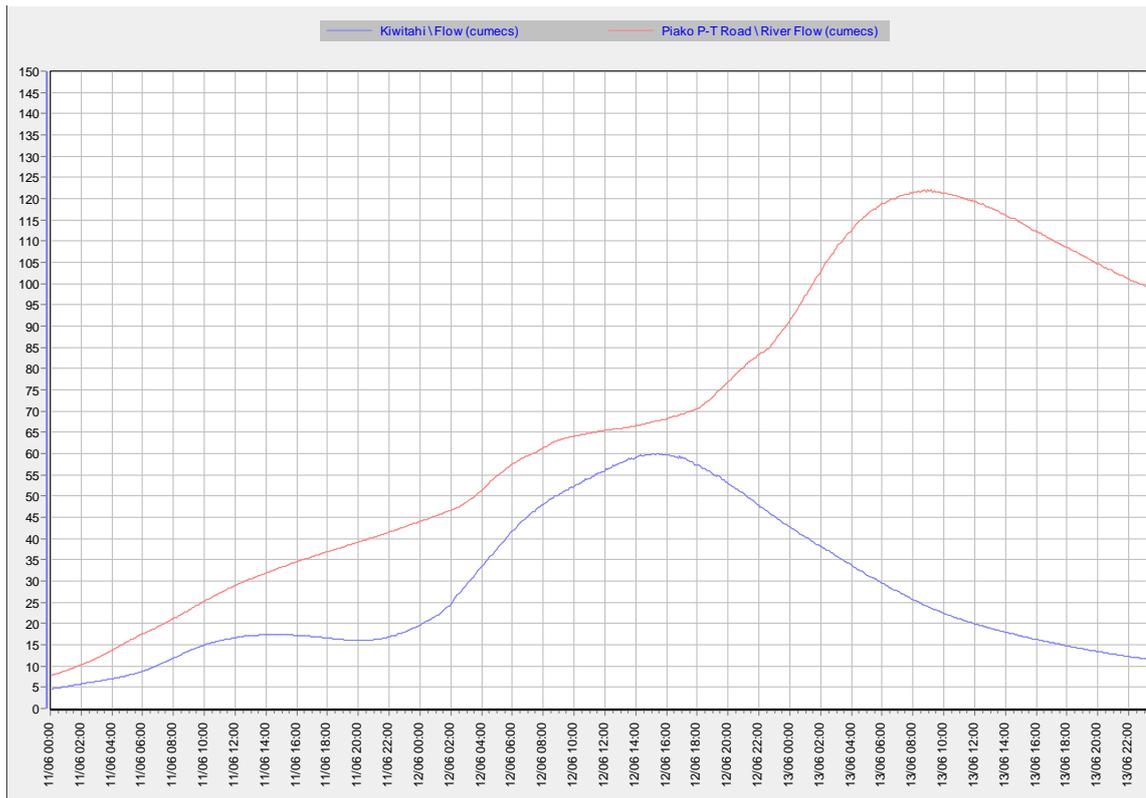
Figure 6: Flows recorded in the Piako River 11 June to 13 June 2014

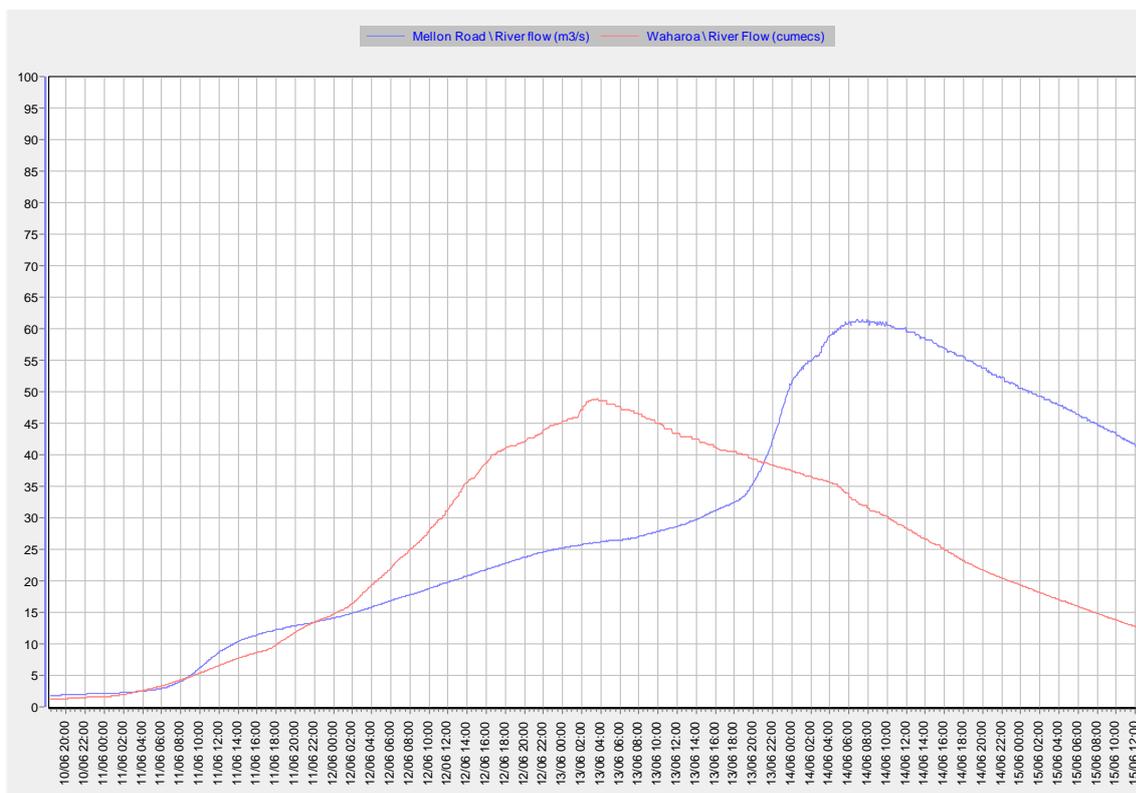
Figure 7: Flows recorded in the Waitoa River 11 June to 15 June 2014

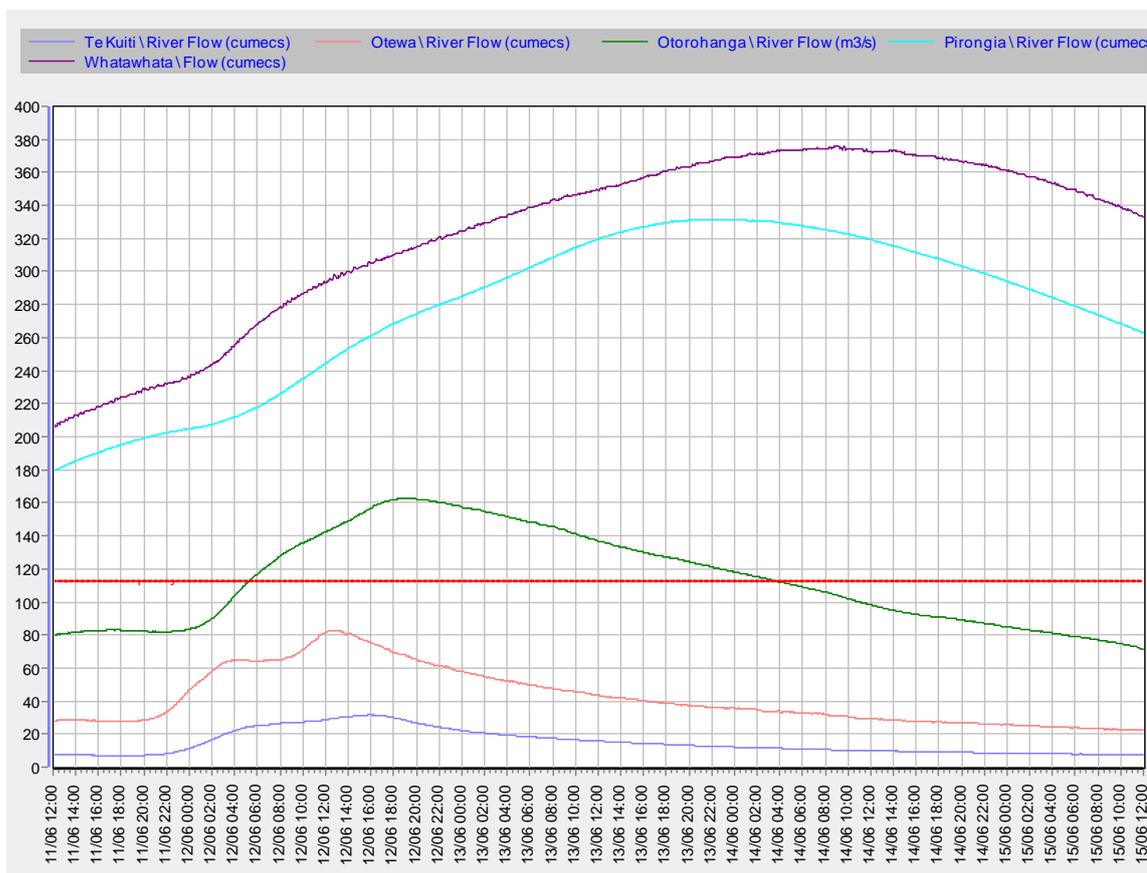
Figure 8: Flows recorded in the Waipa River 11 June to 15 June 2014

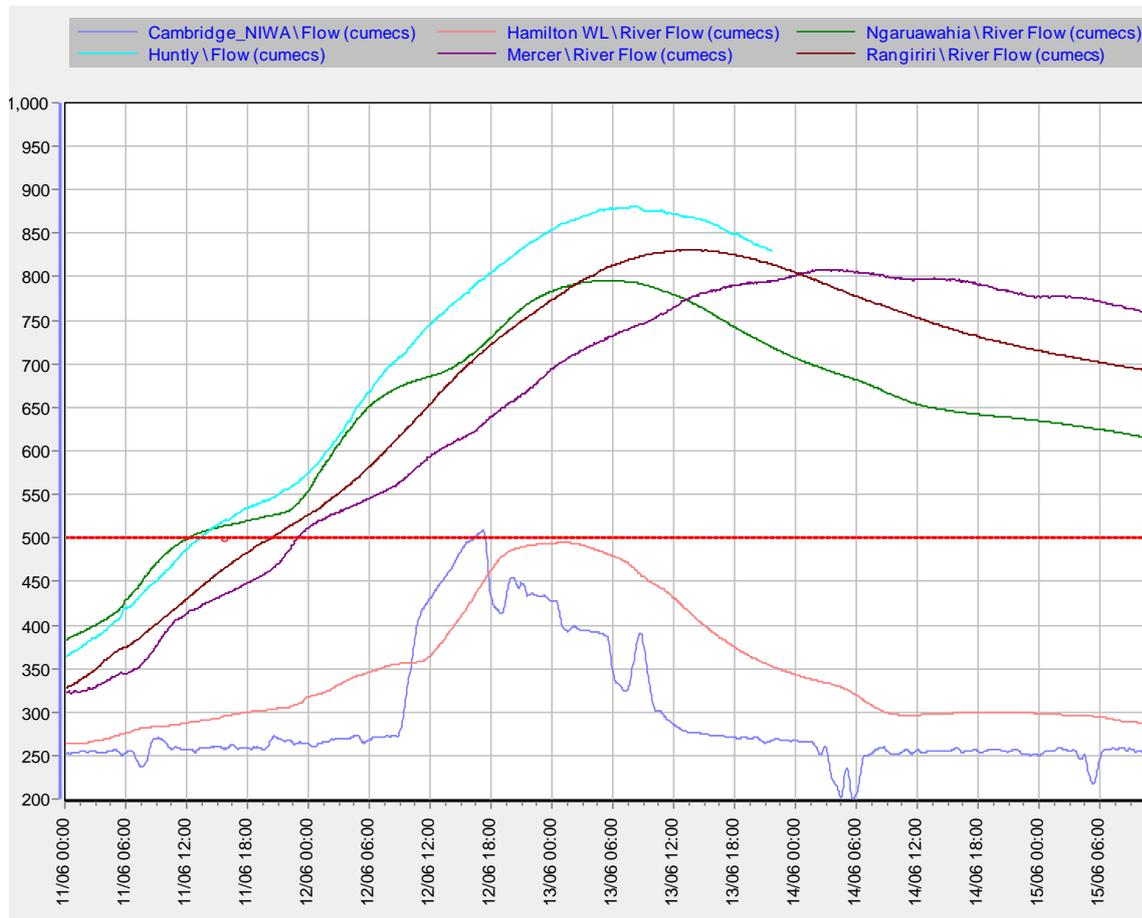
Figure 9: Flows recorded in the Waikato River 11 June to 15 June 2014

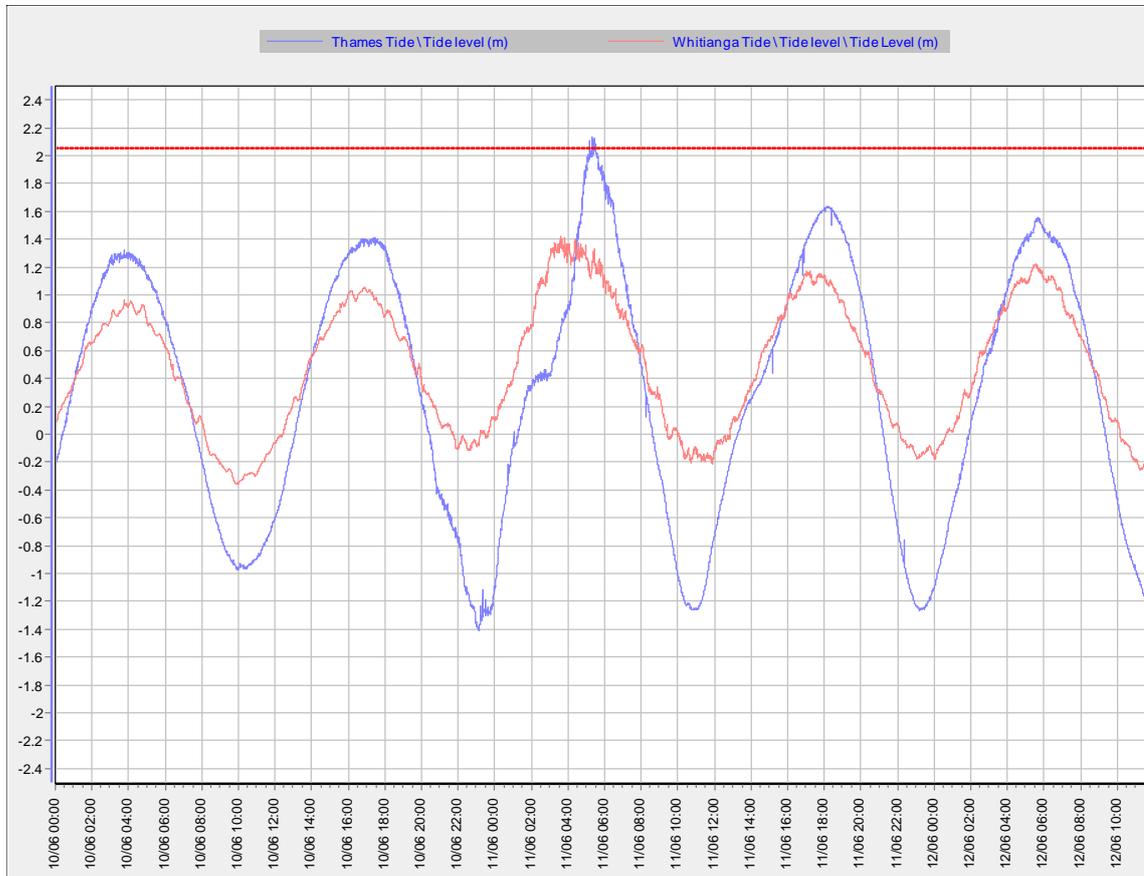
Figure 10: Thames and Whitianga tide gauge levels for the period 10 June to 12 June 2014

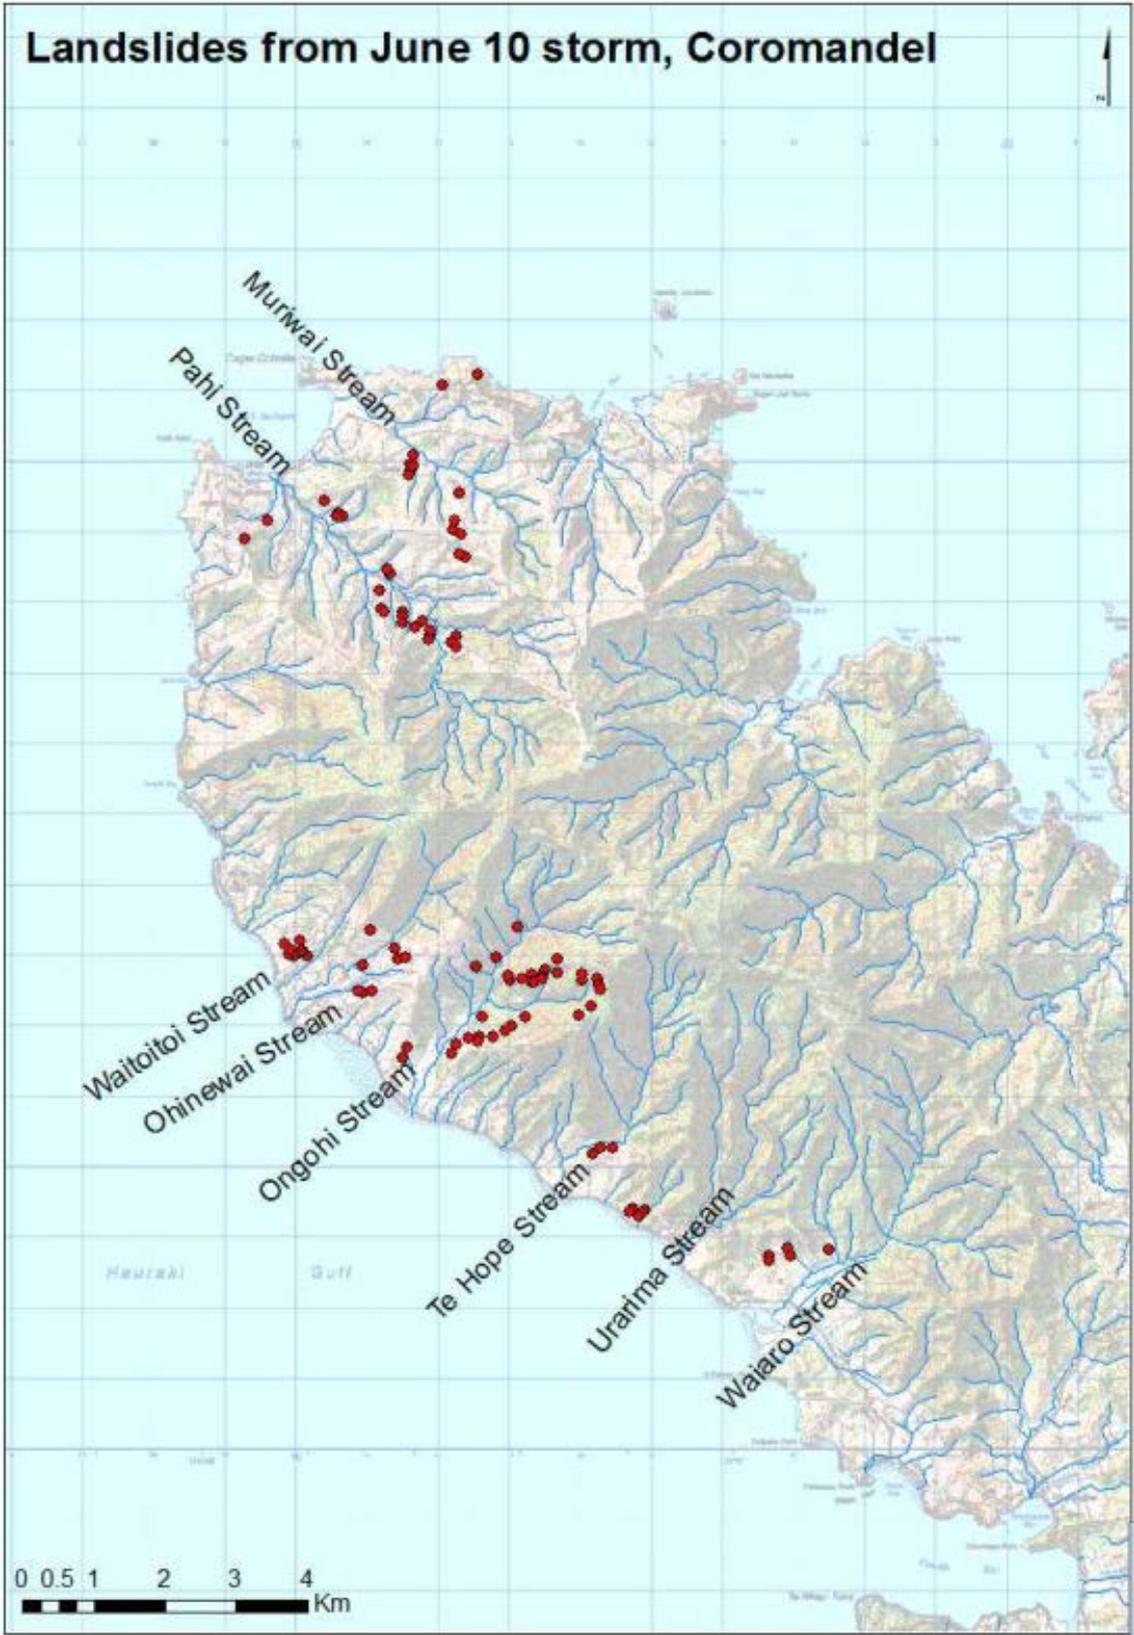
Figure 11: Map of catchment landslides based on helicopter footage/photos taken on flights into these areas – not reflective of landslides over the region as a whole (source: Aerial footage recorded by Kerry Smith, Waikato Regional Council and mapping by Brenda Rosser, GNS)

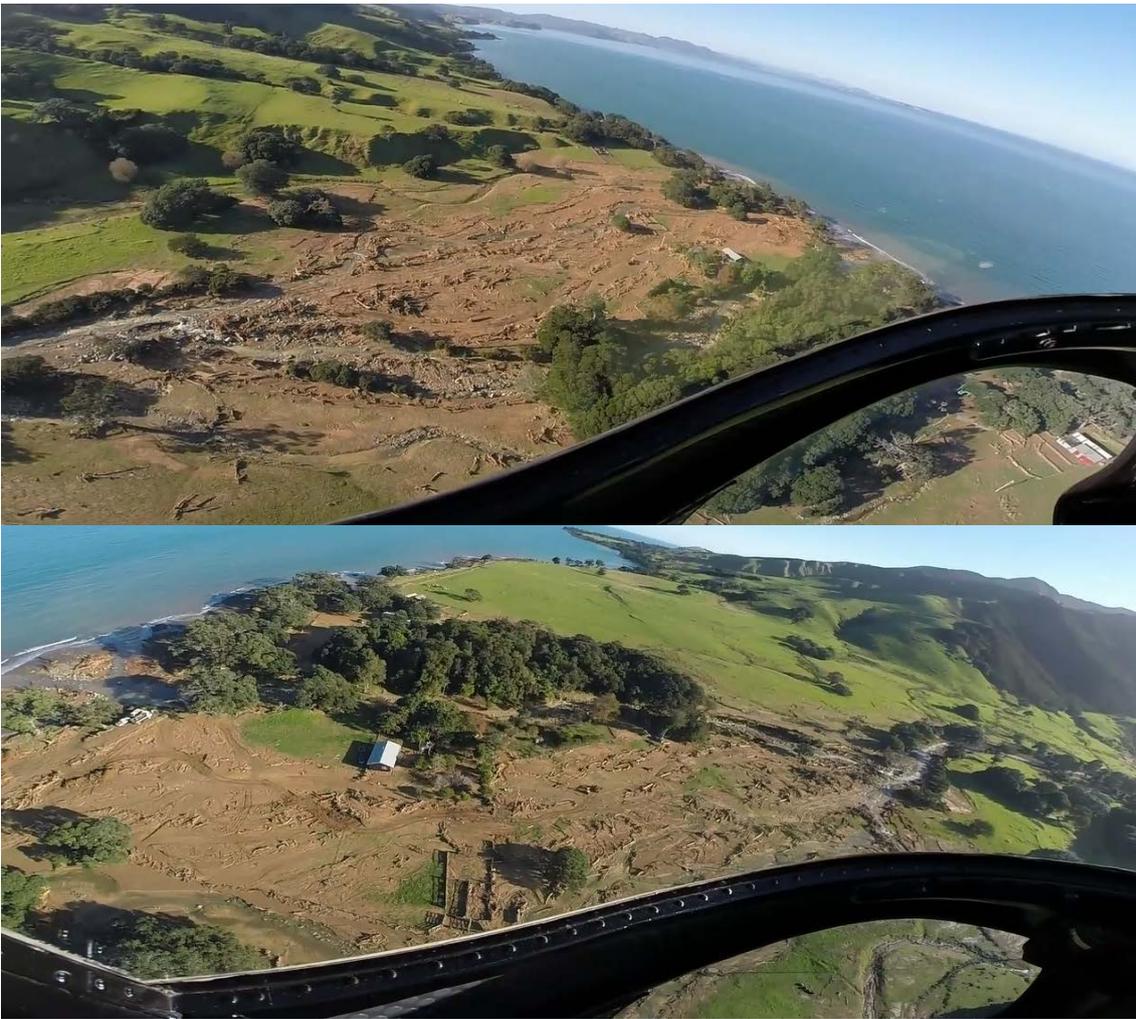
Figure 12: - Ongohi Stream floodplain debris and silt deposition

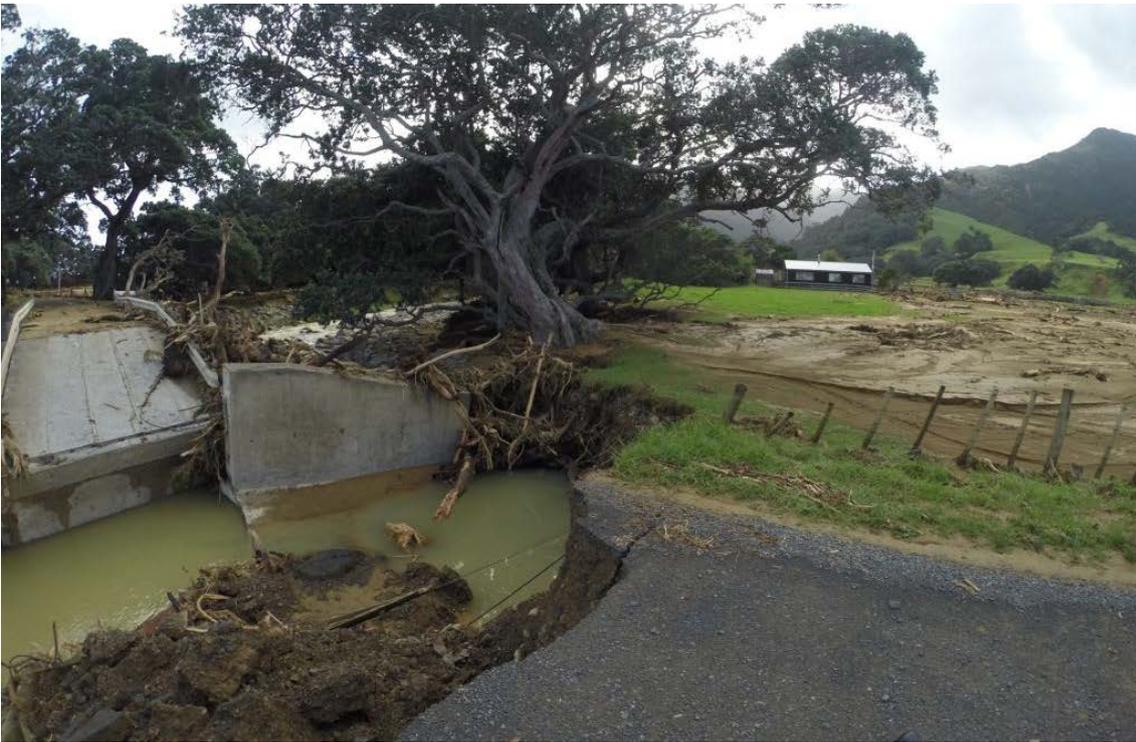
Figure 13: - Ongohi stream bridge damage

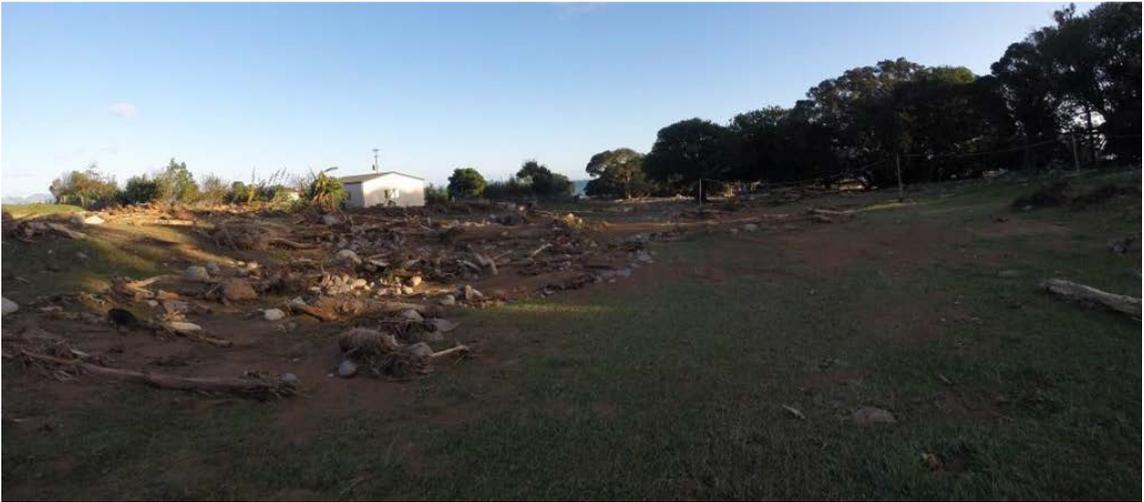
Figure 14: - Ohinewai stream damage

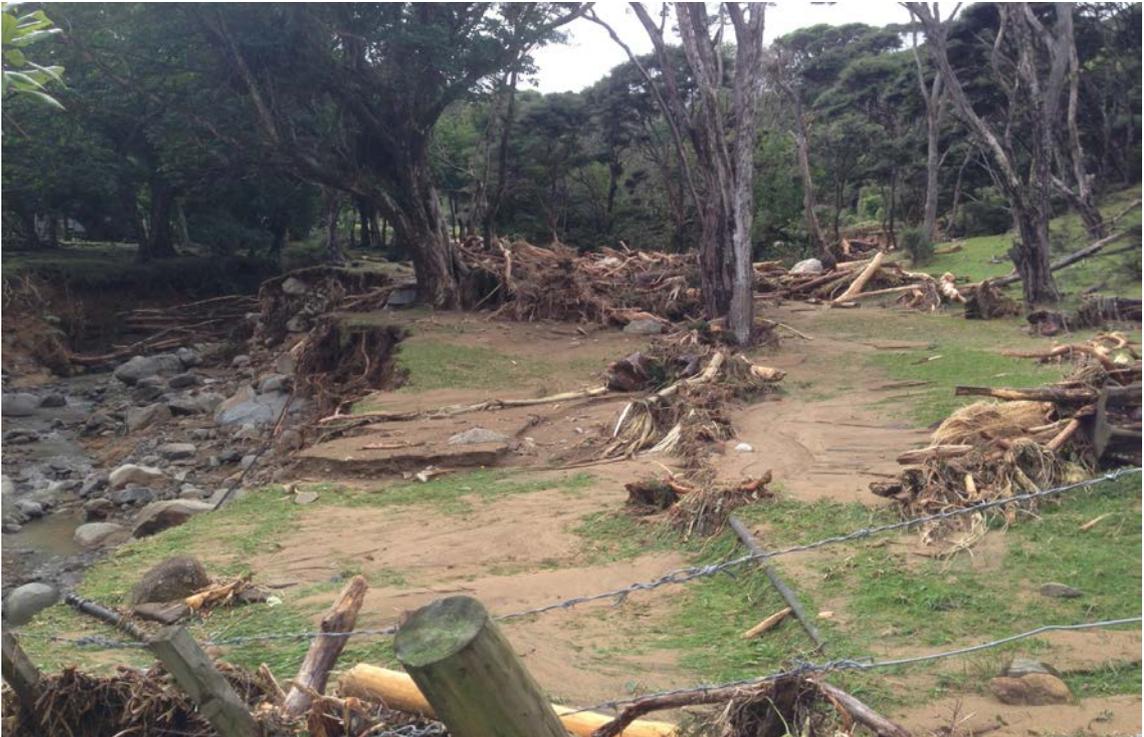
Figure 15: - Darkie stream damage

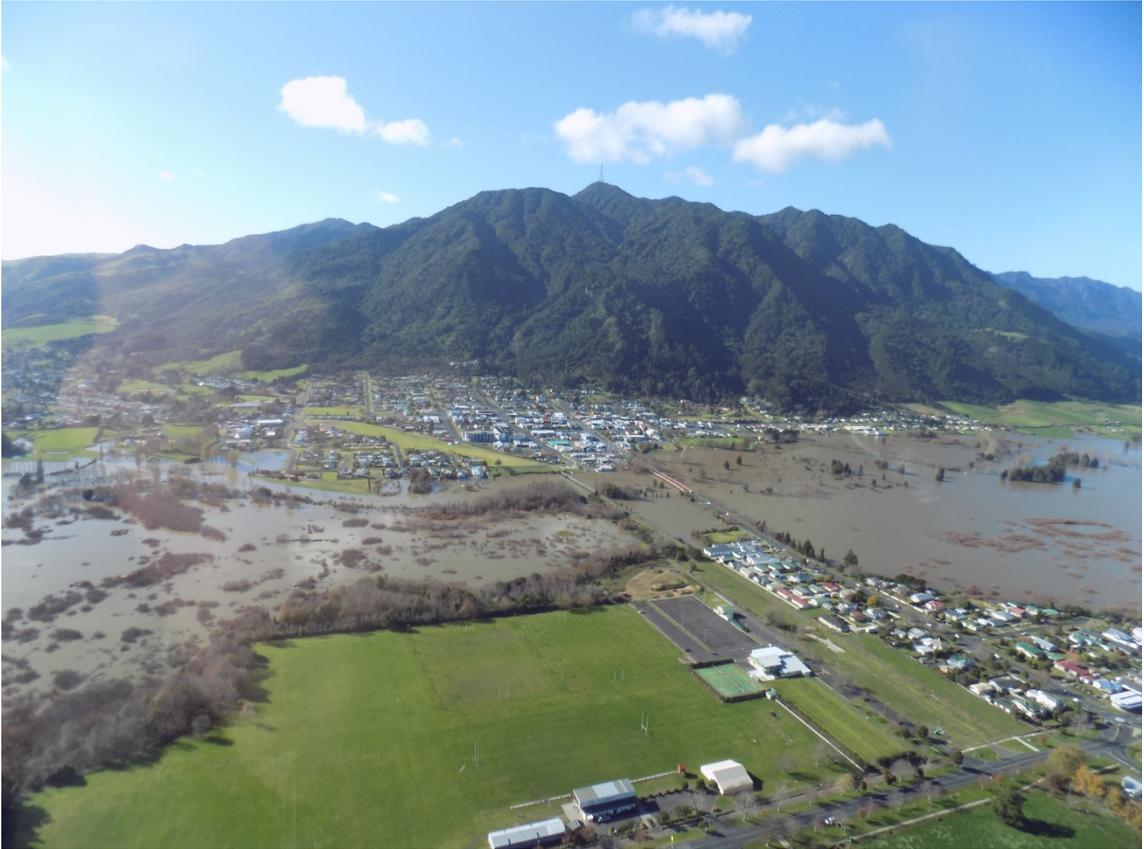
Figure 22: Waihou River –Te Aroha

Images of the flood inundation from the event are shown in Figure 17 to Figure 23

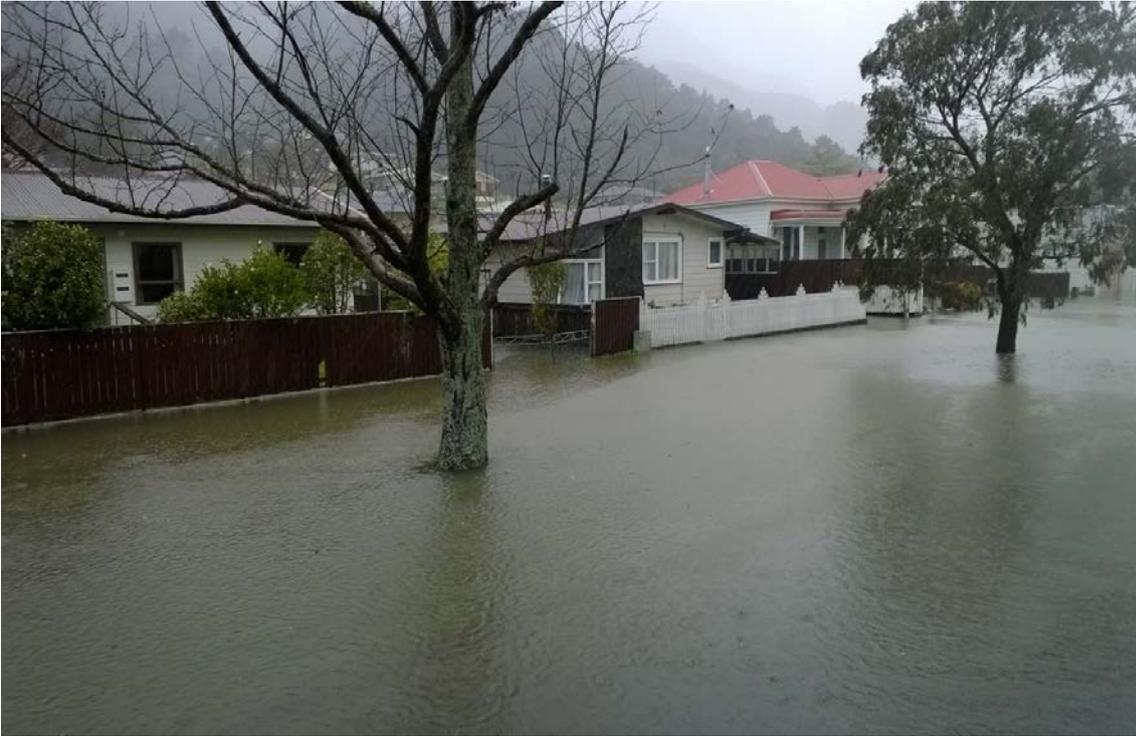
Figure 23: Waihou River – Rewi Street, Te Aroha

observed flood extents particularly in the Rewi Street area where residential properties received inundation.
