Geothermal features annual monitoring report - January 2014

For:
Waikato Regional Council
Private Bag 3038
Waikato Mail Centre
HAMILTON 3240

25 September 2014

Document #: 3133084

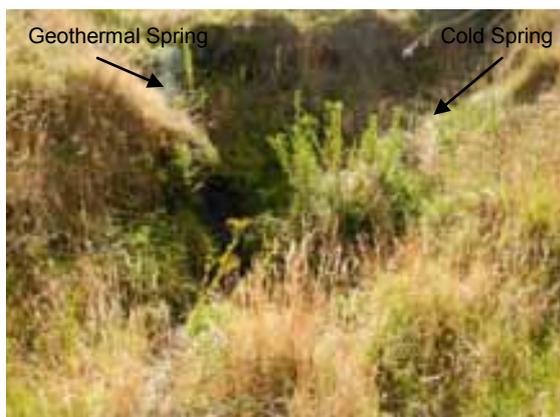
Figure 1: Matapan Road geothermal spring at Atiamuri taken in Feb 2014

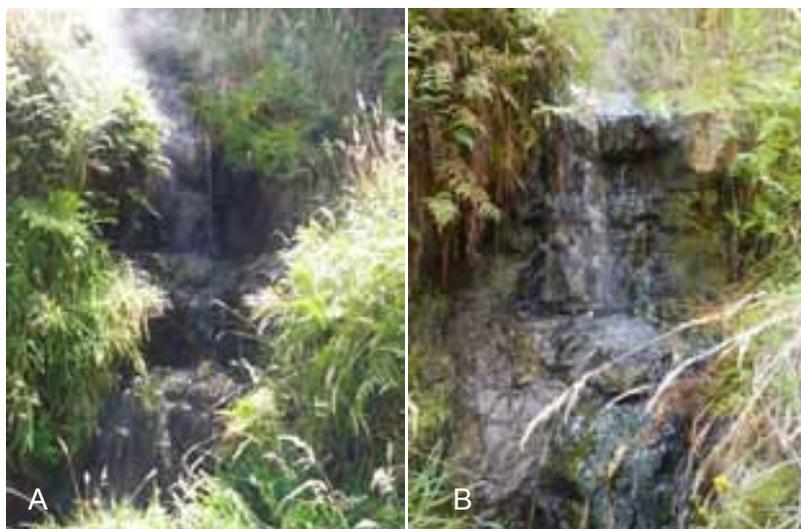
Figure 2: Matapan Road geothermal spring at Atiamuri taken in Jan 2013 (A) and Feb 2014 (B)

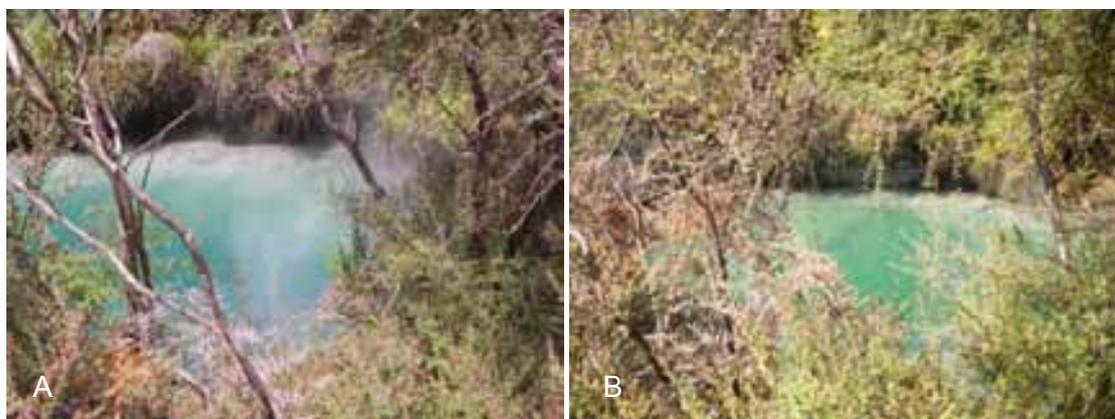
Figure 3: Northern Whangapoa Pool in Jan 2013 (A), Feb 2014(B), Atiamuri

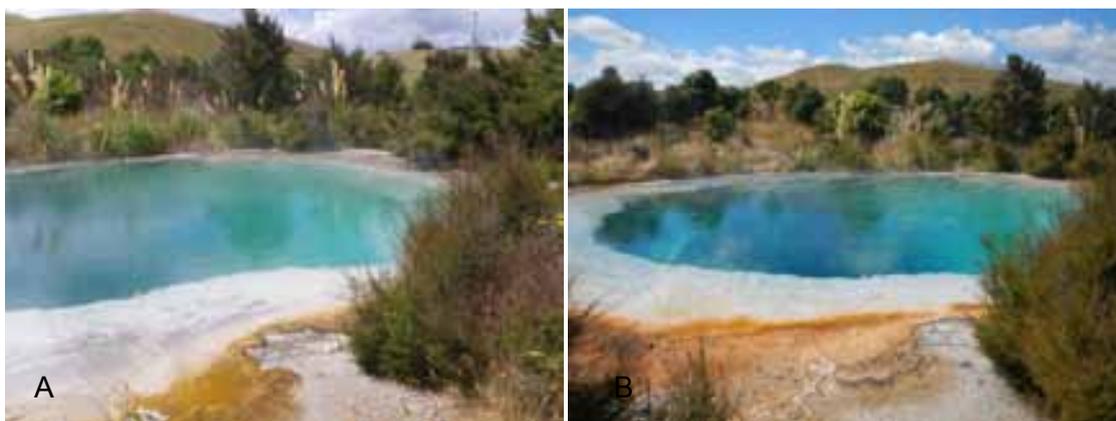
Figure 6: Southern Pool, Whangapoa Pools in Jan 2013 (A), Feb 2014 (B), Atiamuri

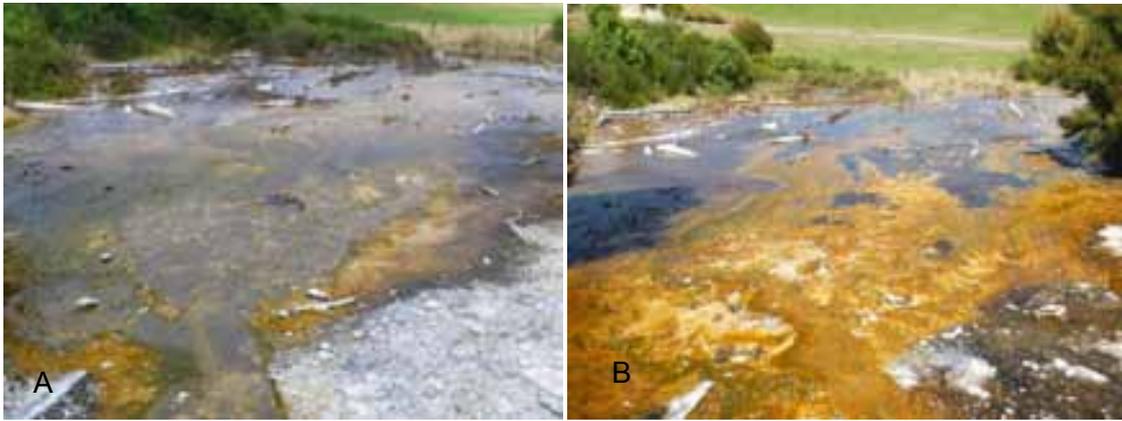
Figure 7: Sinter apron, Southern Whangapoa Pool, Jan 2013 (A), Feb 2013 (B), Atiamuri

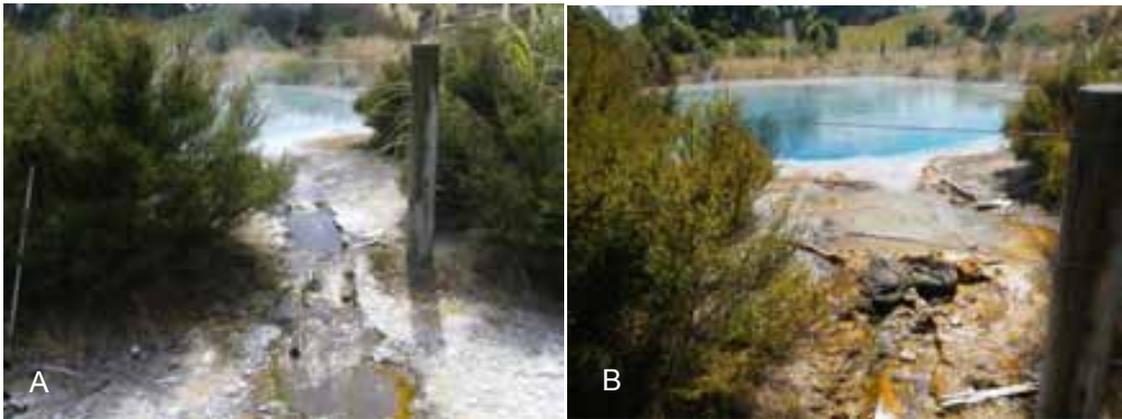
Figure 8: Outlet, Southern Whangapoa Pool, Jan 2013 (A), Feb 2014, Atiamuri

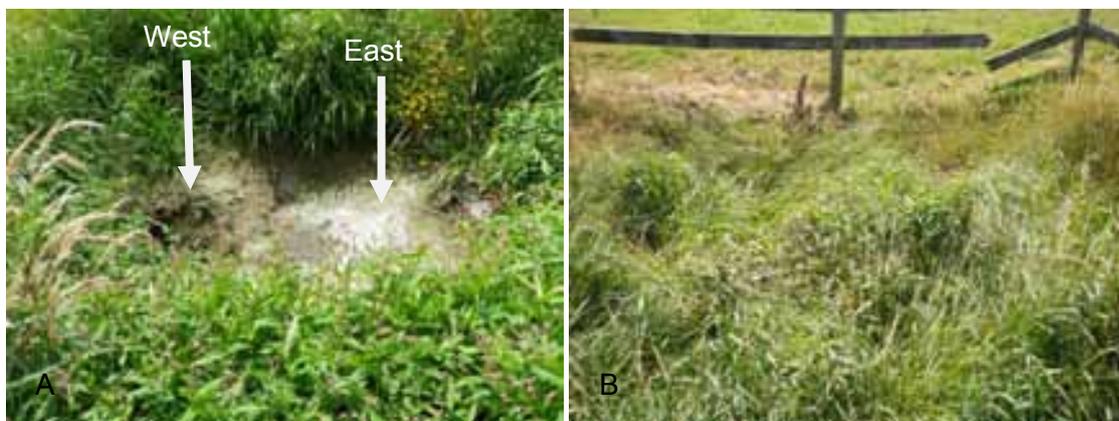
Figure 10: Mud pools off Ohakuri Rd, Jan 2013 (A); Feb 2014 (B), Atiamuri

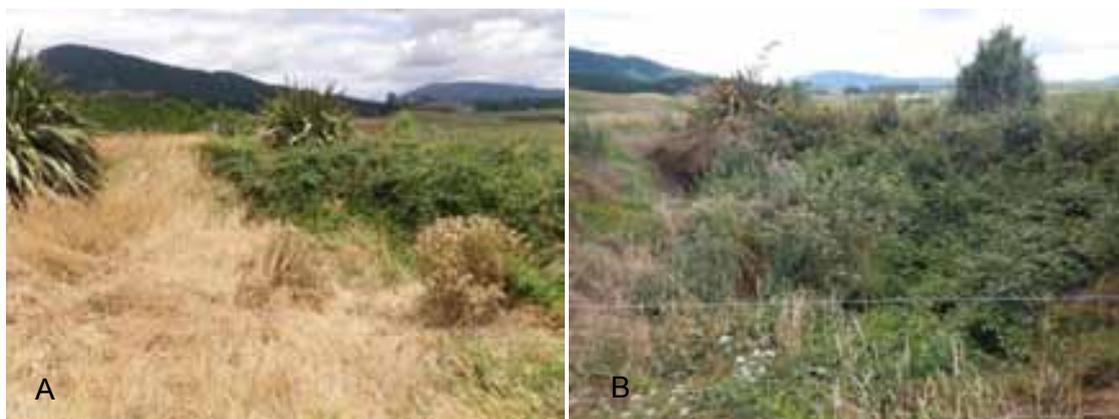
This feature has been filled with logs. During the January 2013 visit, it was noted that the feature was warm. It reached a temperature of 50 °C in the centre of the crater. During the February 2014 visit, the temperature was reading 27 °C in the centre of the crater. The ground outside of the fence appears to be subsiding, and the crater may be sinking.

Figure 11: Berg's Crater, Jan 2013 (A); Feb 2014 (B), Atiamuri

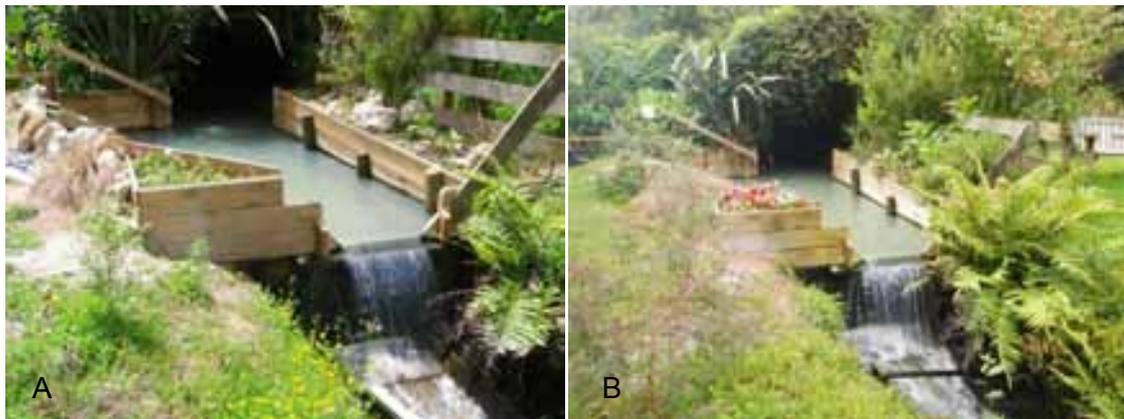
Figure 12: North Pool, Golden Springs Motel in Jan 2013 (A), Feb 2014 (B)

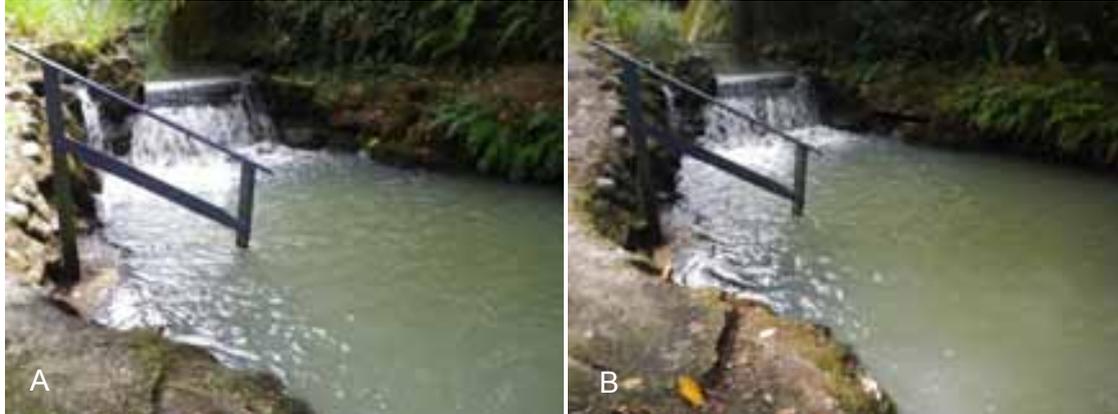
Figure 14: South Pool, Golden Springs Motel in Jan 2013(A), Feb 2014 (B)

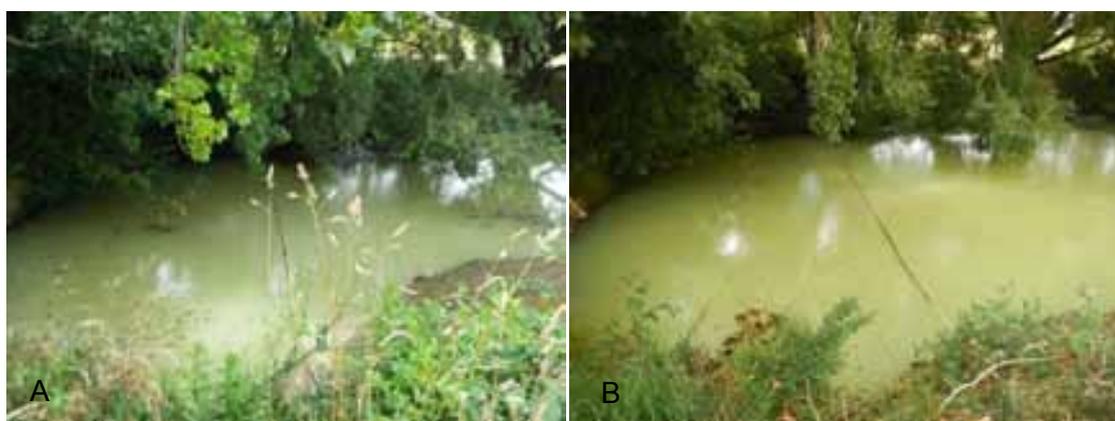
Figure 16: Feature 3, Golden Springs in Jan 2013 (A), Feb 2014 (B)

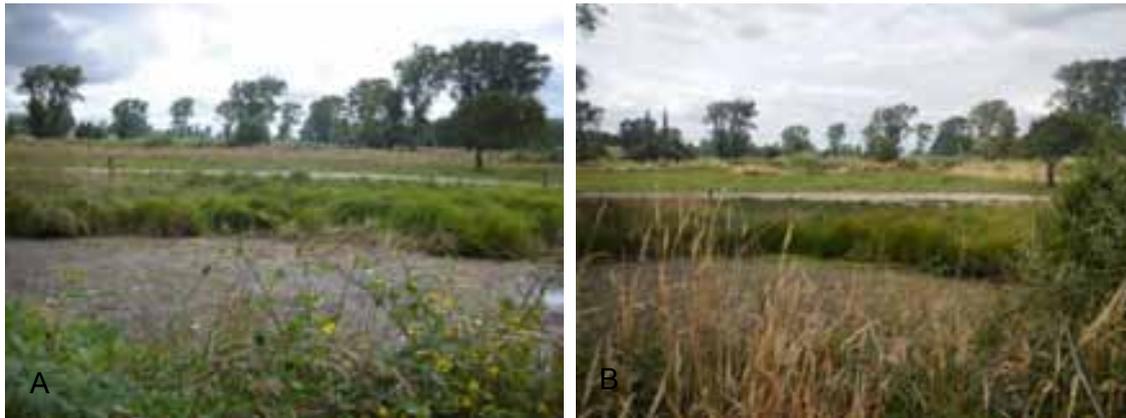
Figure 18: Feature 4, Golden Springs in Jan 2012 (A), Feb 2014 (B)

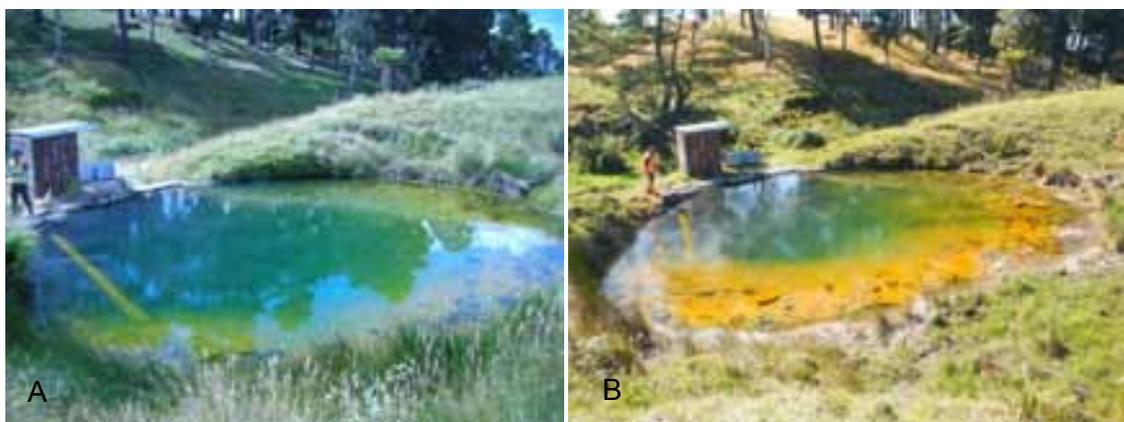
Figure 19: Waipupumahana Pool, Horohoro in Jan 2013 (A), Jan 2014 (B)

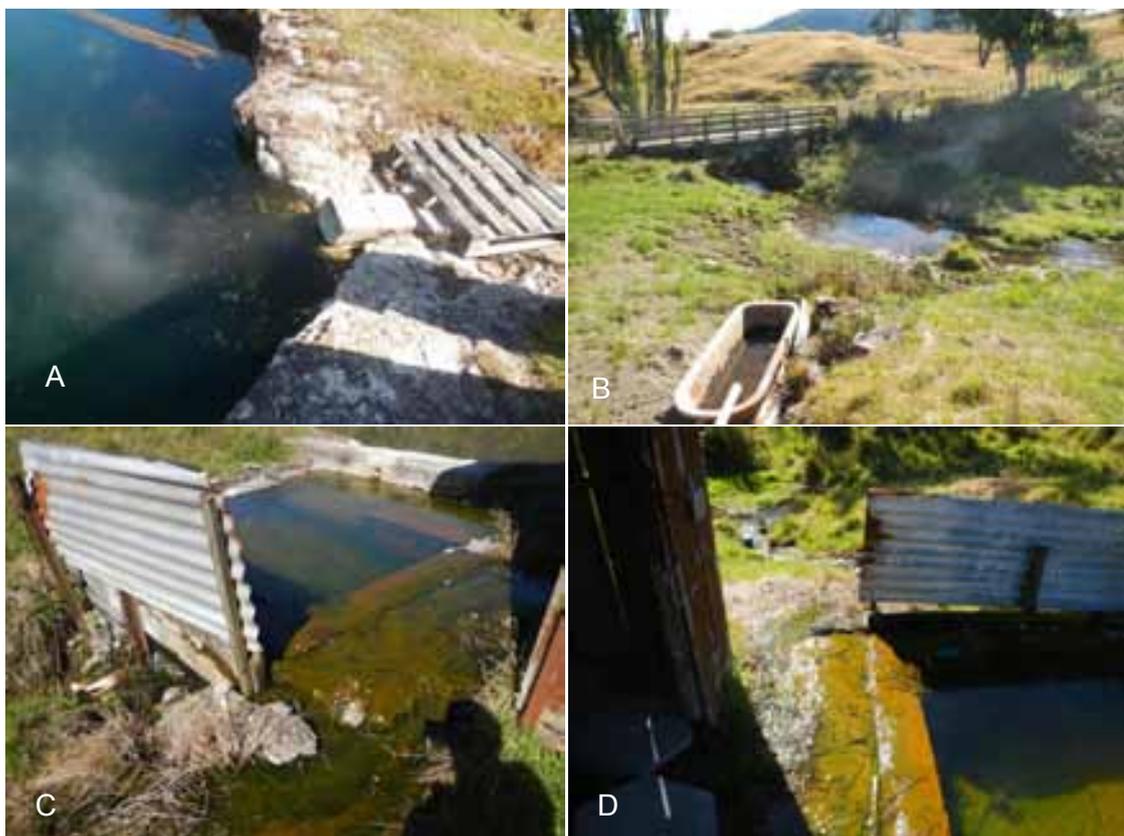
Figure 20: Old (A&B) and New (C&D) outlets, Waipupumahana Pool, Horohoro

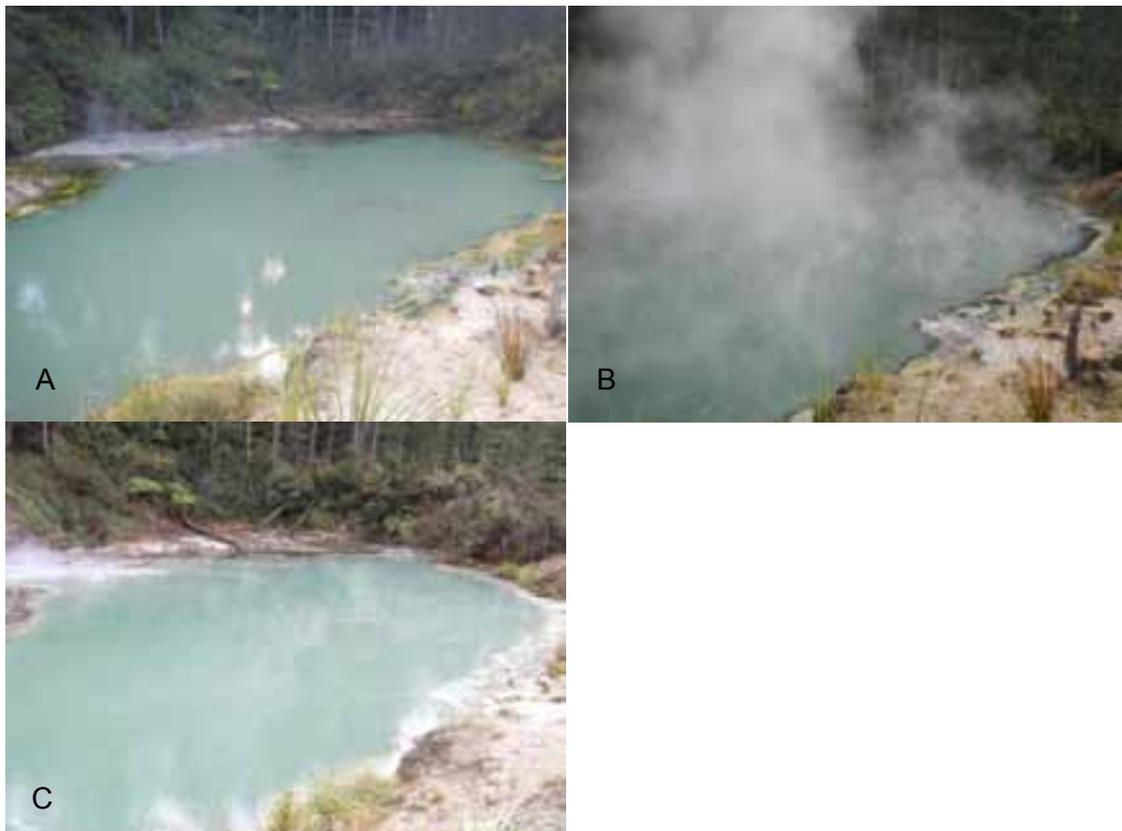
Figure 22: Large Pool: Overview, Apr 2013 (A), June 2013 (B), Sept 2013 (C)

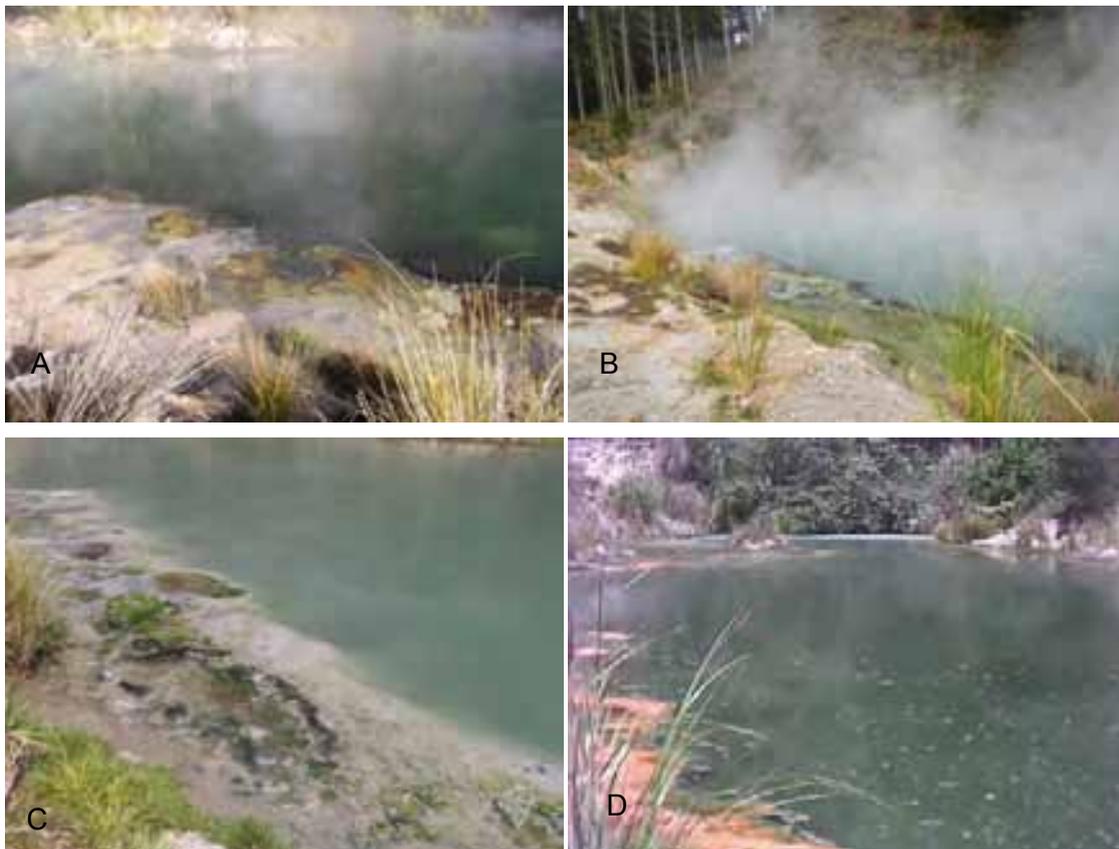
Figure 23: Large pool gas discharge, Apr 2013 (A), June 2013 (B), Sept 2013 (C), Jan 2014 (D)

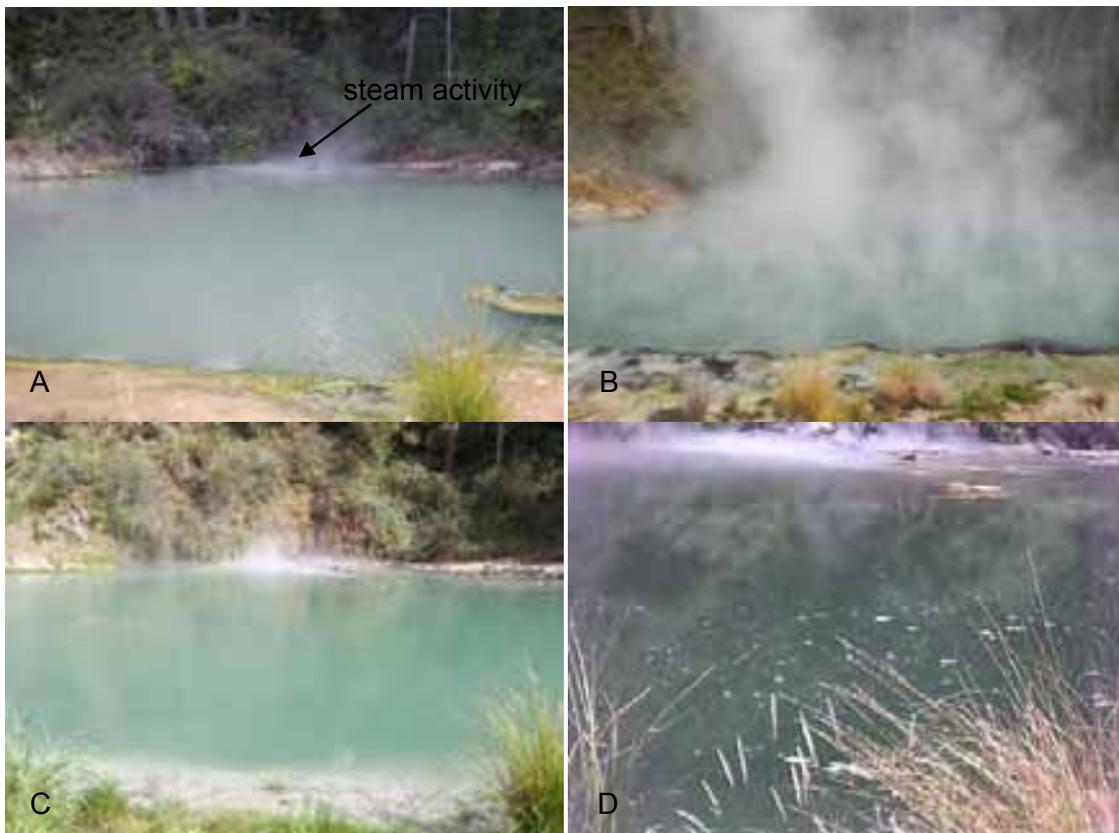
Figure 24: Steam at large pool, Apr 2013 (A), June 2013 (B), Sept 2013 (C), Jan 2014 (D)

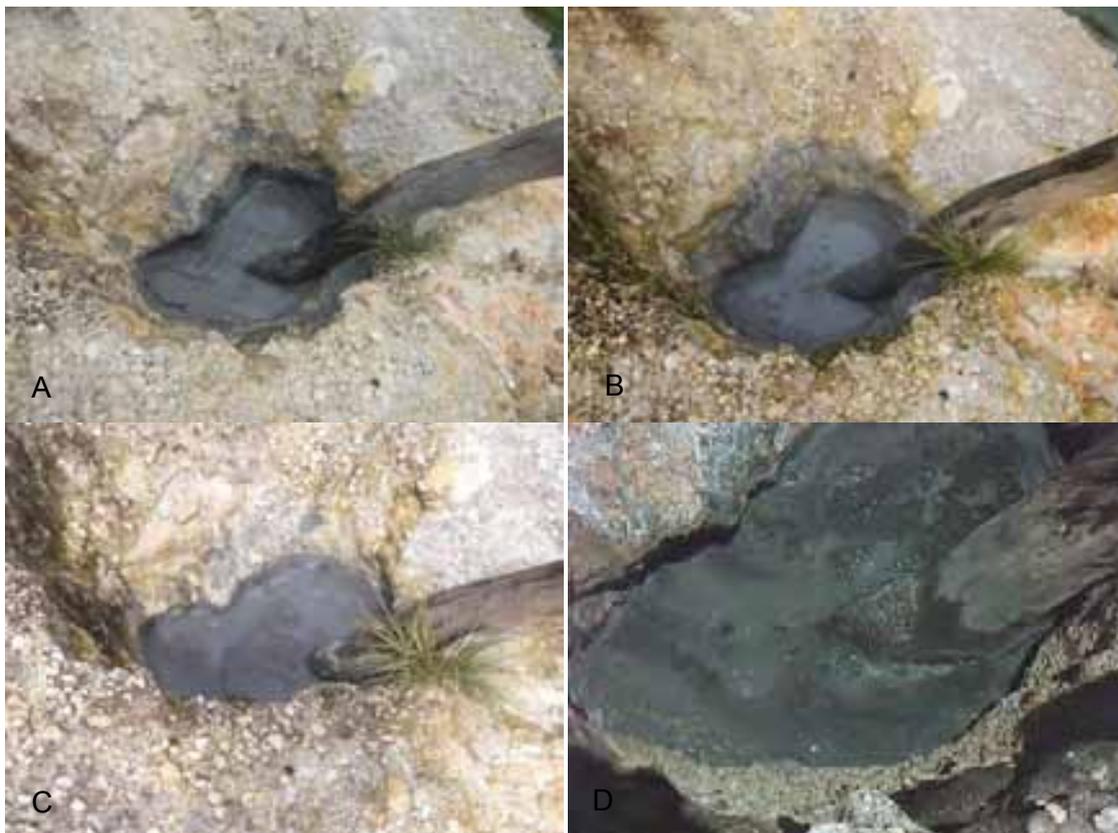
Figure 27: Mud Pool, Apr 2013 (A), June 2013 (B), Sept 2013 (C), Jan 2014 (D)

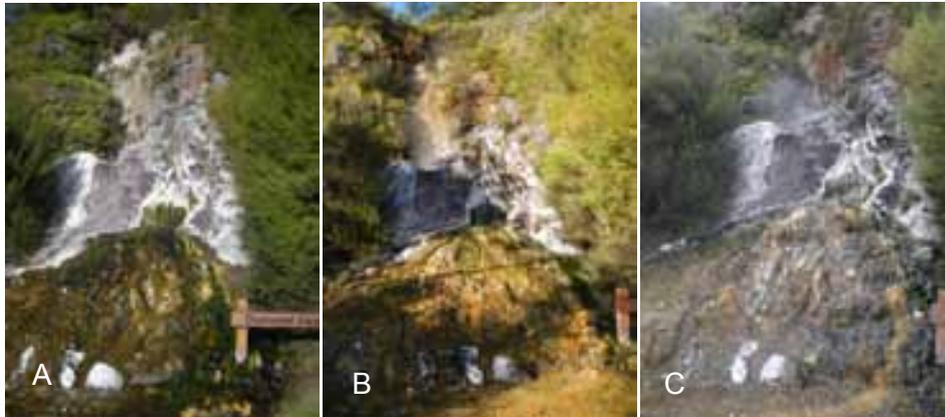
Figure 31: Diamond Geyser, Apr 2013 (A), June 2013 (B), Sept 2013 (C)

The temperature has been consistent throughout the visits. The pH fluctuated between pH 6 and pH 7. The flow had increased from a seep in January 2014. The January 2014 photos have been taken with the IR camera due to technical issues.

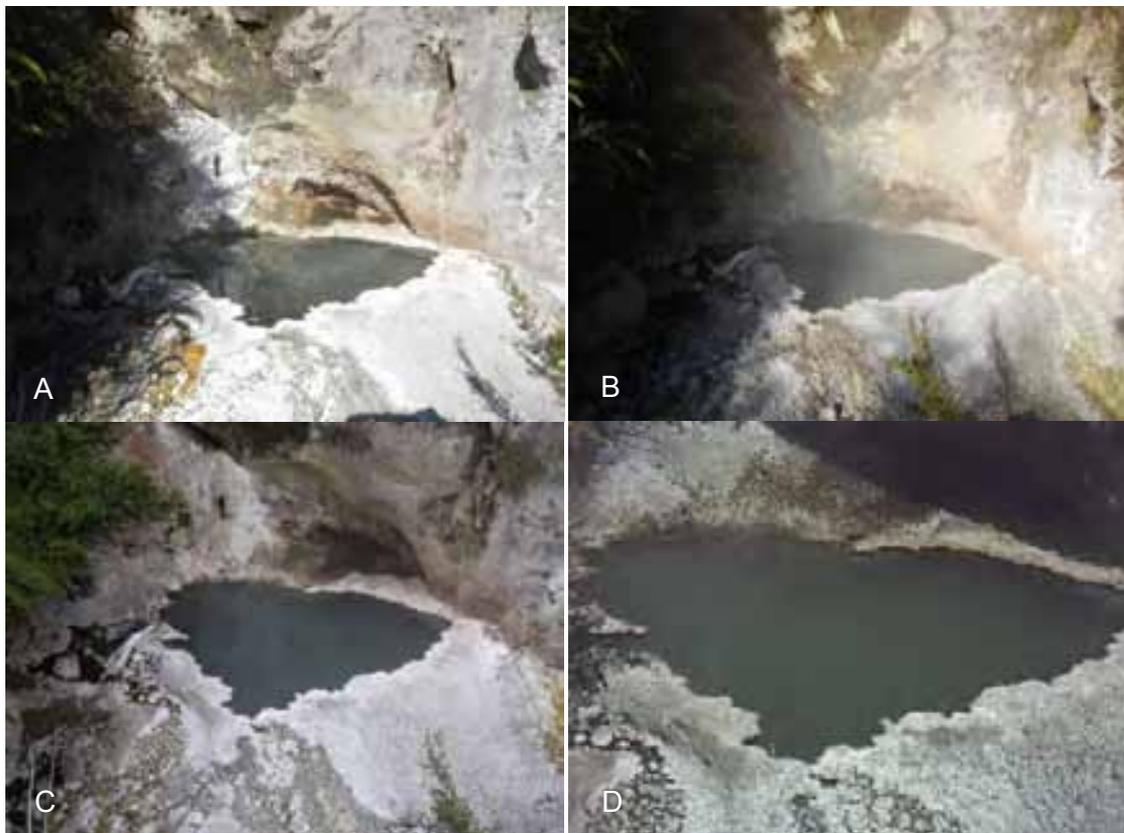
Figure 36: Pool beside Diamond, Apr 2013 (A), June 2013 (B), Sept 2013 (C) Jan 2014 (D)

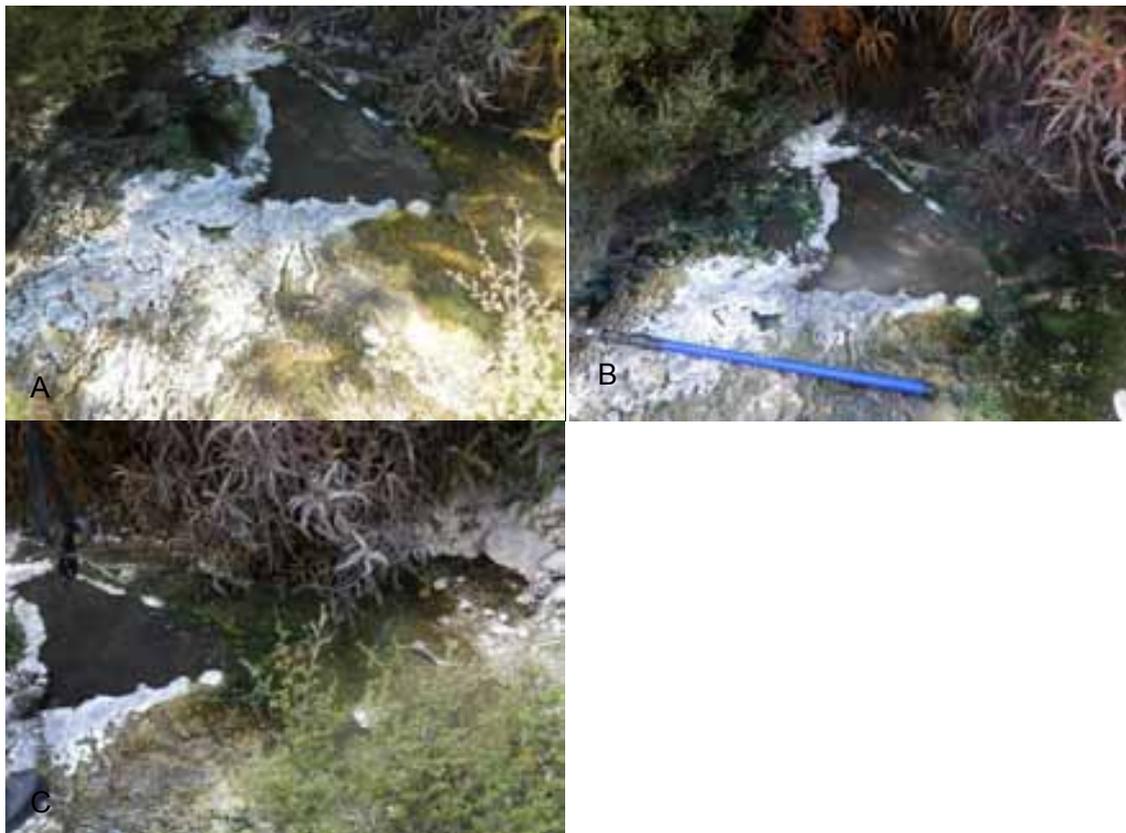
The small pool to the left of the diamond geyser appears to be increasing in size. In April 2013, the temperature reading was 65.4 °C and in June 2013 the temperature was 63.8 °C. There was a reading of pH 6 on both occasions. In January 2014, there was an increase in activity in the area to the left of the diamond geyser. A new geyser may have formed, as there was an abundance of steam and flow periodically pouring down the hill. The soil structure in the area has been degraded by either the flow from above or a new fumarole opening up. The area of increased activity is on the left of the small pool (depicted in Figure 38) and in the bushes. It was not possible to access it.

Figure 38: Small pool beside Diamond Geyser, Orakei Korako, April 2013 (A), June 2013 (B) and Sept 2013 (C)

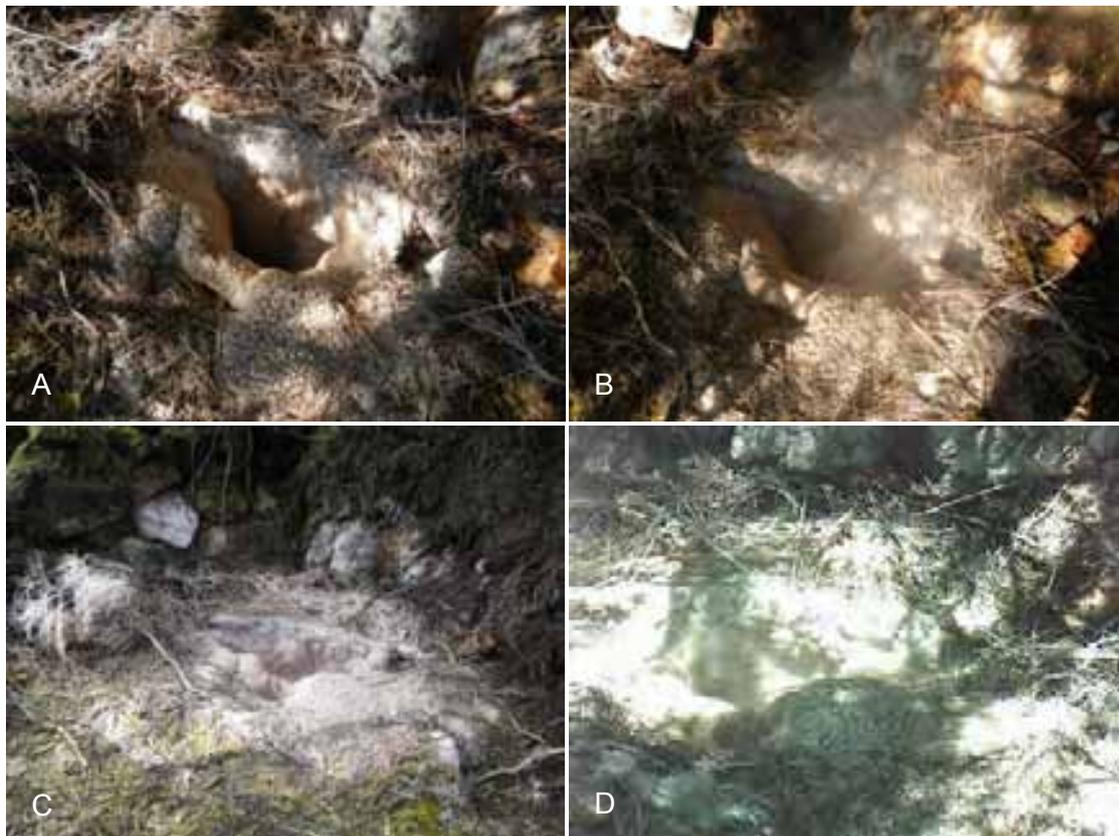
Figure 40: Bush Geyser, Apr 2013 (A), June 2013 (B), Sept 2013 (C), Jan 2014 (D)

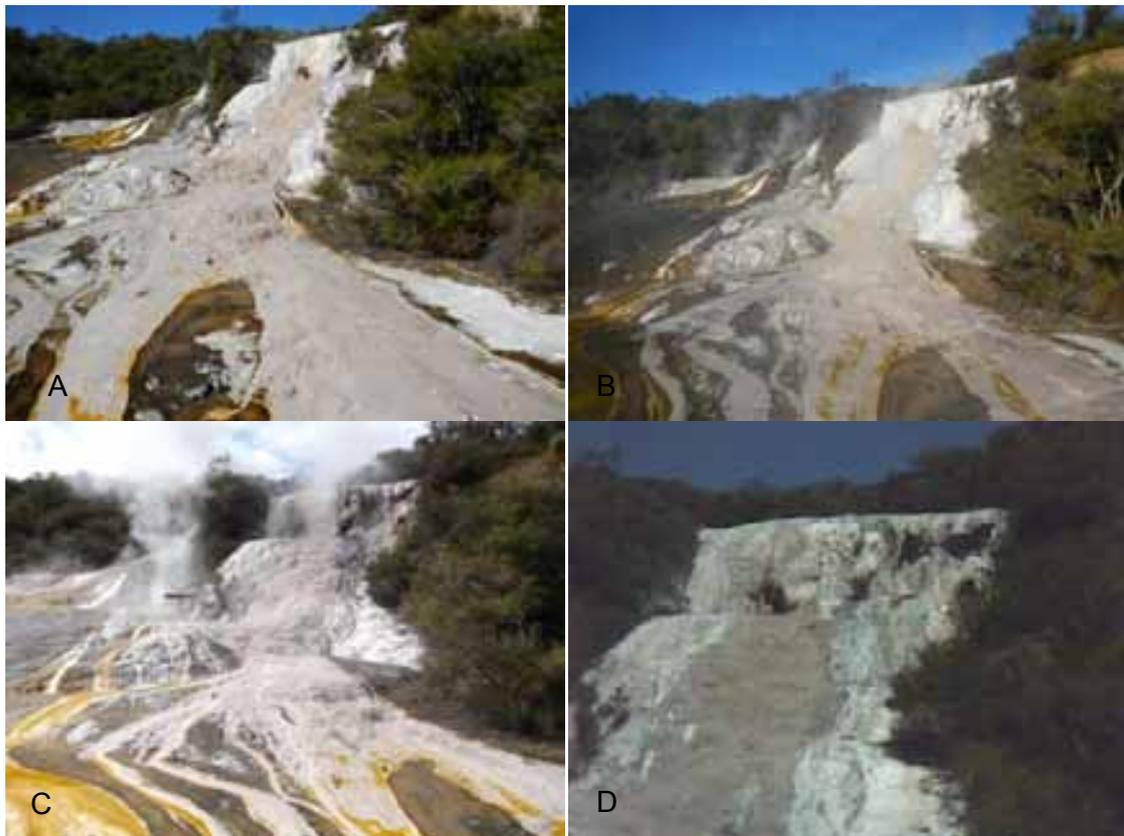
Jan 2014: Erupted at 13:46 and 13:50 for one minute each.

Figure 44: Cascade Geyser, Apr 2013 (A), June 2013 (B), Sept 2013 (C), Jan 2014 (D)

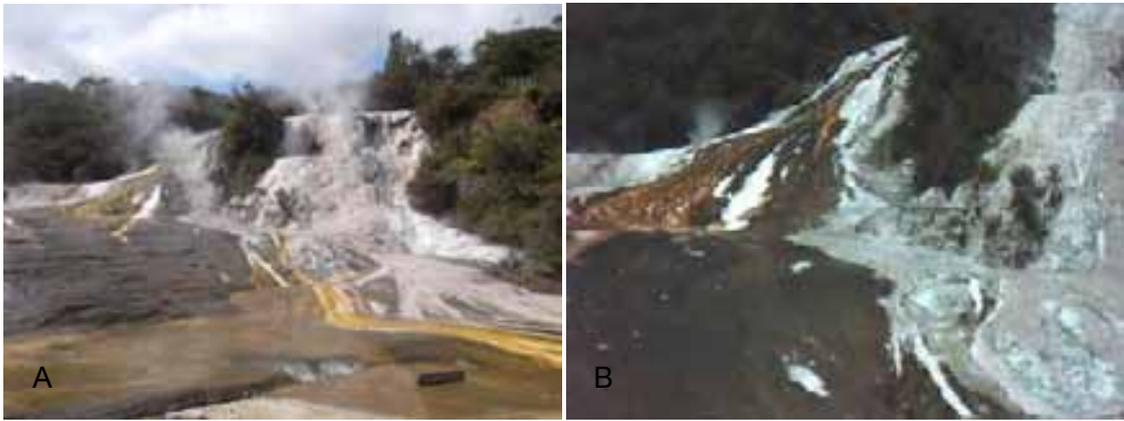
Figure 46: Sapphire Geyser, Orakei Korako in Sept 2013 (A) and Jan 2014 (B)

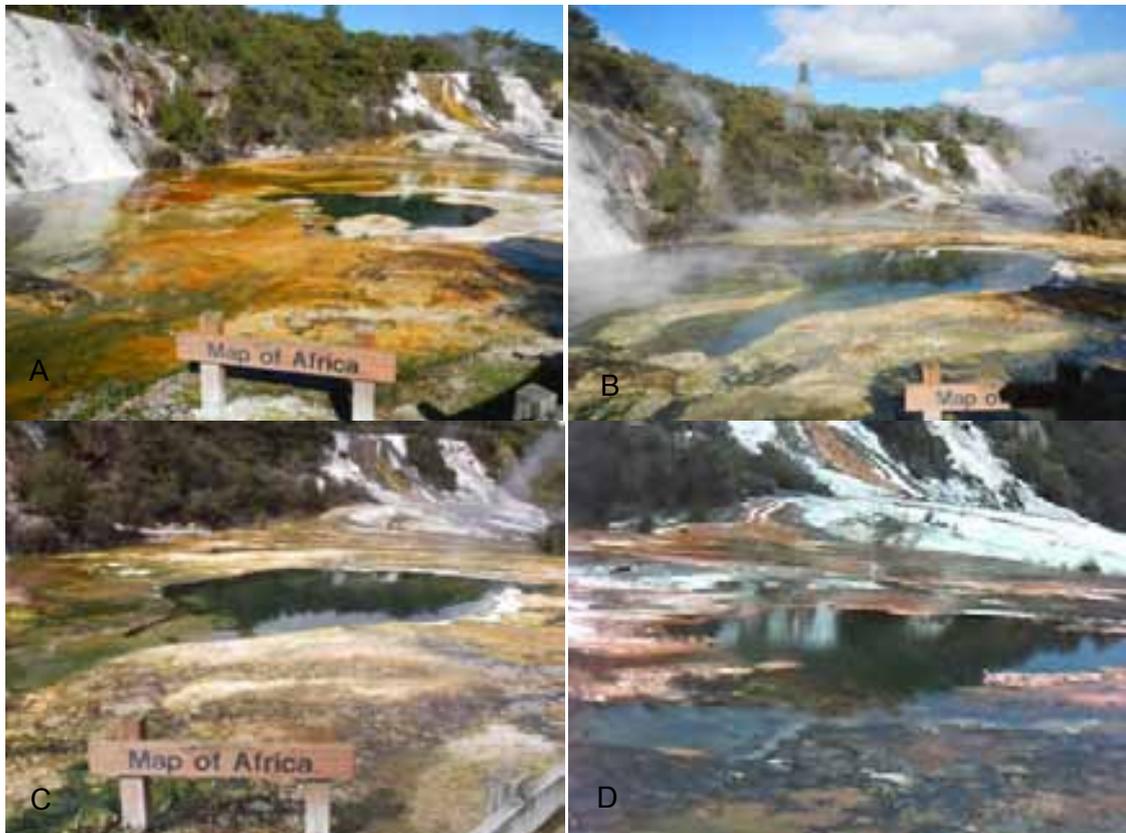
Various coloured algal mats were observed on the water surface during all of the monitoring visits. The area that the mats cover tends to vary at each visit. There was a slight amount of bubbling noticeable during the September 2013 visit compared to the calm surface of the other visits. The pH seems to vary from pH 7 to pH 8. The pool could not be reached to obtain a pH result on the April 2013 visit. The temperature seems to vary between monitoring periods, with the lowest being 33.1 °C during the June 2013 visit and highest of 45 °C during the April 2013 visit.

Figure 50: Map of Africa, Apr 2013 (A), June 2013 (B), Sept 2013 (C), Jan 2014 (D)

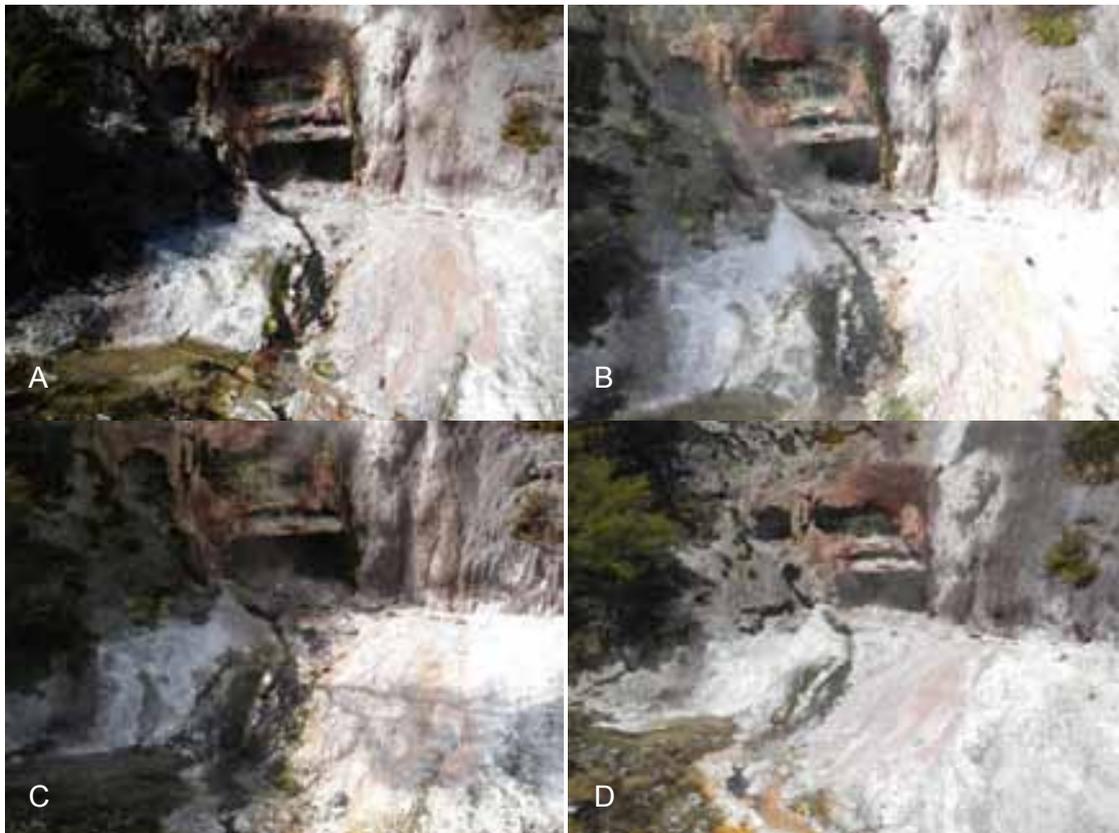
Figure 52: Devil's Throat, Apr 2013 (A), June 2013 (B), Sept 2013 (C), Jan 2014 (D)

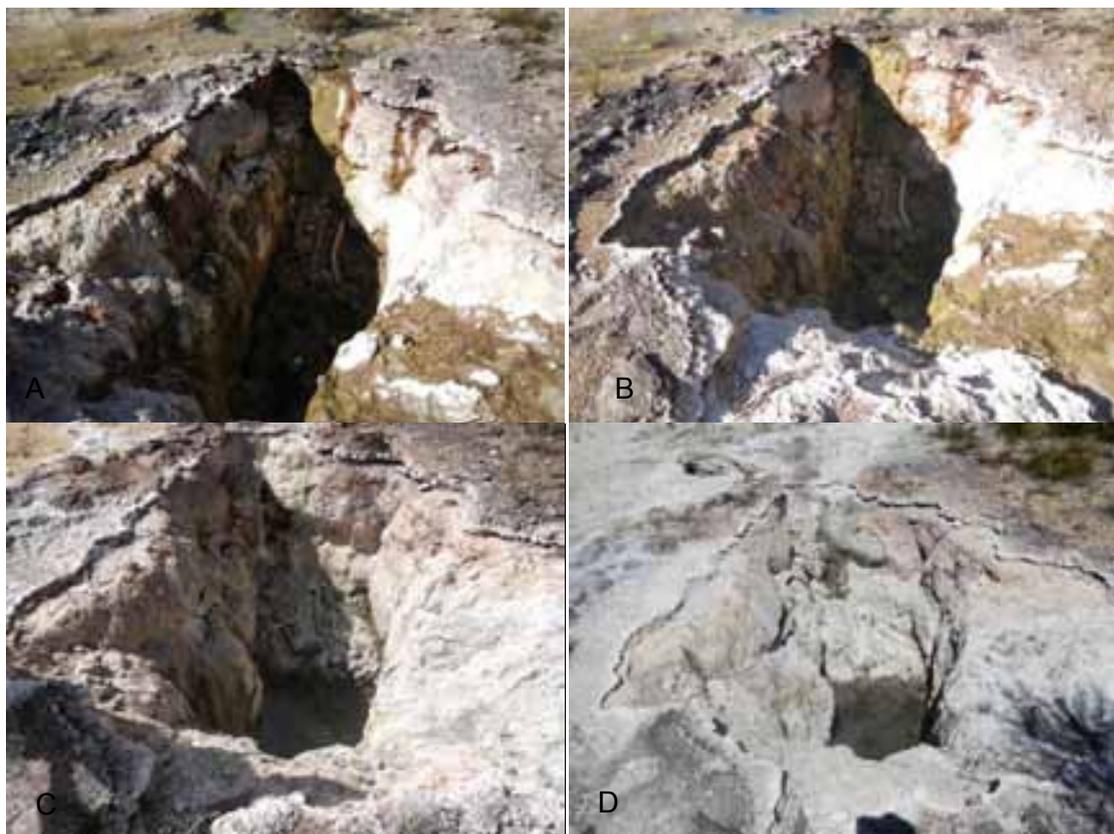
It was noted that the sides of the geyser appeared to have collapsed into the pool during the April 2013 visit. The only water within the geyser is from atmospheric inflow and a temperature was 20.3 °C. During the June 2013 visit there was a small amount of water seeping into the pool; however the geyser is dry and cold. The ground is subsiding to the left of the pool. By the September 2013 visit, water was returning to the pool, and the temperature was 67.4 °C. This had increased to 70.5 °C by January 2014.

Figure 56: Wairiri Geyser at Orakei Korako in Apr 2013 (A), June 2013 (B), Sept 2013 (C) and Jan 2014 (C)

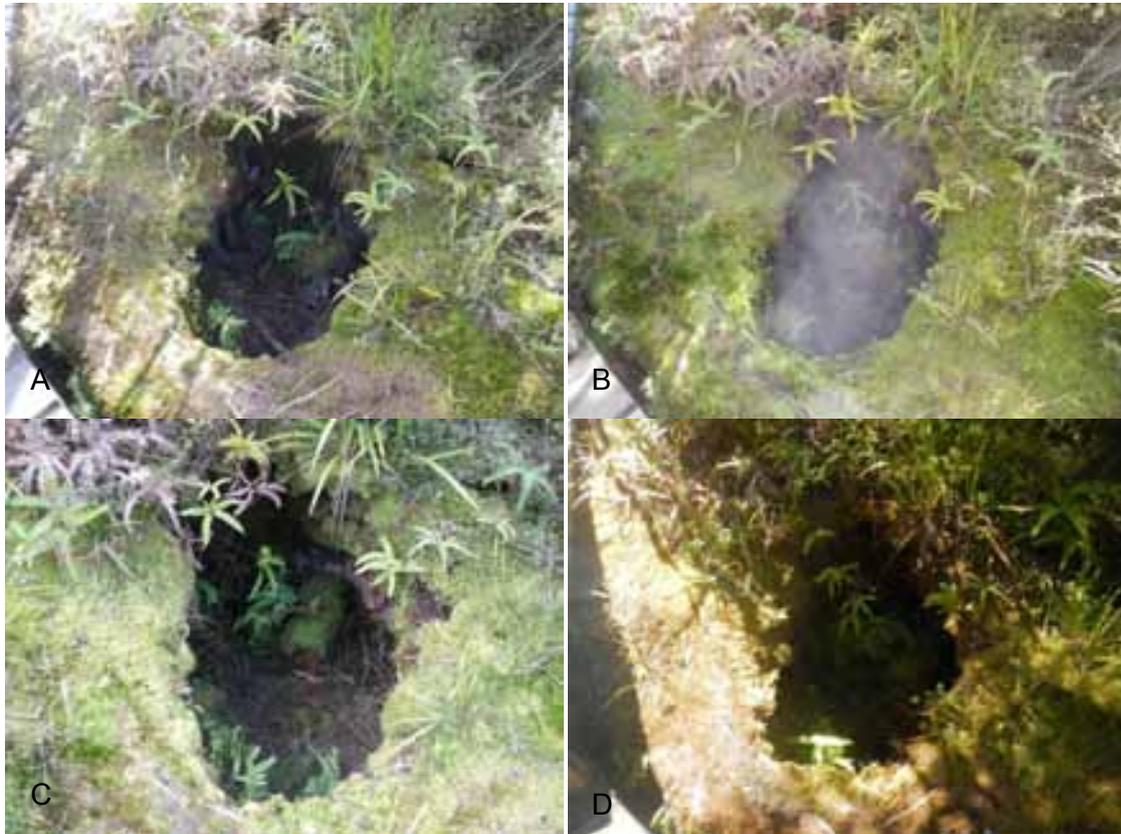
Figure 60: Fumarole, Apr 2013 (A), June 2013 (B), Sept 2013 (C), Jan 2014 (D)

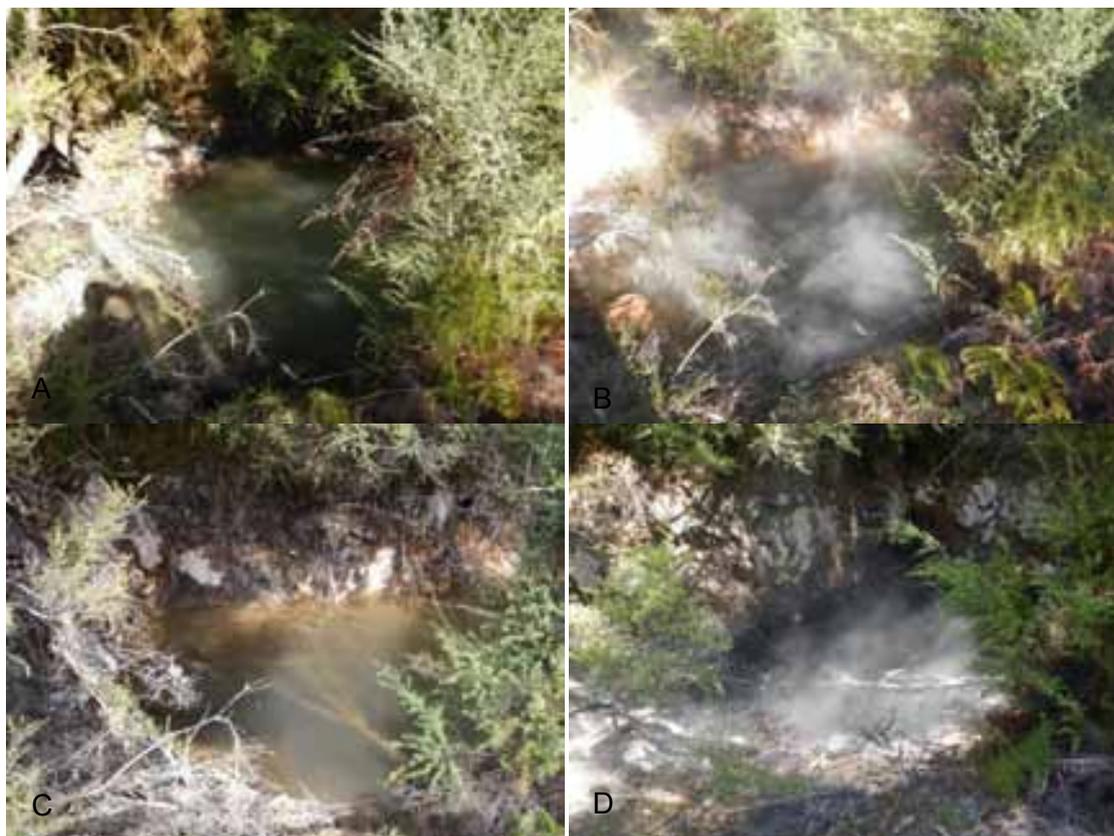
Figure 62: South Pool, Apr 2013 (A), June 2013 (B), Sept 2013 (C), Jan 2014 (D)

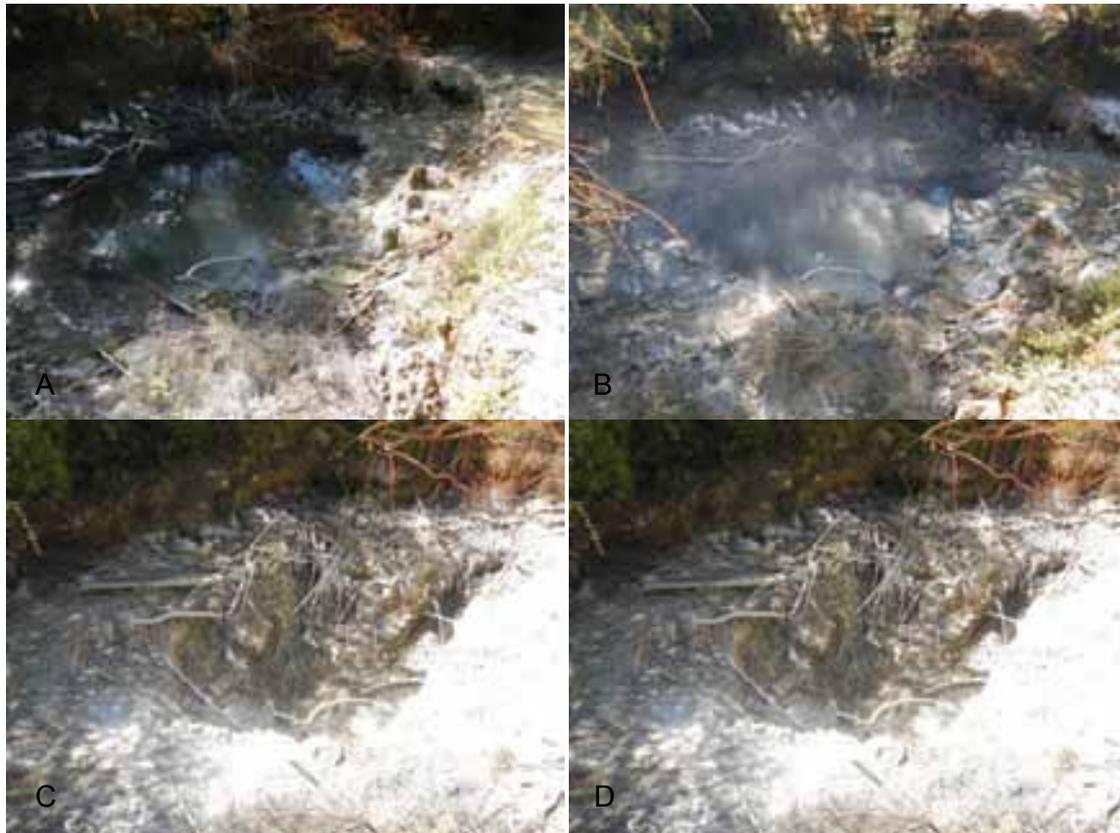
Figure 64: North Pool, Apr 2013 (A), June 2013 (B), Sept 2013 (C), Jan 2014 (D)

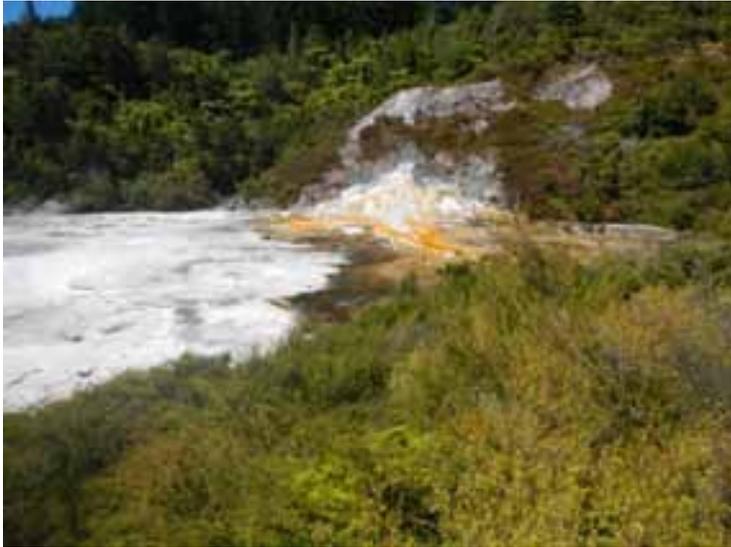
Figure 66: Artist's Palette, with the Pyramid of Geysers in the background in Jan 2014

April 2013: The majority of the pools appeared to be dry and steaming from the viewing platform. The large pool to the left of the platform was overflowing, with constant ebullition. A small pool to the left of the geyser was surging.
