Geothermal features annual monitoring report - January 2014

For:
Waikato Regional Council
Private Bag 3038
Waikato Mail Centre
HAMILTON 3240

25 September 2014

Document #: 3133084

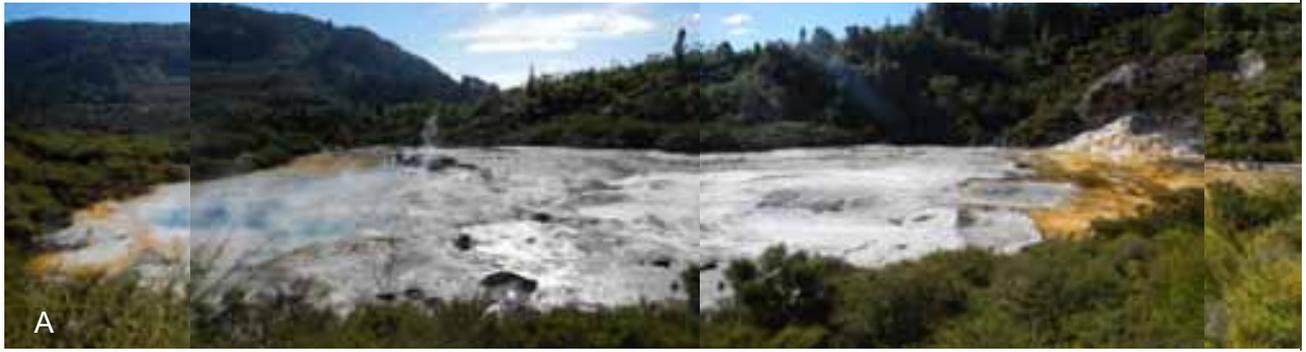
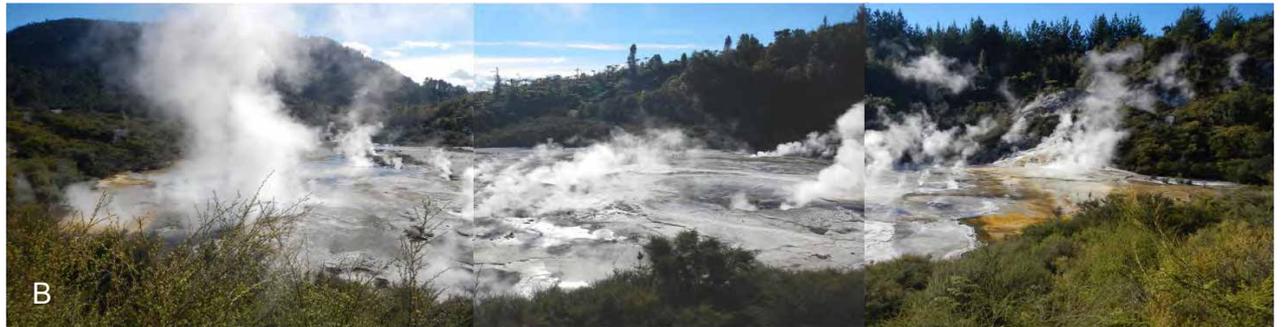
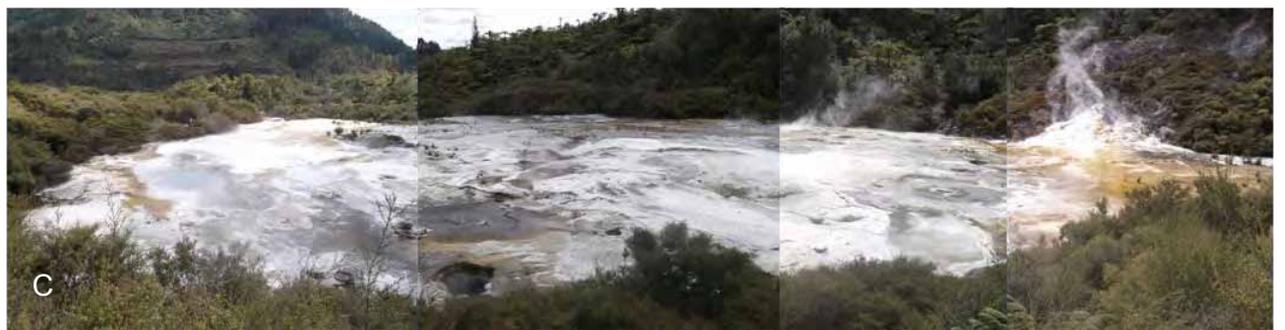
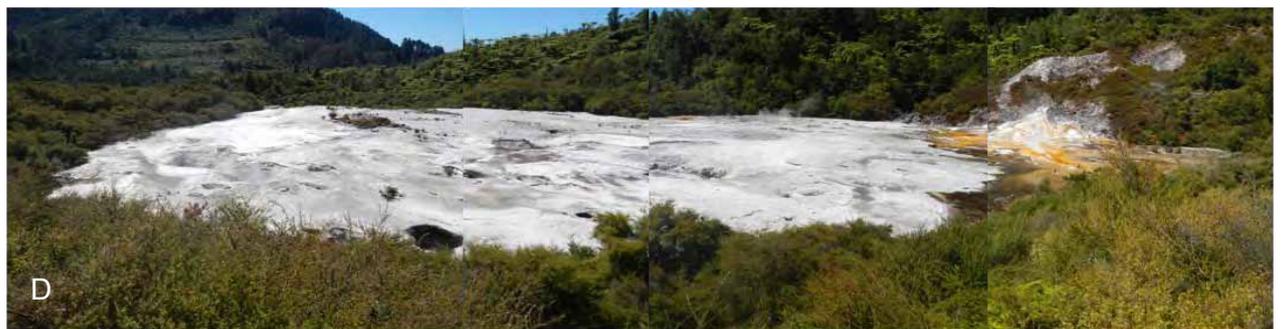
Figure 67: Composite photo, Apr 2013 (A), June 2013 (B), Sept 2013 (C), Jan 2014 (D)

September 2013: The majority of the pools appeared to be dry. The large pool to the left was overflowing at a seep. It was clear and blue, as was the small pool to the southwest of it. The small pool to the northwest of the Geyser was discharging vigorously.

January 2014: The majority of the pools appeared to be dry, apart from one pool to the left of the geyser.

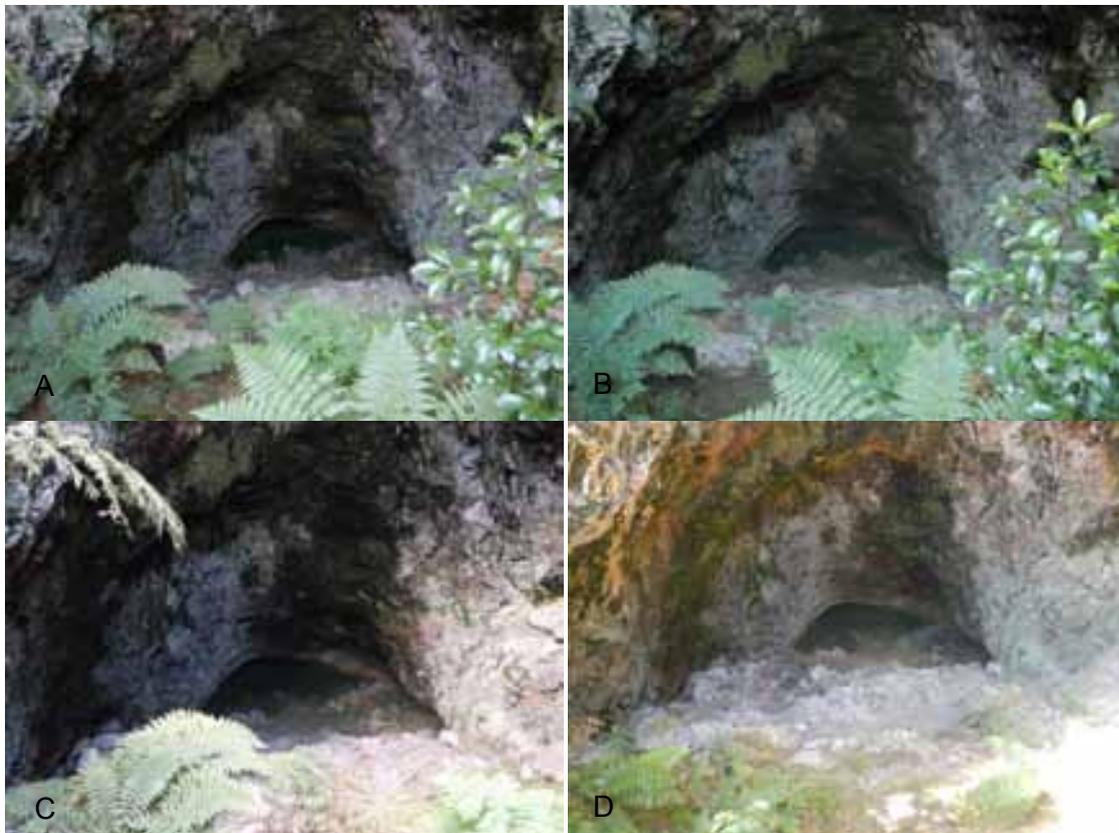
Figure 68: The Ruatapu Cave, Apr 2013 (A), Jul 2012 (B), Sept 2013 (C), Jan 2014 (D)

Date	T(°C)	pH	Flow (l/s)	Water level	Ebullition	Colour
29 April 2013	35	nd	nd	-	Calm	Clear, Blue
26 June 2013	33	nd	nd	-	Calm	Clear, Blue
27 Sept 2013	40.7	nd	nd	-	Calm	Clear, Blue
28 Jan 2014	36.1	nd	nd	-	Calm	Clear, Blue

The water temperature appears to be consistent throughout the pool at the base of the cave.

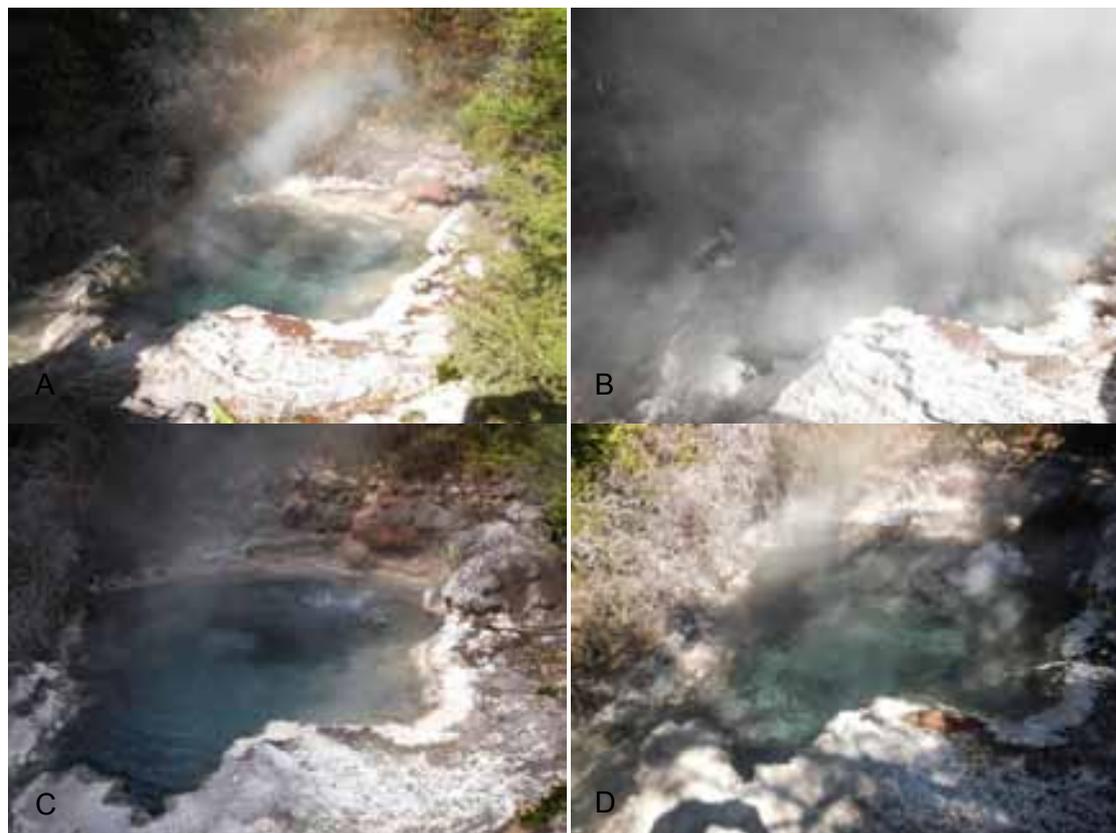
Figure 70: Soda Fountain, Apr 2013 (A), June 2013 (B), Sept 2013 (C), Jan 2014 (D)

Date	T(°C)	pH	Flow (l/s)	Water level	Ebullition	Colour
29 April 2013	97.9	7	~0.5	o/f	Constant upwelling	Clear, blue
26 June 2013	96.7	8	<0.5	o/f	Constant vigorous upwelling	Clear, blue
27 Sept 2013	96.9	8	~0.5	o/f	Boiling	Clear, blue
28 Jan 2014	97.6	8	<0.5	o/f	Constant, boiling	Clear, blue/green

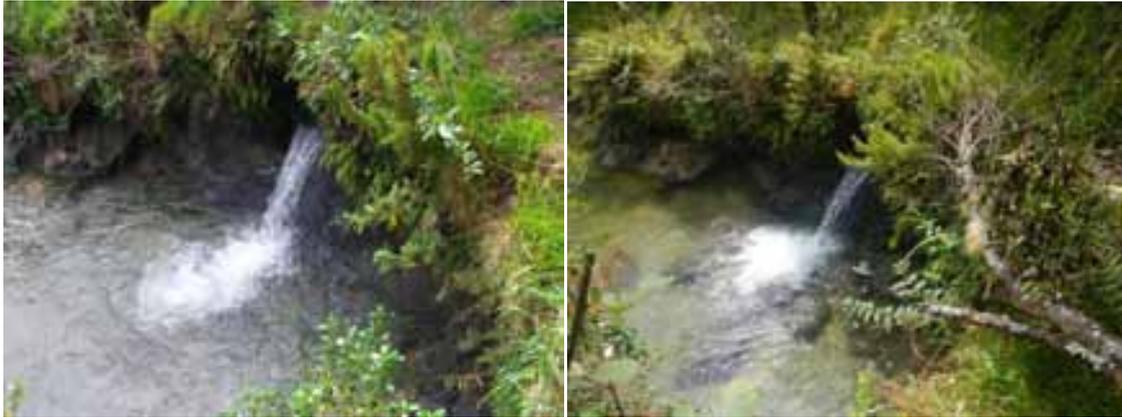
Figure 73: Waihunuhunu Inlet 1, Orakei Korako in Sept 2013 (A), Jan 2014 (B)

Date	T(°C)	pH	Flow (l/s)	Water level	Ebullition	Colour
26 Sept 2013	48.0	7	20-30	O/f from pipe	-	Clear
30 Jan 2014	48.5	7-8	~40	O/f from pipe	-	Clear

The heat of the water can be seen as it gushes out of the pipe.

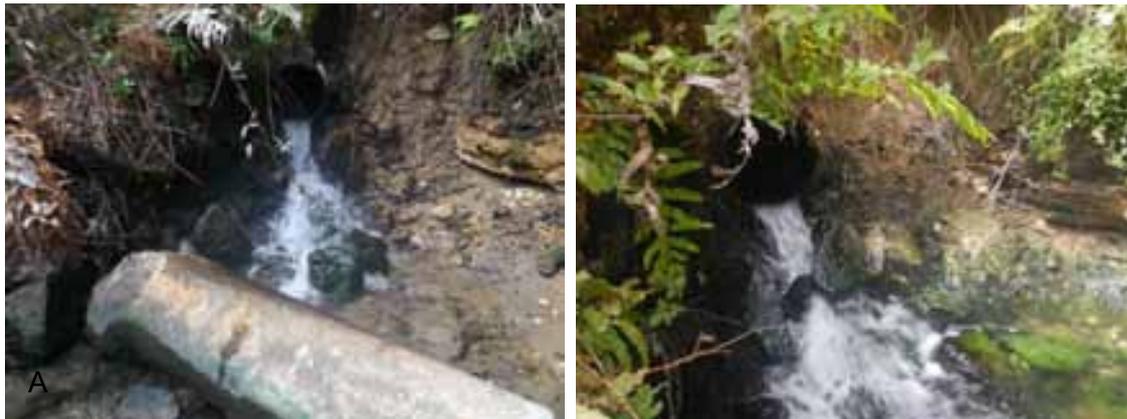
Figure 75: Waihunuhunu Inlet 2, Orakei Korako in Sept 2013 (A), Jan 2014 (B)

Date	T(°C)	pH	Flow (l/s)	Water level	Ebullition	Colour
26 Sept 2013	40.9	6	~3	O/f from pipe	-	Clear
30 Jan 2014	42.8	7-8	~5	O/f from pipe	-	Clear

The heat of the water can be seen as it flows out of the pipe.

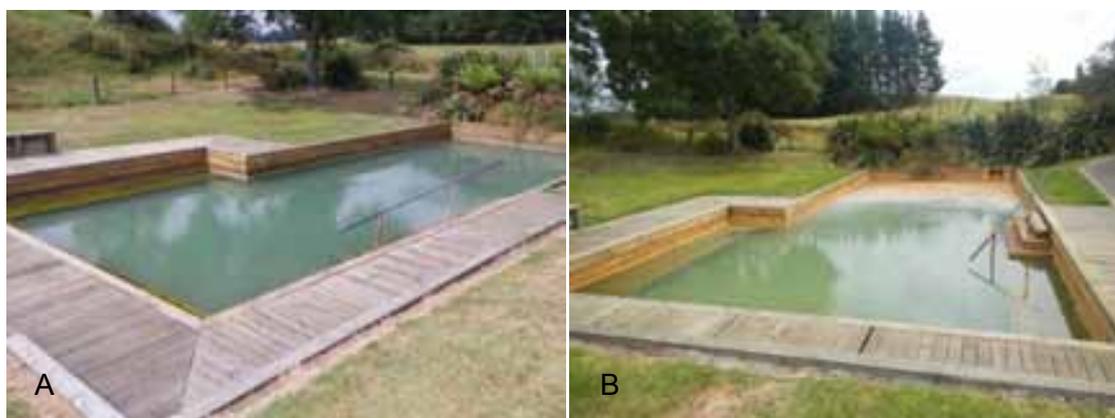
Figure 77: Butcher's Pool, Reporoa in Jan 2013 (A), Feb 2014 (B)

Date	T(°C)	pH	Flow (l/s)	Water level	Ebullition	Colour
31 Jan 2013	38.6	6	~1	o/f	Effervescing all over pool	Murky, green
04 Feb 2014	41.0	7-8	nd	o/f	Effervescing all over pool	Cloudy, green

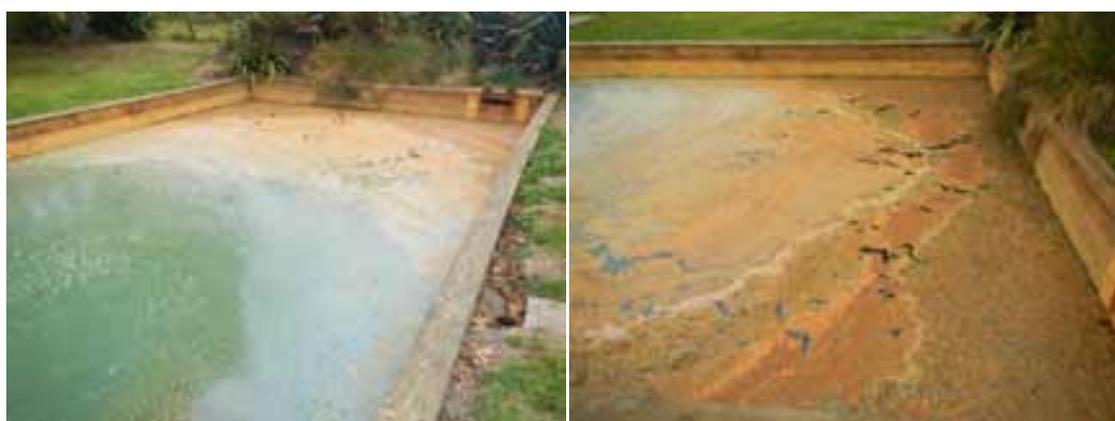
Figure 78: Algal growth at Butcher's Pool, Reporoa in Feb 2014

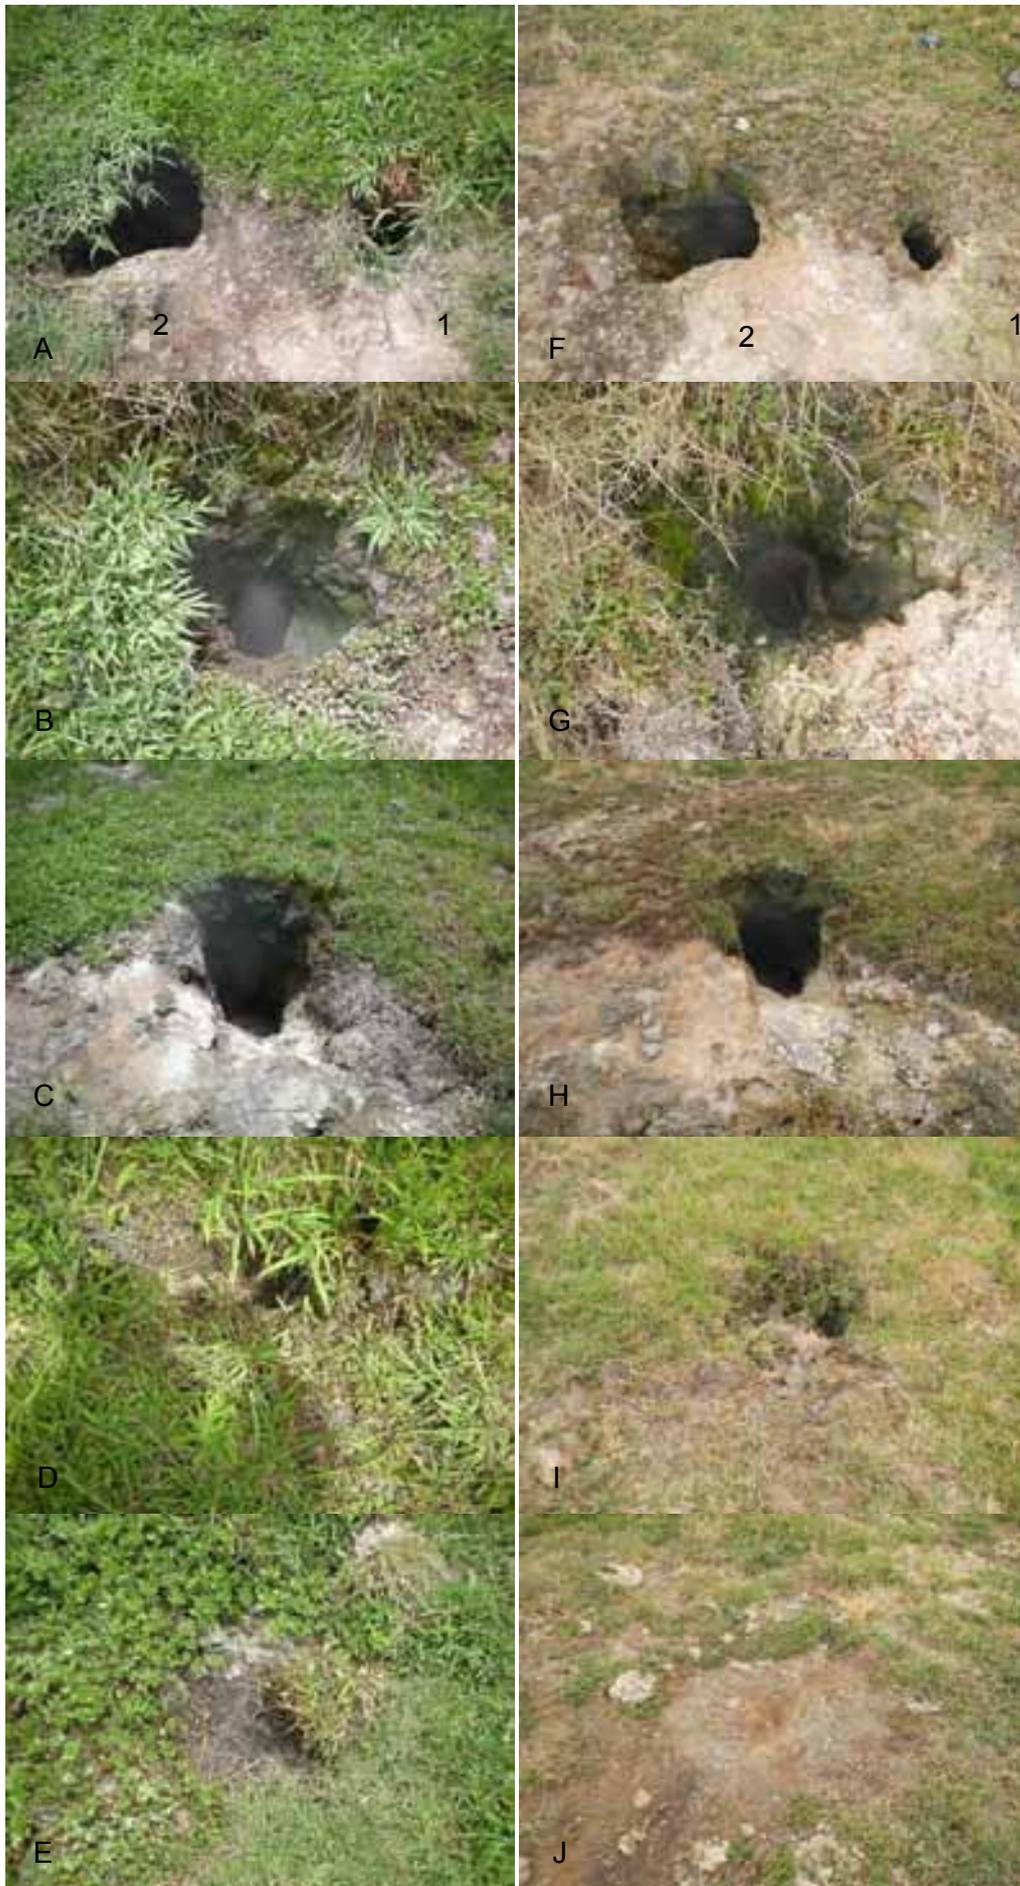
Figure 80: Jan 2013: Vents 1 & 2 (A), 3 (B), 4 (C), 5(D), 6 (E); Feb 2014: Vents 1 & 2 (F), 3 (G), 4 (H), 5(I), 6 (J)

Date	Vent	T(°C)	Flow	Depth (m)	Diameter (m)	Ebullition	Colour
23 Jan 2013	1	71.4	nd	~1.5	~0.23	Audible gas discharge	Black mud
04 Feb 2014	1	68.5	nd	~1.0	0.2x0.28	Audible gas discharge	Black mud
23 Jan 2013	2	71.2	steam	~1.7	~0.6	Audible gas discharge	Black mud
04 Feb 2014	2	60.9	nd	~1.1	0.73x0.5	Audible gas discharge	Black mud
23 Jan 2013	3	76.2	nd	~1.6	~0.5 x 0.66	Audible gas discharge	Black mud
04 Feb 2014	3	87.4	nd	~2.07	0.43x0.34	Audible gas discharge	Black mud
23 Jan 2013	4	61	nd	~3 (angled)	~0.67 x 1	Audible gas discharge	Black mud
04 Feb 2014	4	49.1	nd	~2.4	0.58x0.9	Audible gas discharge	Black mud
23 Jan 2013	5	65	nd	~0.6	~0.6 x 0.7	nd	nd
04 Feb 2014	5	51.9	nd	~0.22	0.75x0.9	Audible gas discharge	nd
23 Jan 2013	6	91.1	nd	ground level	~0.6	nd	nd
04 Feb 2014	6	53	nd	ground level	0.88x1.07	nd	nd

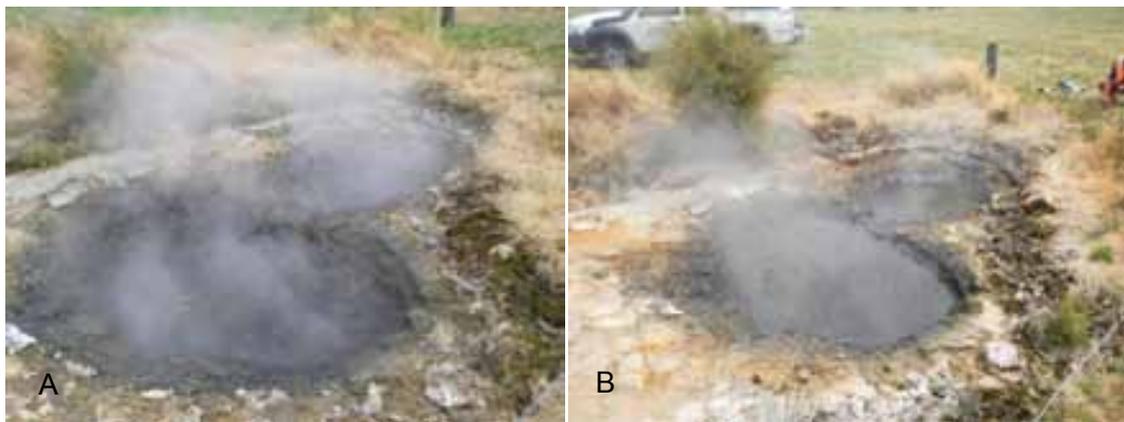
Figure 82: Figure 8 shaped pools, Reporoa in Jan 2013 (A) and Feb 2014 (B)

Date	Pool	T(°C)	pH	Flow (l/s)	Water level	Ebullition	Colour
23 Jan 2013	Large	96.6	8	nd	0.8 m below ground	Vigorous discharge, surging	Dark brown, 0 visibility
04 Feb 2014	Large	96.6	8-9	nd	-	Constant discharge, surging	Brown, murky
23 Jan 2012	Small	81.2	8	nd	0.8 m below ground	Calm	Dark brown, 0 visibility
04 Feb 2014	Small	83.7	7-8	nd	-	Small bubbles	Brown, murky

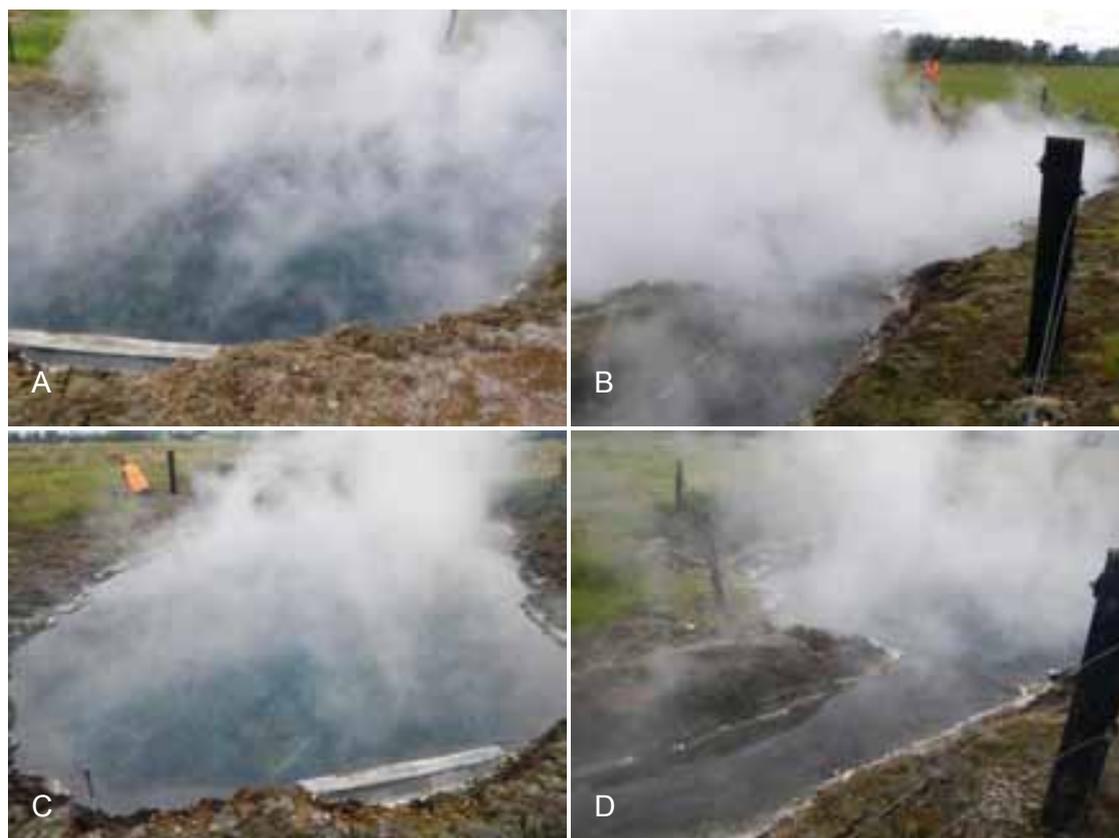
Figure 84: Hot pool 3, Reporoa in Jan 2013 (A&B), Jan 2014 (C&D)

This pool has been fenced off, however the fence posts were black and the wires loose and broken. There was an oily sheen on the surface. The pH had increased from pH 7 to pH 8 since January 2013.

Date	T(°C)	pH	Flow (l/s)	Water level	Ebullition	Colour
23 Jan 2013	93	7	~1.5	o/f	Calm, some steam	Clear, blue
04 Feb 2014	93.7	8	1 – 2	o/f	Calm	Clear, blue

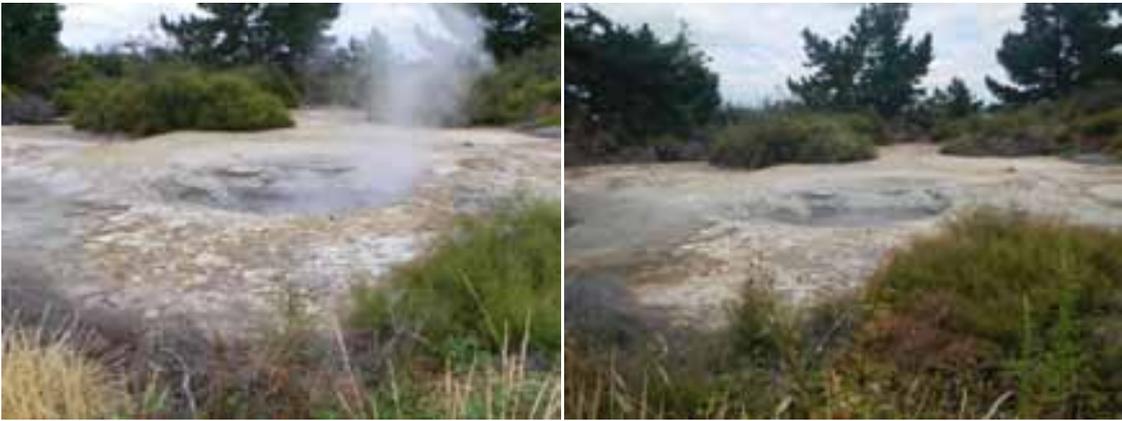
Figure 85: Hot Pool 4, Reporoa in Jan 2013 (A), Jan 2014 (B)

It was too hazardous to get close enough to get a sample for pH. The temperature was measured with the IR gun, and showed a 7.8 °C decrease in temperature since the previous visit in January 2013. The water level had increased and the colour of the pool changed from brown to grey.

Date	T(°C)	pH	Flow (l/s)	Water level	Ebullition	Colour
23 Jan 2013	81	5	nd	1.5 m below rim	Constant gas discharge	Murky, brown
04 Feb 2014	73.2	nd	nd	~1.2 m below rim	Constant gas discharge	Murky, grey

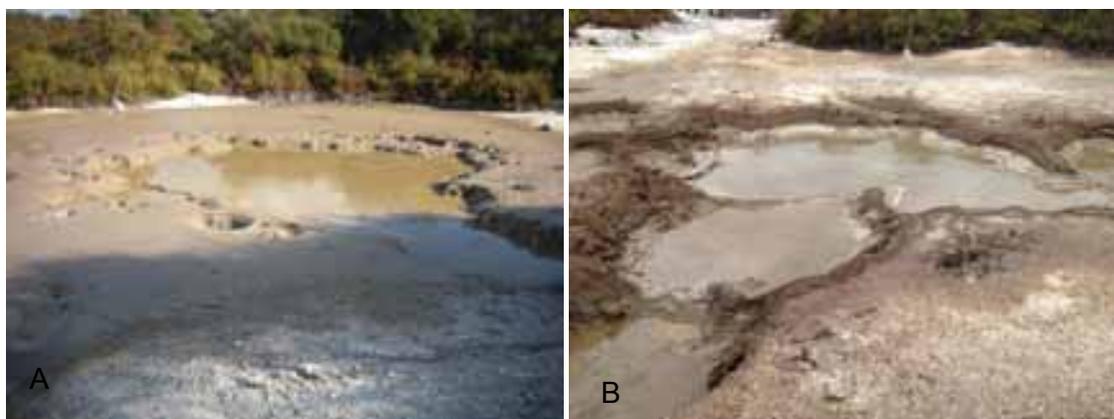
Figure 87: Mud pool, Longview Road, Reporoa in Jan 2013 (A), Feb 2014 (B)

Date	T(°C)	pH	Flow (l/s)	Water level	Ebullition	Colour
23 Jan 2013	23.2	<3	nd	1 m below rim	Gas discharge	Murky, brown
04 Feb 2014	27.6	3	nd	0.75 m below rim	Constant gas discharge	Murky, brown

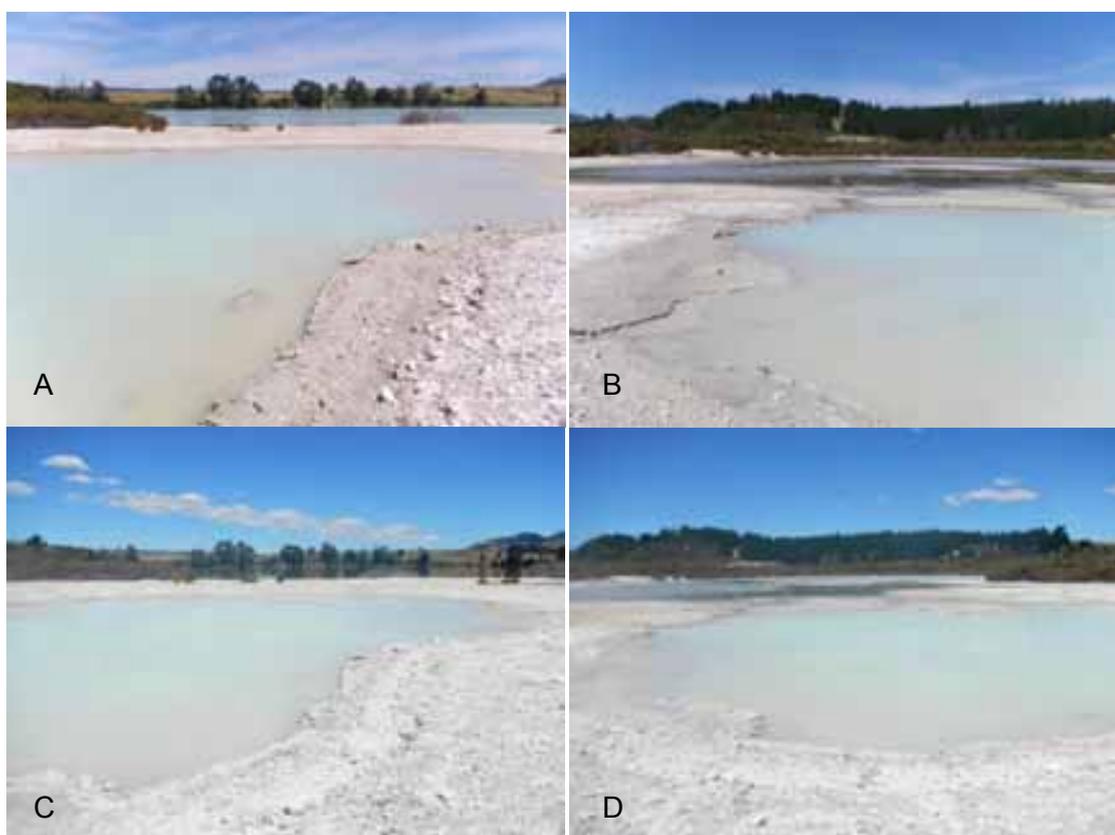
Figure 88: RK3, Rotokawa in Jan 2013 (A&B), Jan 2014 (C&D)

Date	T(°C)	pH	Flow (l/s)	Water level	Ebullition	Colour
29 Jan 2013	54	3	nd	nd	Calm	Murky, blue
29 Jan 2014	50.9	3	nd	nd	Constant discharge	Cloudy, pale milky green

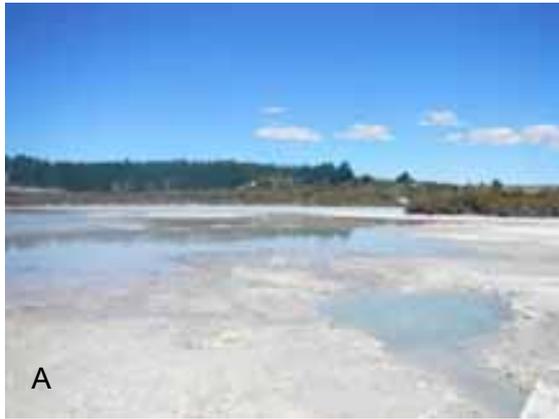
Figure 89: RK4, Rotokawa

Date	T(°C)	pH	Flow (l/s)	Water level	Ebullition	Colour
29 Jan 2014	80.2	2-3	nd	o/f into RK3	Constant discharge	Murky, grey/green

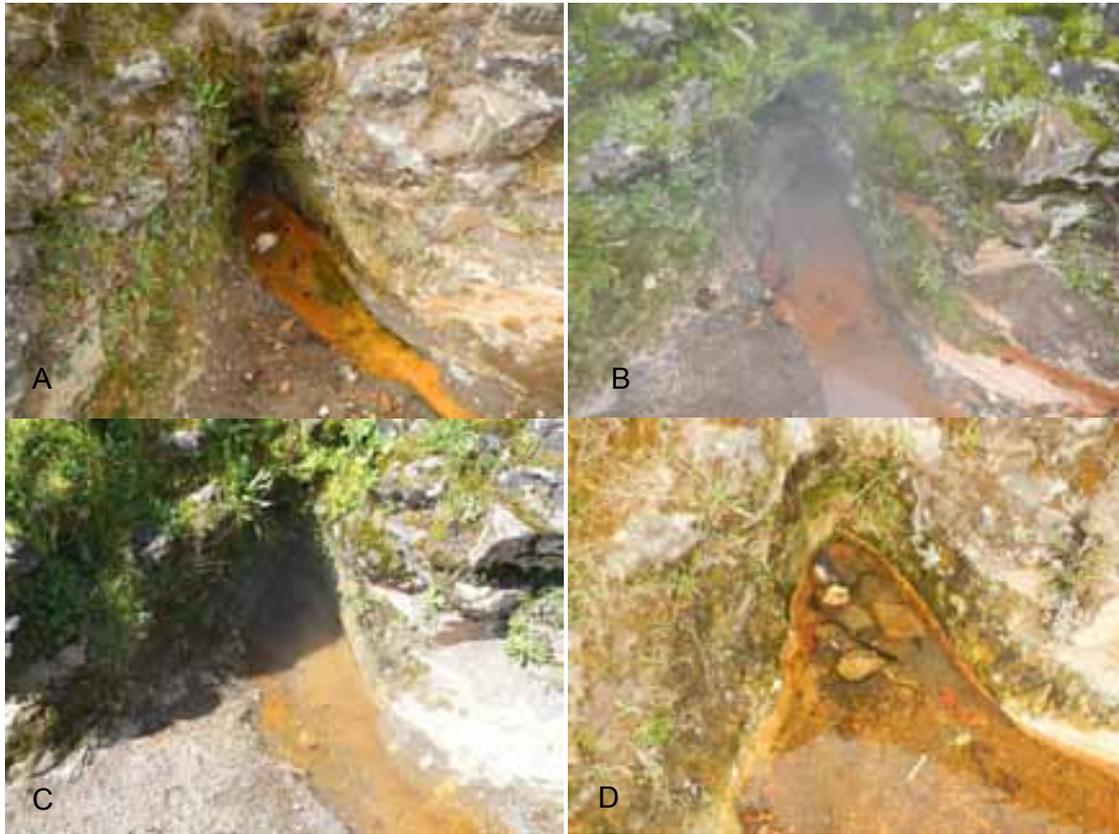
Figure 92: Taharepa Spring, Apr 2013 (A), June 2013 (B), Sept 2013 (C), Jan 2014 (D)

There were no bathers present during the April, June and September 2013 monitoring visits. There were two bathers noted at 17:15 during the February visit.

Date	T(°C)	pH	Flow (l/s)	Water level	Ebullition	Colour
15 April 2013	54	6	seep	nd	No gas	Clear
27 June 2013	62.5	5	seep	nd	No gas	Clear
26 Sept 2013	64.3	5	<0.5	nd	No gas	Clear
04 Feb 2014	63.3	6-7	Seep	nd	No gas	Clear

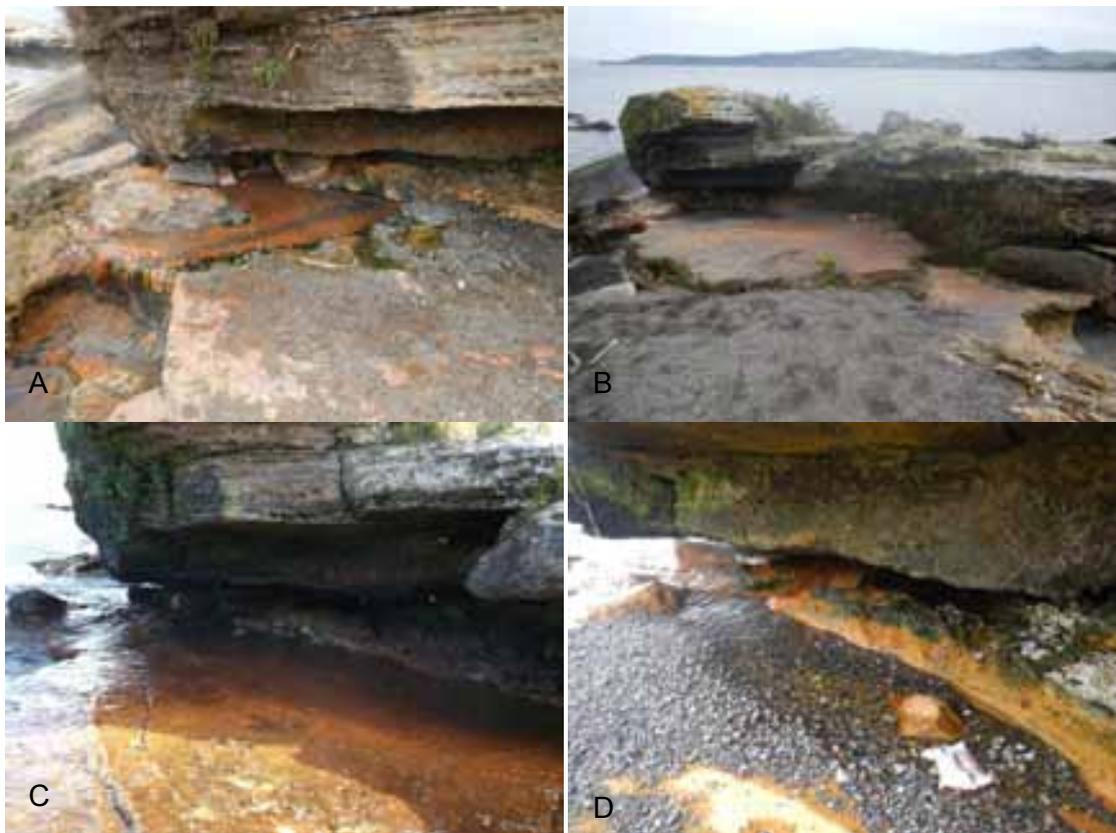
Figure 94: Rocky Point Spring, Apr 2012 (A), June 2013 (B), Sept 2013 (C), Jan 2014 (D)

Date	T(°C)	pH	Flow (l/s)	Water level	Ebullition	Colour
15 April 2013	60.5	6	1	-	Constant bubbles	Clear
27 June 2013	65.8	6-7	~0.5	o/f	Constant	Clear
26 Sept 2013	66.1	-	-	-	-	Clear
04 Feb 2014	65.0	6	<0.5	o/f	-	Clear

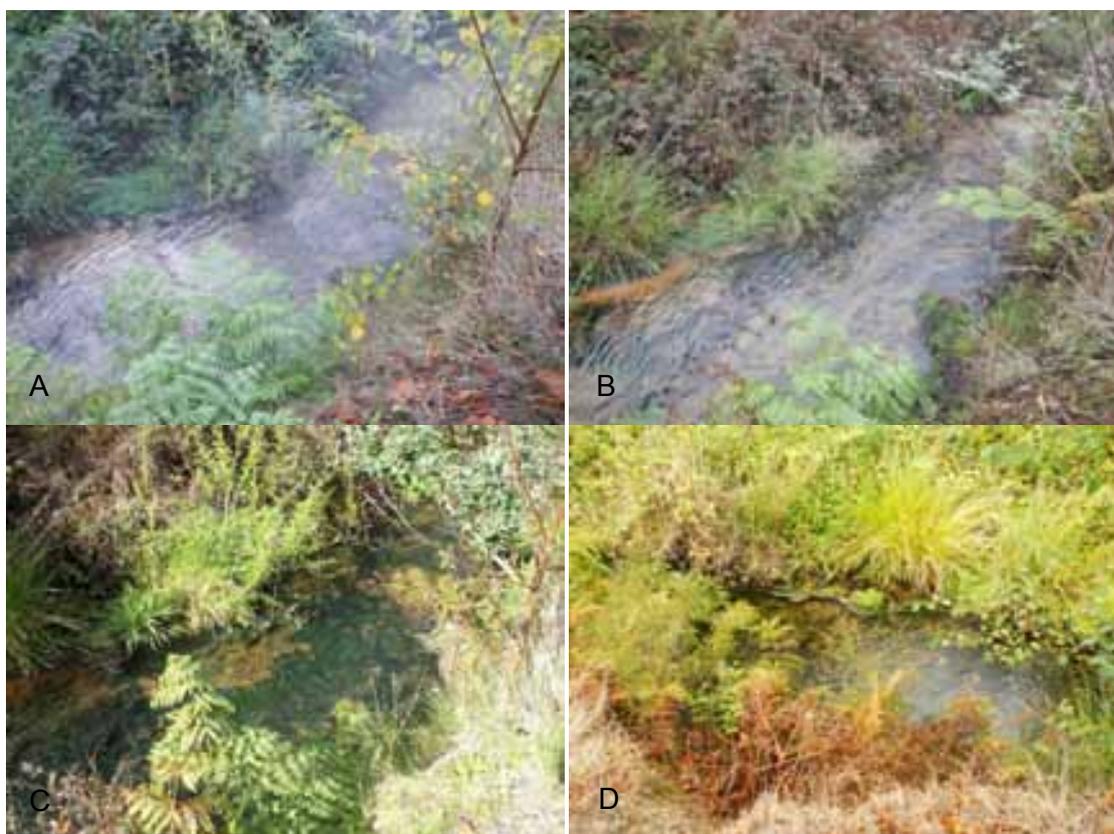
Figure 96: Otumuheke Stream, Apr 2013 (A), Jul 2013 (B), Sept 2013 (C), Jan 2014 (D)

Date	T(°C)	pH	Flow (l/s)	Water level	Ebullition	Colour
30 April 2013	49.2	-	20-30	nd	Calm	Clear
25 June 2013	48.2	5	20-30	nd	Calm	Clear
26 Sept 2013	49.5	5	20-30	nd	Calm	Clear
04 Feb 2014	51.1	5-6	20-30	nd	Calm	Clear

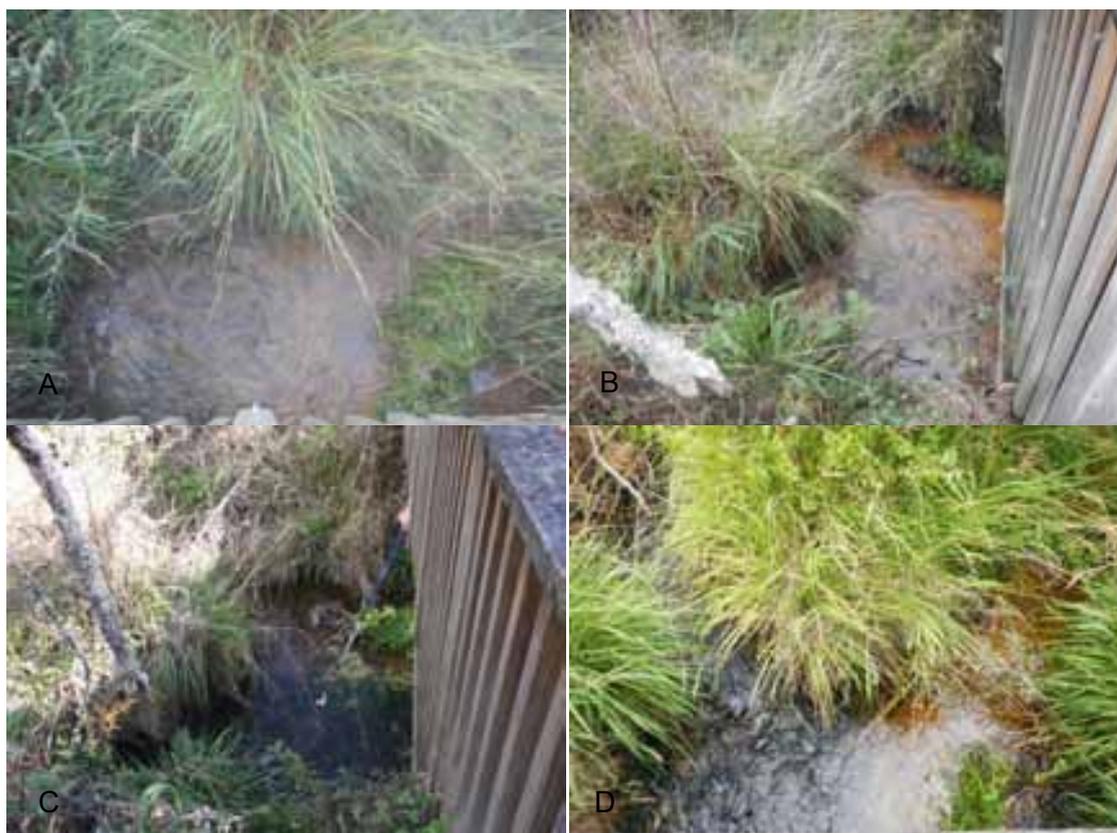
Figure 98: Otumuheke Stream, Apr 2012 (A), June 2013 (B), Sept 2013 (C), Jan 2014 (D)

Date	T(°C)	pH	Flow (l/s)	Water level	Ebullition	Colour
30 April 2013	48.5	6	20-30	nd	Calm	Clear
25 June 2013	47.2	6	~20-30	nd	Calm	Clear
26 Sept 2013	48.6	5	20-30	nd	Calm	Clear
04 Feb 2014	50.4	5-6	20-30	nd	Calm	Clear

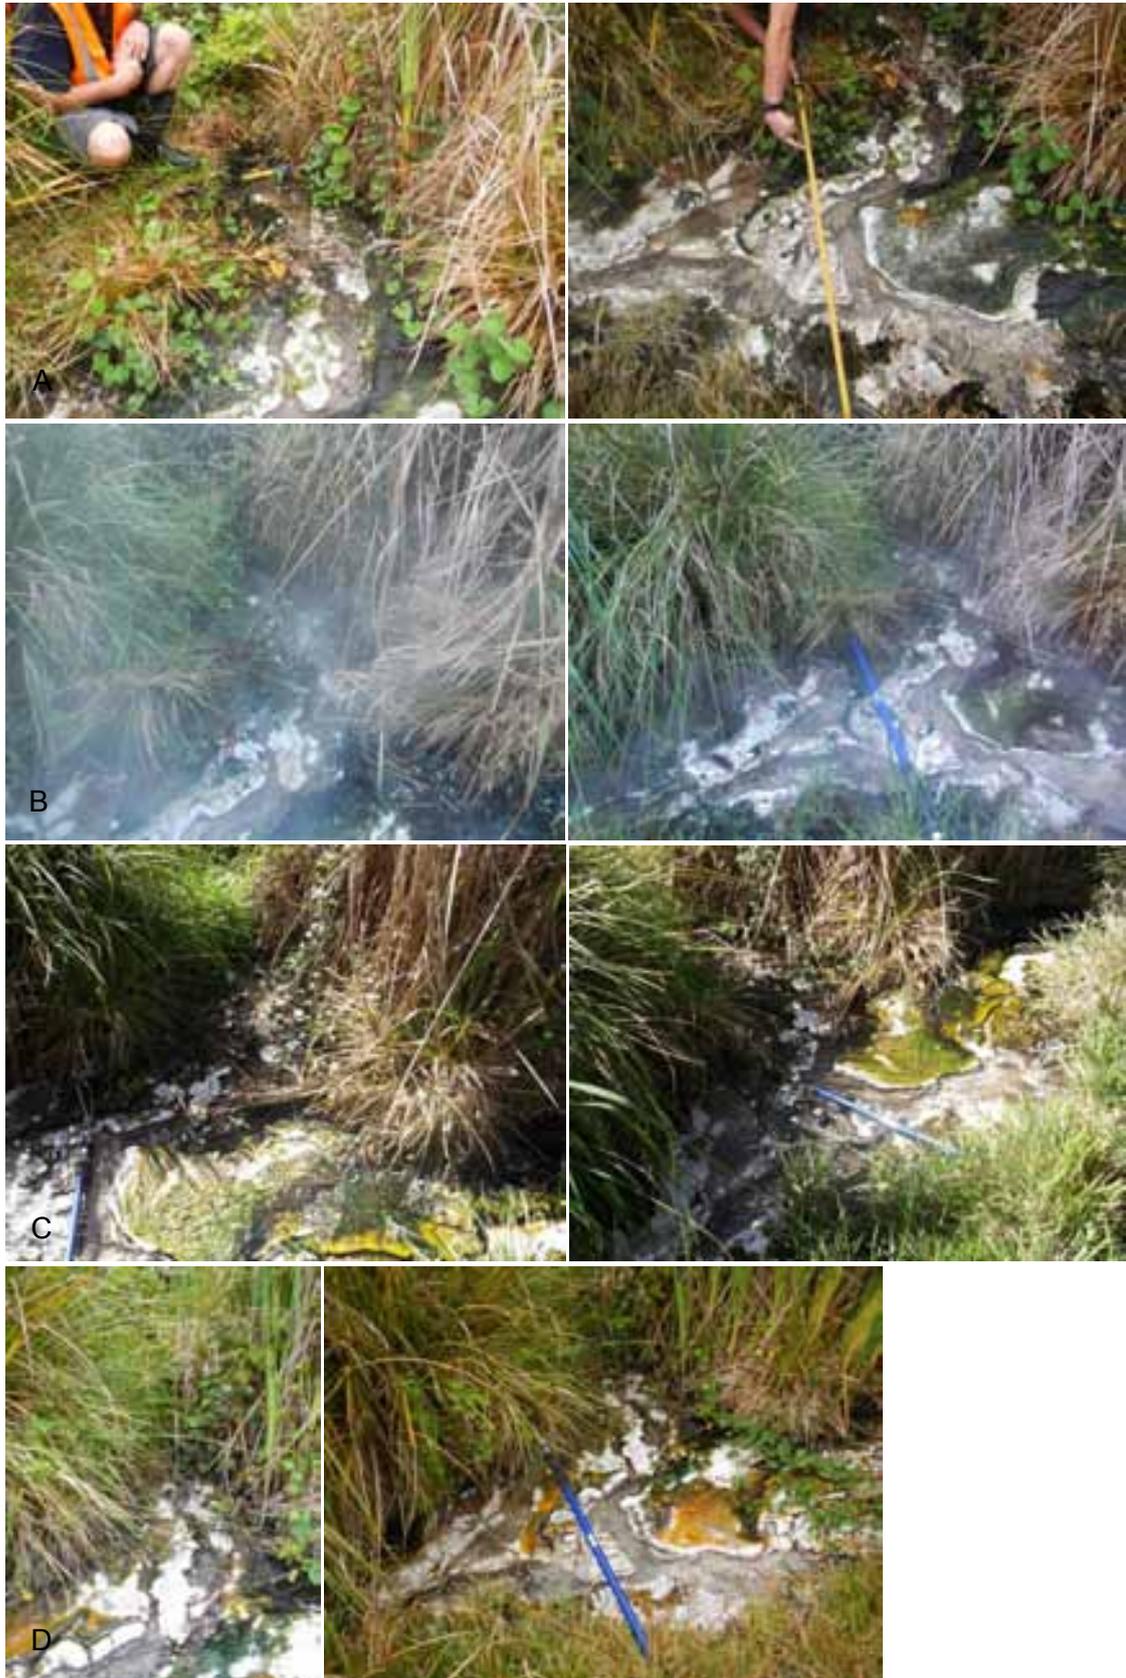
Figure 102: New Spring, Apr 2013 (A), June 2013 (B), Sept 2013 (C), Jan 2014 (D)

Date	T(°C)	pH	Flow (l/s)	Water level	Ebullition	Colour
15 April 2013	65.6	7	<1	Overflowing	Calm	Clear
26 June 2013	63.8	7	<0.5	Overflowing	Calm	Clear
26 Sept 2013	64.5	6	<0.5	Overflowing	Calm	Clear
04 Feb 2014	65.0	7	<0.5	Overflowing	Calm	Clear

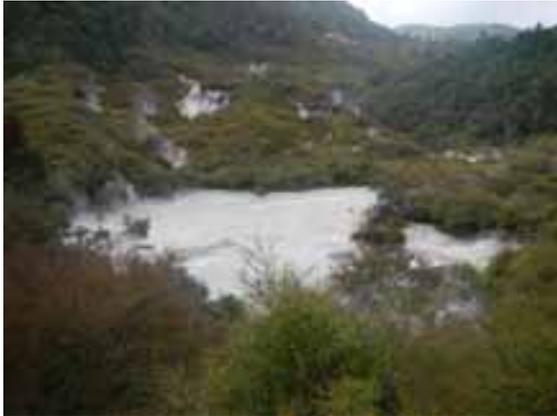
Figure 104: Large pool, Te Kopia, Jan 2014

WRC staff could not access the large pool and mud volcano in January 2014. The Department of Conservation has recently been installing a walkway in the area, therefore, WRC should be able to access the site on the next monitoring visit.

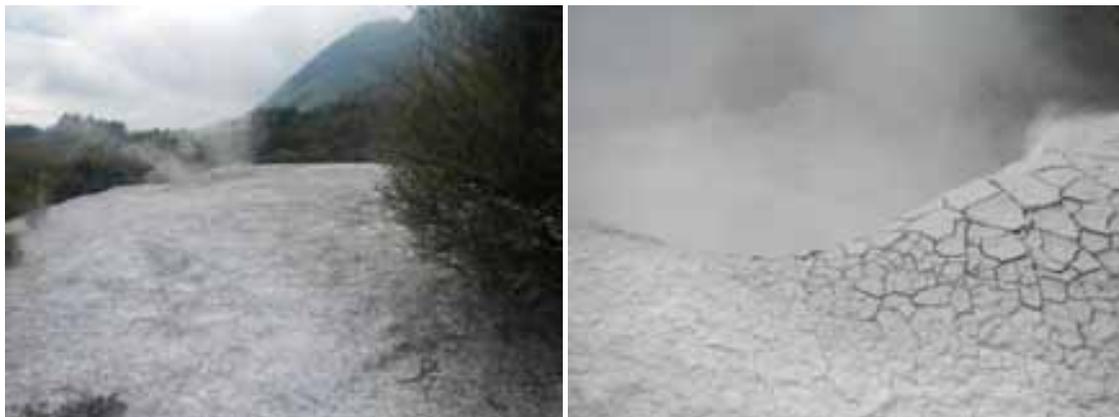
Figure 106: Recent activity at Mud Geyser, Te Kopia, Jan 2014

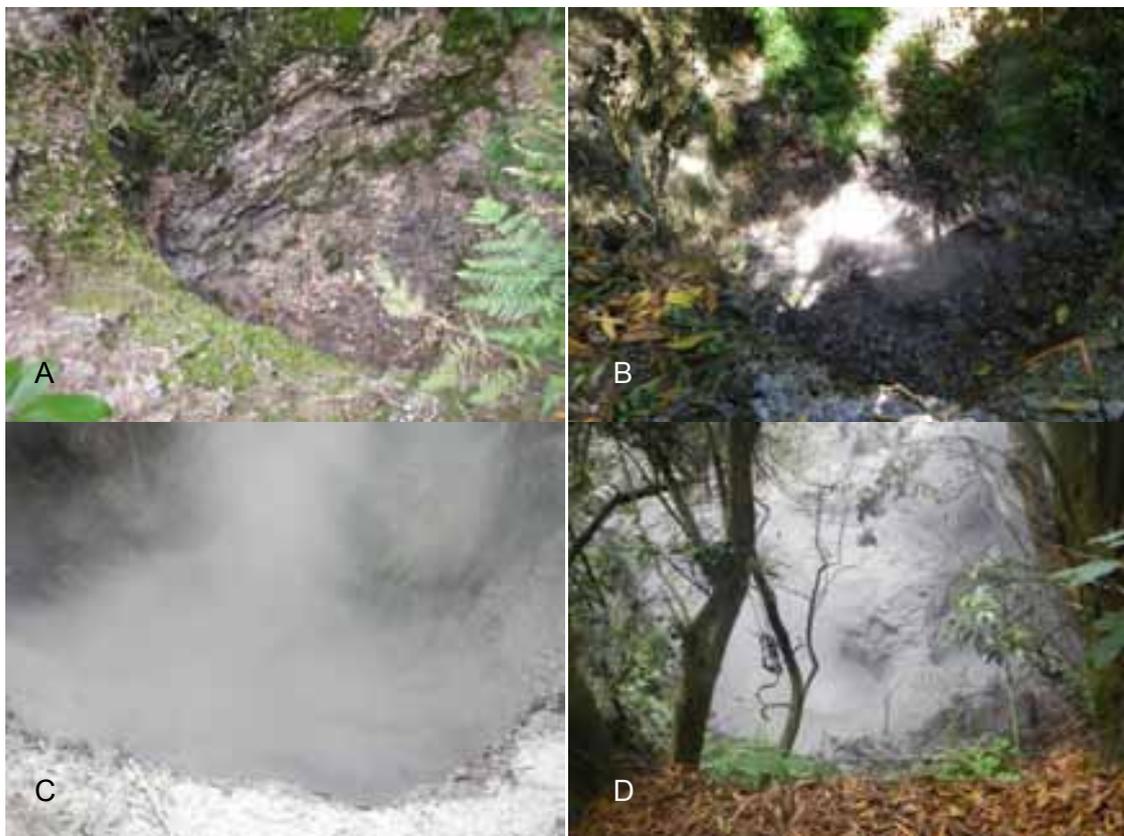
Figure 110: TK8, Te Kopia in Jan 2013 (A&B), Jan 2014 (C&D)

Date	T(°C)	pH	Flow (l/s)	Depth to water	Ebullition	Colour
22 Jan 2013	60	-	Steam	Dry	Audible discharge	Brown/grey mud at base
30 Jan 2014	98.4	-	Steam	3-4 m below lower rim	Vigorous discharge	Brown/grey mud and water

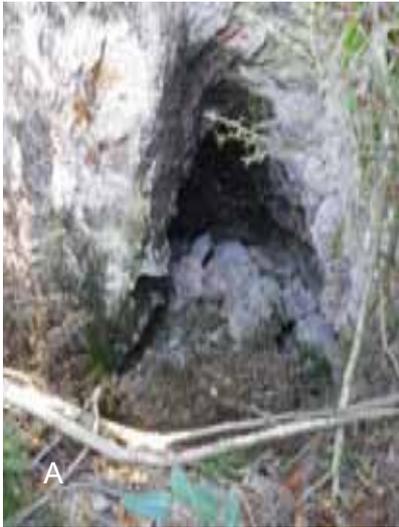
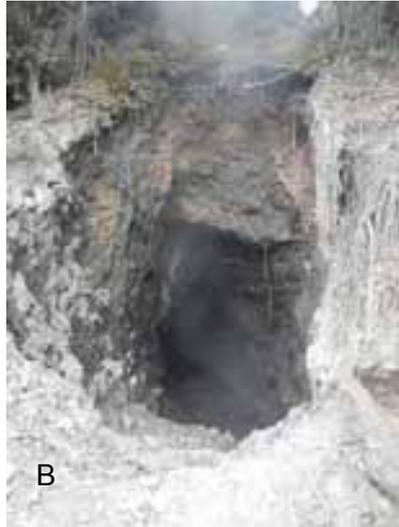
Figure 111: Doom, Te Kopia, Jan 2013 (A) and Jan 2014 (B)

Date	T(°C)	pH	Flow (l/s)	Depth to water	Ebullition	Colour
22 Jan 2013	20	-	-	Dry	Calm	nd
30 Jan 2014	97.7	-	-	6 m below top rim	Vigorous discharge	Brown/grey mud and water

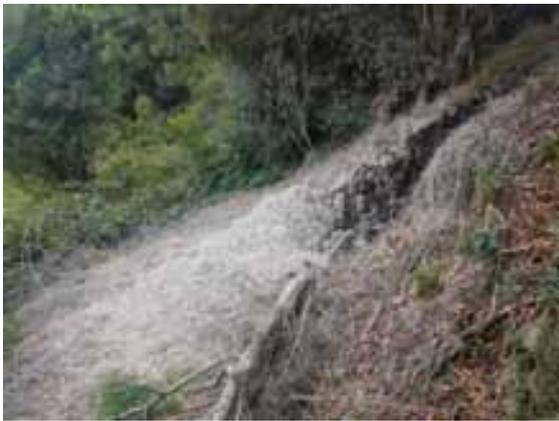
Figure 112: Doom, Te Kopia, Jan 2014

The photo below shows the area of mud splatter from Doom.

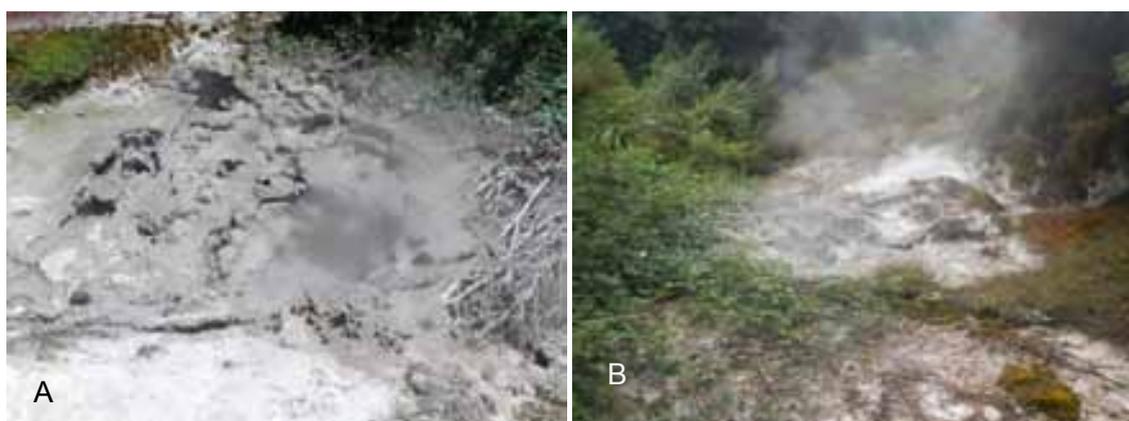
Figure 114: Mud pools by stream, Te Kopia in Jan 2013 (A), Jan 2014 (B)

Date	T(°C)	pH	Flow (l/s)	Water level	Ebullition	Colour
22 Jan 2013	92.3	-	-	Dry	Bubbling mud	Grey mud
30 Jan 2014	57	-	-	Non visible	Audible discharge	Grey mud

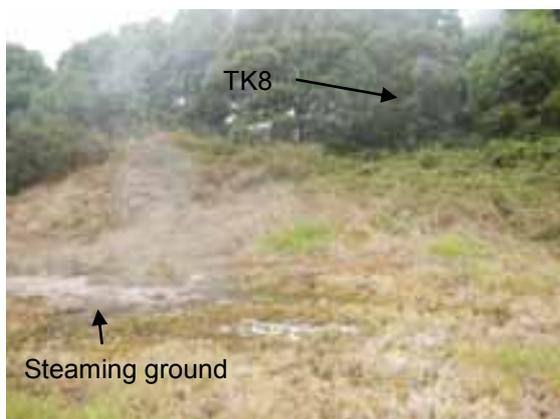
Figure 116: Steaming ground below TK8

The area below TK8 has shown recent activity. The ground is warm in several areas, and has been steaming for the past 6 months. There is a mud pool about the area of steaming ground that erupted recently, as there is mud splatter surrounding the pool. The mud pool is situated in the area to the right of the steaming ground.

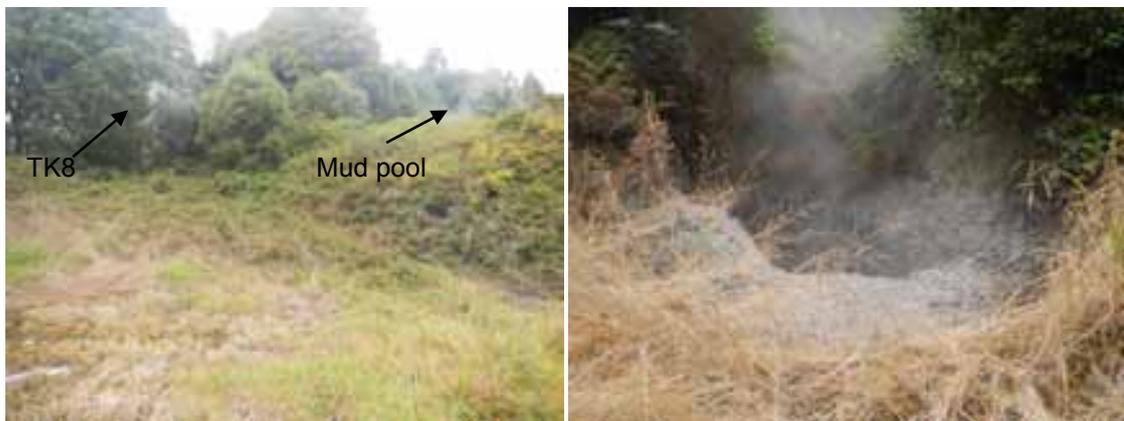
Figure 118: Mud pool below TK8

The mud pool reached a temperature of 82.7 °C. It consisted of brown mud, there was audible gas discharge and the pool measured approximately four metres in diameter. There was no water in the pool.
