Geothermal features annual monitoring report - January 2014

For:
Waikato Regional Council
Private Bag 3038
Waikato Mail Centre
HAMILTON 3240

25 September 2014

Document #: 3133084

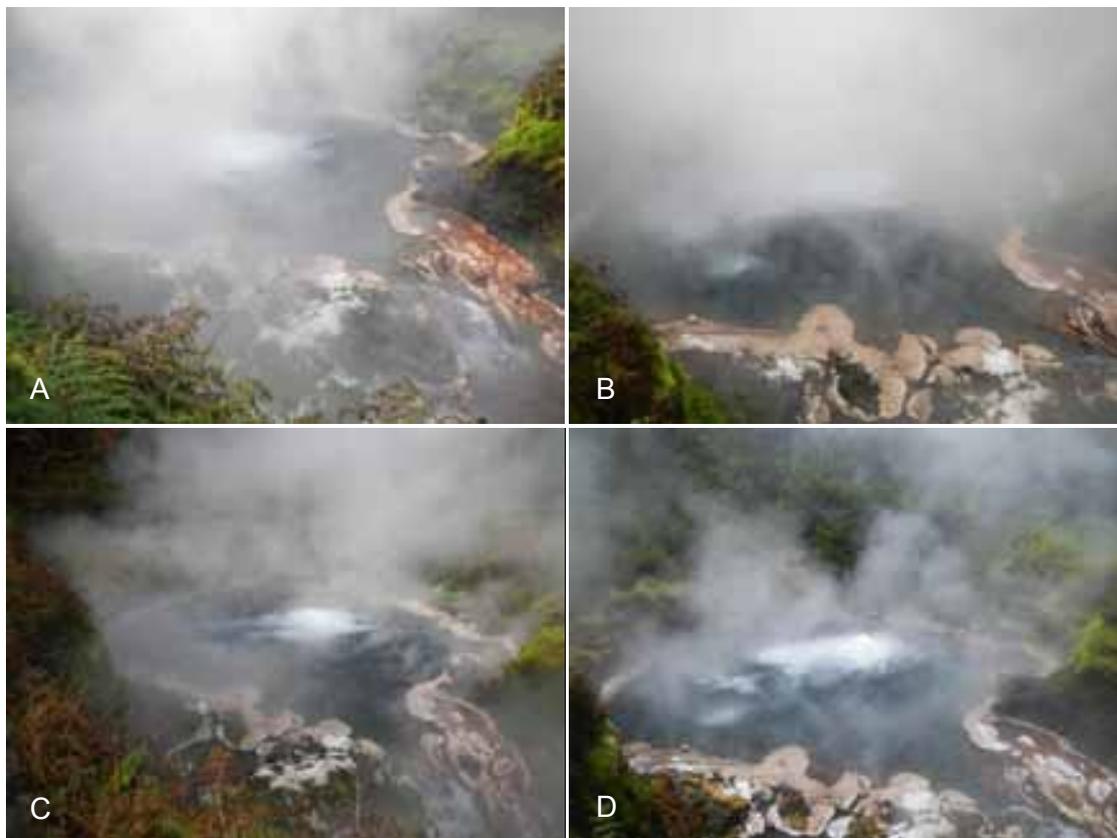
Figure 119: Manaroa Pool, Apr 2013 (A), June 2013 (B), Sept 2013 (C), Jan 2014 (D)

Date	T(°C)	pH	Flow (l/s)	Water level	Ebullition	Colour
30 April 2013	97.5	8-9	~40-50	Overflowing	Surging up to 0.5 m with vigorous upwelling in 2 other areas	Clear, blue
27 June 2013	96.8	nd	~40-50	Overflowing	Surging up to 1 m with vigorous upwelling	Clear, blue
25 Sept 2013	82.9	nd	~40-50	Overflowing	Surging up to 1 m extremely vigorous upwelling in centre	Clear, blue
04 Feb 2014	98.7	7-8	~40-50	Overflowing	Surging, vigorous upwelling	Clear, blue

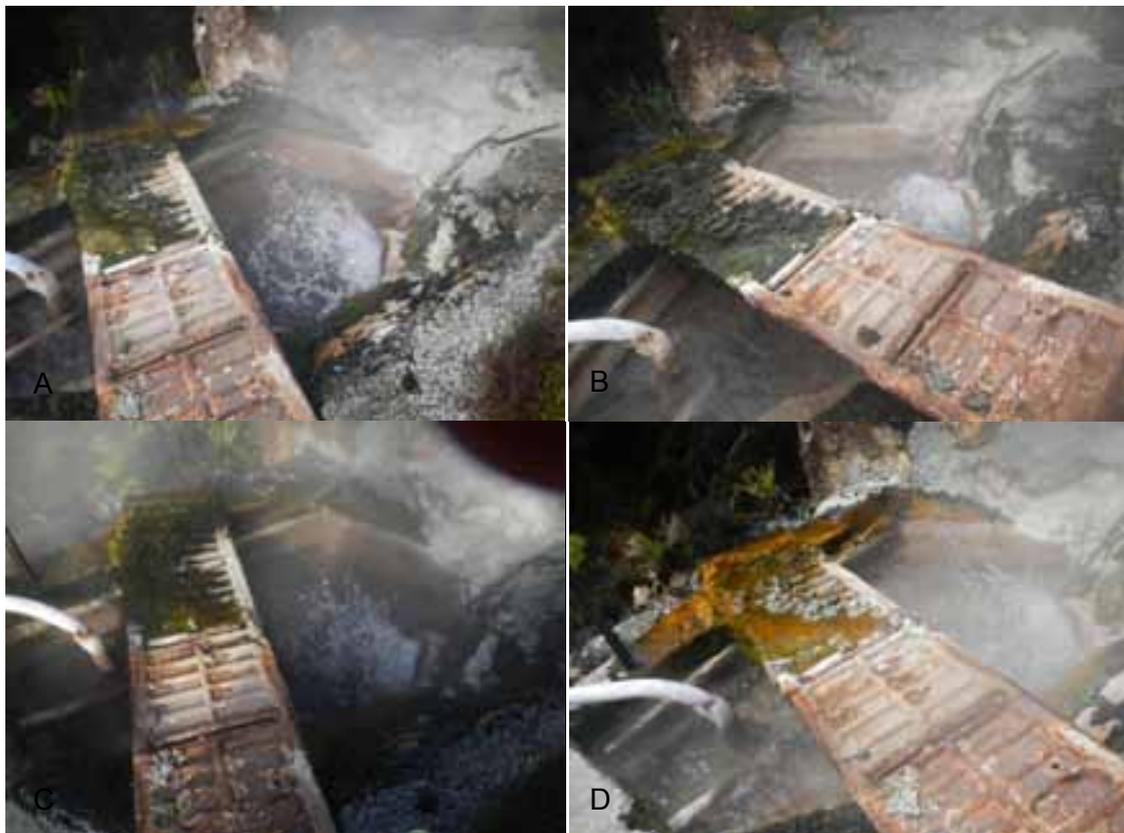
Figure 120: Upper Supply Spr, Apr 2013 (A), June 2013 (B), Sept 2013 (C), Jan 2014 (D)

Date	T(°C)	pH	Flow (l/s)	Water level	Ebullition	Colour
30 April 2013	92.5	9	Piped	Overflowing	Vigorous discharge, boiling	Clear
27 June 2013	94.2	8	Piped	Overflowing	Vigorous discharge, boiling	Clear
25 Sept 2013	83.6	8-9	Piped	Overflowing	Vigorous discharge, boiling	Clear
04 Feb 2014	95.0	7-8	Piped	Overflowing	Vigorous discharge, boiling	Clear

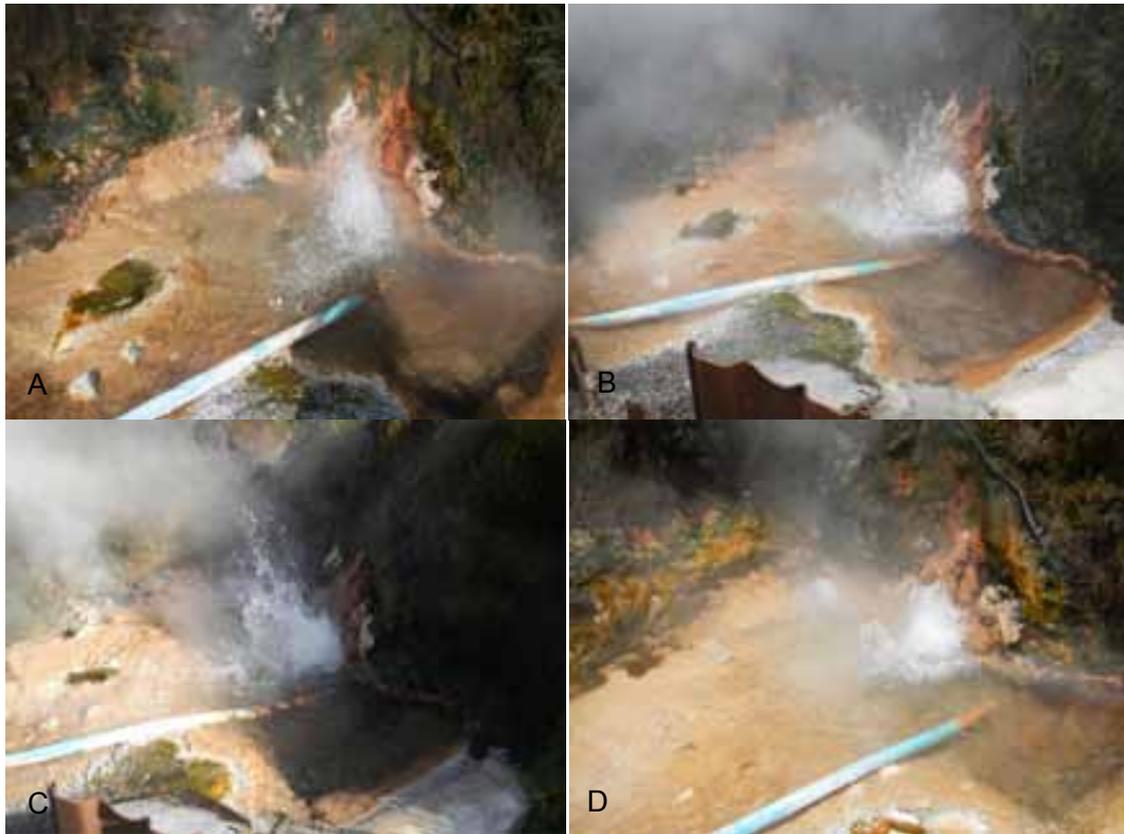
Figure 122: Lower Supply Spring, Apr 2013 (A), June 2013 (B), Sept 2013 (C), Jan 2014 (D)

Date	T(°C)	pH	Flow (l/s)	Water level	Ebullition	Colour
30 April 2013	94.8	9	Piped	Overflowing	Vigorous discharge, boiling	Clear
27 June 2013	94.7	7	Piped	Overflowing	Vigorous discharge, boiling	Clear
25 Sept 2013	87.8	9	Piped	Overflowing	Extremely vigorous	Clear
04 Feb 2014	95.6	8-9	Piped	Overflowing	Vigorous discharge, boiling	Clear

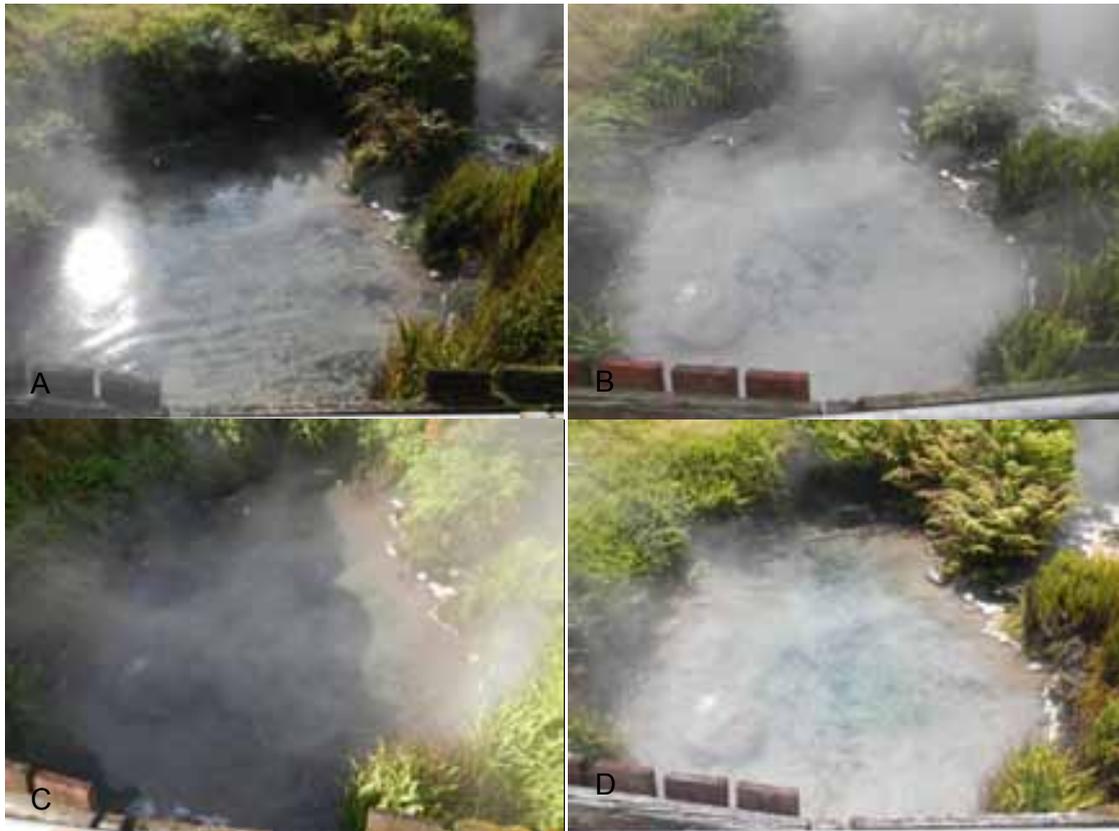
Figure 123: Pool adjacent Lower Supply, Apr 2013 (A), June 2013 (B), Sept 2013 (C), Jan 2013 (D)

There was a temperature drop between June 2013 and September 2013 of 5.7 °C. Temperature had risen back up to 81.3 °C by January 2014.

Date	T(°C)	pH	Flow (l/s)	Water level	Ebullition	Colour
30 April 2013	84.5	7	<0.5	Overflowing	Upwelling from various areas across the whole pool.	Clear
27 June 2013	80.9	7	<0.5	Overflowing	Constant upwelling	Clear, blue
25 Sept 2013	75.2	7-8	<0.5	Overflowing	Constant upwelling	Clear, blue/grey
04 Feb 2014	81.3	7	<0.5	Overflowing	Constant upwelling	Clear

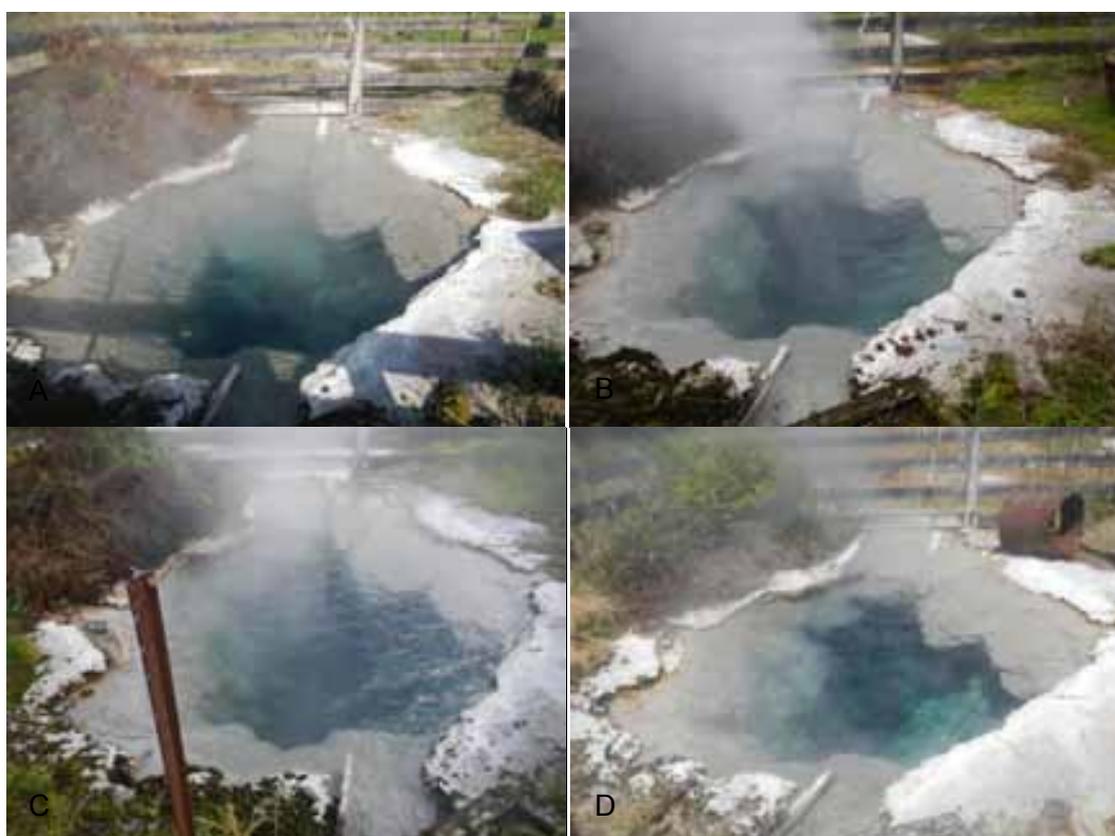
Figure 125: Scalding Spring, Apr 2013 (A), June 2013 (B), Sept 2013 (C), Jan 2014 (D)

This spring is located in a stock paddock and had therefore been fenced off. A slightly submerged sinter shelf extends ~1 metre from the edge before the pool becomes very deep. The clarity of the water allows visibility to a depth of at least 5 m, although the bottom of the pool is not visible at this depth. The pool flows on to a sinter terrace and forms a small stream, which leads into the Otamakokore Stream.

Date	T(°C)	pH	Flow (l/s)	Water level	Ebullition	Colour
30 April 2013	94.0	8	<0.5	Overflowing	Constant near the outlet	Clear, blue
27 June 2013	93.4	8	<0.5	Overflowing	Constant near the outlet	Clear, blue
25 Sept 2013	84.5	8-9	Seep (0.5-1 during surges)	Overflowing	Constant near outlet	Clear, blue
04 Feb 2014	92.4	7-8	<0.5	Overflowing	Constant near outlet	Clear, blue

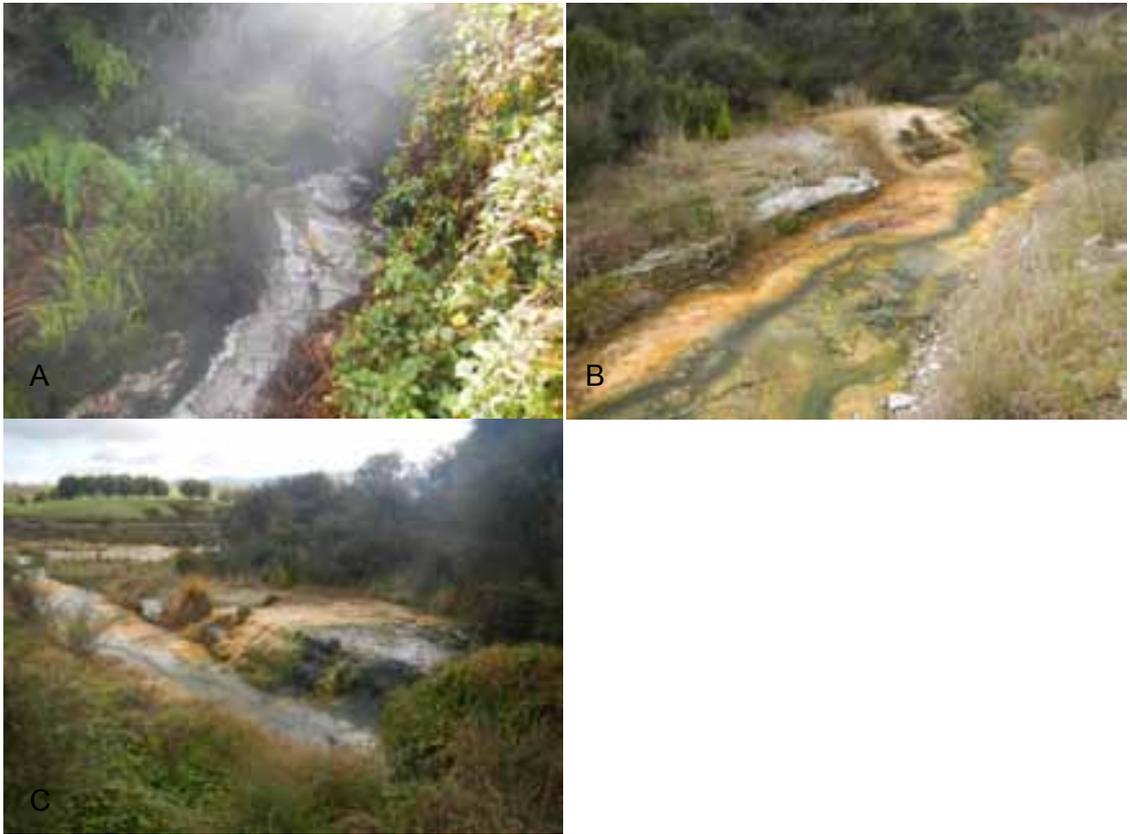
Figure 127: Hot stream (A), and discharge area onto terraces (B) and (C), Apr 2013

The spring discharges into a small stream, which flows onto the sinter terraces. There is new sinter both in the channel and on the margins of the stream. The terrace that the stream flows onto appears to have green and yellow algae growing on it.

April 2013: The spring discharges into a small stream, which flows onto the sinter terraces. The vegetation had died back enough during this visit to allow access to the spring. The flow and pH have remained constant since the January visit but the temperature had dropped by 3.8 °C.

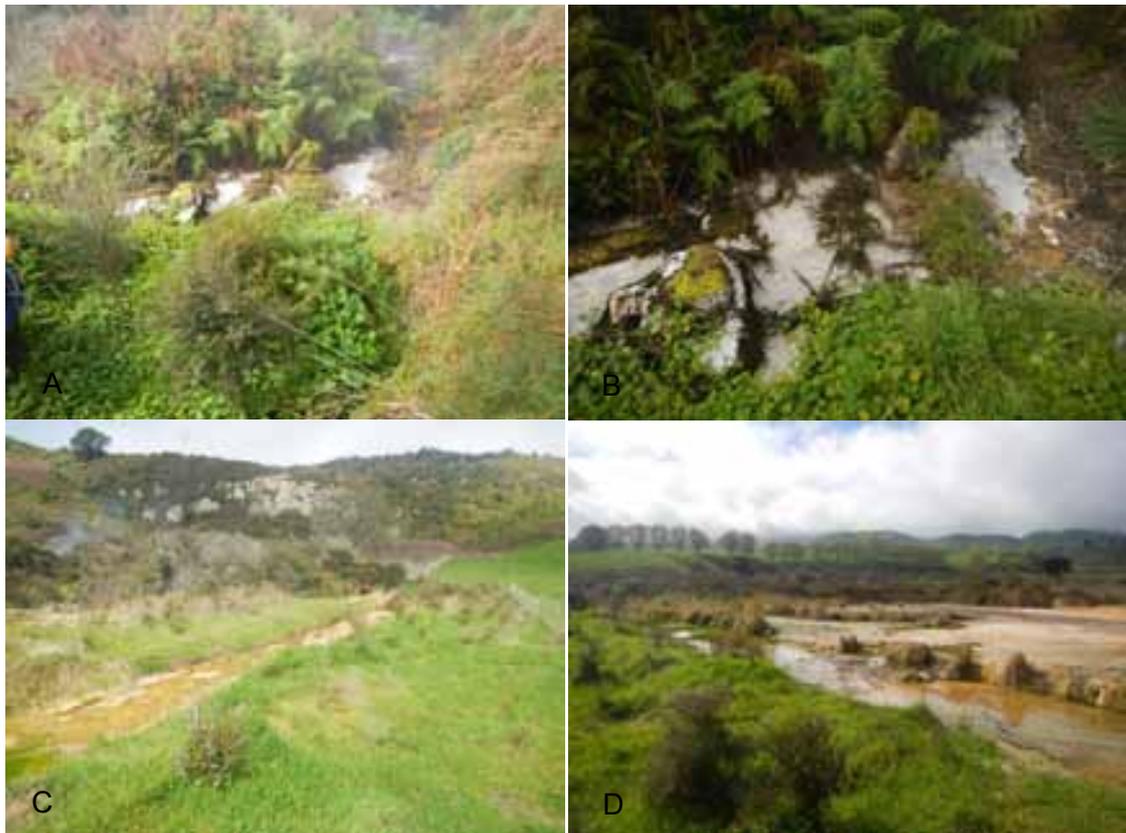
Figure 129: Hot stream (A) and (B) discharge area onto terraces (C) and (D), Sept 2013

The temperature is less during the September 2013 and January 2014 monitoring visits as we could not access the spring itself, and the temperature reading was taken from the stream.

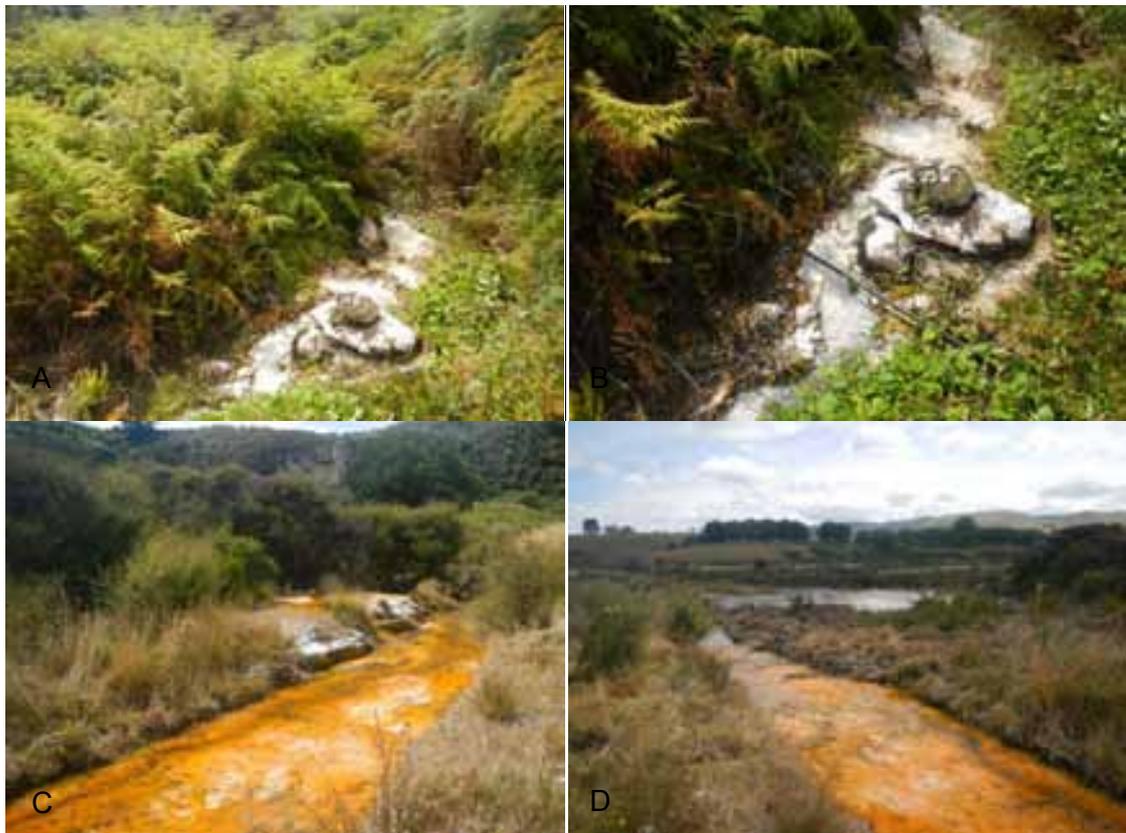
Figure 130: Hot stream (A) and (B), discharge area onto terraces (C) and (D), Jan 2014

January 2014: The stream appears to be widening. The vegetation alongside the stream has grown up to 1.6 m tall. The algal growth has increased.

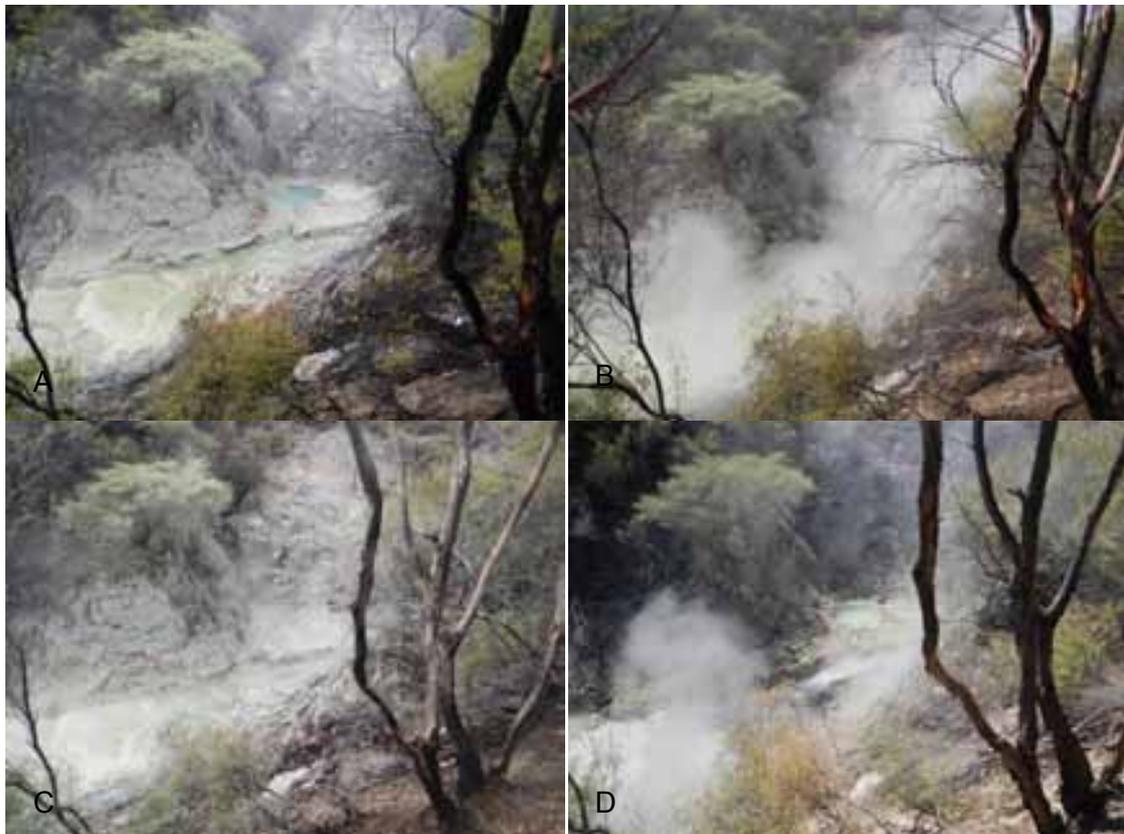
Figure 132: Weather Pool in Apr 2013 (A), June 2013 (B), Sept 2013 (C), Jan 2014 (D)

Date	T(°C)	Water level	Ebullition	Colour
16 April 2013	38.0	Overflowing	Calm	Murky, blue/grey
25 June 2013	26.5	Overflowing	nd	Cloudy, aqua
25 Sept 2013	48.5	Overflowing	Occasional bubbles	Murky, grey/green
29 Jan 2014	48.7	Overflowing	Occasional bubbles	Cloudy, blue/green

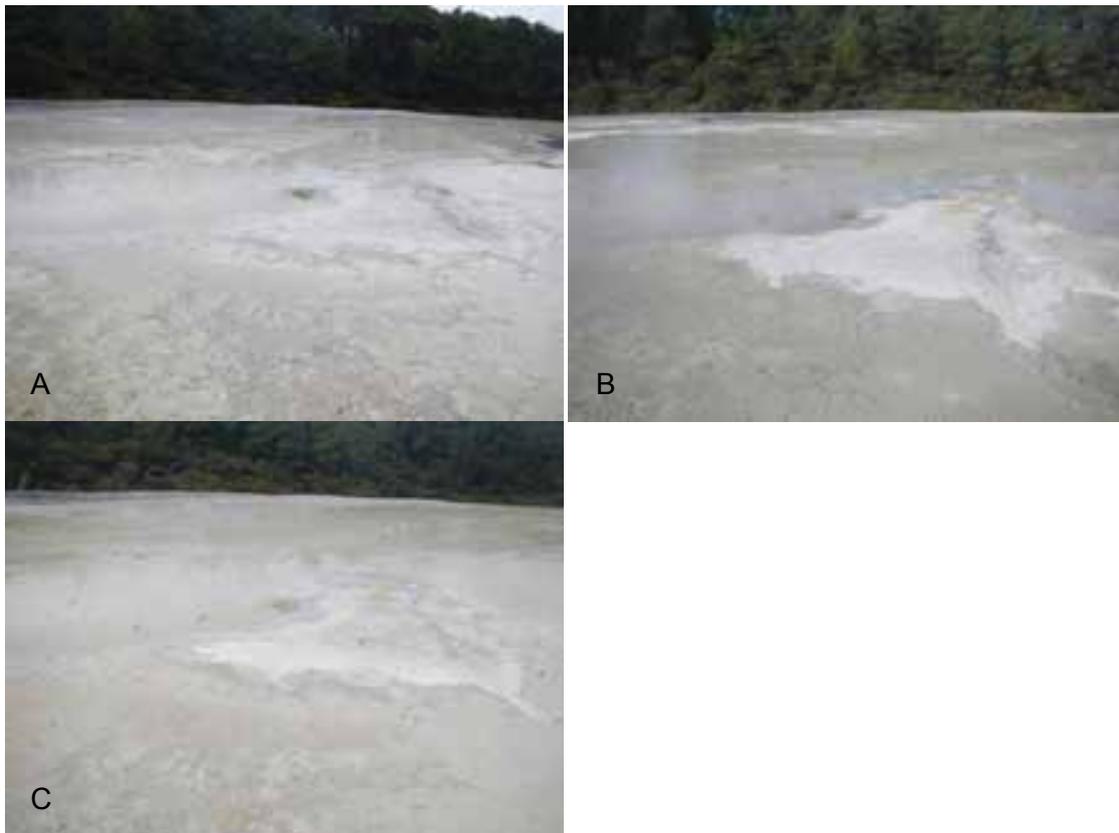
Figure 136: Jean Batten Geyser, Apr 2013 (A), June 2013 (B) and Sept 2013 (C)

Date	T(°C)	pH	Flow (l/s)	Water level	Ebullition	Colour
16 April 2013	55.0	nd	In flow only	No visible water	-	-
25 June 2013	97.2	nd	nd	No visible water	steaming	-
25 Sept 2013	38.5	nd	In flow – seep	No water visible	Steaming, audible discharge	-
29 Jan 2014	94.3	nd	-	No visible water	Steaming, audible discharge	-

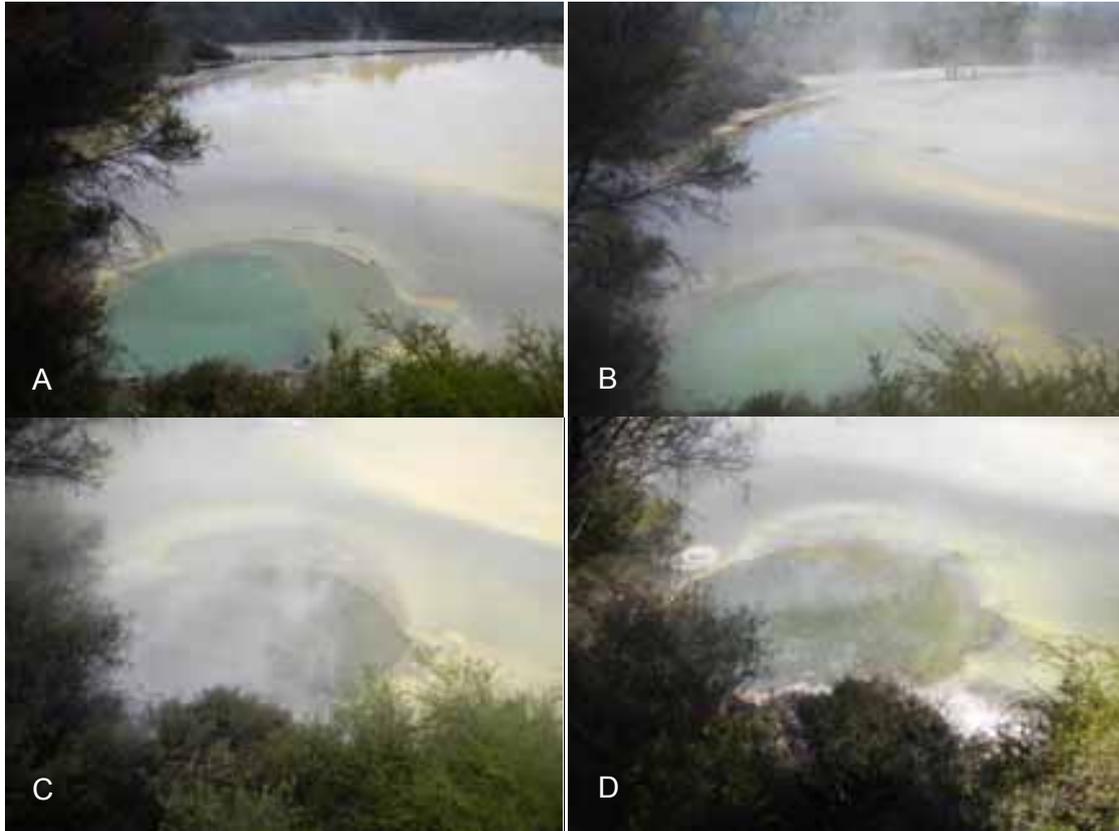
Figure 143: Foreground Pool, Apr 2013 (A), June 2013 (B), Sept 2013 (C), Jan 2014 (D)

Date	T(°C)	pH	Flow (l/s)	Water level	Ebullition	Colour
16 April 2013	60	nd	-	Submerged	constant discharge	Cloudy green
25 June 2013	48	nd	seep	Overflowing	calm	Murky, Pale green
25 Sept 2013	64.7	nd	-	Not overflowing	Constant effervescing	Murky, brown
29 Jan 2014	69.3	nd	seep	Overflowing	Effervescing on far side	Murky, green

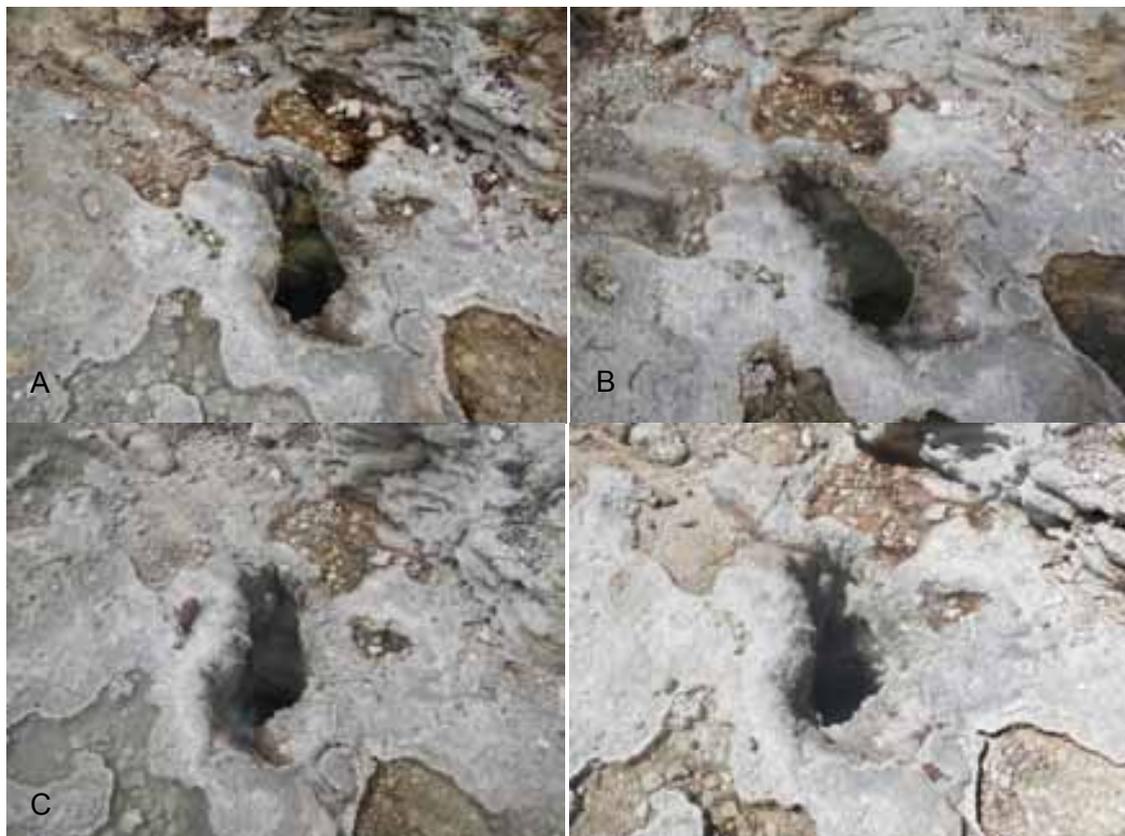
Figure 145: Waiotapu Geyser in Apr 2013 (A), June 2013 (B), Sept 2013 (C) and Jan 2014 (D)

Date	T(°C)	pH	Flow (l/s)	Water level	Ebullition	Colour
16 April 2013	67	4	-	0.1 m below overflow	Calm, occasional bubbles	Clear
25 June 2013	69.1	3	-	0.5 m below overflow	Calm, occasional bubbles	Clear
25 Sept 2013	67	4	-	0.1 m below overflow	Calm	Clear
29 Jan 2014	80.3	5-6	-	0.3 m below outflow	Calm	Clear

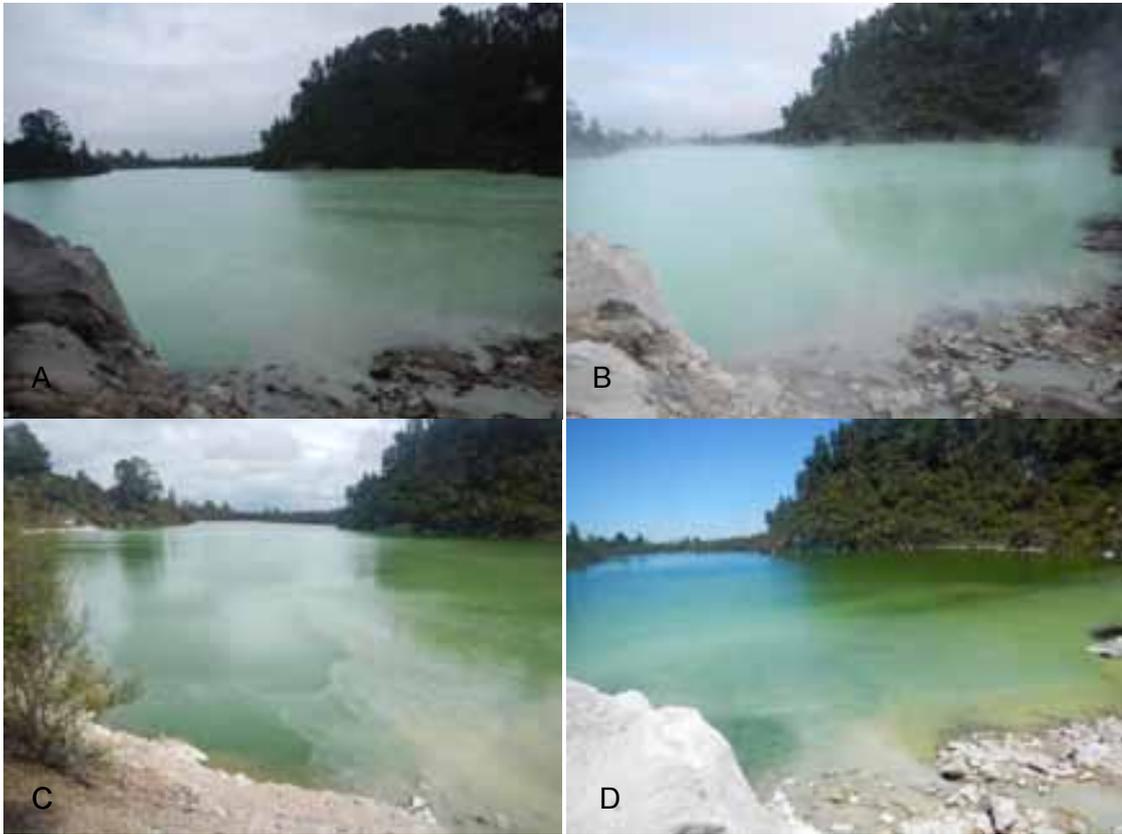
Figure 149: Lake Ngakoro, Waiotapu in Apr 2013 (A), June 2013 (B), Sept 2013 (C), Jan 2014 (D)

Date	T(°C)	pH	Flow (l/s)	Water level	Ebullition	Colour
16 April 2013	29.6	2	Inflow 20 l/s	nd	Bubbles around the edge	Cloudy, green
25 June 2013	33	3	nd	nd	Effervescing around the edges	Cloudy, Pale green
25 Sept 2013	17.2	2	Inflow 30 l/s	nd	Discharge around edges	Murky, green
29 Jan 2014	28.3	3	Inflow 20 l/s	nd	Discharge around edges	Cloudy green

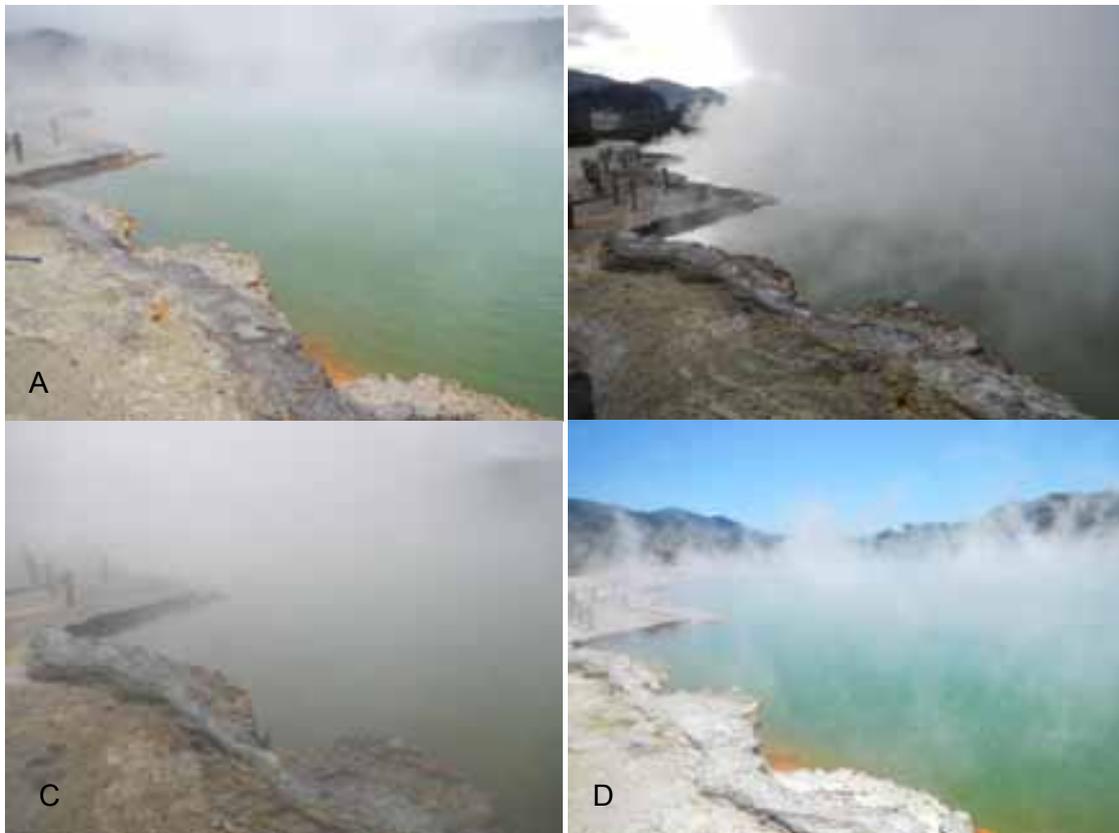
Figure 151: Champagne Pool, Apr 2013 (A), June 2013 (B), Sept 2013 (C), Jan 2014 (D)

Date	T (°C)	pH	Flow (l/s)	Water level	Ebullition	Colour
16 April 2013	63	4	-	-	Calm with a smell of H ₂ S	Green with visibility to 5 m depth.
25 June 2013	73.4	5	Seep	Overflowing	Effervescing around edges, upwelling further in.	Green with visibility to 5 m depth.
25 Sept 2013	63.9	6	Seep	Overflowing	Effervescing all over	Murky, green
29 Jan 2014	75.2	5	<0.5	Overflowing	Effervescing	Green, clear with 3 m visibility

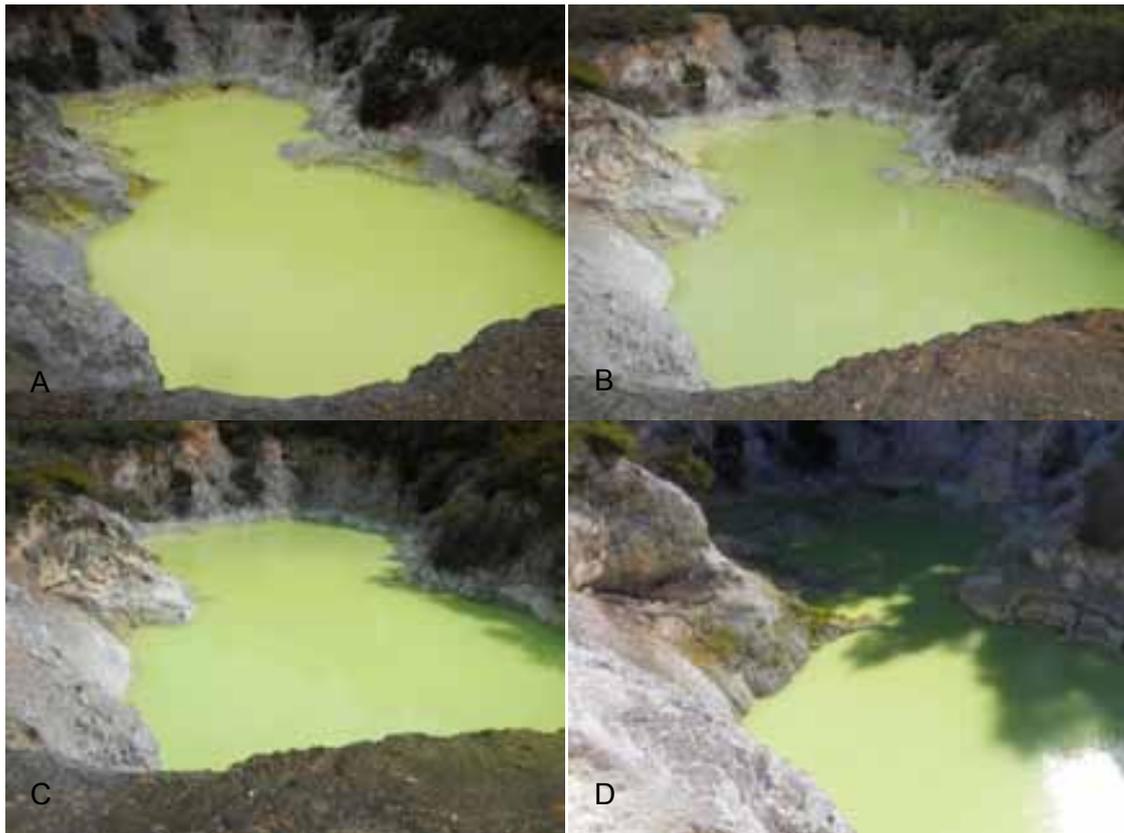
Figure 152: Devil's Bath, Apr 2013 (A), June 2013 (B), Sept 2013 (C), Jan 2013 (D)

Date	T (°C)	pH	Flow (l/s)	Water level	Ebullition	Colour
16 April 2013	21.6	nd	-	2-3 m below high water mark	Constant discharge in several areas.	Bright green
25 June 2013	14.8	nd	Inflow ~4 l/s	2-3 m below high water mark	Constant discharge in several areas.	Cloudy, pale green
25 Sept 2013	26.2	nd	-	2 m below high water mark	Effervescing	Cloudy, lime green
29 Jan 2014	26.4	nd	Inflow ~10 l/s	2 m below high water mark	Small bubbles all over	Murky, bright yellow/green

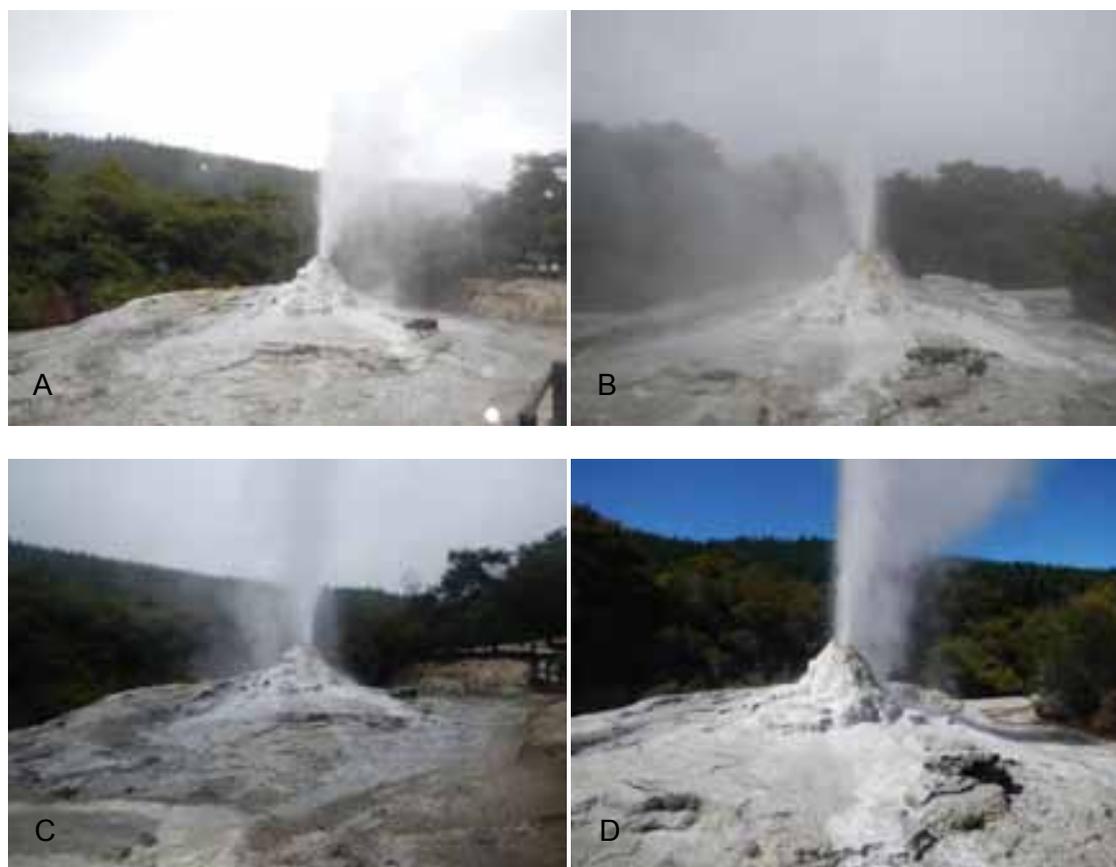
Figure 154: Lady Knox Geyser, Waiotapu in Apr 2013 (A), June 2013 (B), Sept 2013 (C) and Jan 2014 (D)

Date	T(°C)	pH	Height	Eruption duration	Colour
16 April 2013	-	-	5	Over 26 minutes	Clear
25 June 2013	74	8	5	Over 35 minutes	Clear
25 Sept 2013	80	5-6	3-6 m	Over 30 minutes	Clear
29 Jan 2014	84.5	5	4-6 m	Over 35 minutes	Clear

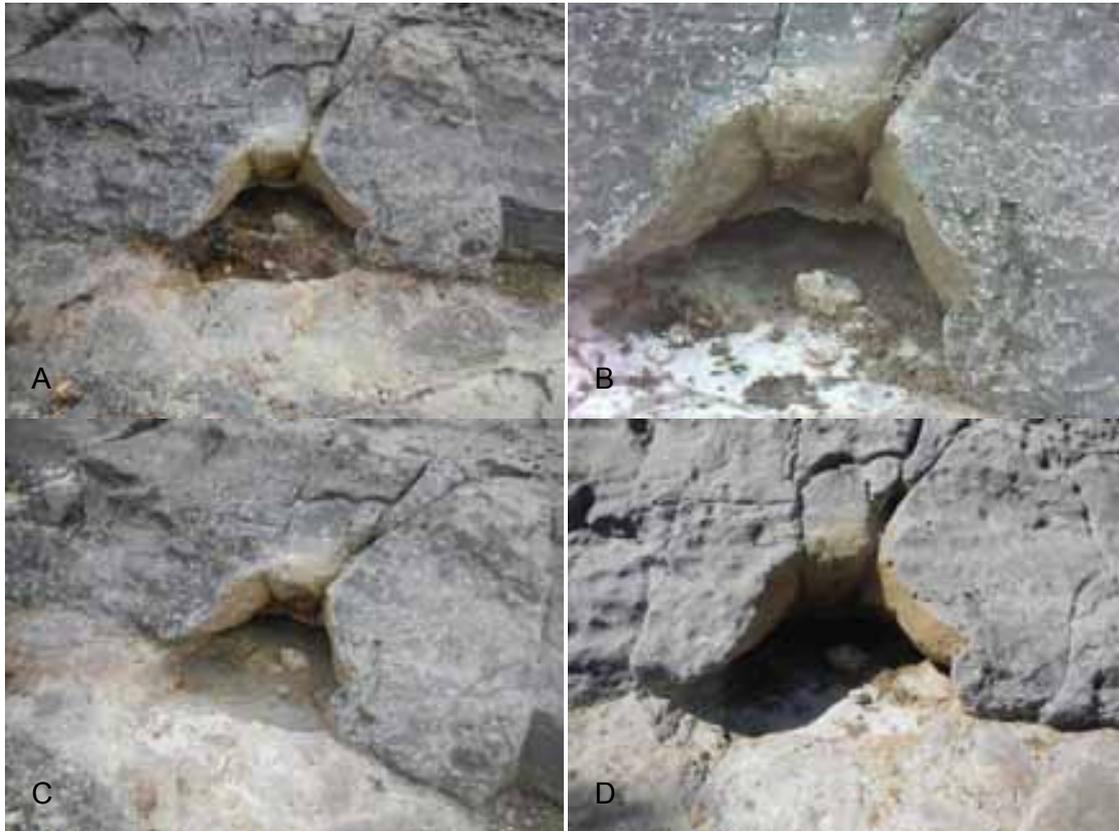
Figure 156: Knox Spring Hole and Channel, Apr 2013 (A), June 2013 (B), Sept 2013 (C) and Jan 2014 (D)

Date	T (°C)	pH	Flow (l/s)	Level	Ebullition	Colour
16 April 2013	Spring 60 Channel 83.0	nd	<0.5 (from below spring)	Dry	Audible discharge and steam with an H ₂ S odour	Clear (from below spring)
25 June 2013	Spring 50.0 Channel 67.7	nd	<0.25 (from below spring)	Dry	Audible discharge and steam with an H ₂ S odour	Clear (from below spring)
25 September 2013	Spring 61.0	3	<0.5 (from below spring)	Small amount of water	Audible discharge and steam with an H ₂ S odour	Clear
29 Jan 2014	Spring 49.2 Channel 79.7	3	<0.5 (from below spring)	Dry	Audible discharge and steam with an H ₂ S odour	Clear, yellow/grey (from below spring)

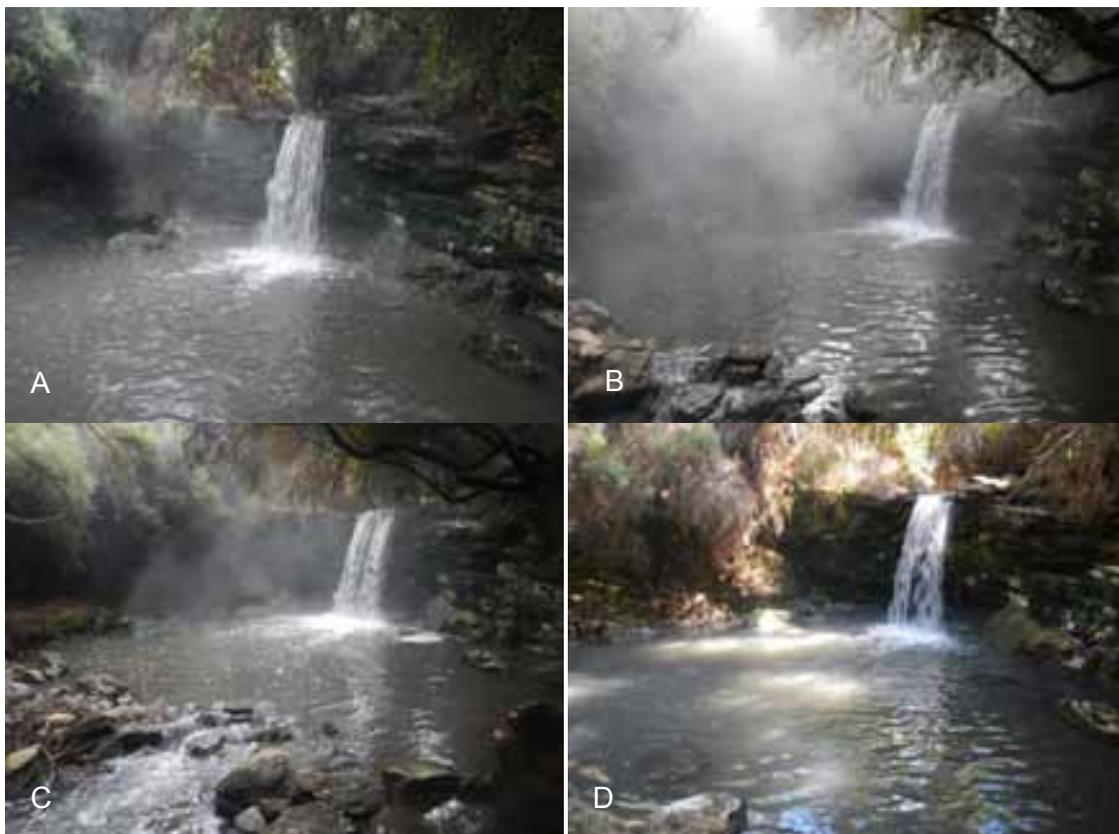
Figure 158: Hidden Pool, Knox Geyser area, Waiotapu in Apr 2013 (A), June 2013 (B), Sept 2013 (C) and Jan 2014 (D)

Date	T (°C)	pH	Flow (l/s)	Water level	Ebullition	Colour
16 April 2013	37.0	3	~10	Overflowing	Calm, some steam	Murky, brown
25 June 2013	35.6	3	7	Overflowing	Calm, steaming	Murky (~0.5 m), brown.
25 Sept 2013	35.8	3	~20	Overflowing	Calm	Murky (~0.2 m), brown
29 Jan 2014	38.9	2-3	~9	Overflowing	Calm	Murky, grey

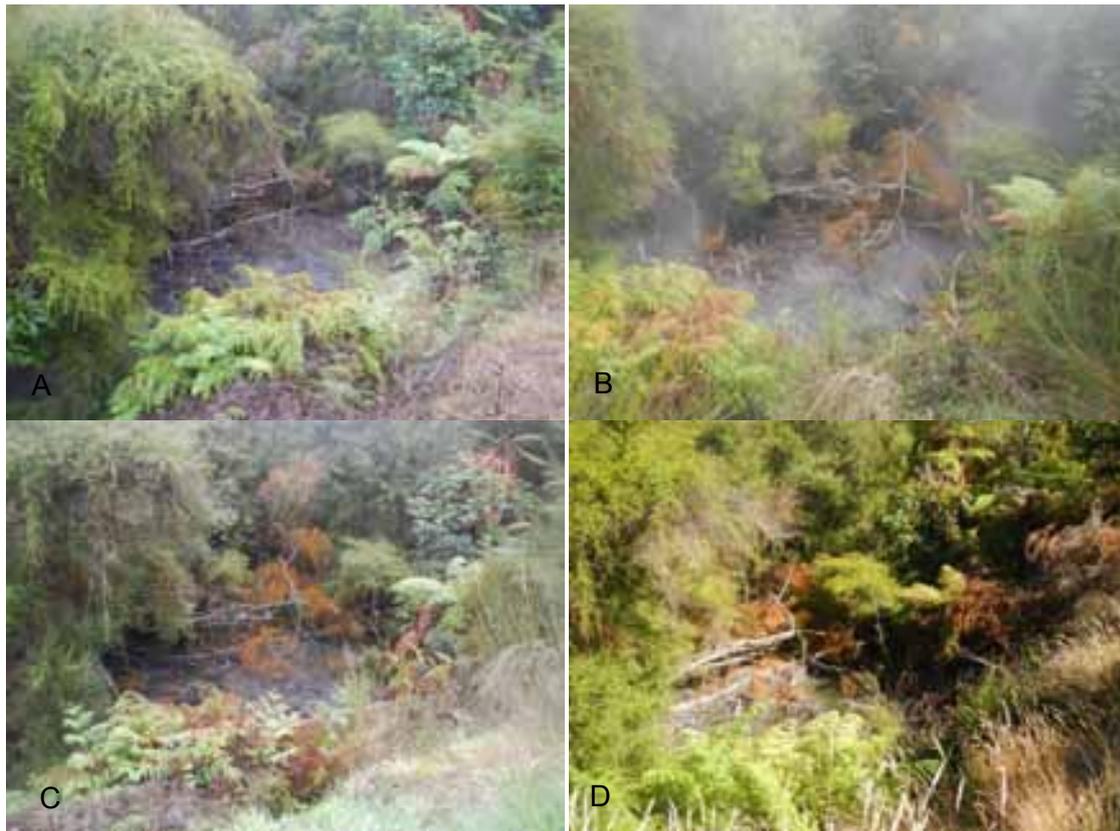
Figure 160: Venus Pool, Waiotapu in Apr 2013 (A), June 2013 (B), Sept 2013 (C) and Jan 2014 (D)

Date	T(°C)	pH	Flow (l/s)	Water level	Ebullition	Colour
16 April 2013	41.4	4	nd	Nd	Calm	Clear
25 June 2013	40.8	4	nd	Nd	Calm	Clear
25 Sept 2013	40	3-4	nd	Nd	Calm	Clear
29 Jan 2014	46.4	4	nd	Nd	Calm	Clear

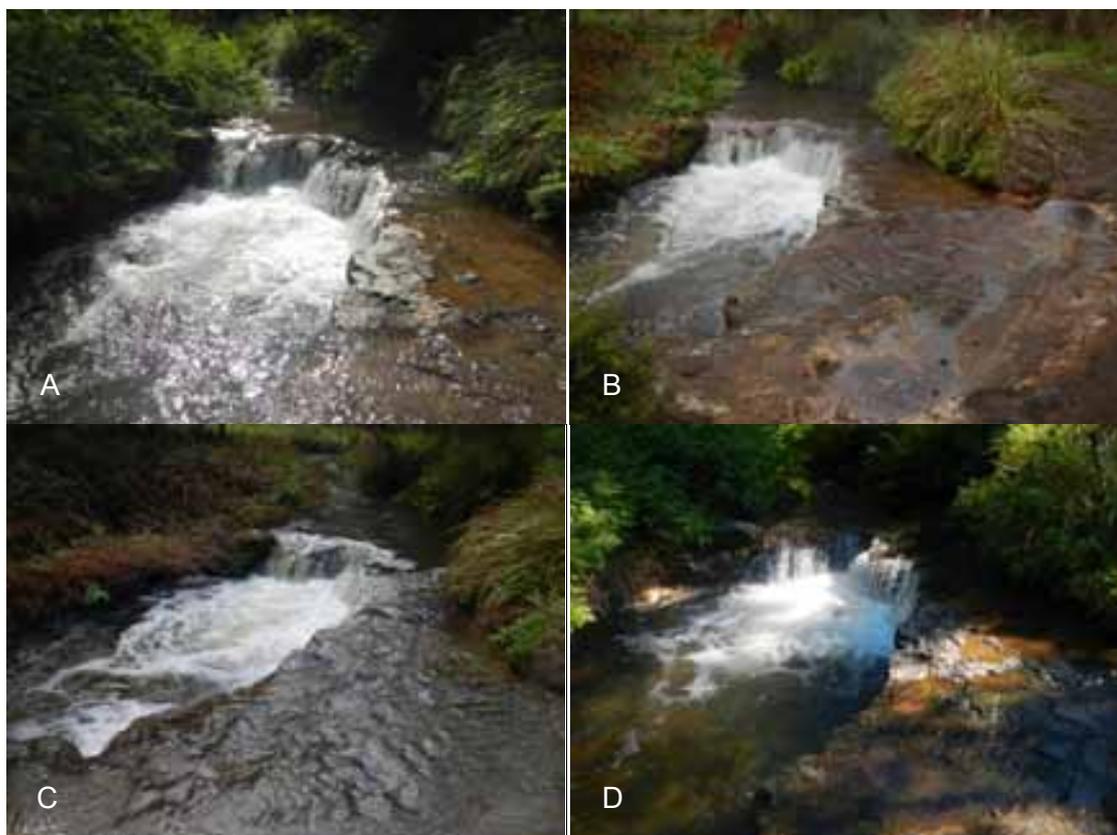
Figure 163: Kerosene Creek Pool, Apr 2013 (A), June 2013 (B), Sept 2013 (C), Jan 2014 (D)

September 2013: 0 bathers. Vegetation on the TL bank appears to have been burnt for about 50 m. There appears to be more flow than usual.

Date	T(°C)	pH	Flow (l/s)	Water level	Ebullition	Colour
30 April 2013	37.4	3	120	o/f	Calm, with a slight non definable odour	Clear, brown
25 June 2013	31.7	3	~120-130	o/f	Calm, with a slight odour	Murky, brownish
25 Sept 2013	28.3	3-4	~180	o/f	Calm, with a slight odour	Murky (0.5 m), brown
29 Jan 2014	37.6	3	~130-150	o/f	Calm, with a slight odour	Clear (~1 m), brown
