Geothermal features annual monitoring report - January 2014

For:
Waikato Regional Council
Private Bag 3038
Waikato Mail Centre
HAMILTON 3240

25 September 2014

Document #: 3133084

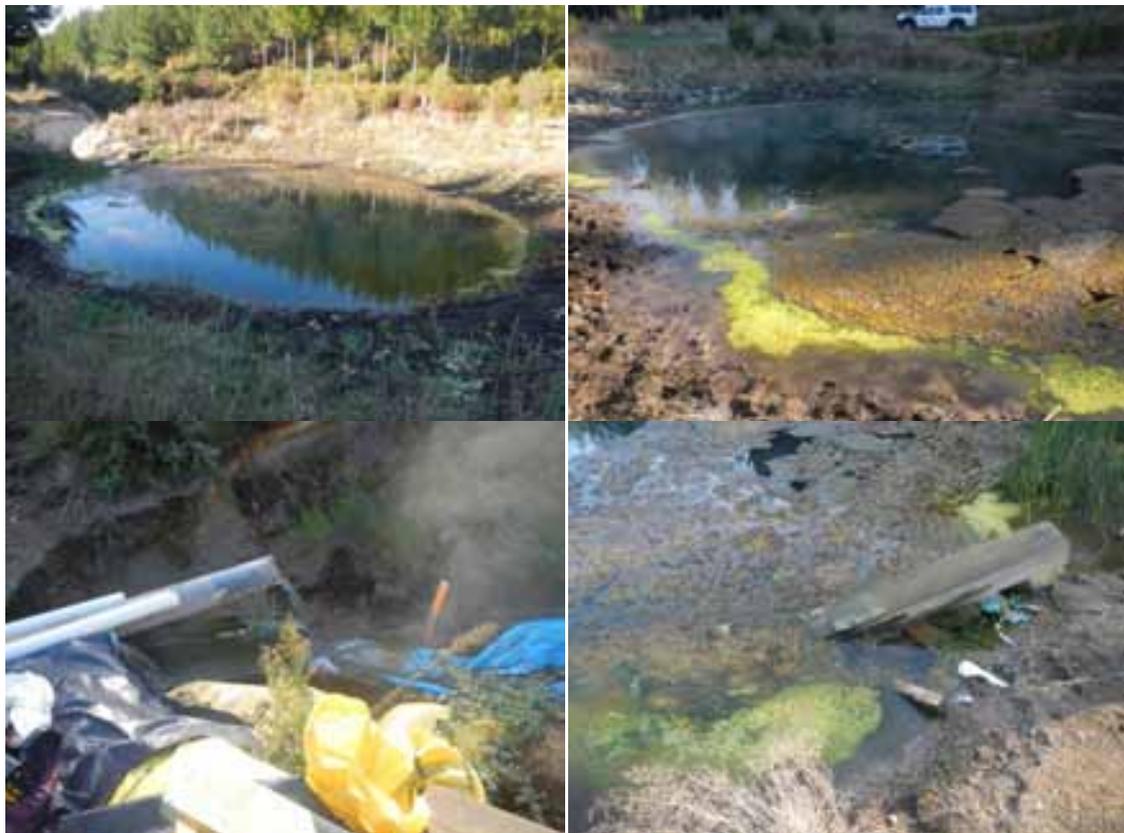
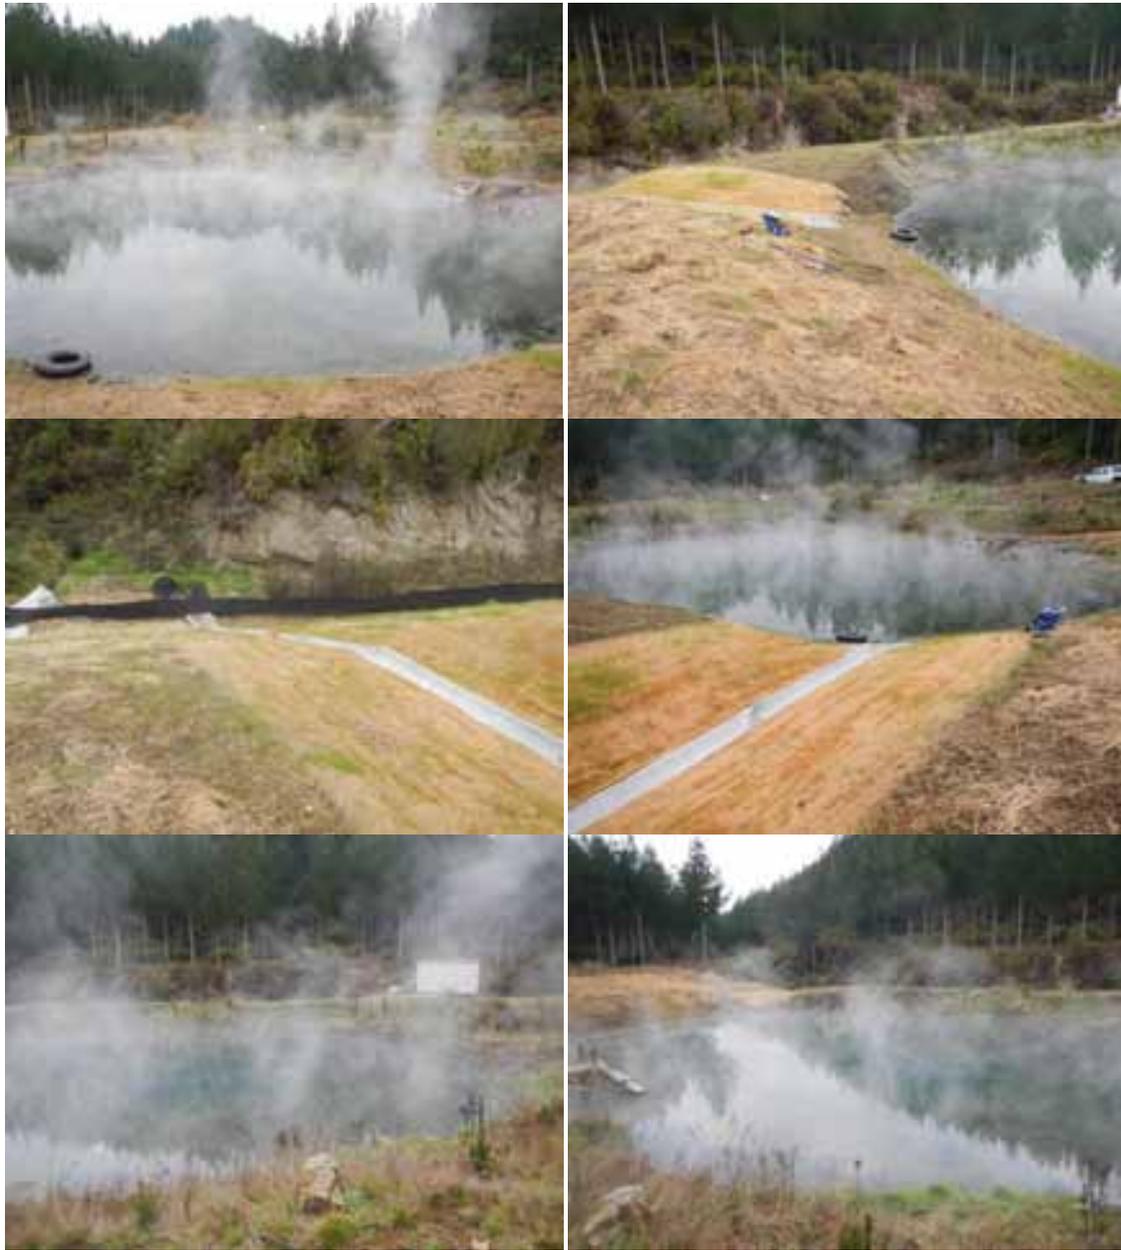
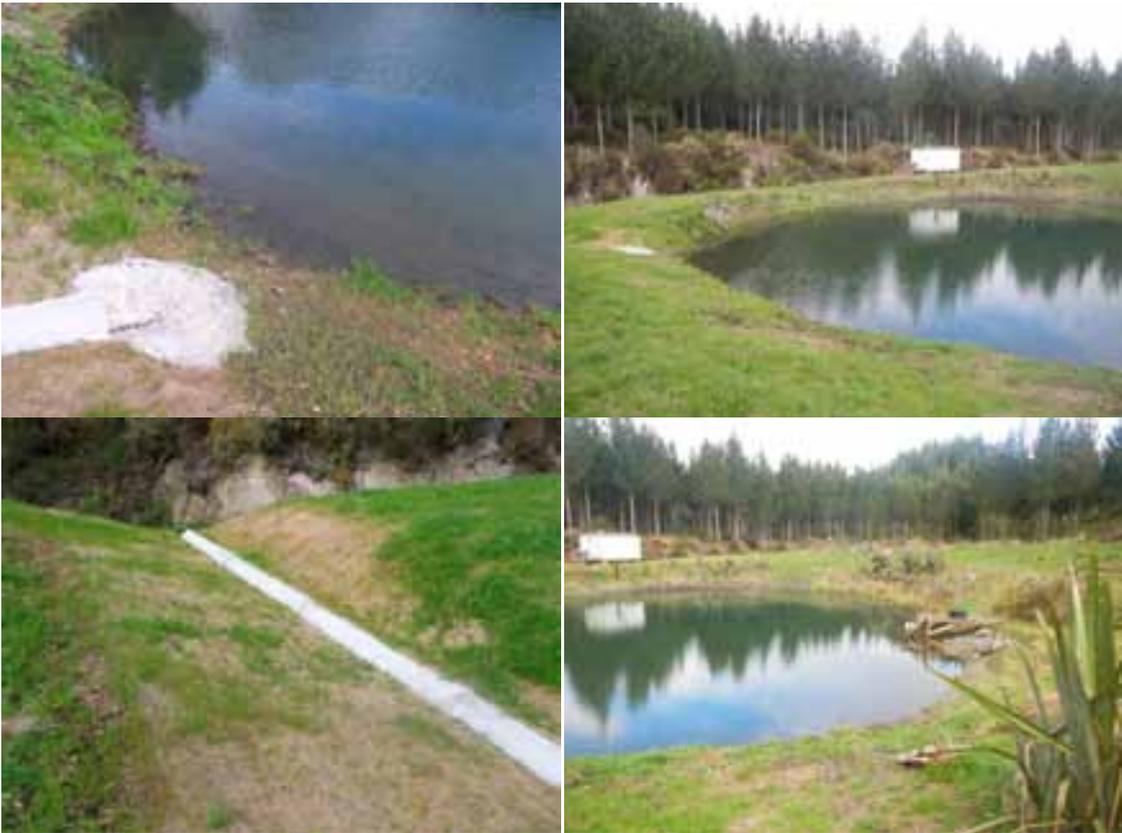
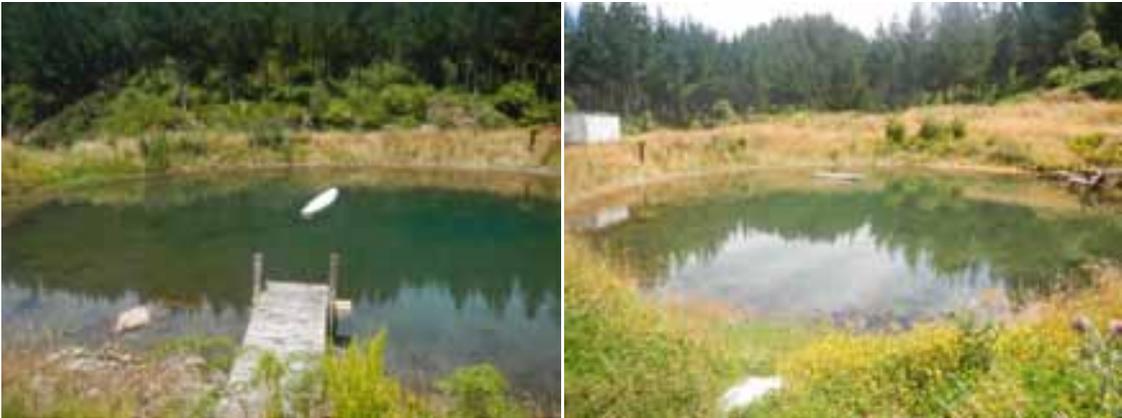
An incident at the pool in April 2012 resulted in the bank breaching. This incident has caused the level to drop by approximately one metre or 1 m. Pipes were placed at the outlet to control the outflow. Remediation of the pool had been carried out by June 2013.

Date	T (°C)	pH	Flow (l/s)	Water level	Ebullition	Colour
30 April 2013	48.3	7-8	~3.5	o/f	Constant in the centre	Clear, Green
25 June 2013	35.1	8	nd	~0.5 m below outflow	Occasional bubbles	Clear, Bluish
26 Sept 2013	33.2	6-7	nd	0.4 m below outflow	Upwelling in centre	Clear, green/blue
30 Jan 2014	36.1	8-9	nd	~0.3 m below outflow 790 mm below top of Jetty	Intermittent upwelling	Clear, blue/green
