# Inundation of Whitianga town during the 1960 Chilean tsunami

Prepared by: Brendan Morris and Jose Borrero

For:  
Waikato Regional Council  
Private Bag 3038  
Waikato Mail Centre  
HAMILTON 3240

30 June 2014

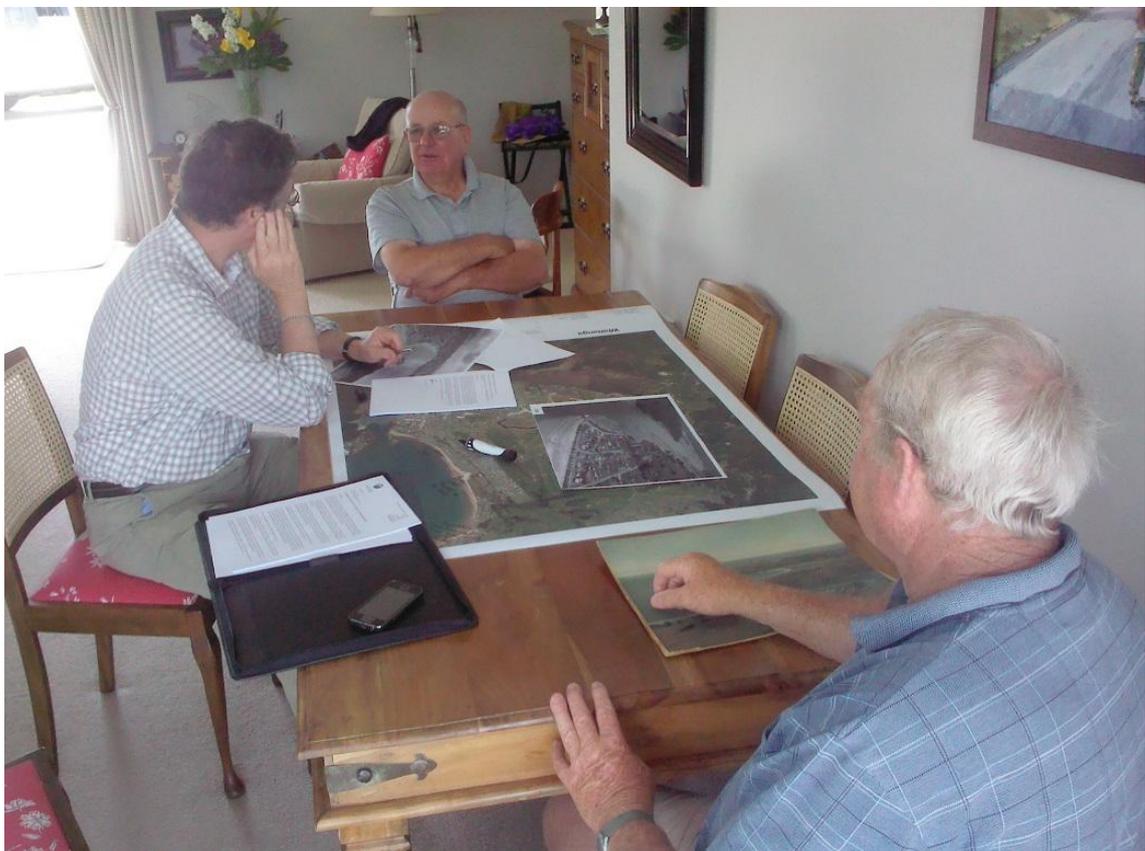
**Photo 3: The levels of inundation in the town and locations of landmarks identified by Robin Lee and Walter Russell were mapped on this 1955 historical oblique photograph.**

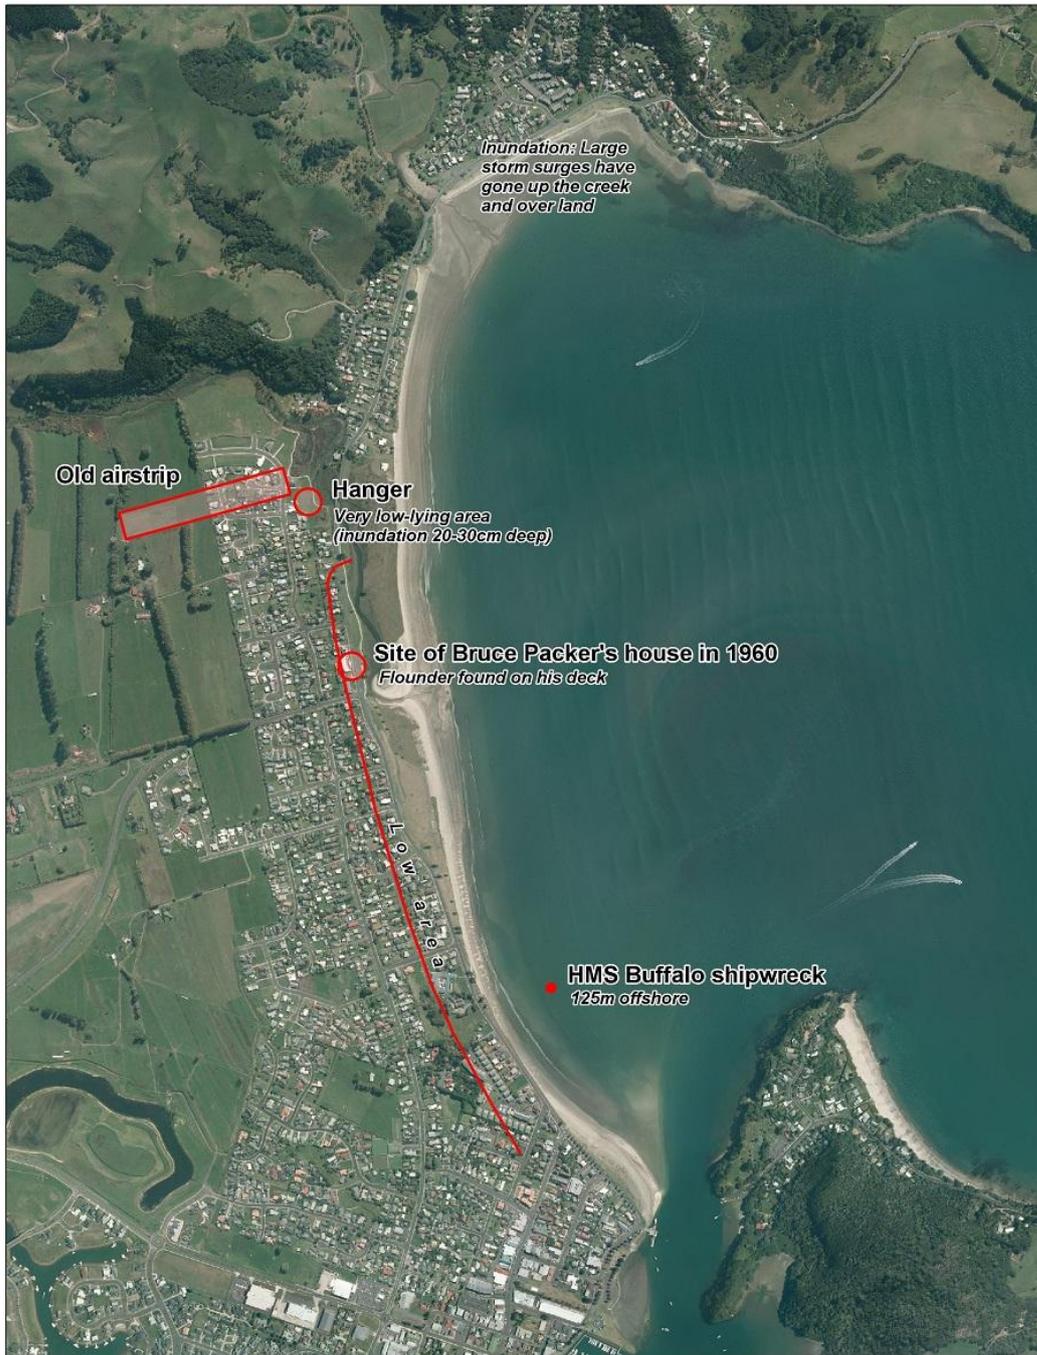
**Map 1: Recent aerial photograph of Whitianga showing tsunami inundation landmarks along Buffalo Beach identified by Robin Lee and Walter Russell.**

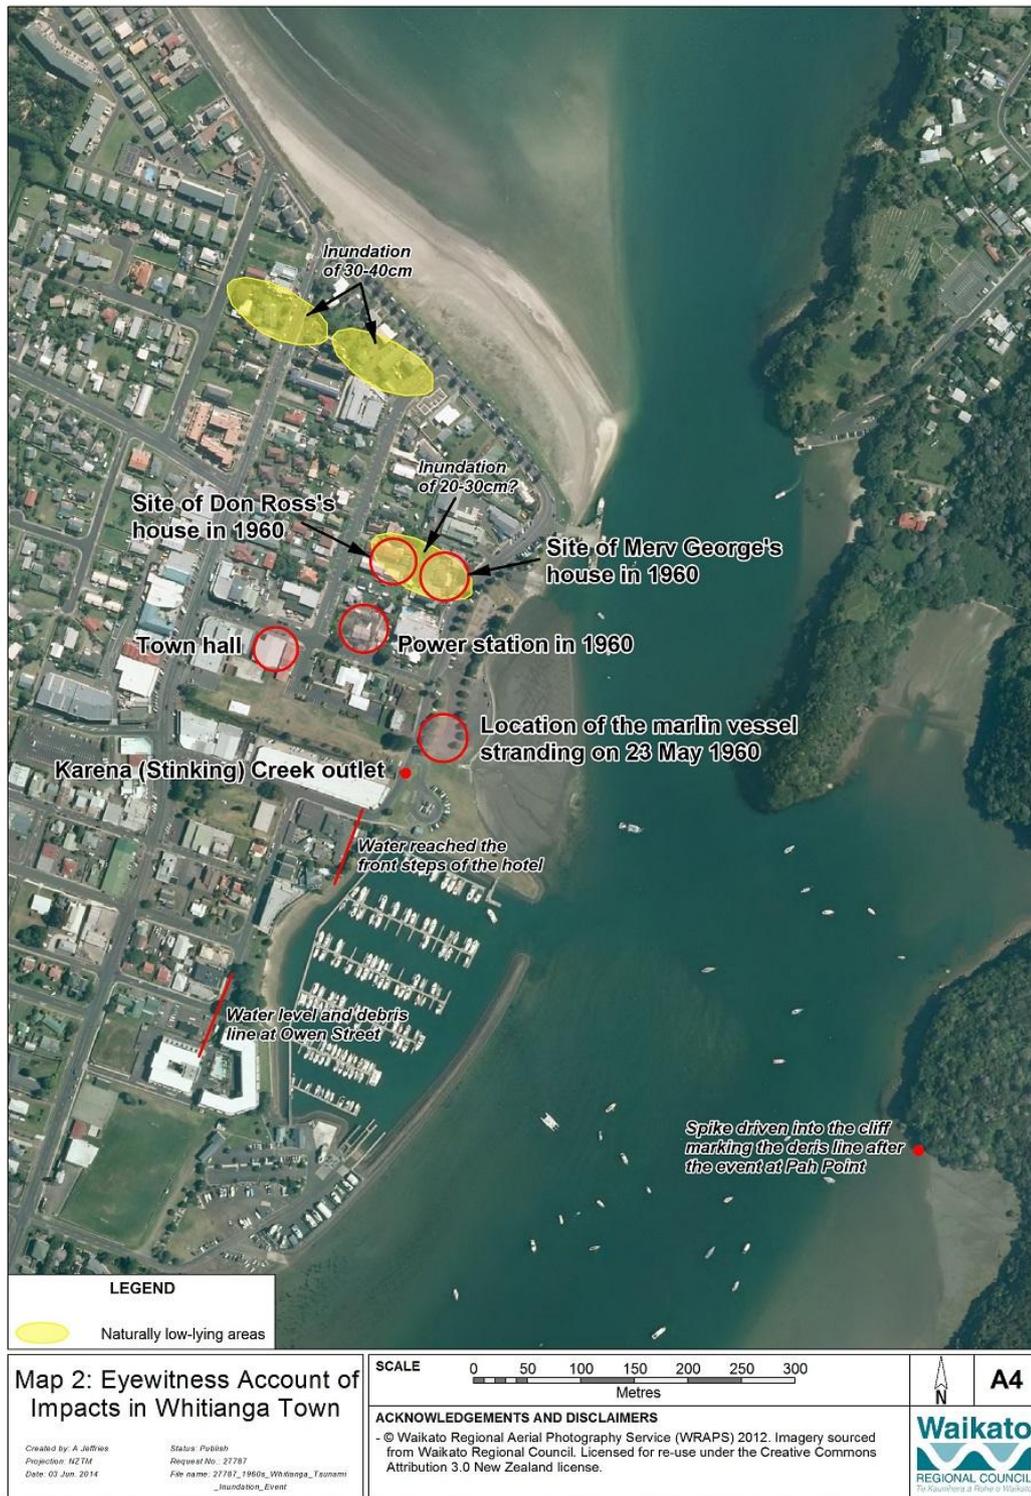
**Map 2:Recent aerial photograph of Whitianga town showing tsunami inundation landmarks identified by Robin Lee and Walter Russell.**

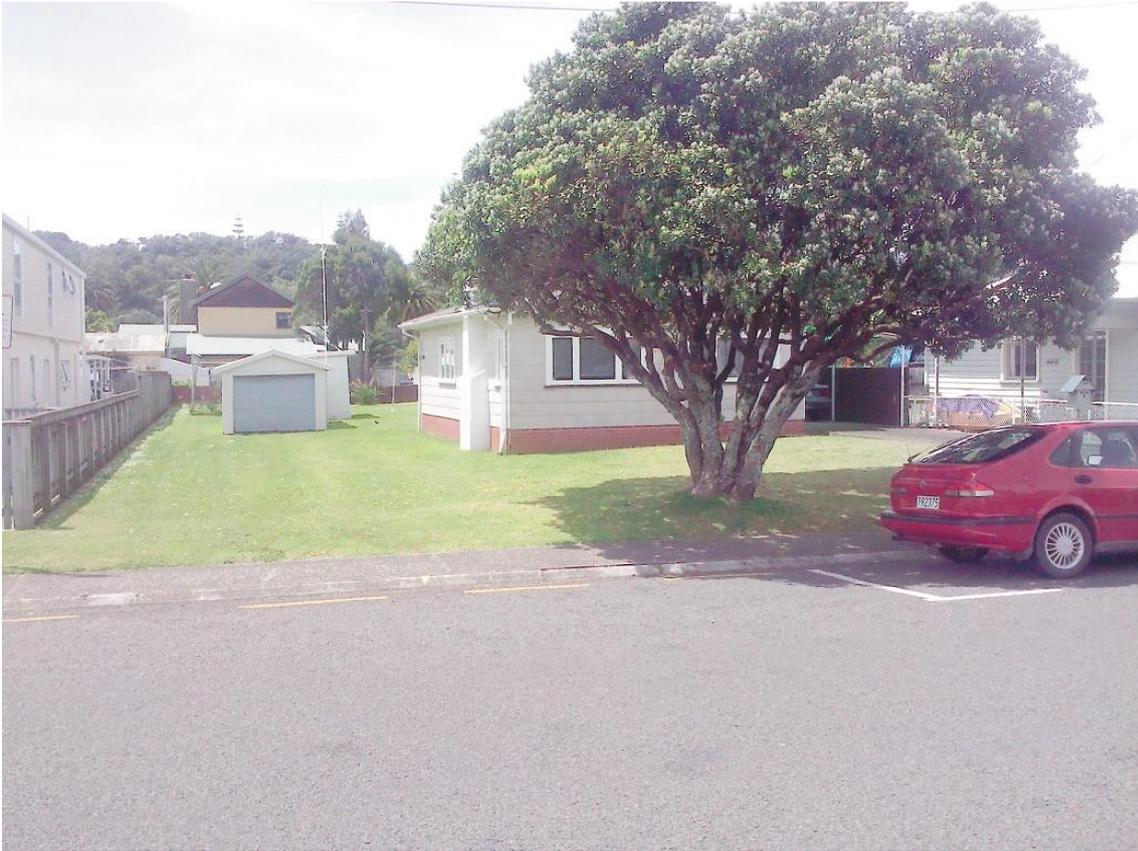
**Photo 4: The low-lying area (swale) on the eastern side of #6 Mill Street (Don Ross' house).**

Walter confirmed that from talking to Merv George, the water reached the steps on his house, but did not flow into the house. Walter estimates the depth to be around 20-30 cm. He also noted that the water likely flowed through to Don Ross' section as well, since this section is the continuation of the swale beyond Merv George's house (Photo 4).

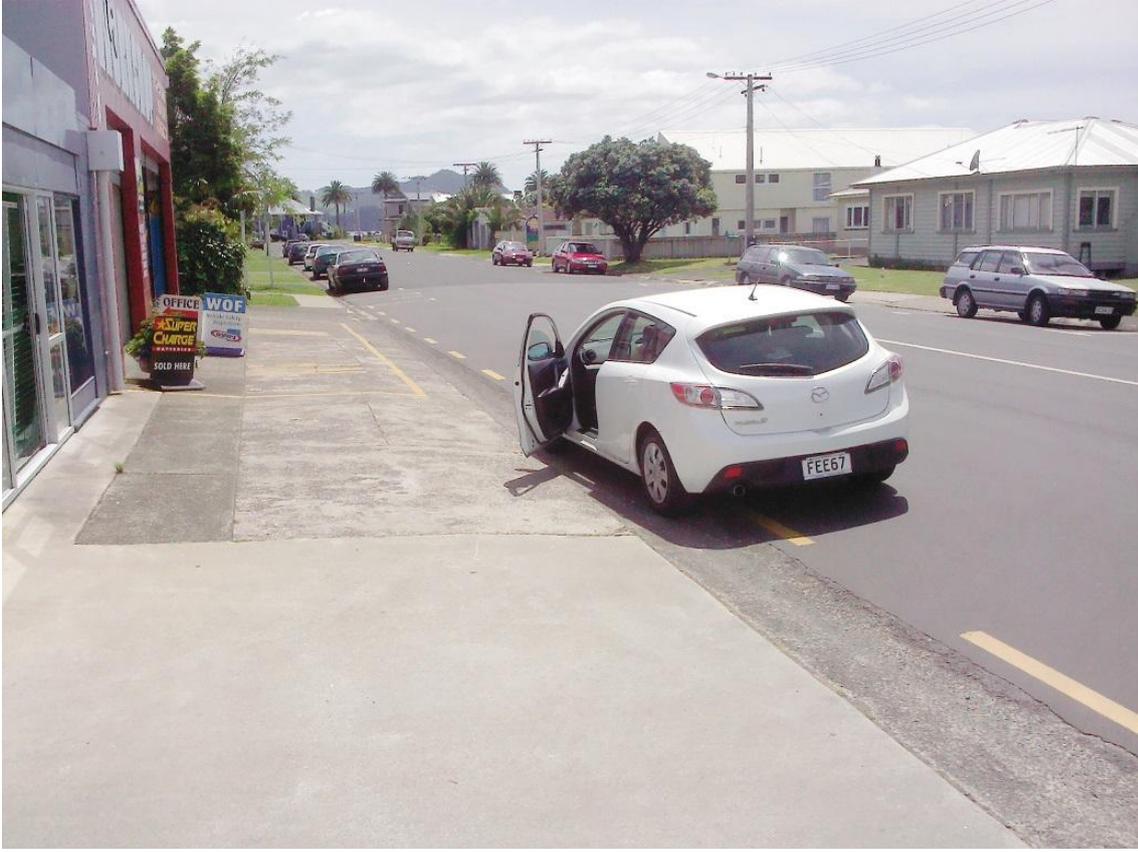
**Photo 5: Looking down Mill Road towards the Esplanade from the corner of Mill Road and Monk Street.**

With reference to Monk Street, Walter stated that the water reached the power station (which was situated at what is now 3 Monk Street), and that being the case, was likely to have reached the hall as well – probably via the gutters. Monk Street has a fairly low elevation (Photo 5).

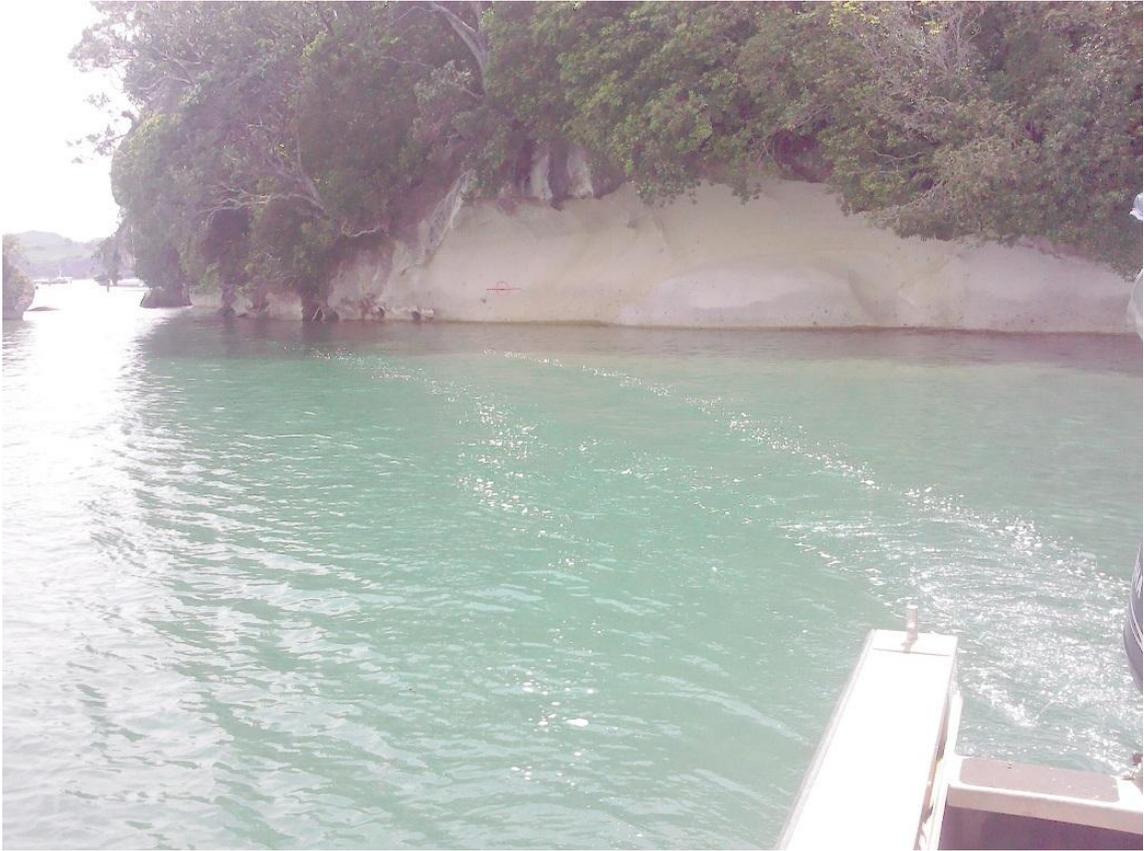
**Photo 6: Looking towards the marker peg site showing maximum inundation level at Pah Point.**

Walter explained that the marker peg was driven into the cliff a few days after the event at the high tide level – on the other side of the harbour. The original peg is suffering wear and tear, but is still intact. There are signs of cliff erosion around the peg. The level of the peg is roughly 1m above the high tide mark.

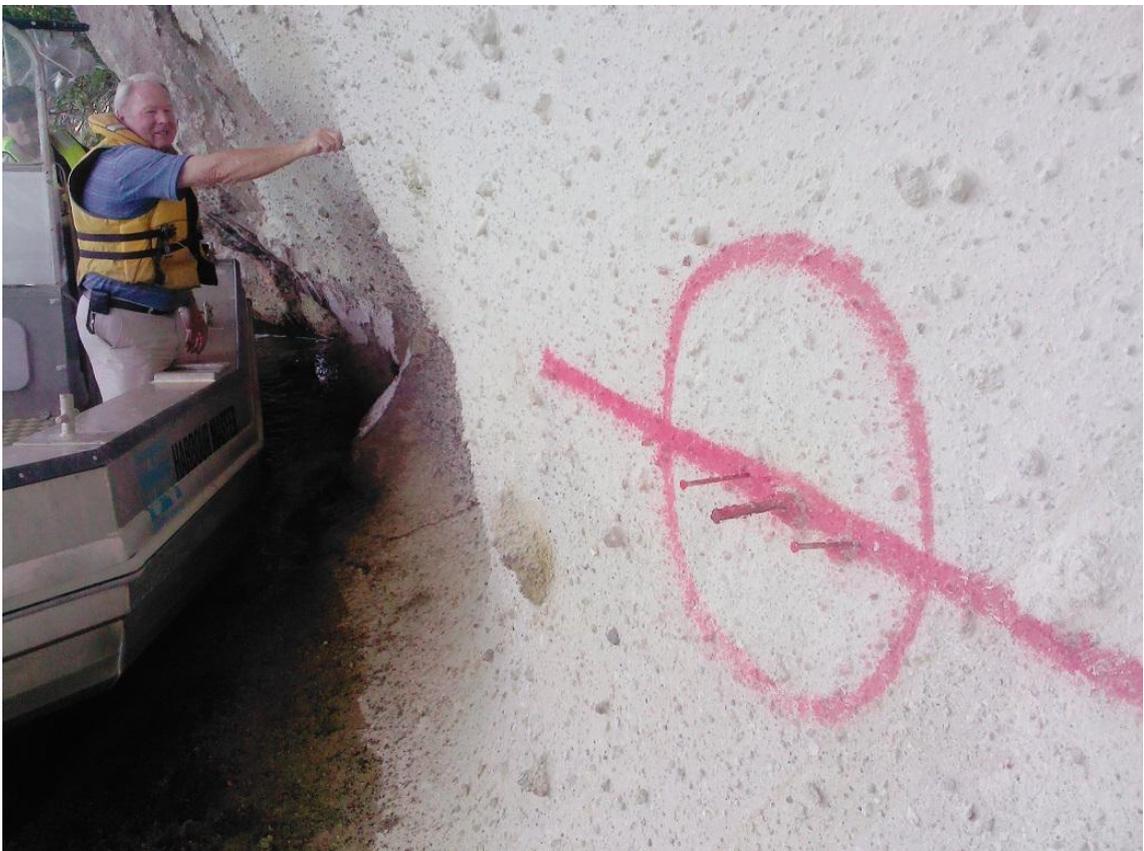
**Photo 7: Walter Russell showing the site of the maximum inundation level at Pah Point. The original marker peg is in the middle of the circle.**

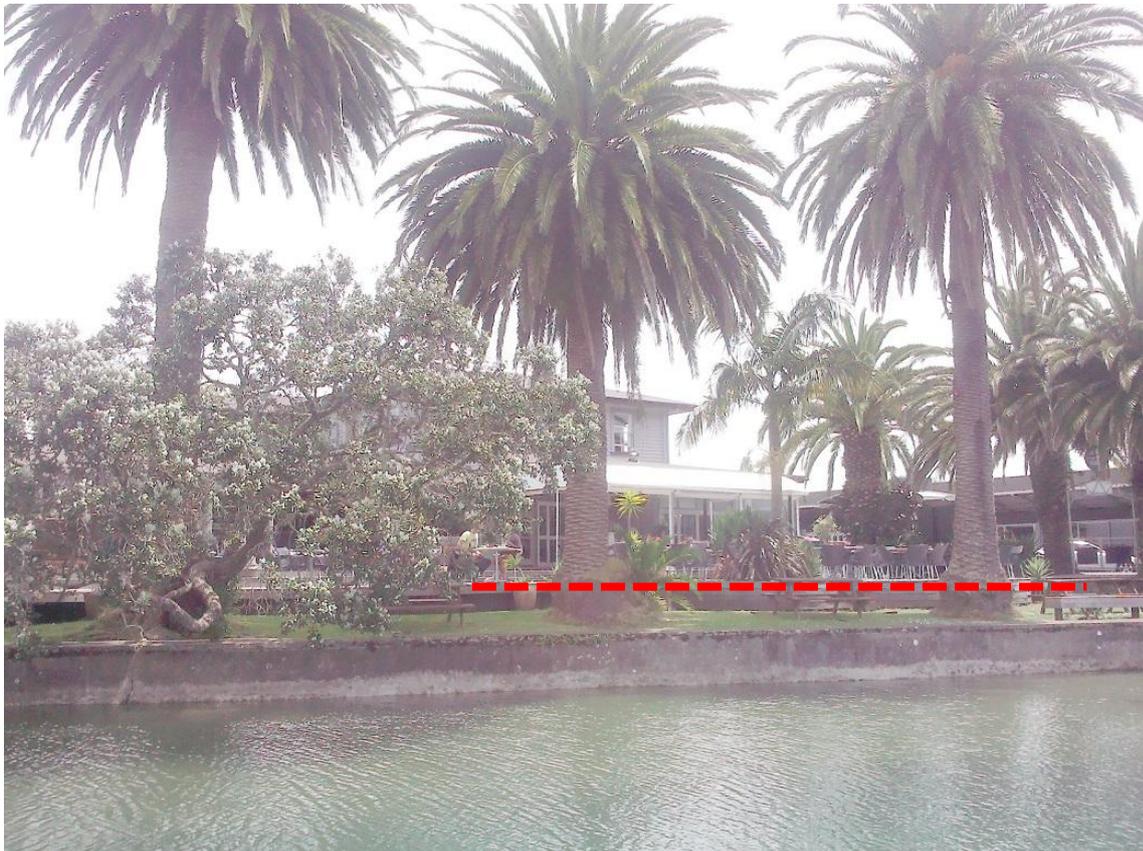
**Photo 8: The Whitianga Hotel taken from the marina, showing the approximate level of inundation as described by eyewitnesses (level of the original steps).**

Observation of the hotel from the marina indicated that projection of a similar water level to that indicated by the peg across the harbour would approximate inundation up to just below the hotel floor level – or inundation of the steps in front of the hotel as reported (Photo 8).

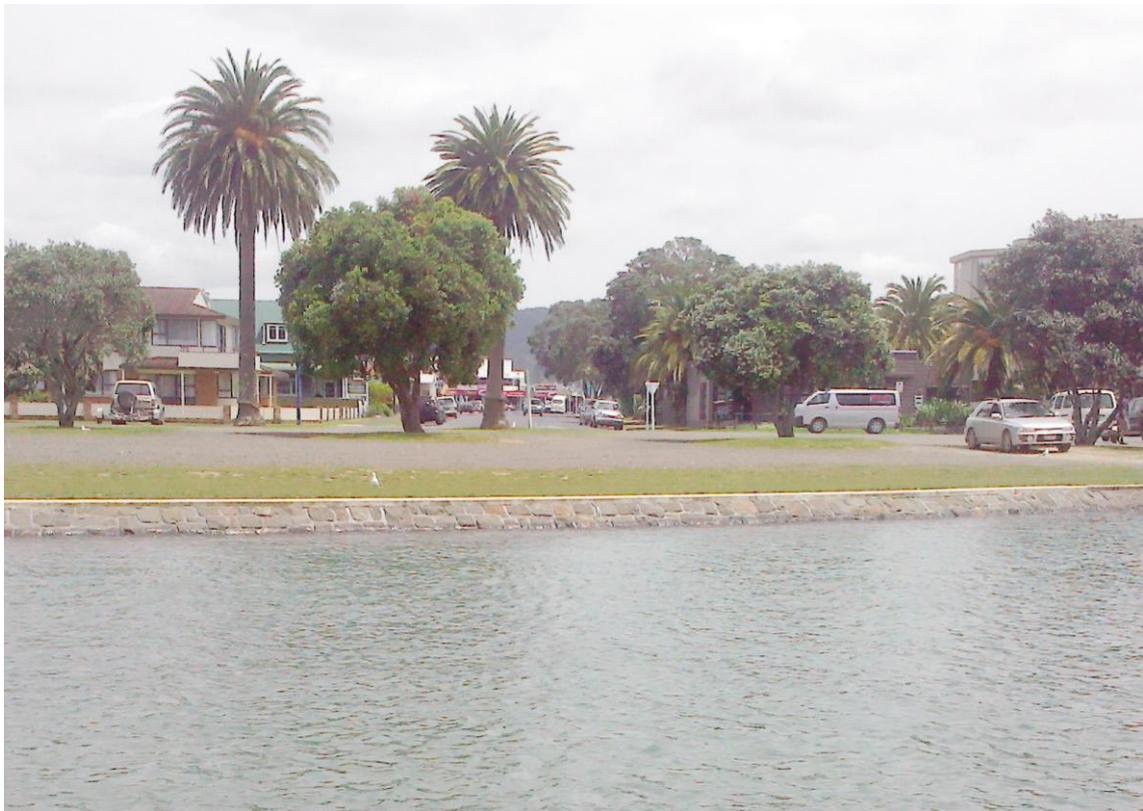
**Photo 9: Looking north up Monk Street from the harbour.**

An inspection of the area in front of Monk Street was made from the harbour (Photo 9). On-water observation suggests that a water level that inundated the hotel steps would

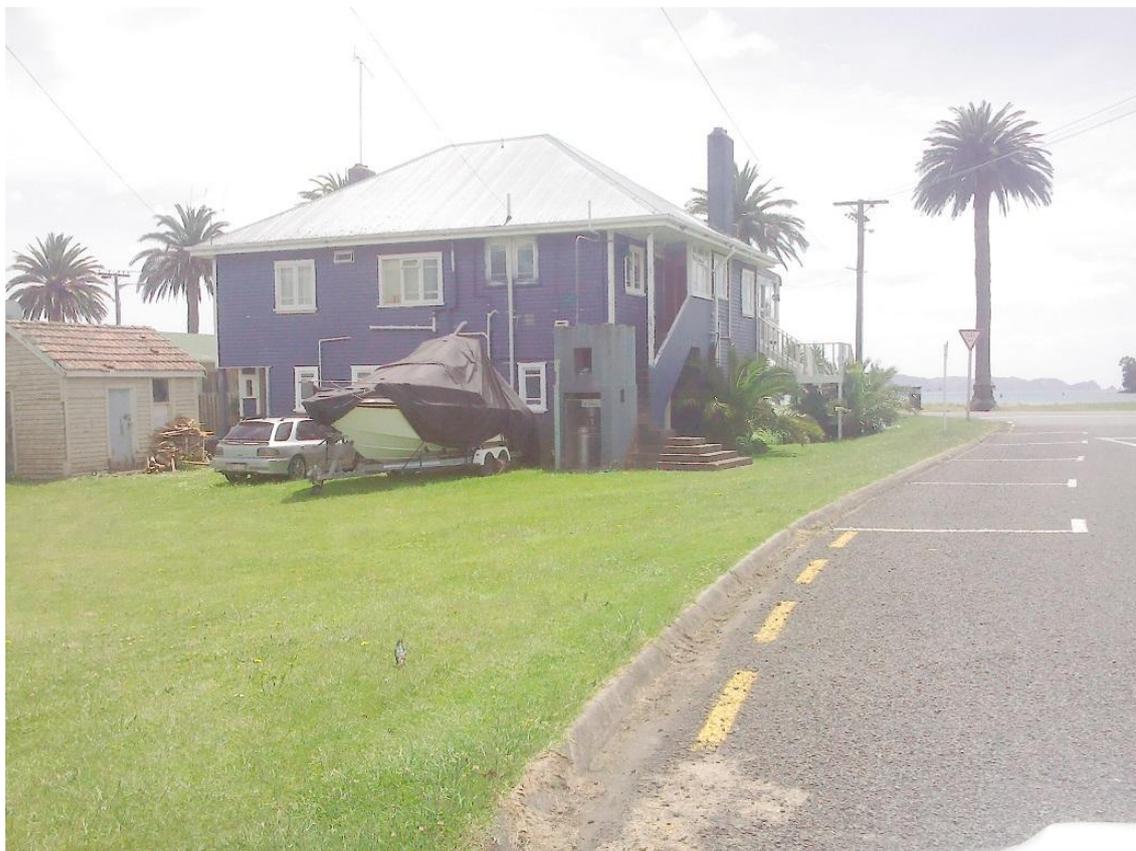
**Photo 10: House at the corner of Mill Street and the Esplanade – a low-lying area subject to ponding and storm surge.**

As previously mentioned, Walter is unclear whether there was overtopping of water into Mill Road from the sea, but has seen water overtopping the dunes and flowing down Mill Road towards Monk Street during storm surge events since the tsunami. Since Mill Road slopes away from Buffalo Bay, water that overtops from the ocean drains down the gutters in Mill Road and out through Monk Street towards the harbour. The water that does overtop the dunes has a tendency to pond, due to the fact that the drainage is into sand – the water cannot get away (Photo 10).

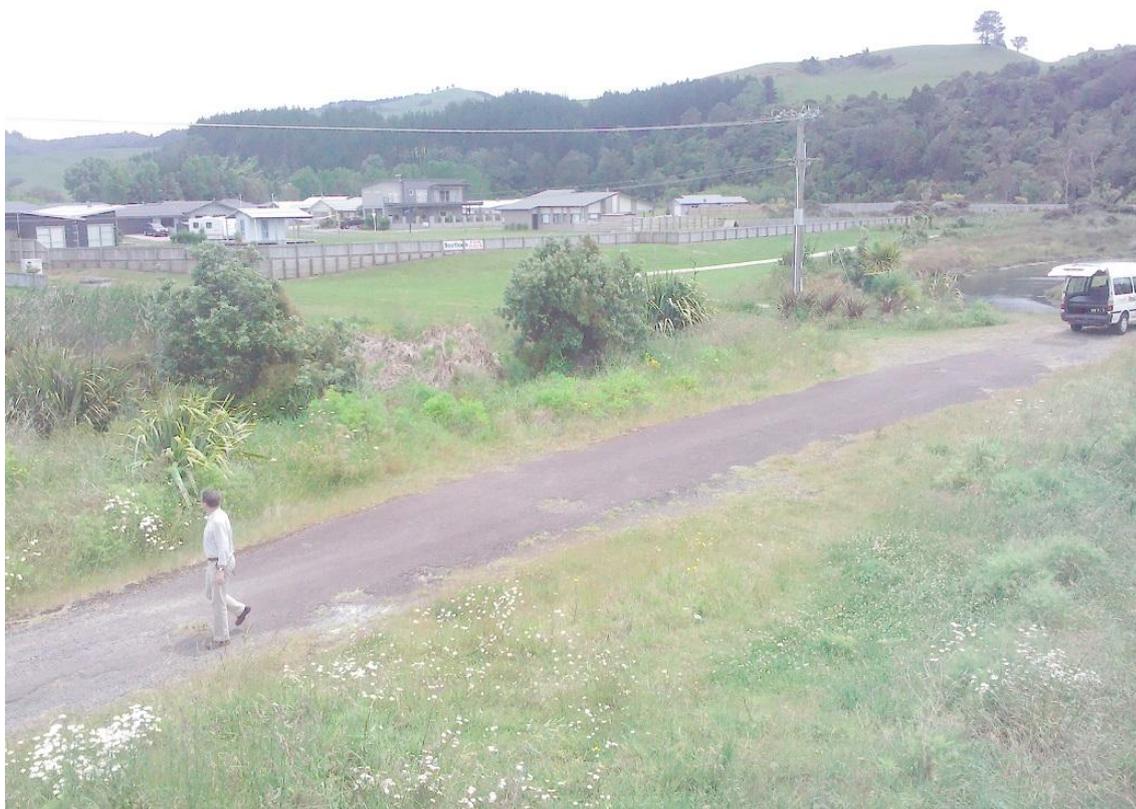
The location of the old aircraft hangar was confirmed – it was situated just above stream level in front of the houses that have been built there. The level of the hangar floor was confirmed as being similar to the small stream access road that runs to the stream, adjacent to Buffalo Beach Road by the bridge (Photo 11).

**Photo 11: Site of the old aircraft hangar adjacent to Taputapuatea Stream on Buffalo Beach Road, showing the stream access road.**

Walter stated that further down Buffalo Beach Road, the water reached what is now Admiralty Lodge – adjacent the mouth of the Taputapuatea Stream on Buffalo Beach Road.

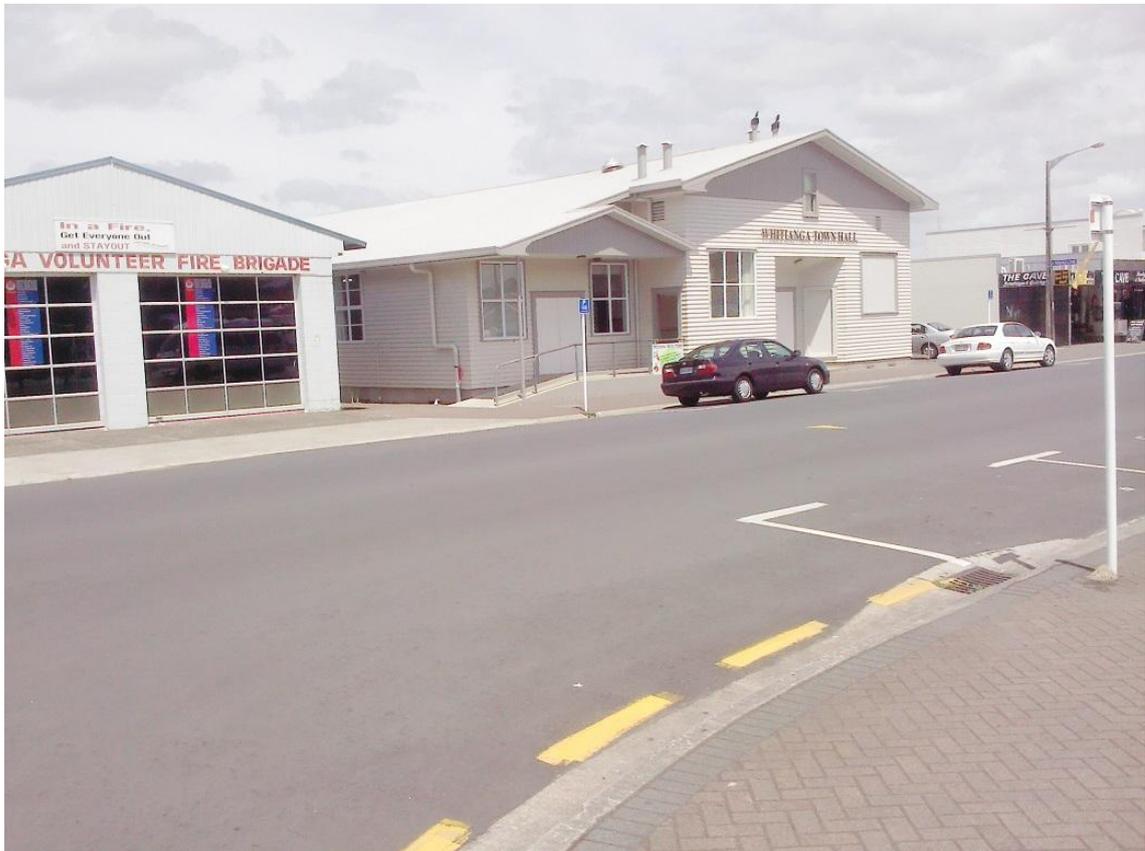
Ted's father was playing badminton in the town hall that evening. One of the players observed that water had flowed up to the hall door (Photo 12), so they followed the water down to the wharf. Ted states that people then walked around the wharf once the tide went out, and followed the water back up Monk Street.

**Photo 12: View from the north-east corner of Mill Road and Monk Street looking towards the old Volunteer Fire Brigade Building and town hall.**

On the second occasion, the water reached the Fire Station door, which was located next to the hall (slightly less inundation). The water then receded again, but this time people were unable to walk around the wharf, due to the erosion of sand and consequent water depth.

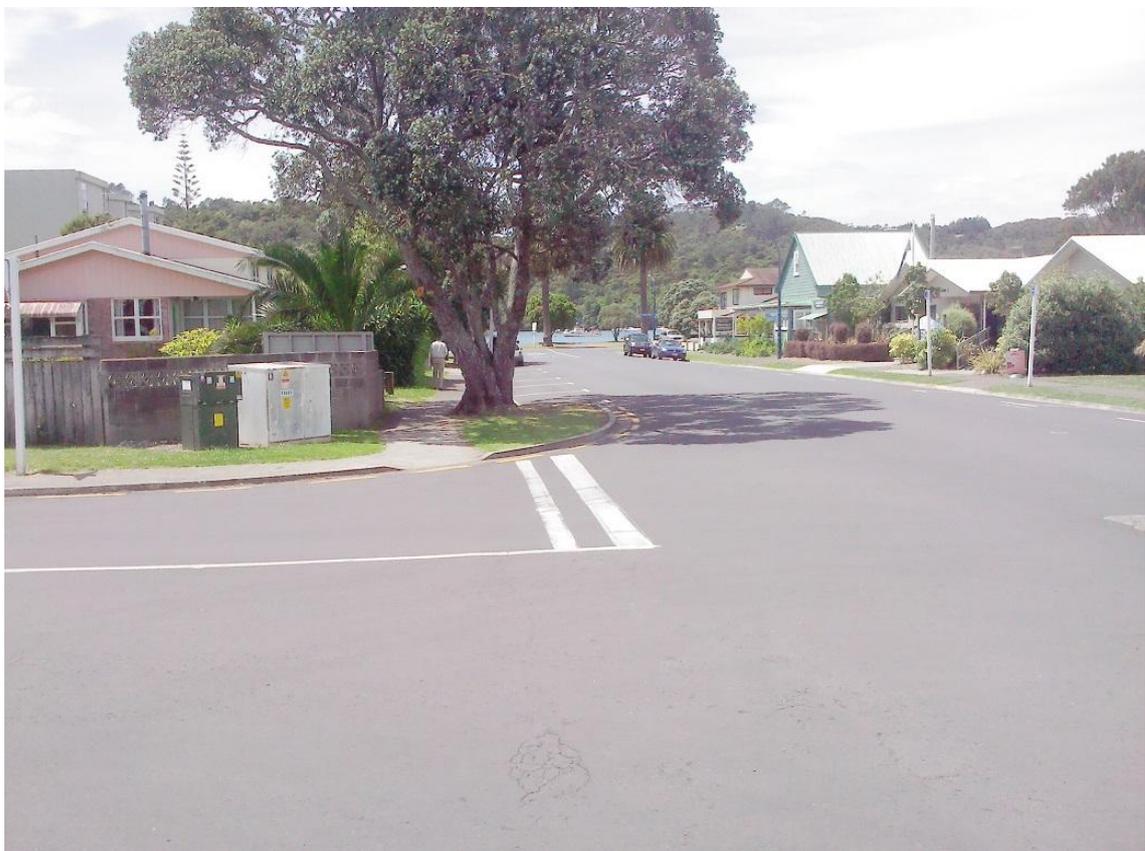
**Photo 13: View from the north-east corner of Mill Road and Monk Street looking south along Monk Street towards the harbour.**

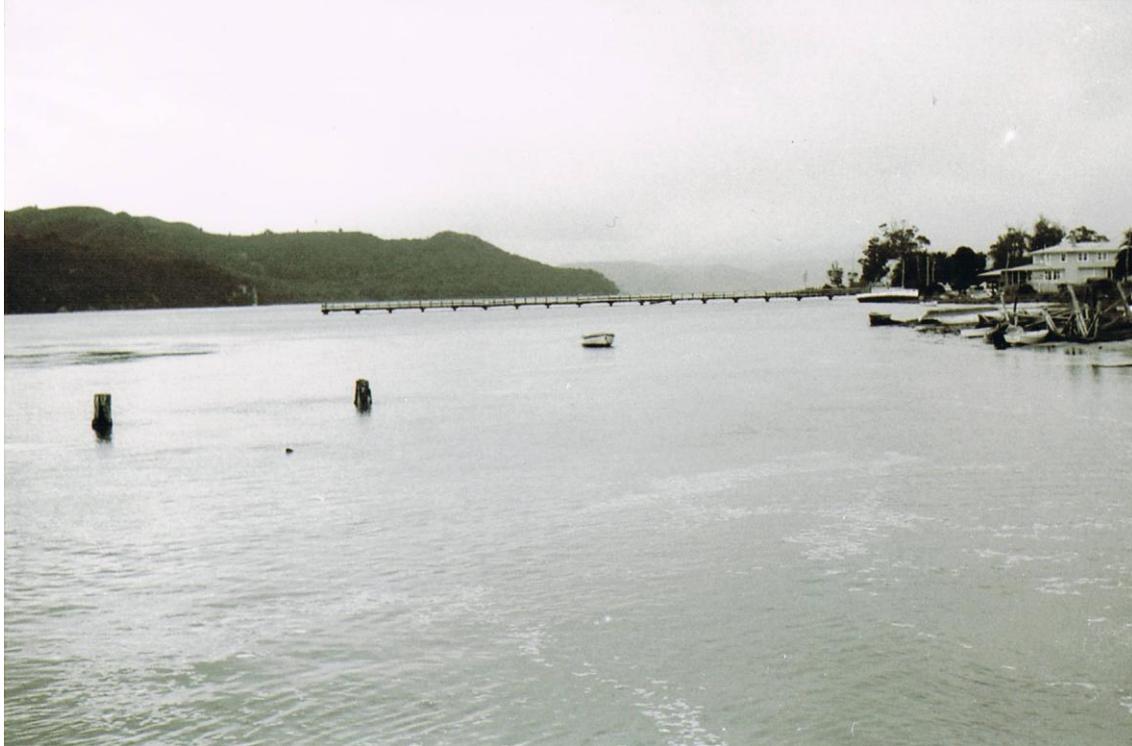
**Photo 14: View of the harbour from the wharf taken on the morning of 24 May 1960. On the upper right, the Marlin is seen resting ashore near Karena Creek and the hotel (photo courtesy Ted Ramsbotham).**

Bruce Smith drove the Marlin onshore near Karena (Stinking) Creek in order to get the boat out of danger.

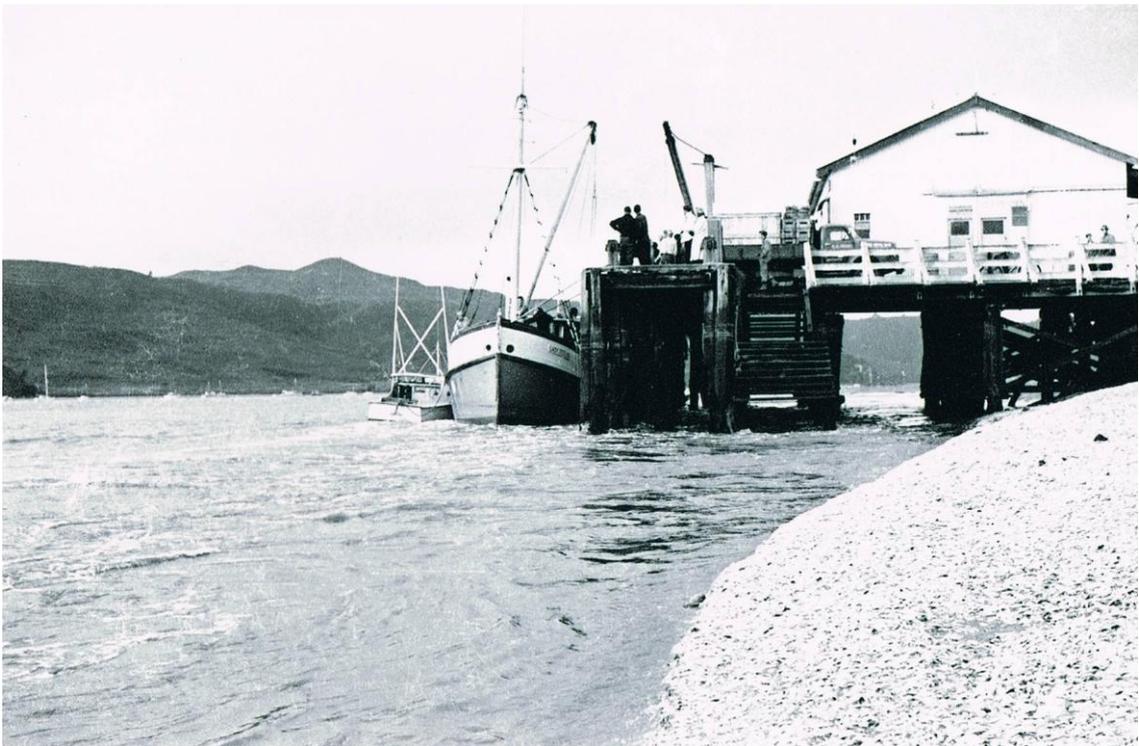
**Photo 16: View of the wharf at the bottom of the tidal range taken on the morning of May 24 1960 (photo courtesy Ted Ramsbotham).**

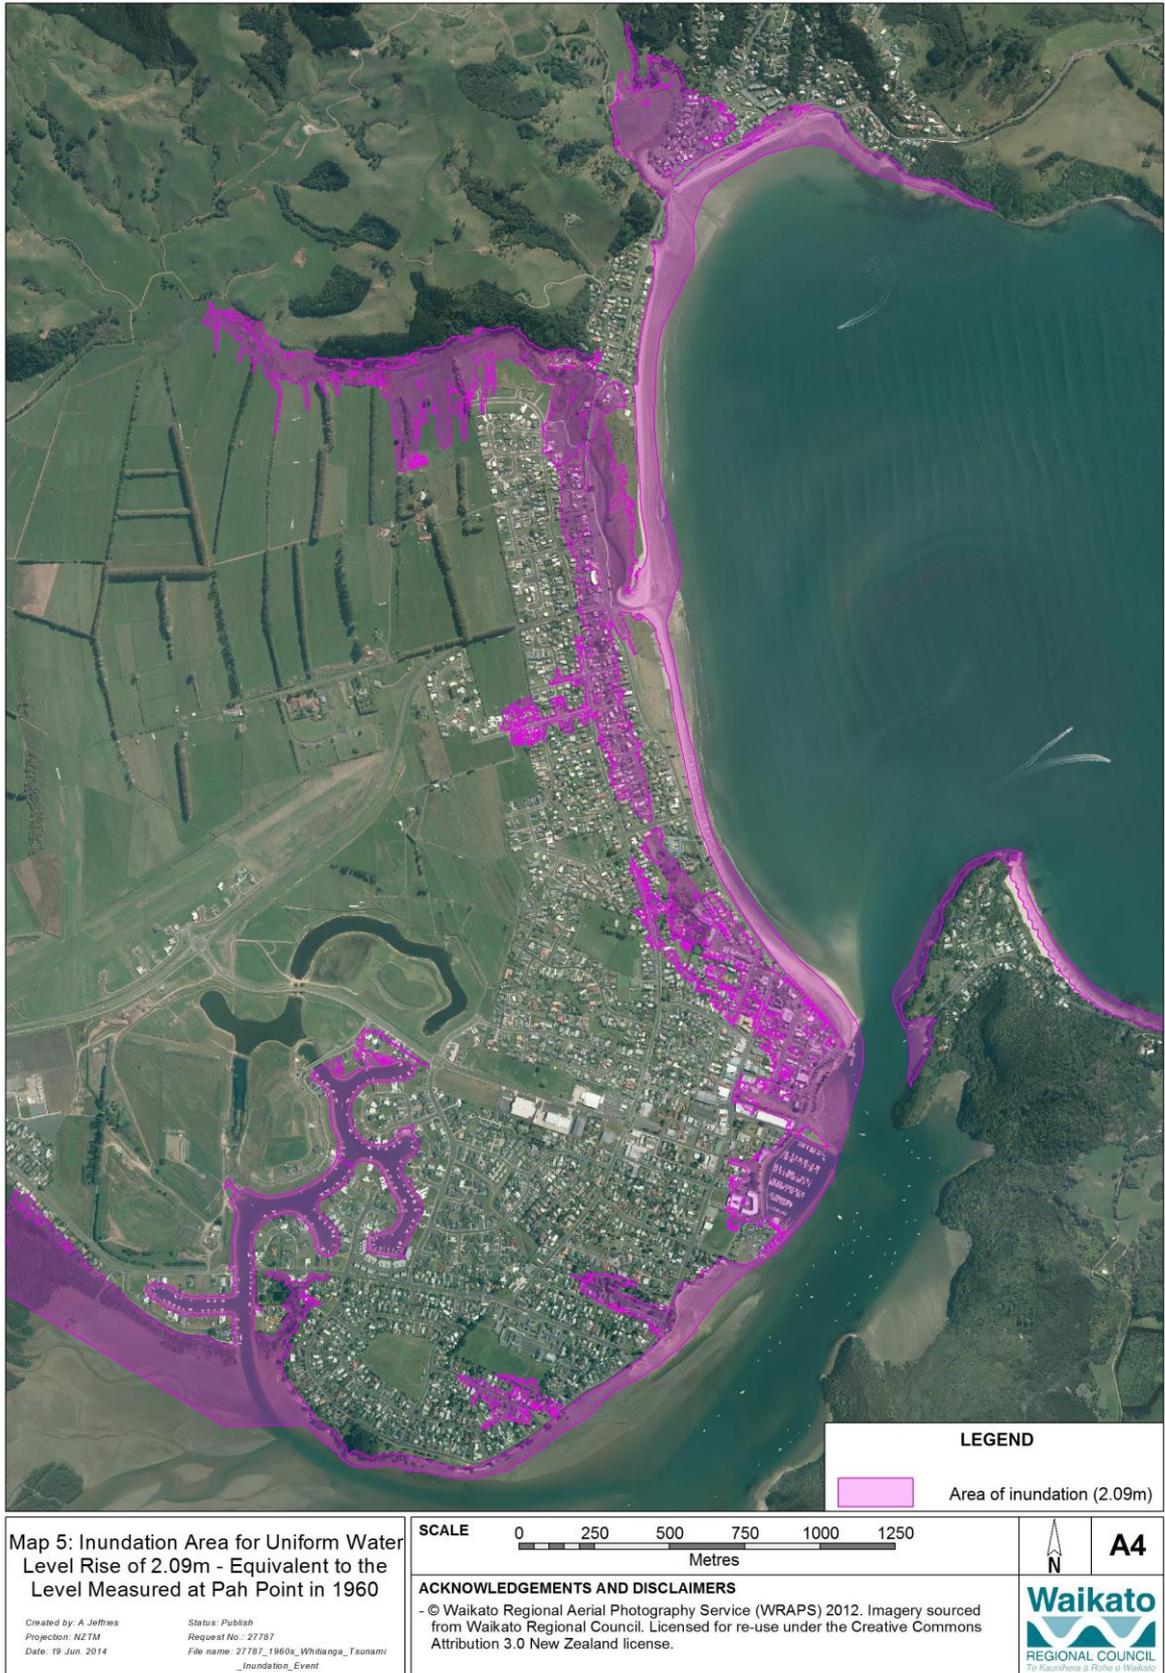
**Map 5: Inundation area for uniform water level rise of 2.09m – equivalent to the level measured at Pah Point in 1960.**

- Inundation up to the steps of the Hotel and to the end of Owen Street.

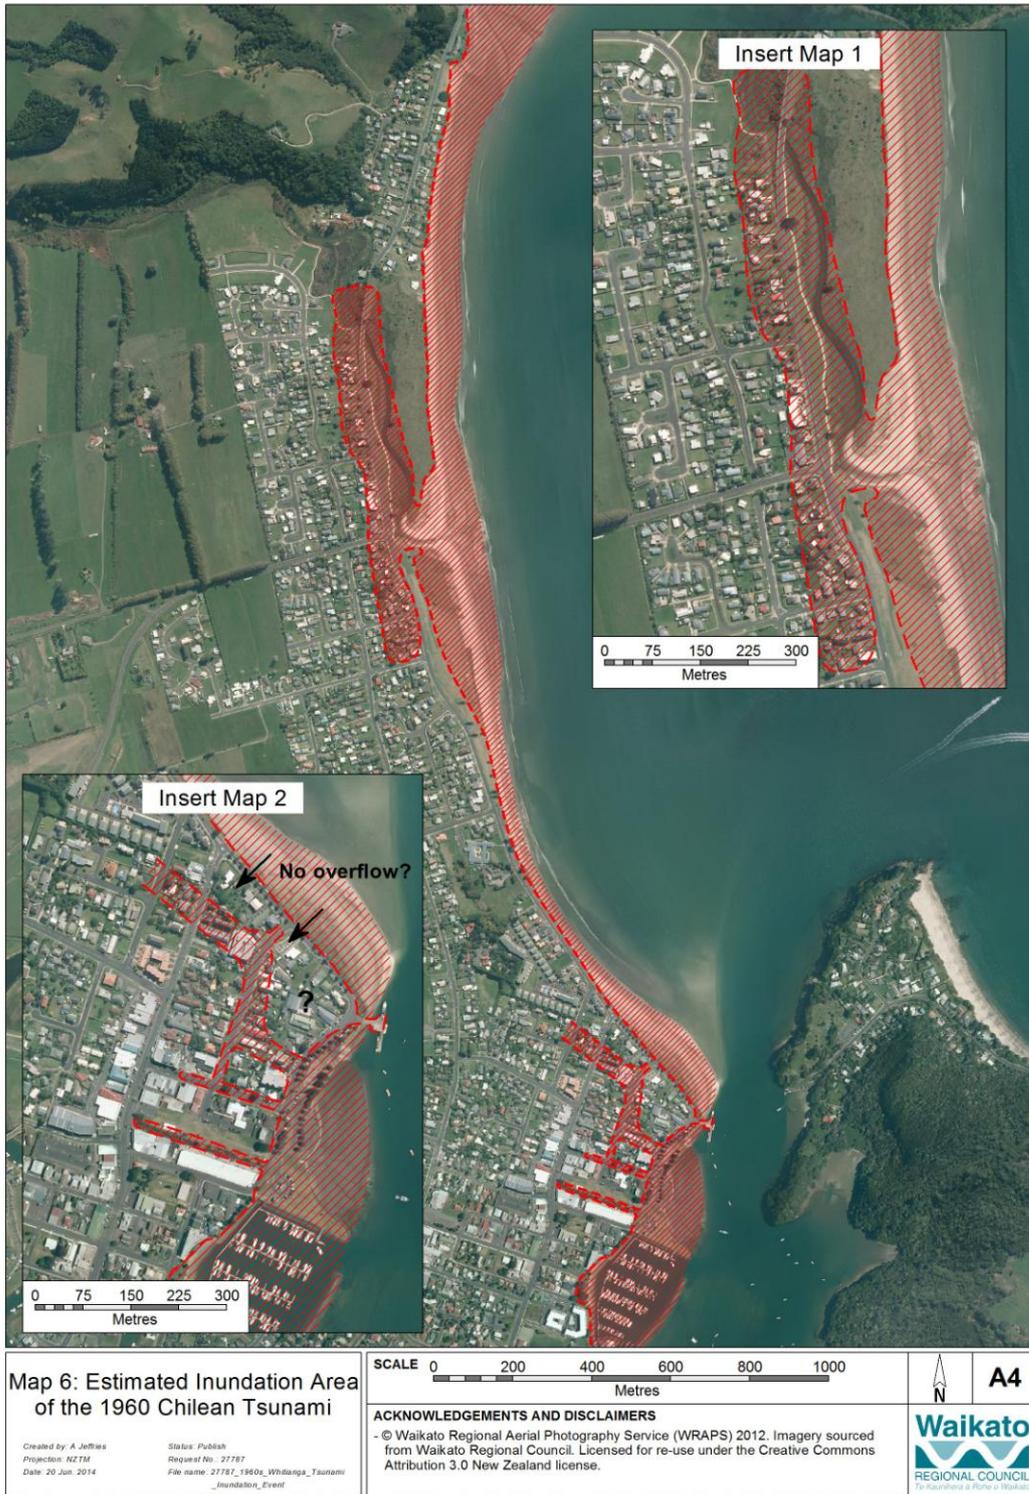
**Map 6: Estimated inundation area of the 1960 Chilean tsunami.**

- We rely primarily on modelling results, supported by eyewitness evidence
- Modelling results for Cases 3 and 4 suggest that inundation around the stream entrance flooded properties along Buffalo Beach Road, flowed into the swale behind the foredunes and inundated the location of the old aircraft hangar
- Modelling results are supported by eyewitness evidence of inundation of the aircraft hangar and seaweed on the front lawns as described by Howard Pascoe, and reporting of fish/seaweed on lawns and a goat swimming in a backyard by Don Ross.
