Waikato and Waipa Rivers Flood Event 6-16 July 2002

Final Technical Report

Prepared by:
Adam Munro

For:
Environment Waikato
PO Box 4010
HAMILTON EAST

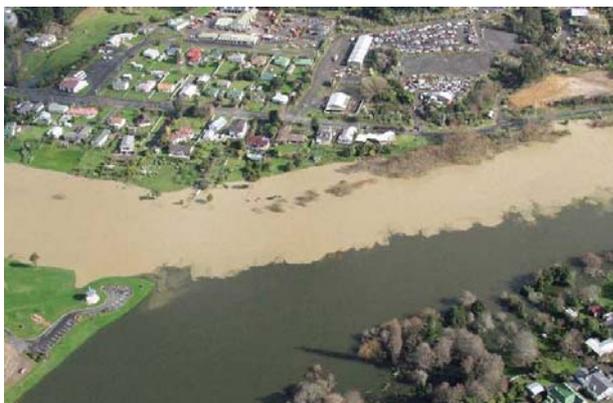
Right: The Waikato and Waipa Rivers meeting at Ngaruawahia.

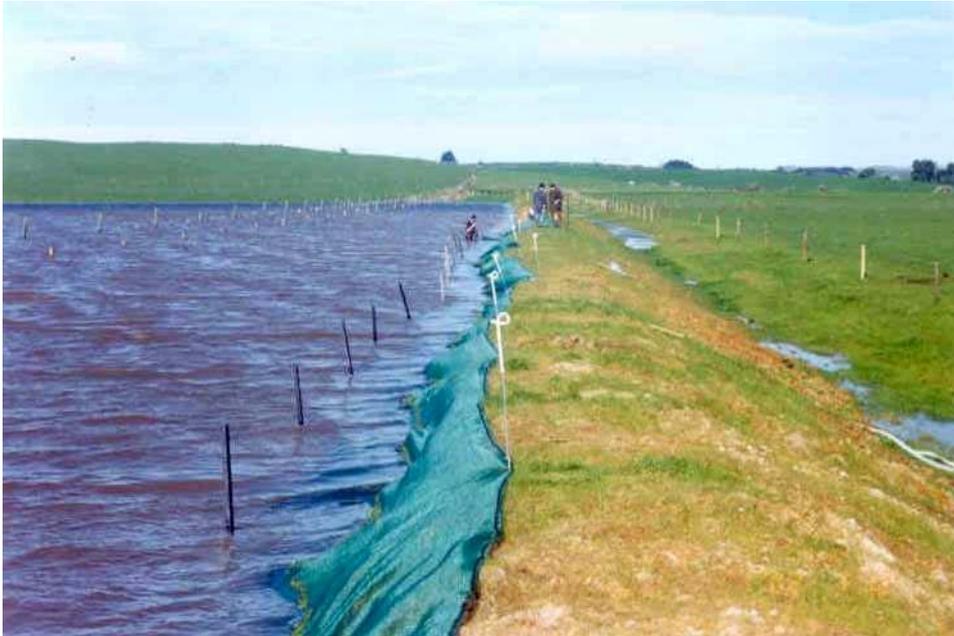
Figure 4: Erosion prevention works being installed on the Deroles stopbank, which was damaged from wave effects.

- Waikokowai- Harvey's Compartment – Pump failed to operate, causing ponding.
- Deroles – Erosion of return bank due to wave action on Lake Whangape (Figure 4).
- Morrison Road- Main Floodgate was overtopped, causing erosion of the fill material.
- Miller Farlane- Pump not efficient- emergency pumps were used.
- Minor seepage within Meremere West and Churchill East compartments. These are normal and expected processes during flood events since the stopbanks rest on deep sand foundations.

The erosion at Morrison Road Floodgate, Deroles Stopbank, Kimihia pump outlet and the Mangatawhiri Contour Drain Stopbank can be considered as actual flood damage. Therefore, **the flood damage cost is approximately \$80,000** not including the costs of actual works during the event (approximately \$25,000) and losses in farm productivity.

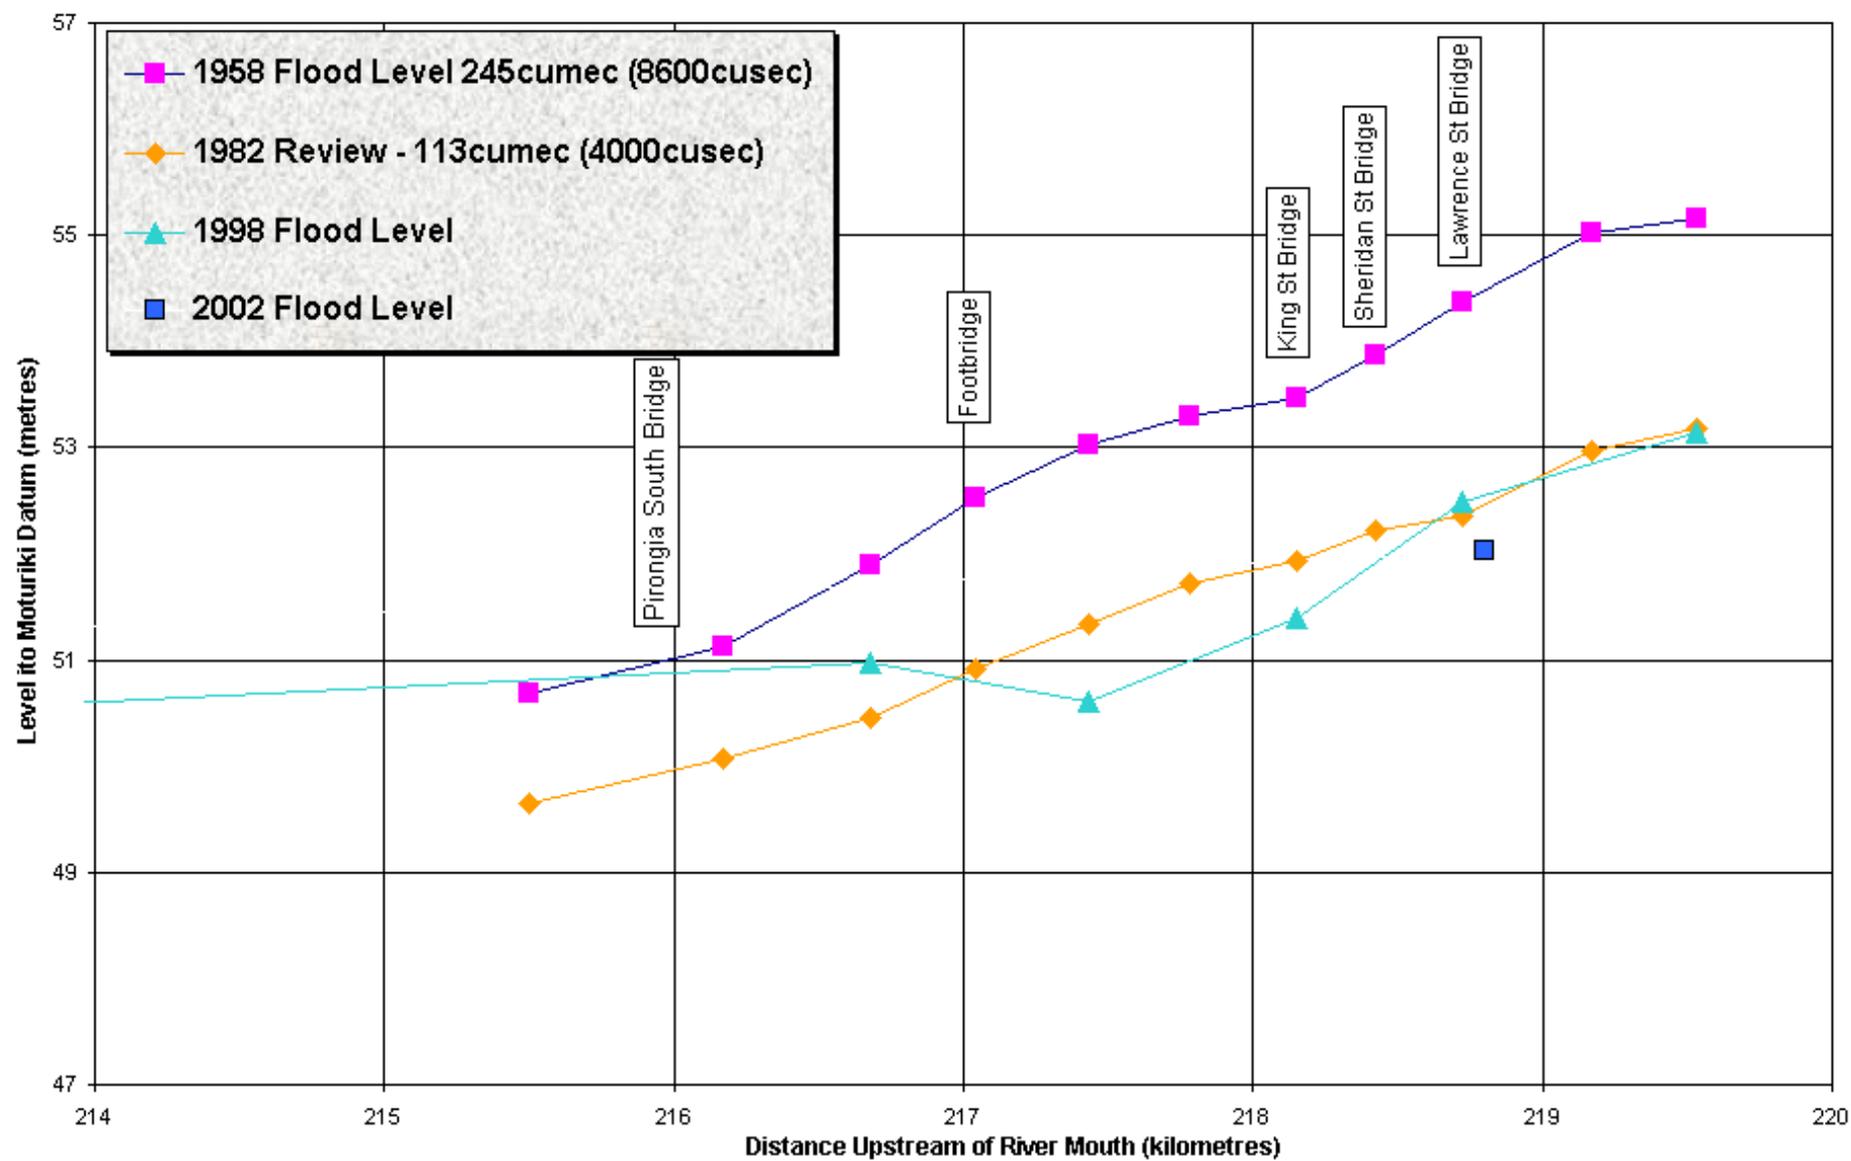
**ENVIRONMENT WAIKATO
TE KUITI: JULY 1998 FLOOD PROFILES**

Te Kuiti to Ngaruawahia pegged from debris levels 1 month from the event
