# The Condition of Lakes in the Waikato Region Using LakeSPI

Prepared by:  
Tracey Edwards, John Clayton, Mary de Winton  
(National Institute of Water and Atmospheric Research Ltd.)

For:  
Environment Waikato  
PO Box 4010  
HAMILTON EAST

NIWA Client Report: HAM2005-125  
December 2005

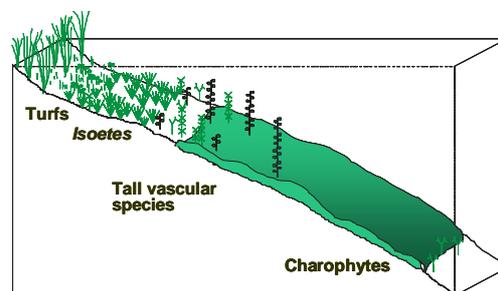
**Figure 1:** Depth profile illustrating the main components of native lake vegetation.

In a pristine state, lakes in the Waikato Region would have once contained a diverse range of native plant species down to a depth determined by water clarity. For many of the Waikato shallow lakes it is likely that plant growth would have occurred across the entire lake bottom at some stage during their development and maturation (Figure 1). Today, there are very few Waikato lakes that remain in an all-native vegetated state, and Lakes Rotopiko North and Rotopiko East (Serpentine lakes) are the best remaining examples.

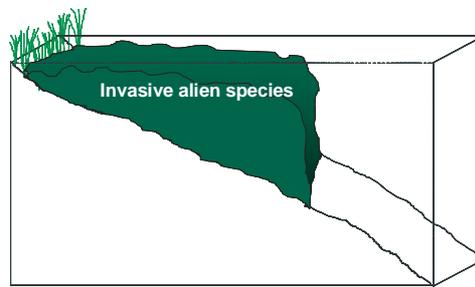
**Figure 2:** Depth profile illustrating the potential impact of invasive species.

With the introduction of invasive submerged plant species during the mid 1900's, native plants in most lakes were displaced by invasive weed species, often forming tall monospecific weed beds (Figure 2). Some west coast dune lakes (Lake Puketi, Rotoroa and Parkinson) remain in this state and are vulnerable to collapse. Many of the Waikato lakes have now proceeded to the next and, often final stage where de-vegetation has occurred (Figure 3). Although invasive species are not favourable in terms of overall lake condition, the presence of any submerged plants in a lake is preferable to none, because they mitigate many of the symptoms of eutrophication (e.g., lock-up nutrients, maintain water clarity, compete with phytoplankton).

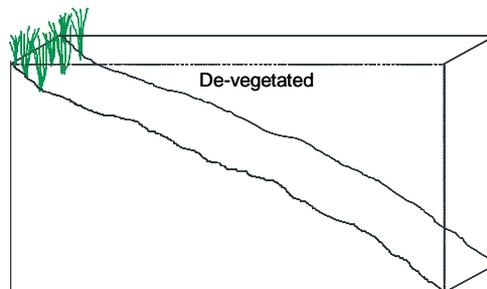
**Figure 3:** Depth profile illustrating a de-vegetated lake.

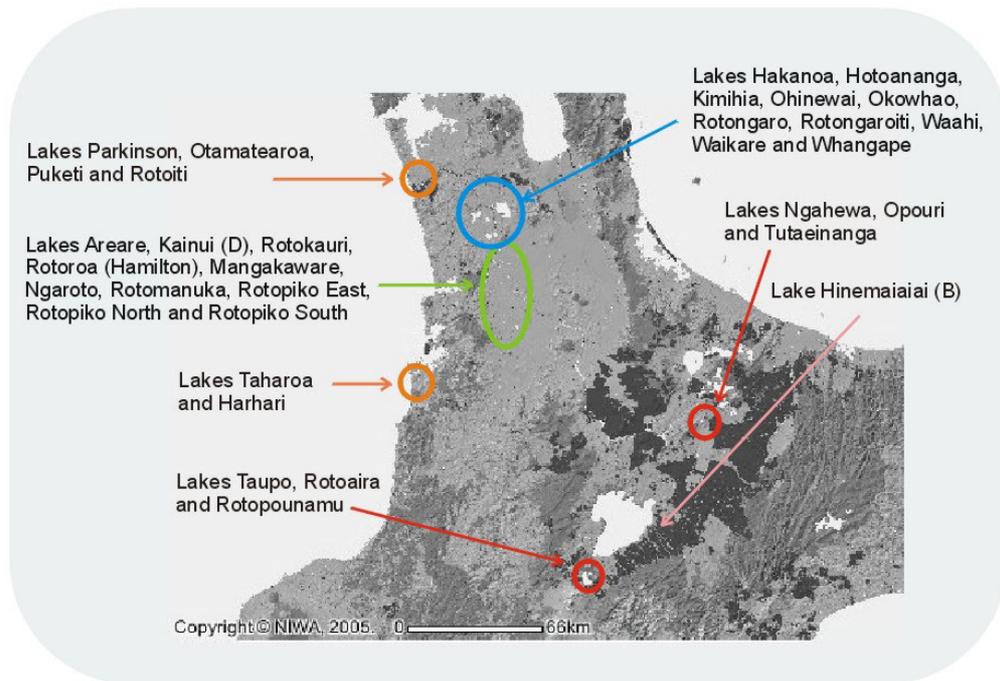
**Figure 4:** Location of lake groups within the Waikato Region; orange rings are dune lakes, green rings peat lakes, blue rings riverine lakes, red rings volcanic zone lakes and the pink arrow points to one hydrolake.

Thirty-three lakes in total were selected for LakeSPI assessment. The location of lakes is indicated in Figure 4 and includes dune lakes along the West Coast, riverine lakes adjacent to the northern reach of the Waikato river, Peat influenced lakes within the Waikato basin and lakes within the Taupo volcanic zone. The lakes also vary in size and depth (Table 3.1).
