West Coast Hazard Project

Prepared by:
Tonkin & Taylor Ltd

For:
Environment Waikato
PO Box 4010
HAMILTON EAST

October 2007

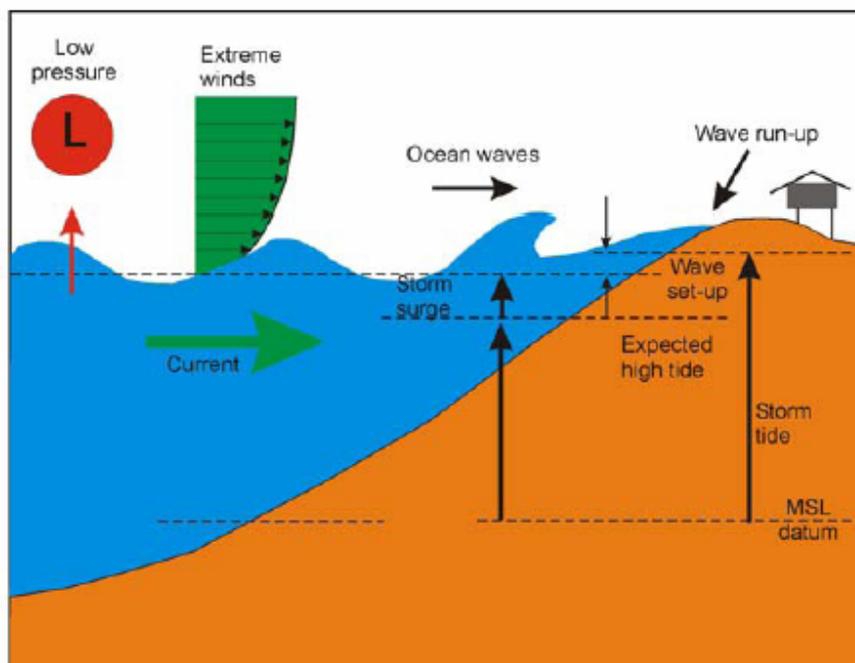
Figure 3- Components of storm surge (source: MfE 2003)

Storms increase water levels along the coast in a number of ways (Figure 3-1). As a storm nears the coast, a rise in local water levels occurs. This increase in local water level (storm surge) is due to the atmospheric drop in pressure associated with a deep low pressure system and by onshore winds causing a build up of water along the coast (wind set up).

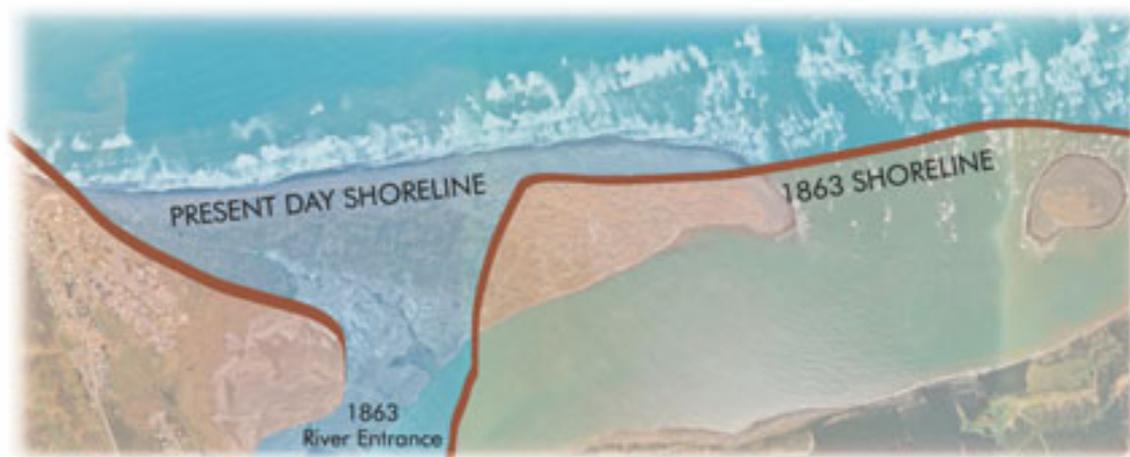
Figure 4- Comparison of shoreline position between 1863 and 1996. Source: Dahm 1999

lies more than 2km north of the 1863 position and the inland extent of erosion exceeds 600m in places.

The changes experienced may represent a dominance of longshore drift in relation to river discharge.

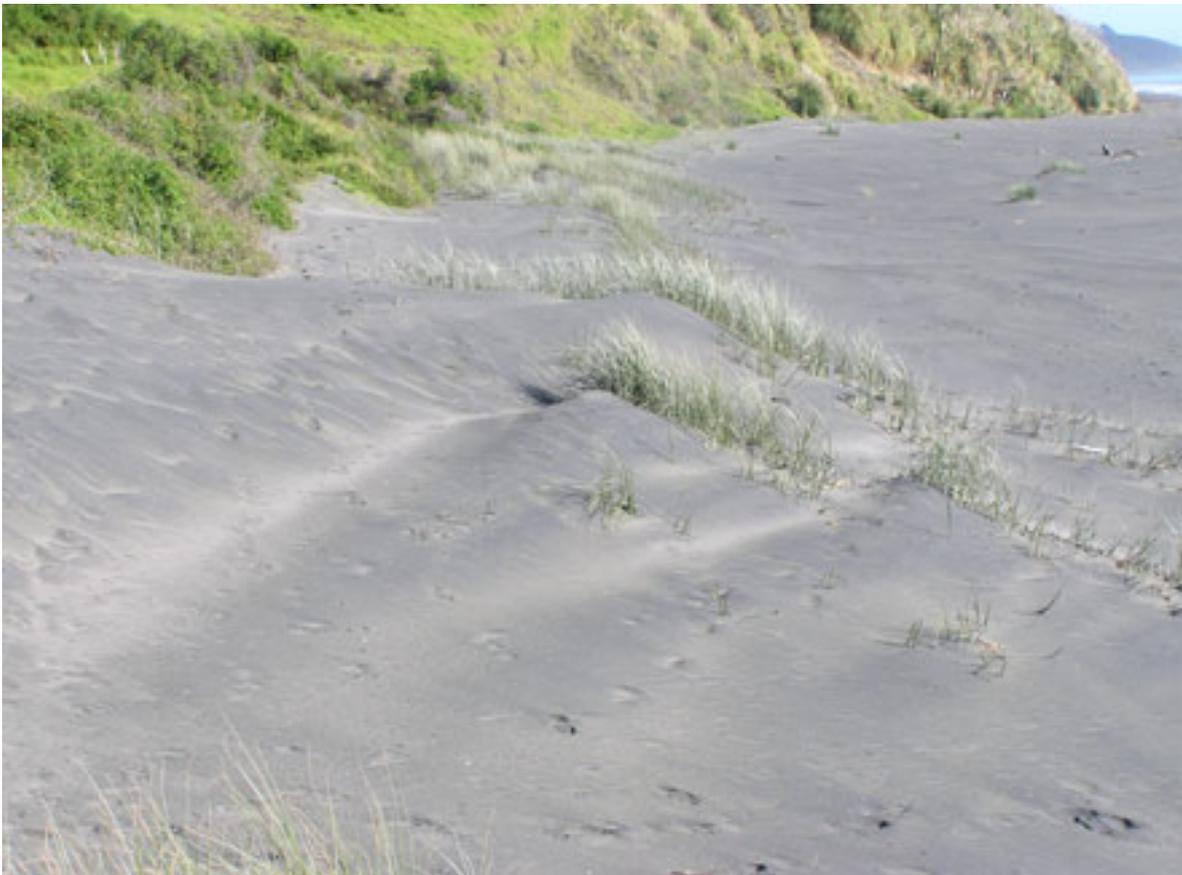
Photo 4- Early stages of dune recovery (November 2006) at seaward end to Riria Kereopa Memorial Drive - following severe coastal erosion in early 2000's. Source: J.Dahm.

The dunes in some areas are now recovering (e.g. in front of the parking area at the end of Riria Kereopa Memorial Drive, Photo 4-), though erosion continues on the margins of the entrance channel.

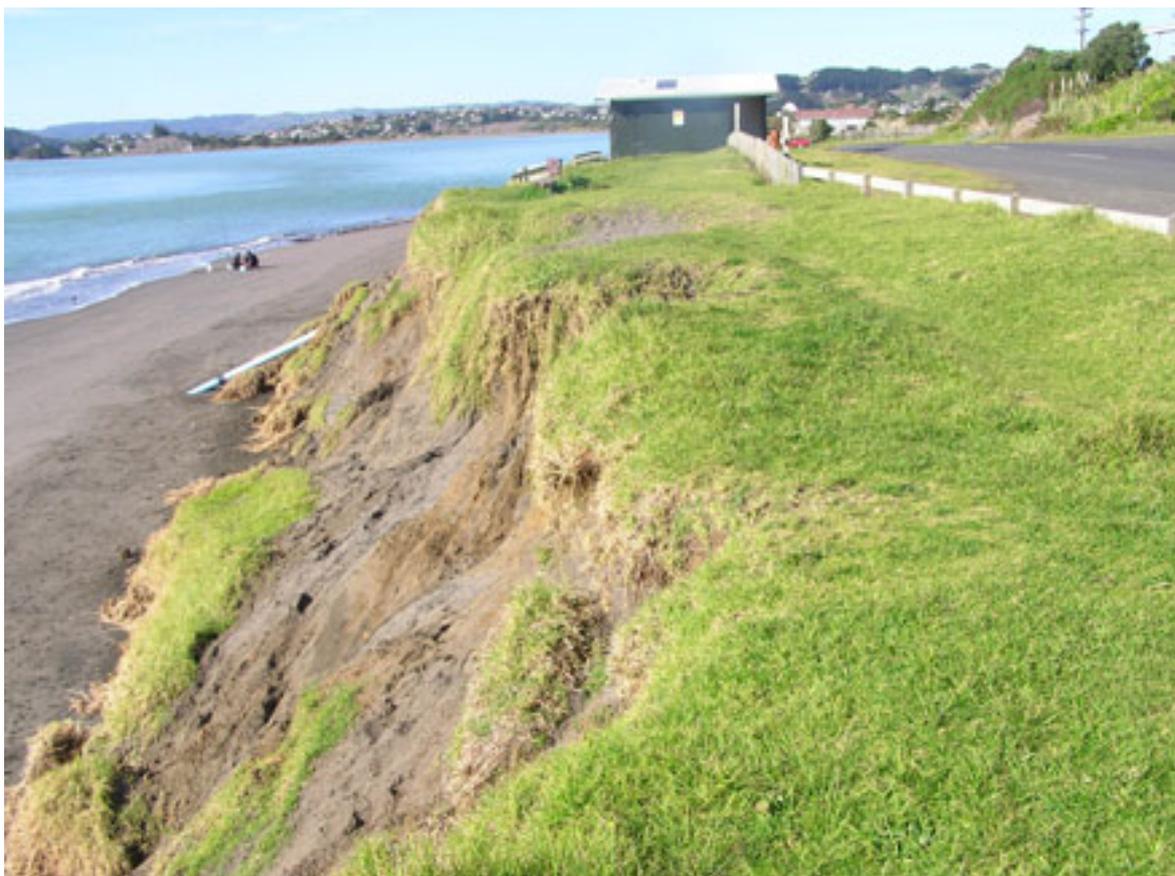
Photo 4-1 Toilet block threatened by erosion along southern side of harbour entrance adjacent to Riria Kereopa Memorial Drive (November 2006). Source: J.Dahm

Ongoing erosion along the margins of the harbour entrance potentially threatens a public parking area and toilet block located on the seaward side of the road.

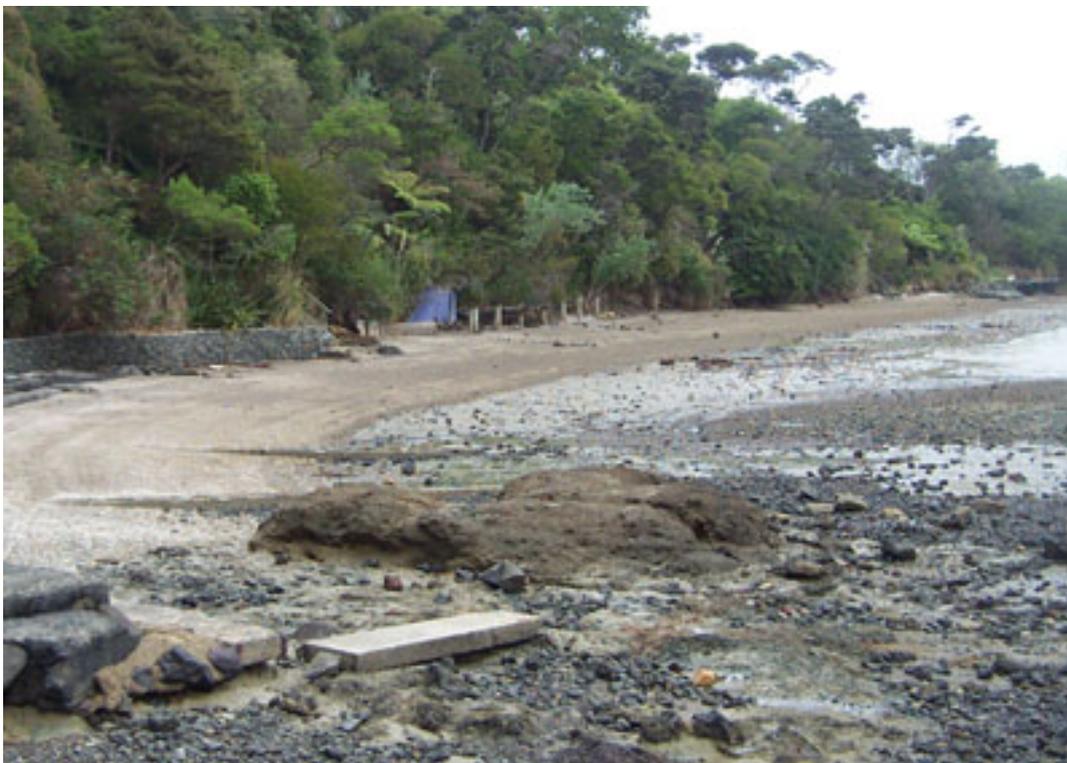
Photo 4-2 Typical harbour beach composed of veneer of sand over rock platform.

Most of the beaches around the rest of Raglan Harbour are largely thin veneers or envelopes of sand over rock, typically backed by cliffs, low banks, seawalls or rocky shorelines rather than dunes.

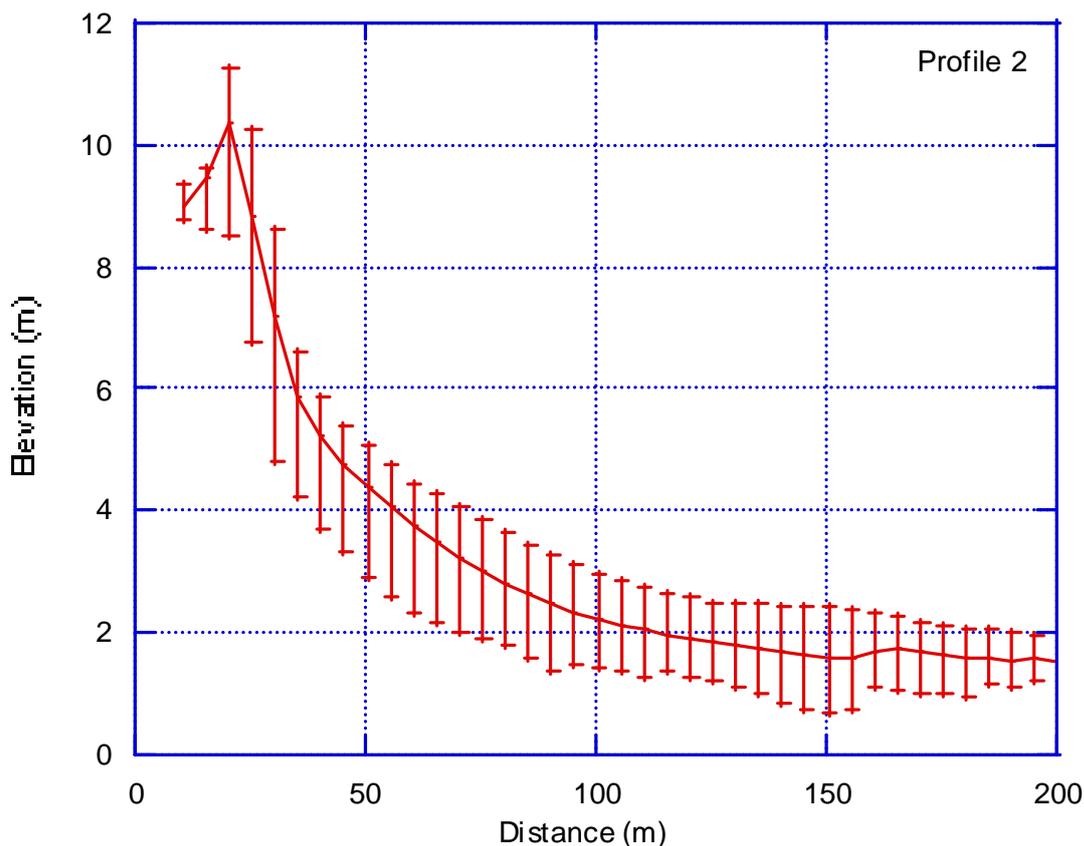
Figure 4-1 Showing beach profile envelope for Ruapuke beach along Profile 2 from 1995 to 2006. Profile shown represents average beach profile, error bars denote maximum and minimum beach elevation. (Source: Keith Smith)

This sand system consists of a beach and dune overlying a rock platform. Beach profiling has been conducted at the site since 1995 and is the only beach profile data available for west coast beaches within the Waikato Region. Profiles showing the maximum erosion and accretion noted to date are shown in Figure 4-1

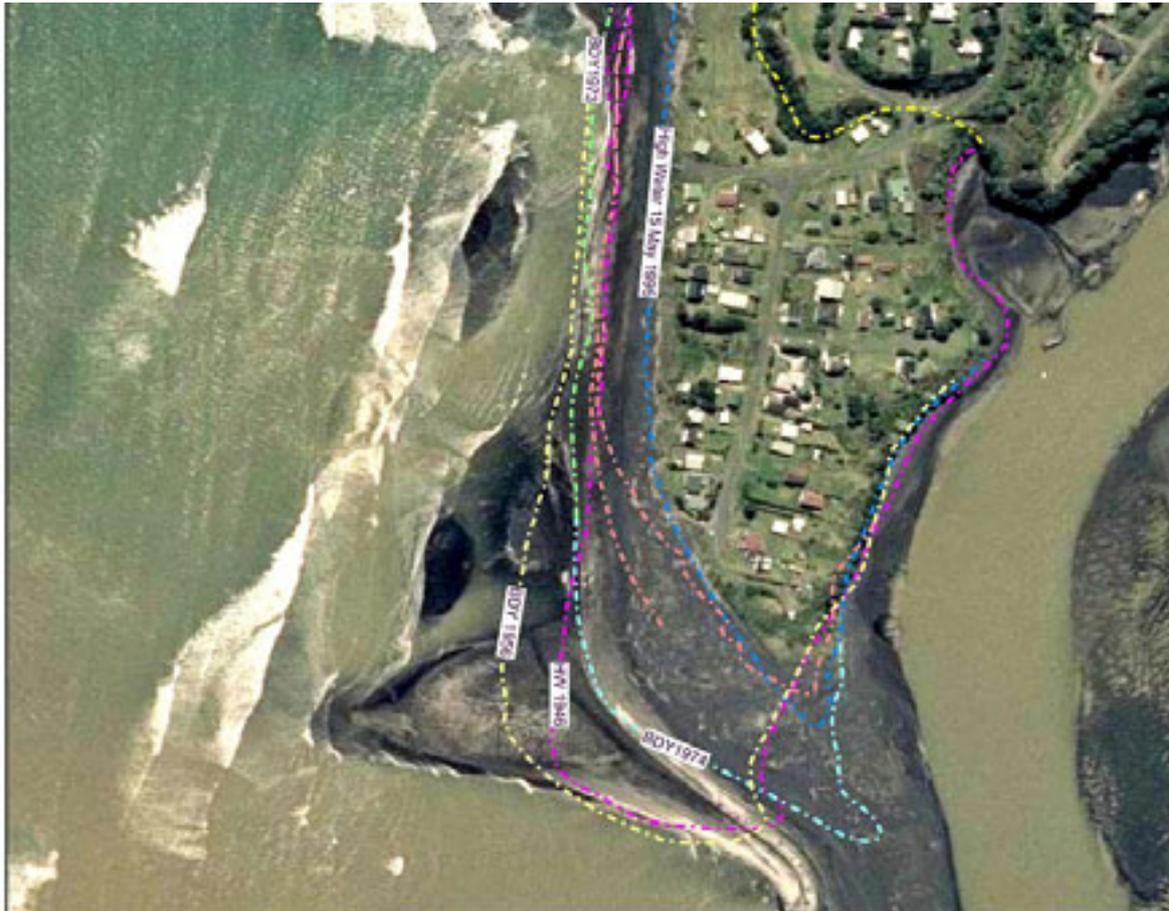
Figure 4-2 Mokau Spit shoreline change. Source: Environment Waikato

Shoreline changes to 1995 were mapped by Environment Waikato (Figure 4-2) from available aerial photos (dating from the 1940's) and historic surveys (dating from 1884 and 1886), covering just over 100 years. This data indicates that the spit experiences very significant shoreline changes, as common on sandy shorelines close to river entrances, with the distal end of the spit fluctuating by more than 200m.

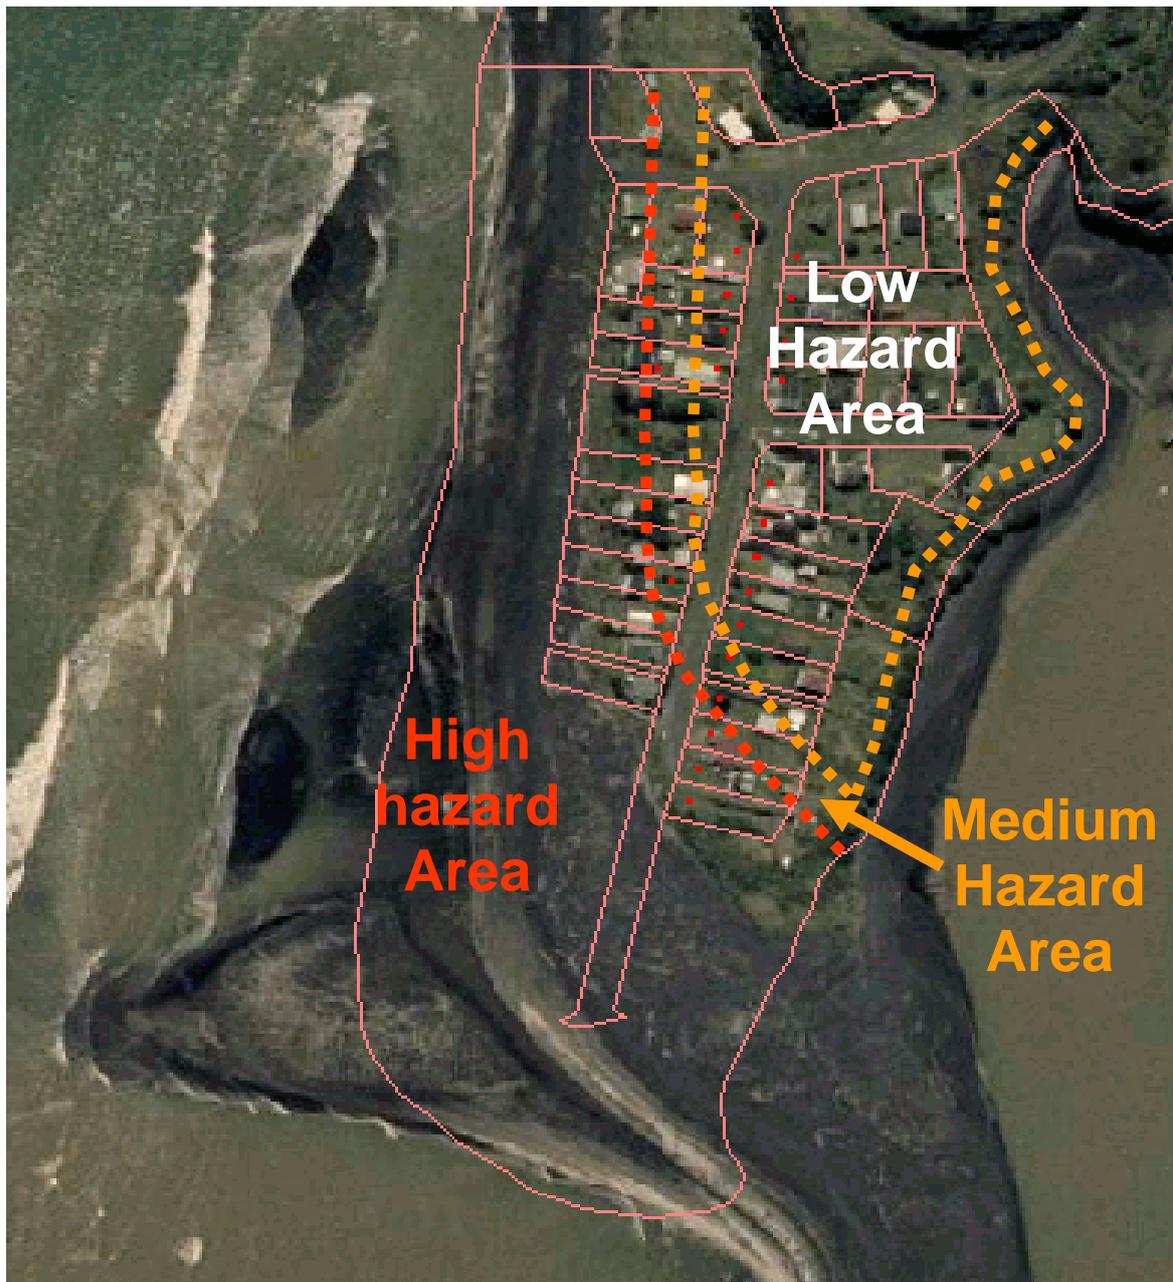
Figure 4-3 Mokau Spit Hazard areas. Source: Environment Waikato

Environment Waikato has made approximate estimates of the level of risk to different properties, identifying 3 different risk areas (Figure 4-3).

The high-risk area shown on this map is most at risk and property within this area could be lost to erosion within the next 50 years if the apparent trend for long term erosion superimposed continues (Dahm et al., 2004). The medium and low risk areas might also be affected but that the nature and scale of erosion would have to change significantly for these properties to be affected within the next few decades (Dahm et al., 2004).
