Condition report for flood protection and land management assets for all zones

For:
Waikato Regional Council
Private Bag 3038
Waikato Mail Centre
HAMILTON 3240

December 2021

Document #: 20419287

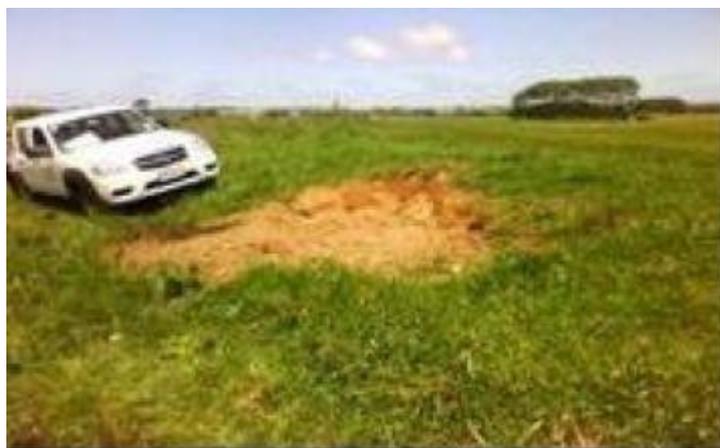
The main issues to rectify with respect to condition of stopbanks are stock damage and vegetation with deep root systems that can affect the integrity of the structure.

Stock Damage - Bull Hole

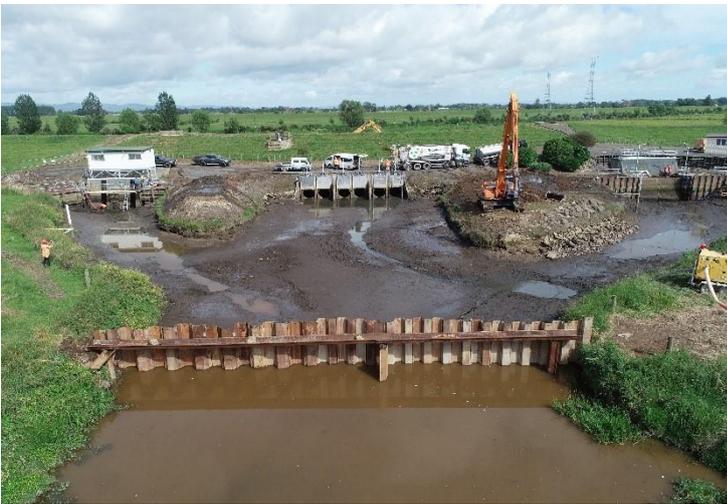
Mill Road Structural Audit – Waihou Piako Zone

Other pumpstations across the region have deteriorating component issues, including deteriorating inlets, outlets, pipes and screens.

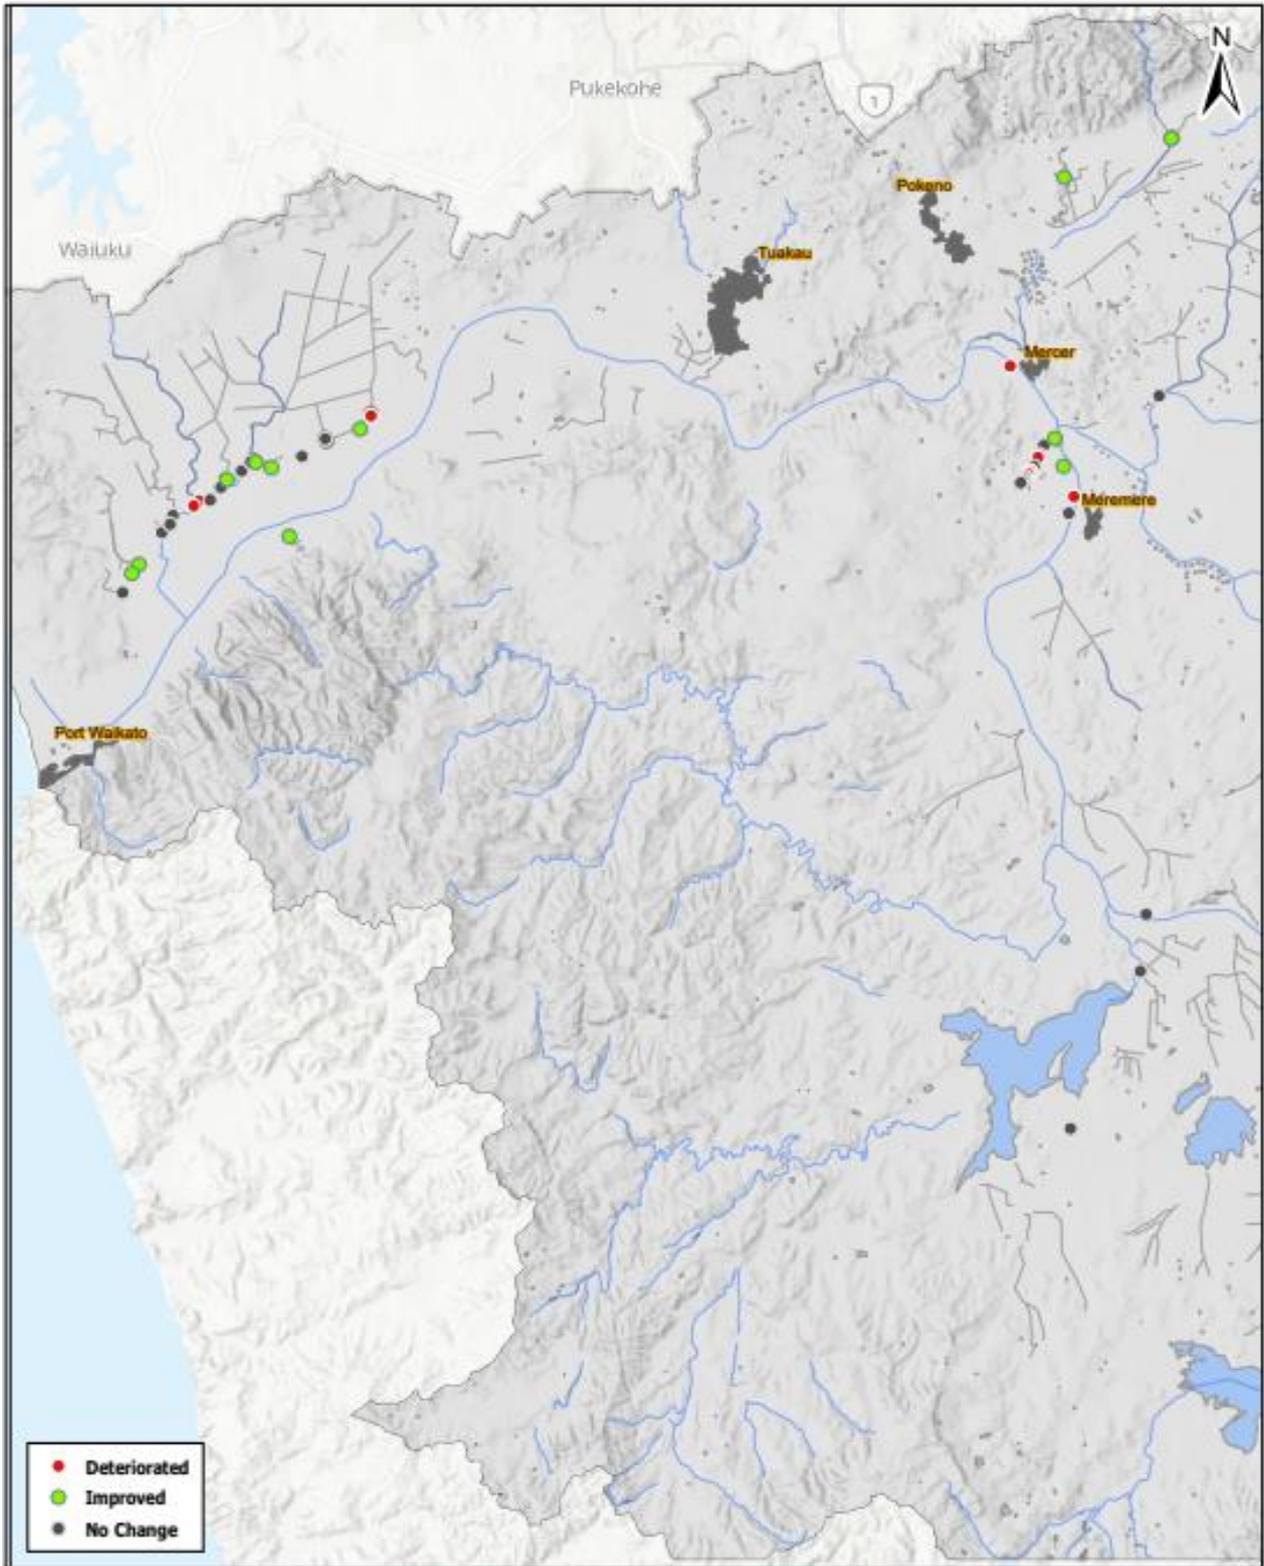
Floodgate Condition Change map.
2020-21
ICM Zone: Lower Waikato (western)

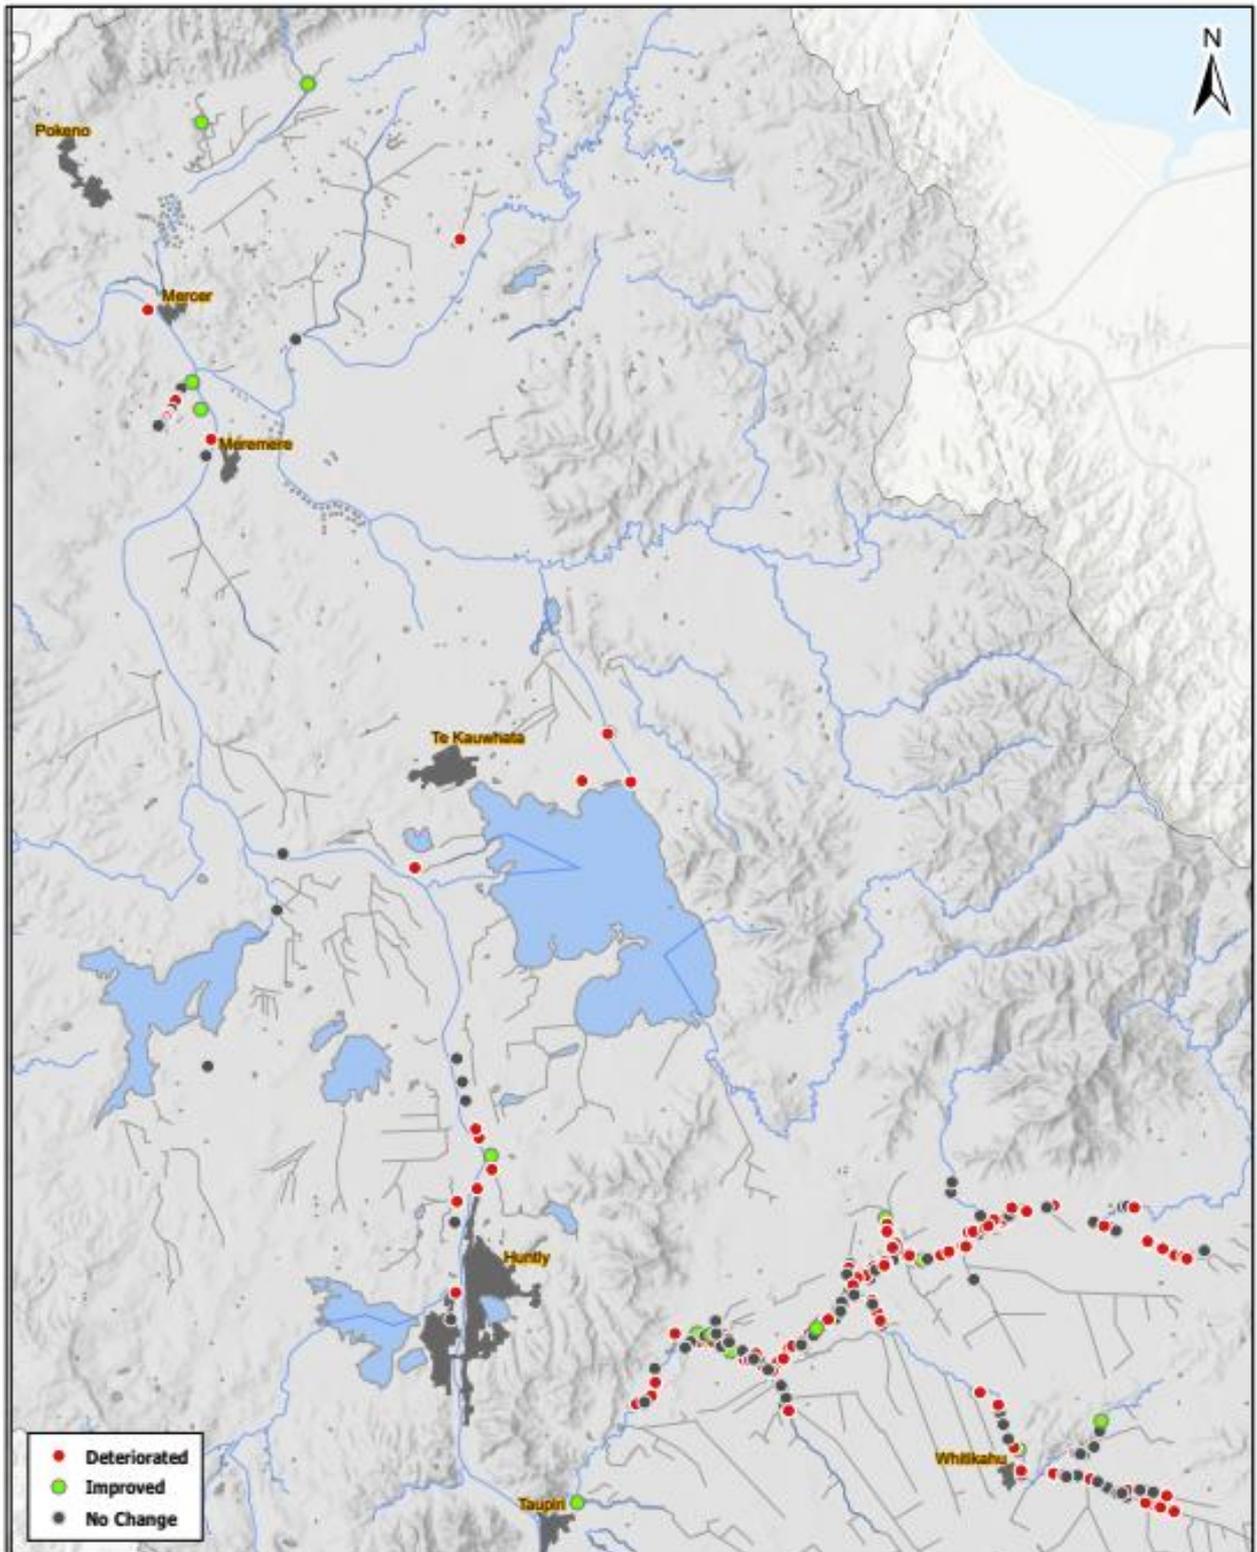
Floodgate Condition Change map.
2020-21
ICM Zone: Lower Waikato (eastern)

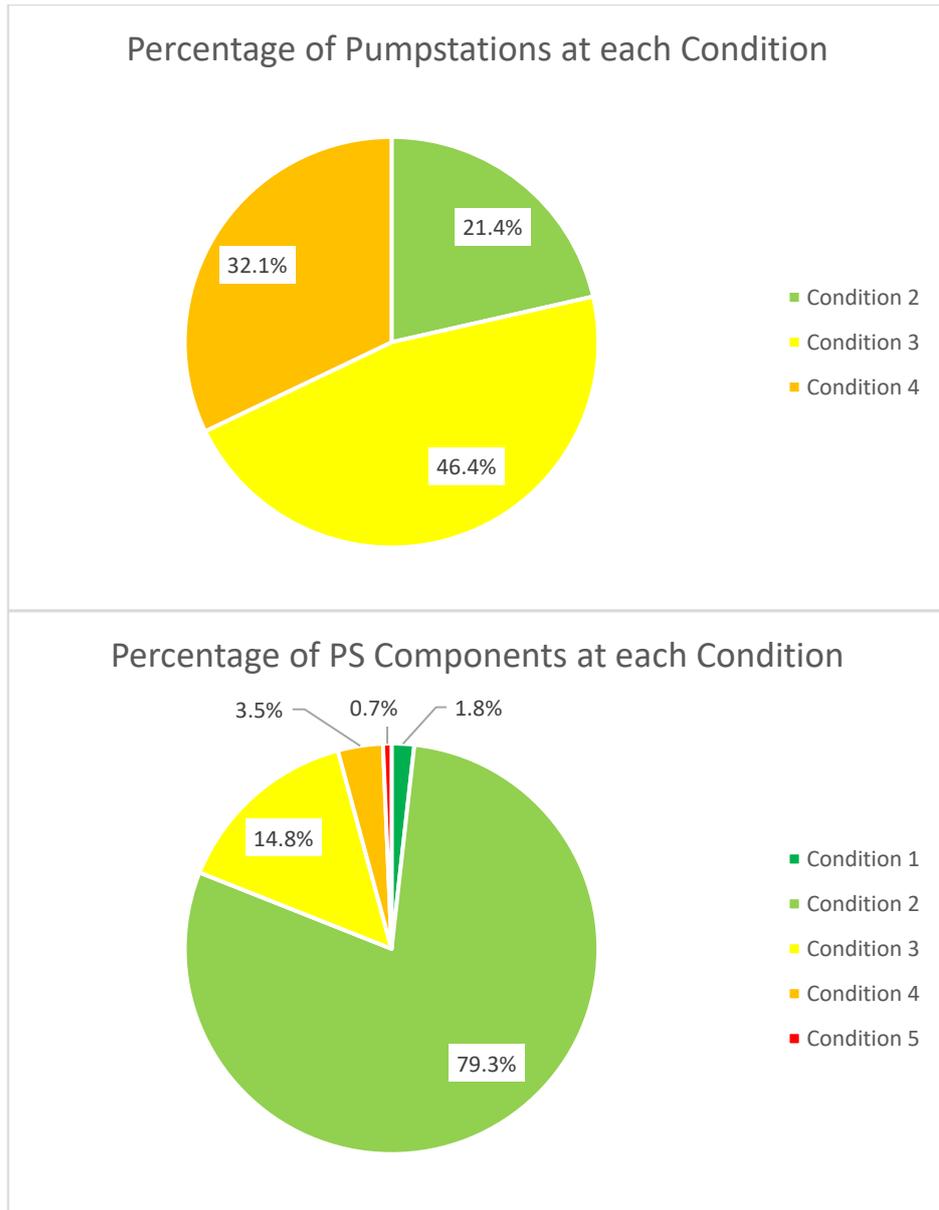
28 Pumpstations were inspected this year, with 68% of them found to be in an average to good condition, with the remaining 32% (or 9 Pumpstations) in poor condition.

Those Pumpstations in poor condition, are most likely to be in poor condition due to issues with Inlets, Outlets, Pipework, Pumps and Switchboards.

A list of both parent and child assets in a poor condition is shown below. These assets should be prioritised in any upcoming capital works programme as they present an urgent risk to the safe operating of the assets.

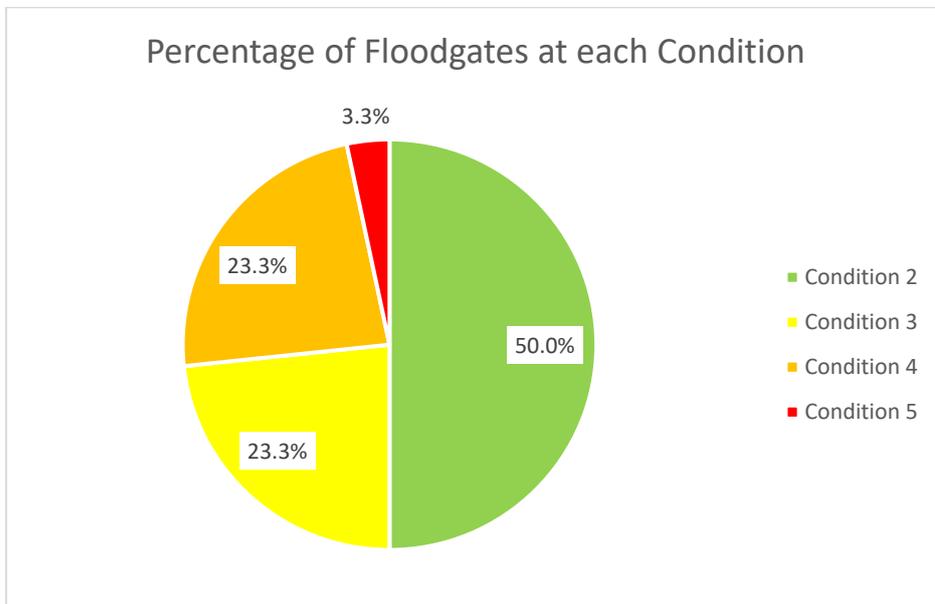
73% of the 60 floodgates are in average to good condition, meaning there are 16 floodgates that are condition 4 or 5. Where floodgates are in poor condition, it is frequently due to poor condition Inlets and Outlets; there are 6 inlets and 16 outlets in poor condition.

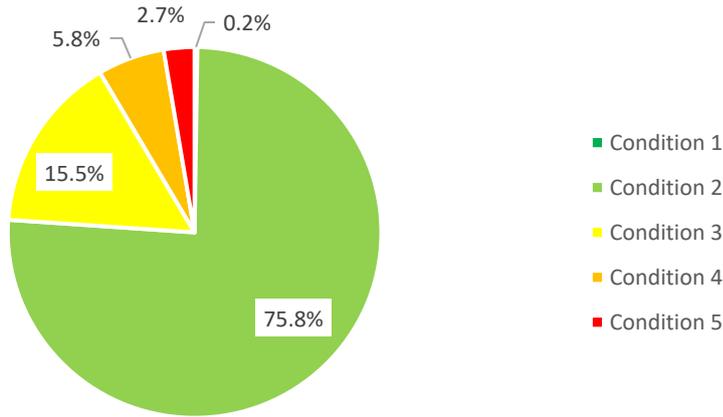
Percentage of FG Components at each Condition

100% of Round Flap Valves and Bank Revetment (Piles) had deteriorated, along with 49% of outlets and 38% of Rack and Pinion lifting gear.

The fact that Rack and Pinion lifting gear showed such high deterioration and improvement suggests a large discrepancy between the old and new condition assessment standards.

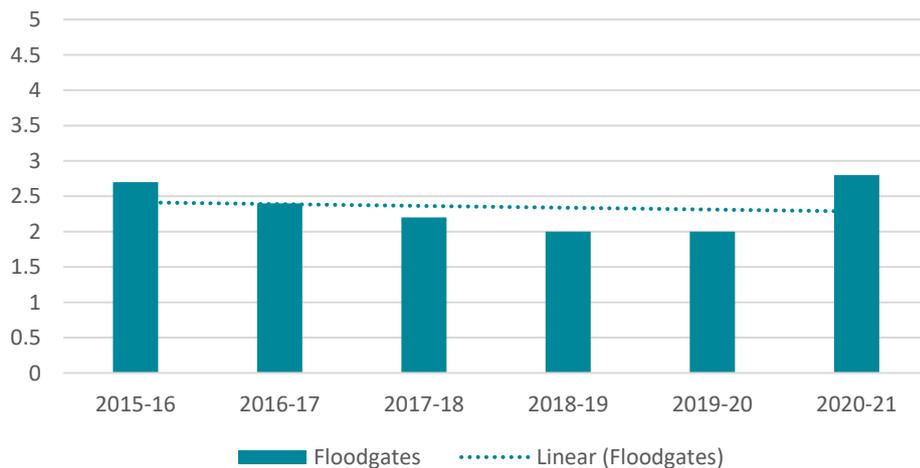
Floodgate Average Condition Over Time

Similar to the Piako Pumpstations, this year shows a significant swing towards deterioration in the average condition. This could be due to the new condition scoring criteria, represent a genuine deterioration in the asset base, or be a combination of the two.

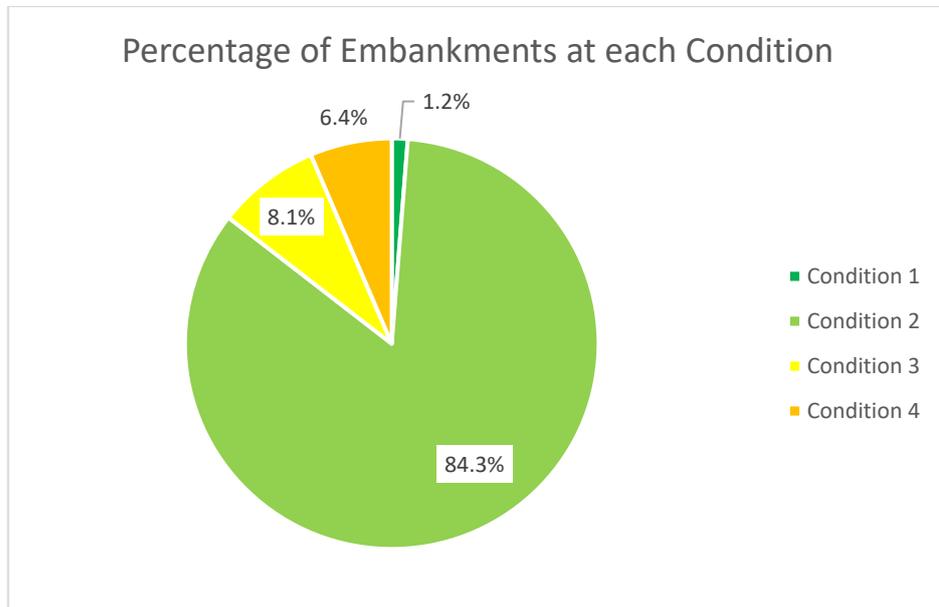
94.6% of the 133km of embankments surveyed in Piako are in average to very good condition, with 85.5% in good or very good condition. Vegetation was the concern most mentioned in the inspection notes.

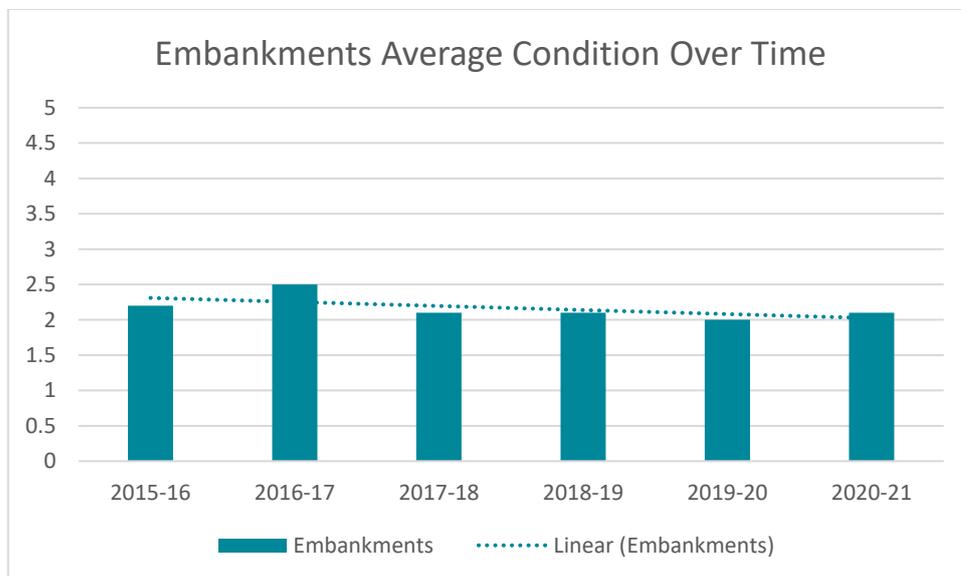
The trend is for a slow improvement in average condition; there is a very small rise this year but it is statistically negligible. Maintenance programs for stopbanks appear to be generally successful.

As seen below, Awaiti: Reservoir Canal Road to Tee Head SB is the only stopbank in poor condition currently. This has a ConQuest action for an upgrade scheduled for Summer 21/22, so the issue is being actively managed.

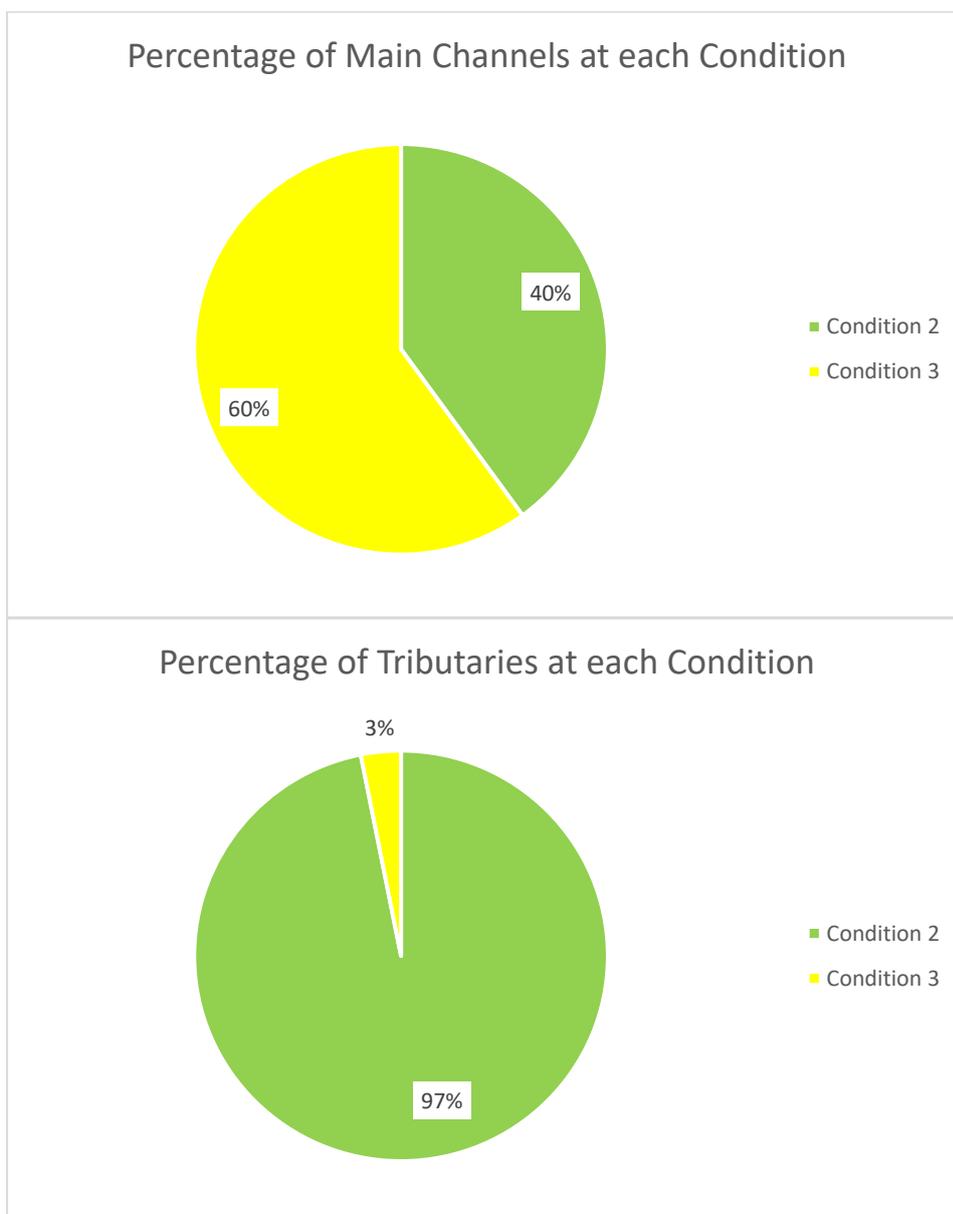
362km of Main channels and Tributaries were inspected this year, with all of it being in an average to good condition. Inspection notes mention the need for dredging of main channels and erosion as the main concerns.

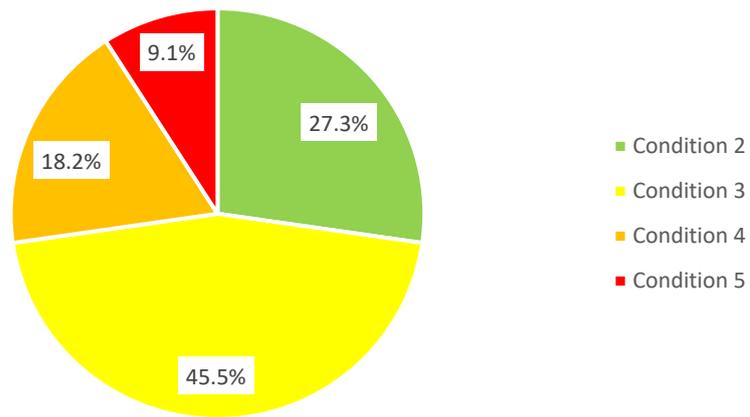
Percentage of Floodgates at each Condition

There are 11 floodgates in Thames Valley; 73% are in an average to good condition, with 3 in a poor or very poor condition.

The floodgates in a poor condition mostly had issues with Inlets and Outlets, these component asset types also showed the greatest deterioration. These asset types, along with Rack and Pinion lifting gear also showed the greatest deterioration since last year.

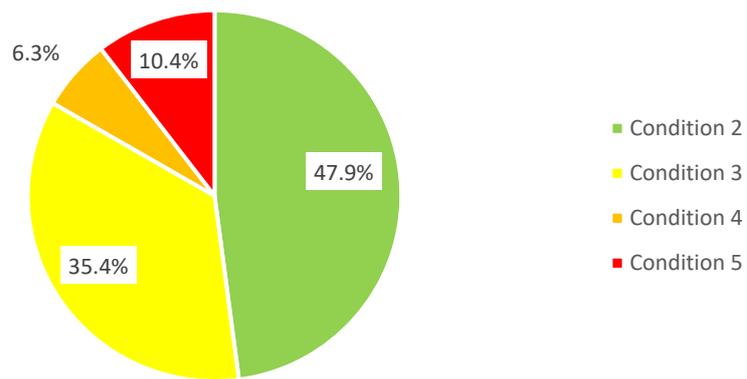
Percentage of FG Components at each Condition

Floodgate Average condition has been deteriorating steadily over the last six years. This, combined with the 55% deterioration this year suggests that there may be a large number of assets needing major attention in Thames Valley in the next 10 years. To avert this, the current maintenance schedule should be reviewed for effectiveness.
