Whangarahi River Survey Coromandel 2008

“Towards Streams for Fish Passage”

Manu Waiata Restoration & Protection Society
2009

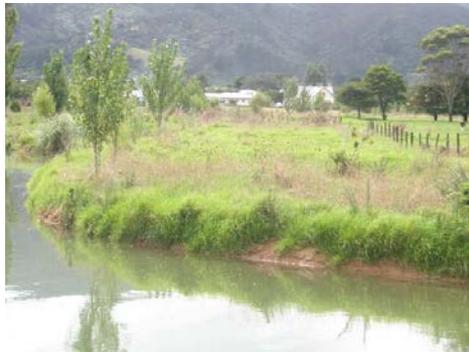
LANDOWNER Robert Alexander. Owns the large flood plain. Stony stream bed, recently dredged by EW. River banks low, clay, covered in kikuyu. No trees. Riparian margin is fenced off with electric fences. Doesn't want to interfere with flood management. However he is open to planting if it is O.K with EW. His wife is an entomologist.

An example of fenced off riparian margin with great planting potential on Robert Alexanders land.

Recommendation: Plant trees in the places that don't impose any flood danger, such as on the northern banks. There are many places like this within this property. Discuss shaping and sloping of the banks to provide a low flood apron. Include planting native grasses for inanga spawning habitat
Zoned for Peninsula Project restoration.

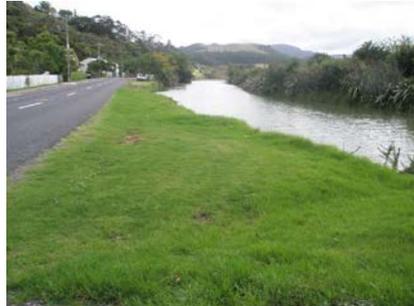
One of the places for potential planting along Hauraki road.

Recommendation: Establish tree cover alongside road edge to provide shade cover, helping keep water cool and provide food, (falling insects) for fish. There is enough room for planting, though it is only a small width. Planting here would be of tremendous value. A respectful consultation with landowners across the road needs to take place.

Discuss shaping and sloping of the banks and formation of some small bays.
Include planting of native grasses for inanga spawning habitat.
Zoned for Peninsula Project restoration.

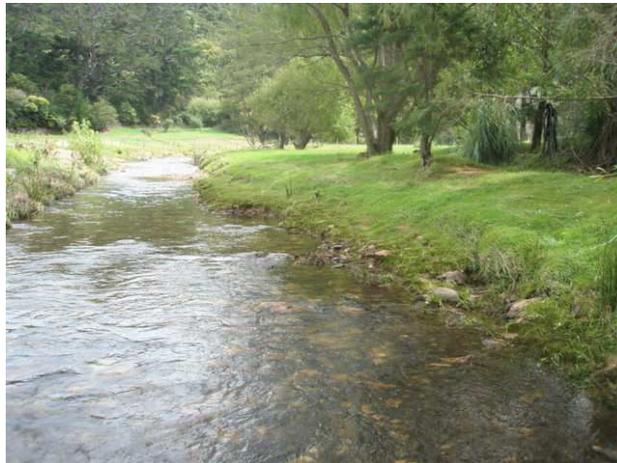
An example of riparian margin typical on Kenny Leggin's property. Just waiting to be planted.

Recommendation: Provide Landowner with riparian planting as provided for in the peninsula project.

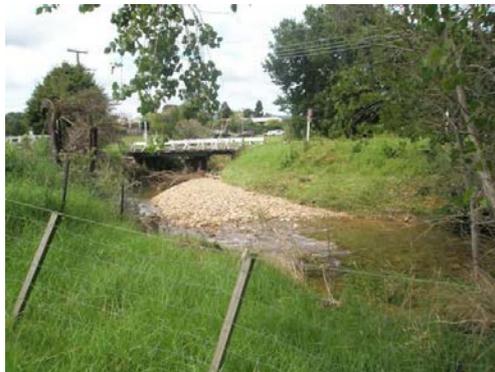
Good space for planting above the Albert st. bridge.

Recommendation: Plant trees towards Taumatawahine confluence and along the opposite bank.

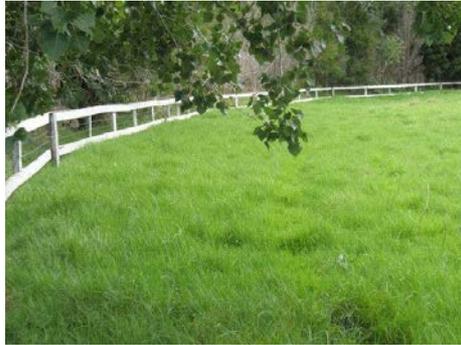
Zoned for Peninsula Project restoration The riparian strip became council owned when the area was subdivided. It is 20m wide. There is no physical indication that it exists. Not planted. Sprayed.

A small section of the riparian margin now owned by T.C.D.C. The margin is not indicated and follows along the fence line on the grassy paddocked side of the fence and is 20m wide.

Recommendation: Plant the council riparian strip in full. This is a fair deal for being able to subdivide on a flood plain.

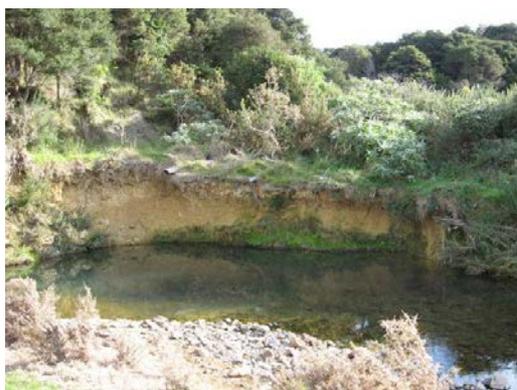
Paddocks stop on true right bank, and margin becomes gorse and teatree. There is a house with its lawn mown to the water's edge. Another sharp bend with a deep pool

Bare pool which a pohutukawa could shade

Recommendation: Again a pohutukawa would provide lovely shade for what could be a lovely pool, providing lovely habitat

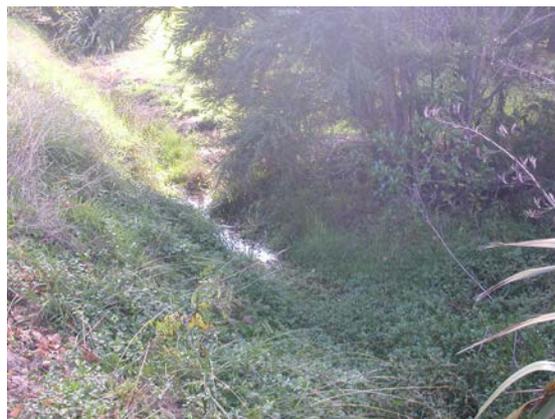
TRUE RIGHT. A side stream comes in under Hauraki road. It is weed choked but of a fair size. Locals report lots of eels present in this stream. An eel was sighted during the survey in Hauraki stream near here.

Tributary with weeds, reported to have eels.

Recommendation. Plant all the banks to create shade to help prevent weed continuing weed congestion. Remove the weeds. Fence off the stream.

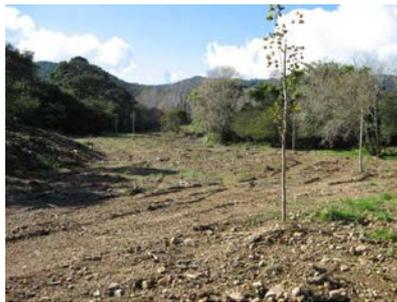
A river bend with an alluvial fan. There has been a major clearance here followed with a line of willows planted.

Clearance with willows planted on the alluvial fan.

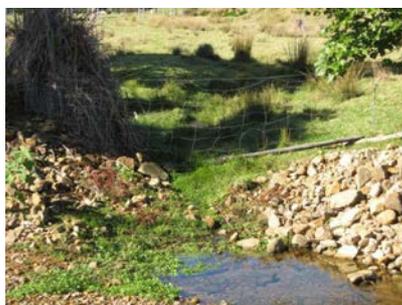
“Pound creek”. Small overgrown tributary on true left bank, grazed by sheep. Banks not fenced off.

Possible site for wetland restoration.

Recommendation: Recreate a wet land here if the owner agrees.

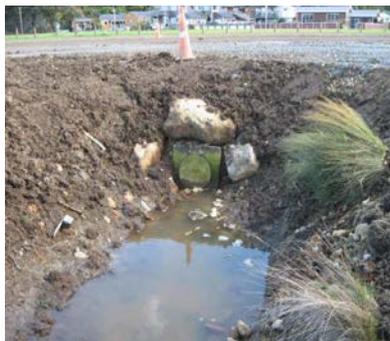
1. PATUKIRIKIRI.

Once a drain, documented of old as a stream, fish to enter the Patukirikiri must negotiate a closed concrete lid!

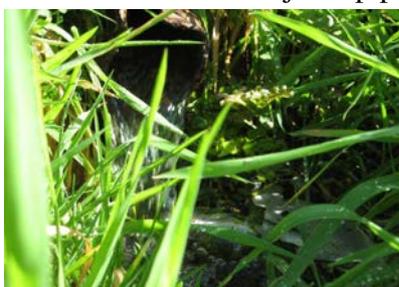
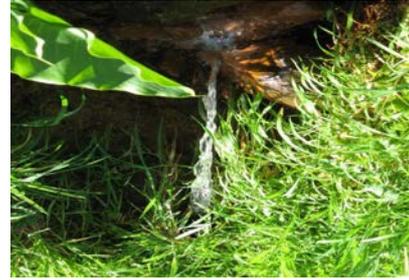
2. DISJUNCT PIPE

A small stream enters the Whangarahi on the true right bank about half way between where it flows between Albert street and Te Tiki road. Fish passage into this stream is impossible due to two small disjunct pipes.

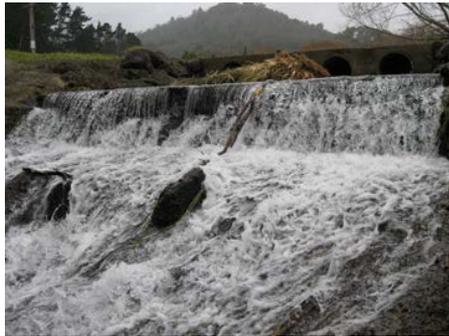
3. CULVERT / WATERFALL AT THE PETOTE-CADMAN STREAM CONFLUENCE.

The Karaka river finishes where the Petote and Cadman stream flow into it. The Petote flows into the confluence over a dam and waterfall obstructing fish passage.

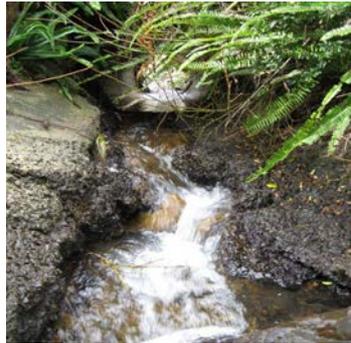
5. CULVERT ON DRIVEWAY AT THE END OF ALBERT ST.

While some fish may be able to negotiate this culvert, it exists in an area that would otherwise be habitat for fish that can't climb (inanga) for some way upstream if the stream were in natural condition.

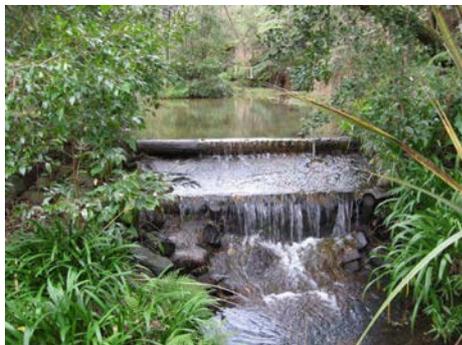
6.a. PROPERTY WITH POND AND DAM.

This dam obstructs fish passage.

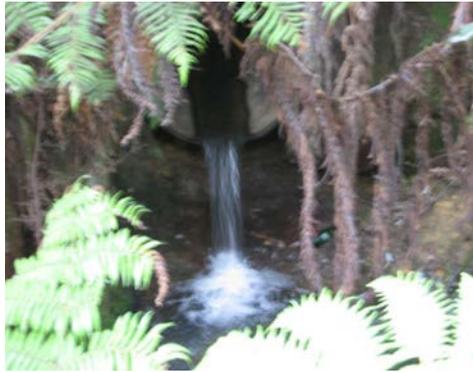
7. DISJUNCT CULVERT AT THE END OF EDWARD ST.
This culvert makes for impossible fish passage.

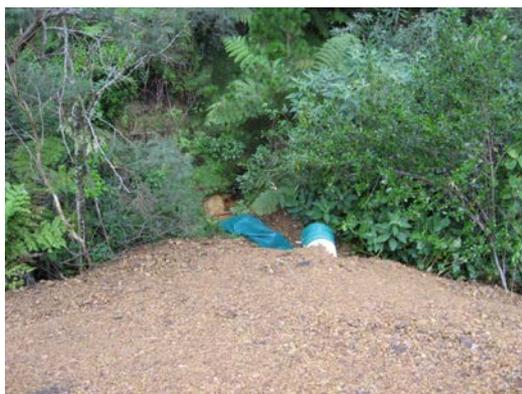
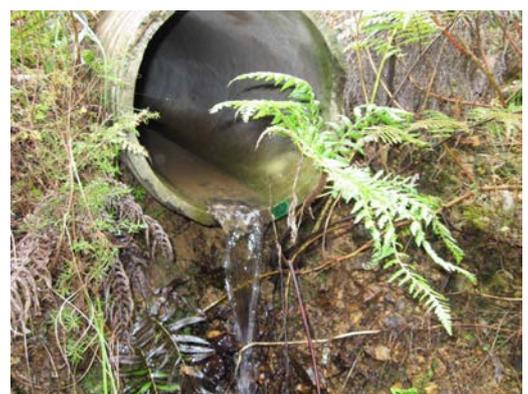
8. TWO DISJUNCT CULVERTS UNDER HOUSE SITE.
These culverts are just off the main stem of Greenhills stream in a tributary as it enters the main ranges. The house site is located in upper Edward St. A pile of earth over 10 meters high covers two branches of this stream for the house site. One pipe is set far too high with a plastic sleeve, the other is just far too high.

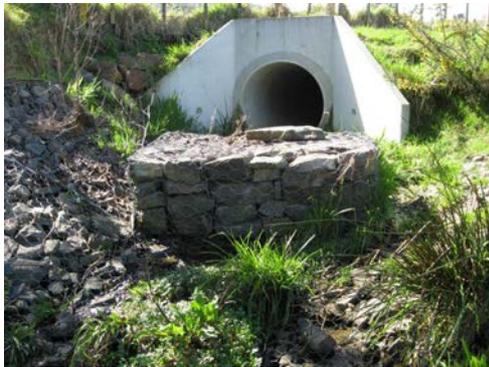
9. DISJUNCT CULVERT ENTRANCE AT CONFLUENCE WITH THE WHANGARAHI.

A large Gambian basket has been placed at the stream mouth in front of the culvert severely obstructing fish passage.

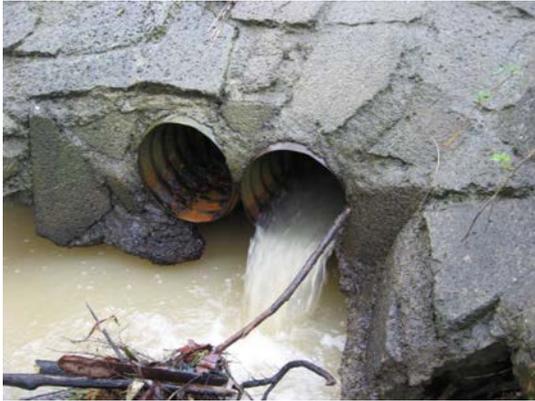
11. DISJUNCT CULVERT

This culvert is part of a private driveway. It is set above the stream at normal flow levels.

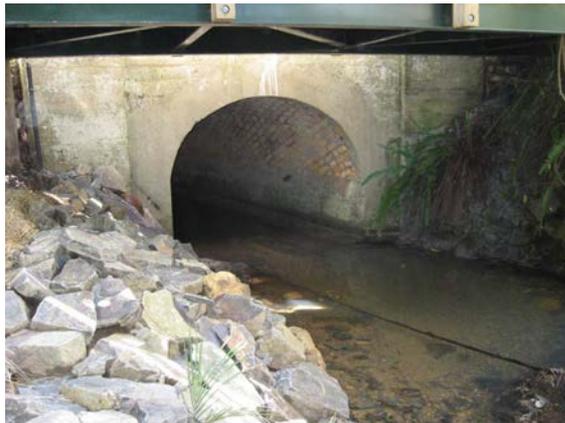
12b. PIPED DRAIN ENTRANCES FLOWING INTO THE CULVERT UNDER RINGS RD.

This drain was until 2008 an open streamlet that native fish used to access spring-fed ponds on nearby private properties. The pipe is 67 meters long with no light and three changes of angle. The three manholes have lids instead of grills, creating total darkness. 3 springs once fed the flow. The flow has been divided between the new pipe and a new open stream bed, diminishing fish passage.

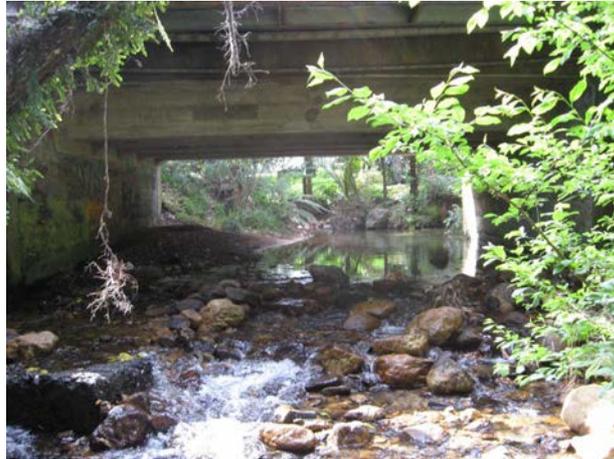
13. RINGS ROAD BRIDGE

Bridges are the best type of structure for roads crossing streams.

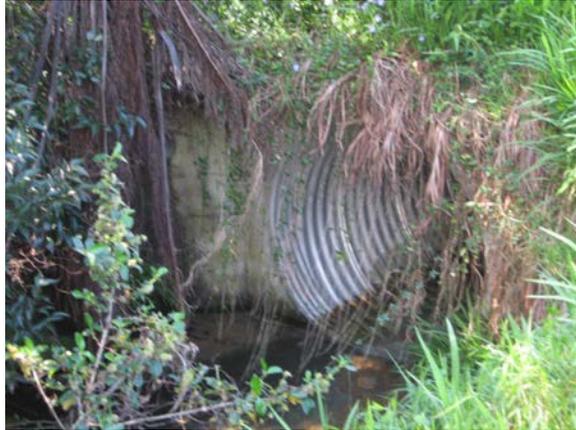
17. CULVERT NEAR RINGS ROAD.

A nice low set large culvert providing for fish passage.

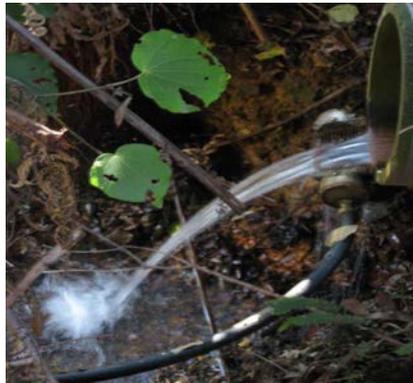
18. CULVERT UNDER RINGS ROAD.

All fish passage stops with this culvert!

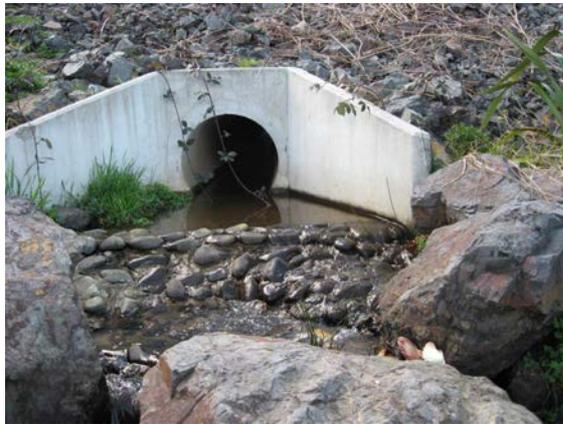
19. 1st CULVERT IN BEACH LANE SUB-DIVISION.

This culvert was set too high. Some attempt at mitigating the effects has been made. A rocky fish ladder has been set in front. If the culvert hadn't been set high the passage would have been relatively smooth.

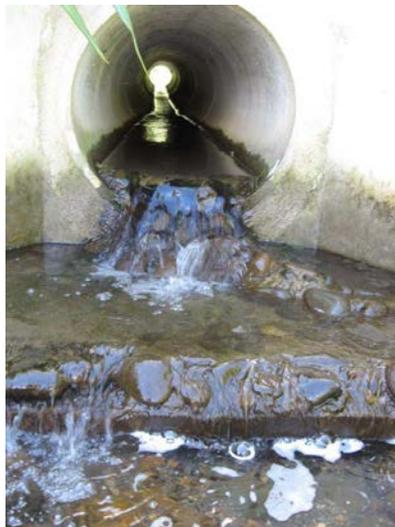
20.2nd CULVERT IN BEACH LANE SUB-DIVISION.

This culvert also has a fish ladder. This recently placed culvert would have been much better by being set lower.

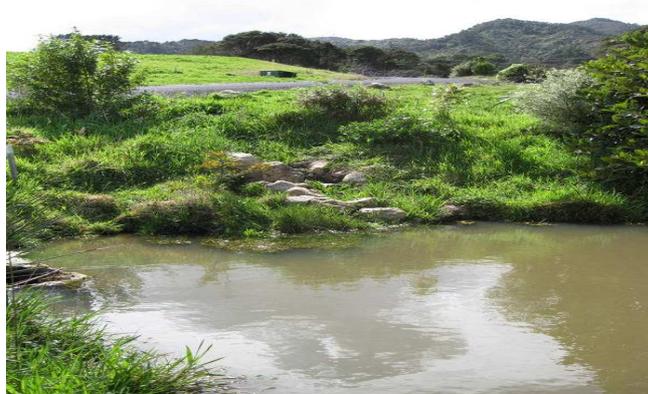
23. POND WITH PIPE RUNNING IN.

This pond is fed by a pipe that fish cannot enter. The pipe entrance is hidden under the boulders in the background.

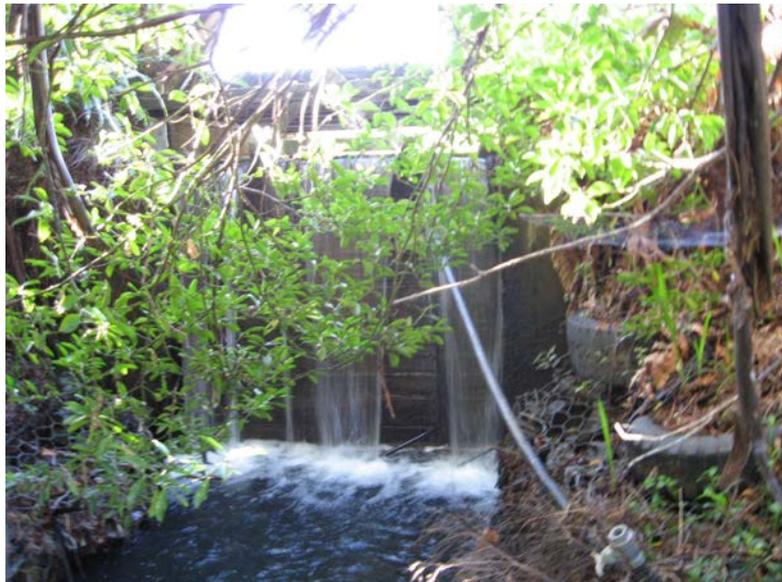
25.DAM LEADING INTO PRIVATE POND.

This dam makes fish passage impossible very near to the beginning of the upstream journey.

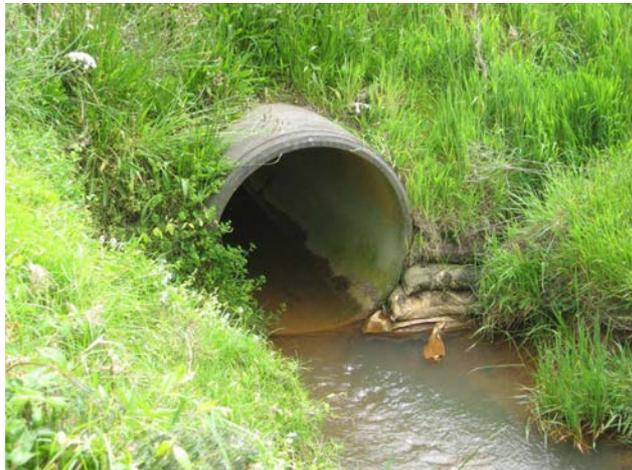
27. CULVERT UNDER DRIVEWAY.

This culvert is set well, allowing an unbroken flow.

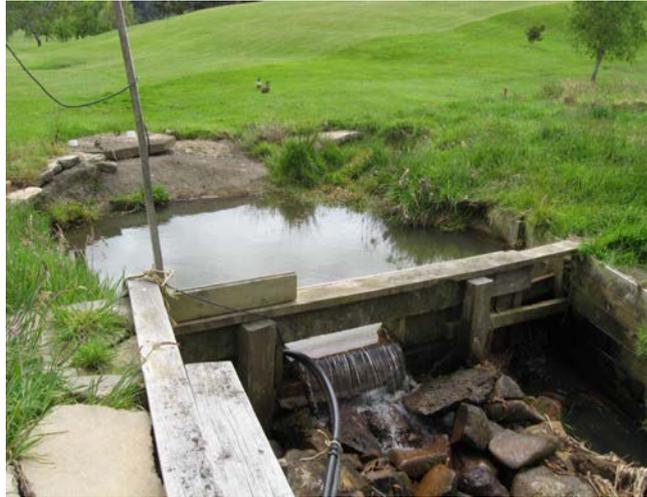
28. OUT FLOW FROM LONG CULVERT UNDER THE GOLF COURSE.

This entrance is inadequate for fish passage as seen in this photo. The dammed flow hard to see on the lower right is adjustable. It does improve when this is lowered. From this pond the stream is piped for about a kilometer.
